SCALY BARK CREEK MITIGATION SITE
Stanly County, NC
DENR Contract 002030

Restoration Plan
May 14, 2010

SCALY BARK CREEK MITIGATION SITE Restoration Plan

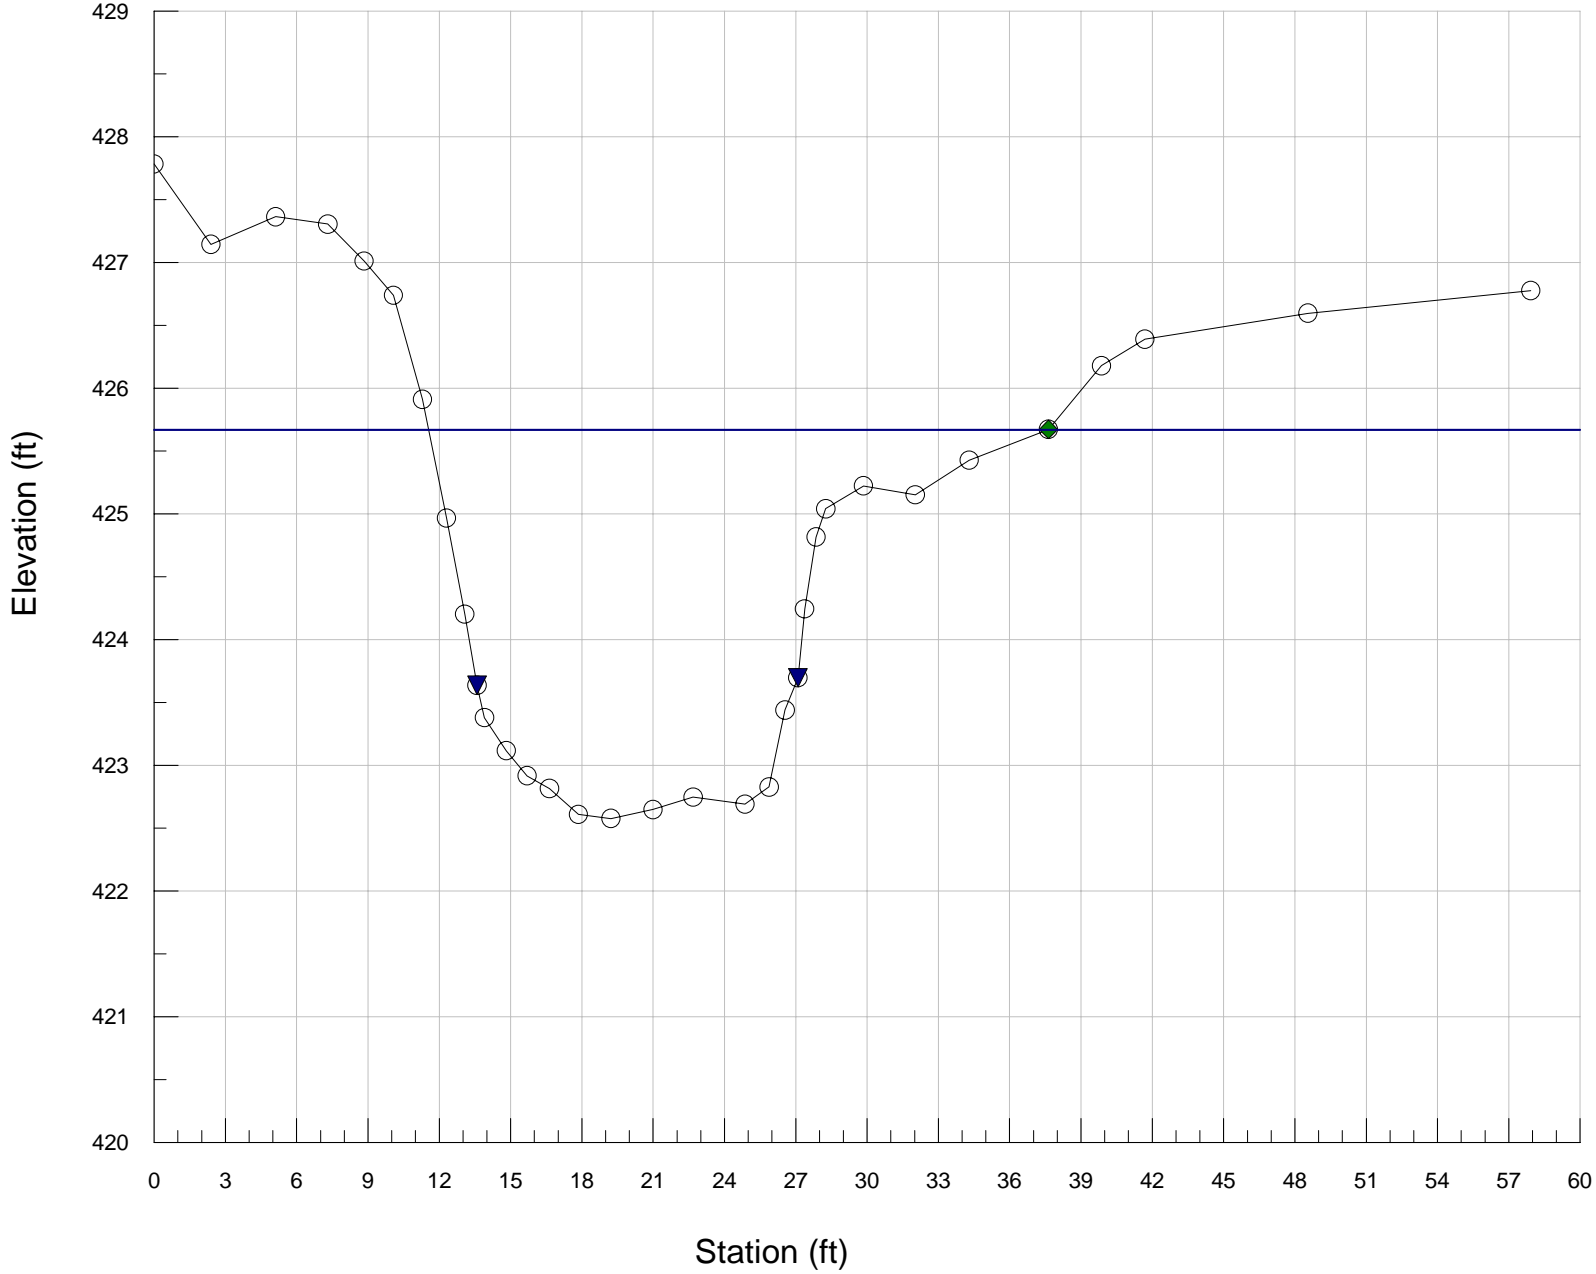
X1 Pool US Scaly Bark
RIVERMORPH CROSS SECTION SUMMARY

River Name: Scaly Bark Creek
 Reach Name: Reach 1
 Cross Section Name: Scaly Bark X1 Pool
 Survey Date: 11/10/09

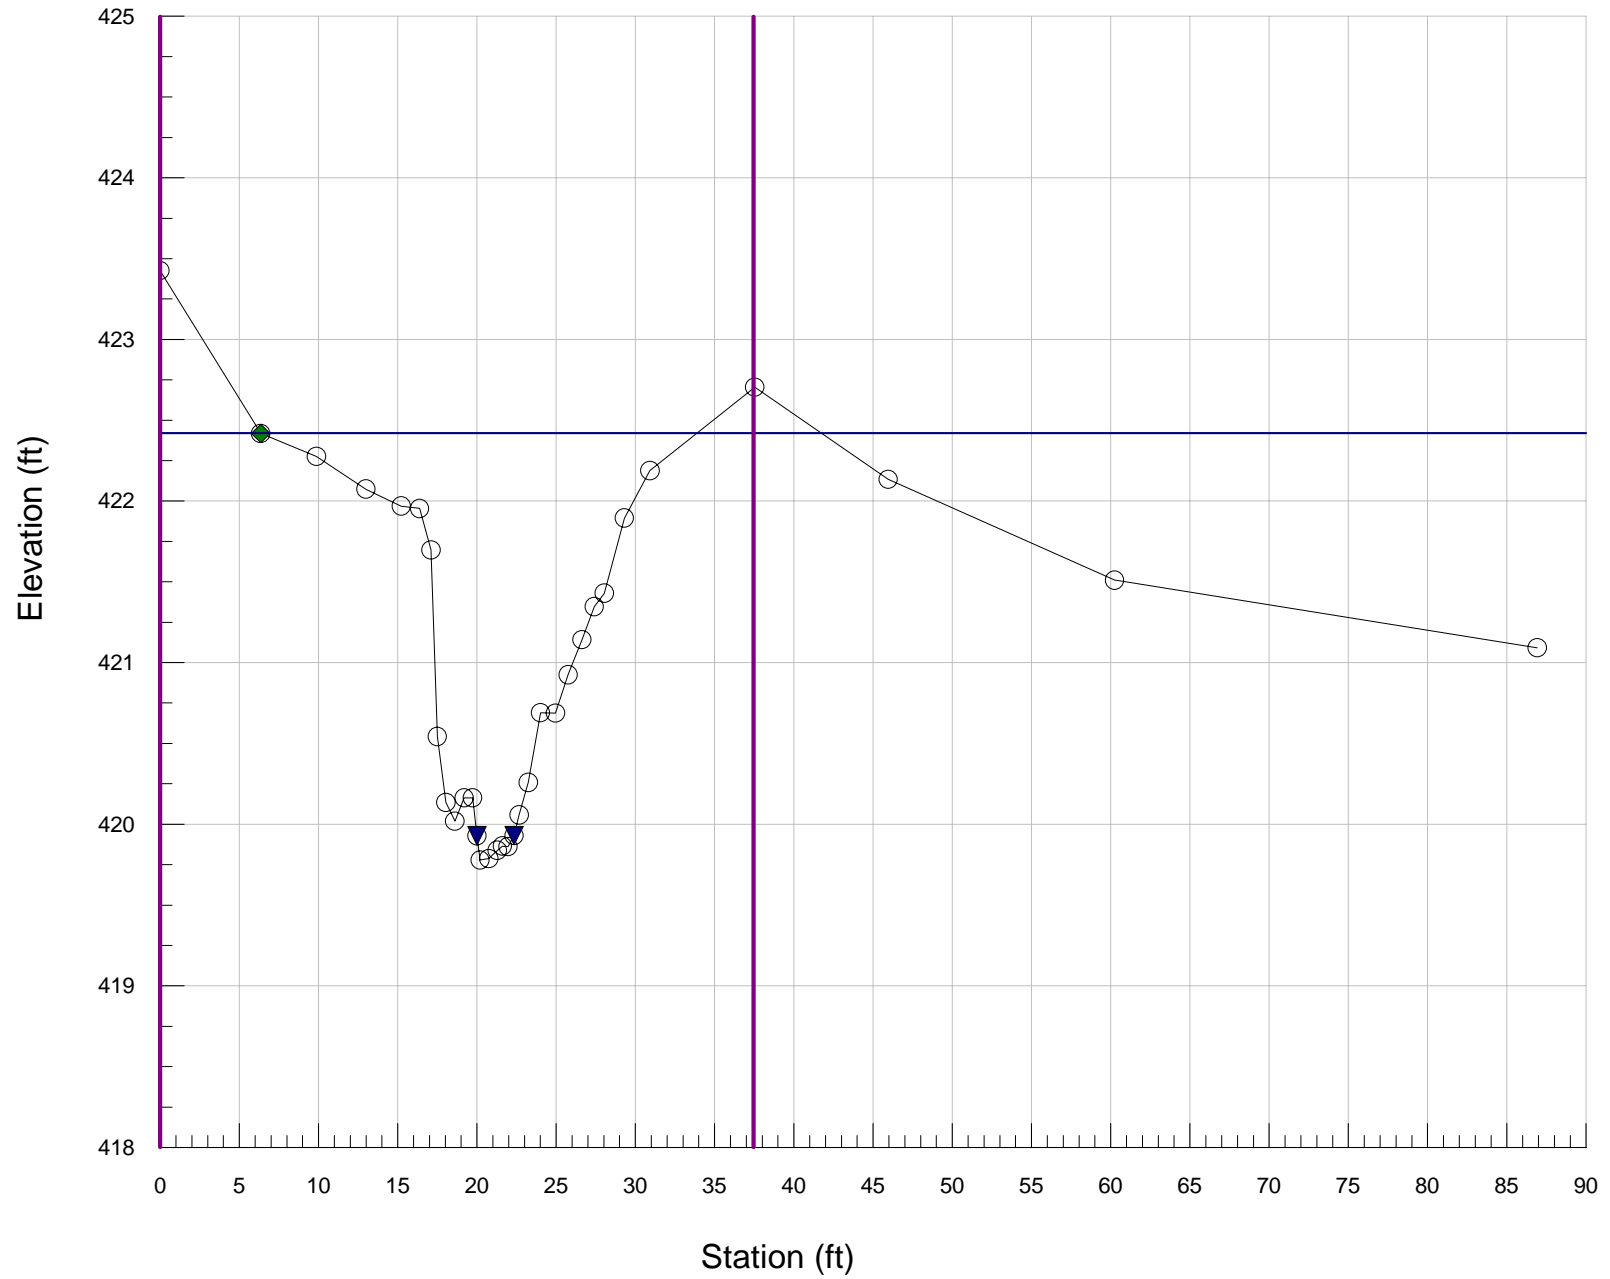
X2 Riffle US Scaly Bark
RIVERMORPH CROSS SECTION SUMMARY

River Name: Scaly Bark Creek
 Reach Name: Reach 1
 Cross Section Name: Scaly Bark X2 Riffle
 Survey Date: 11/10/09

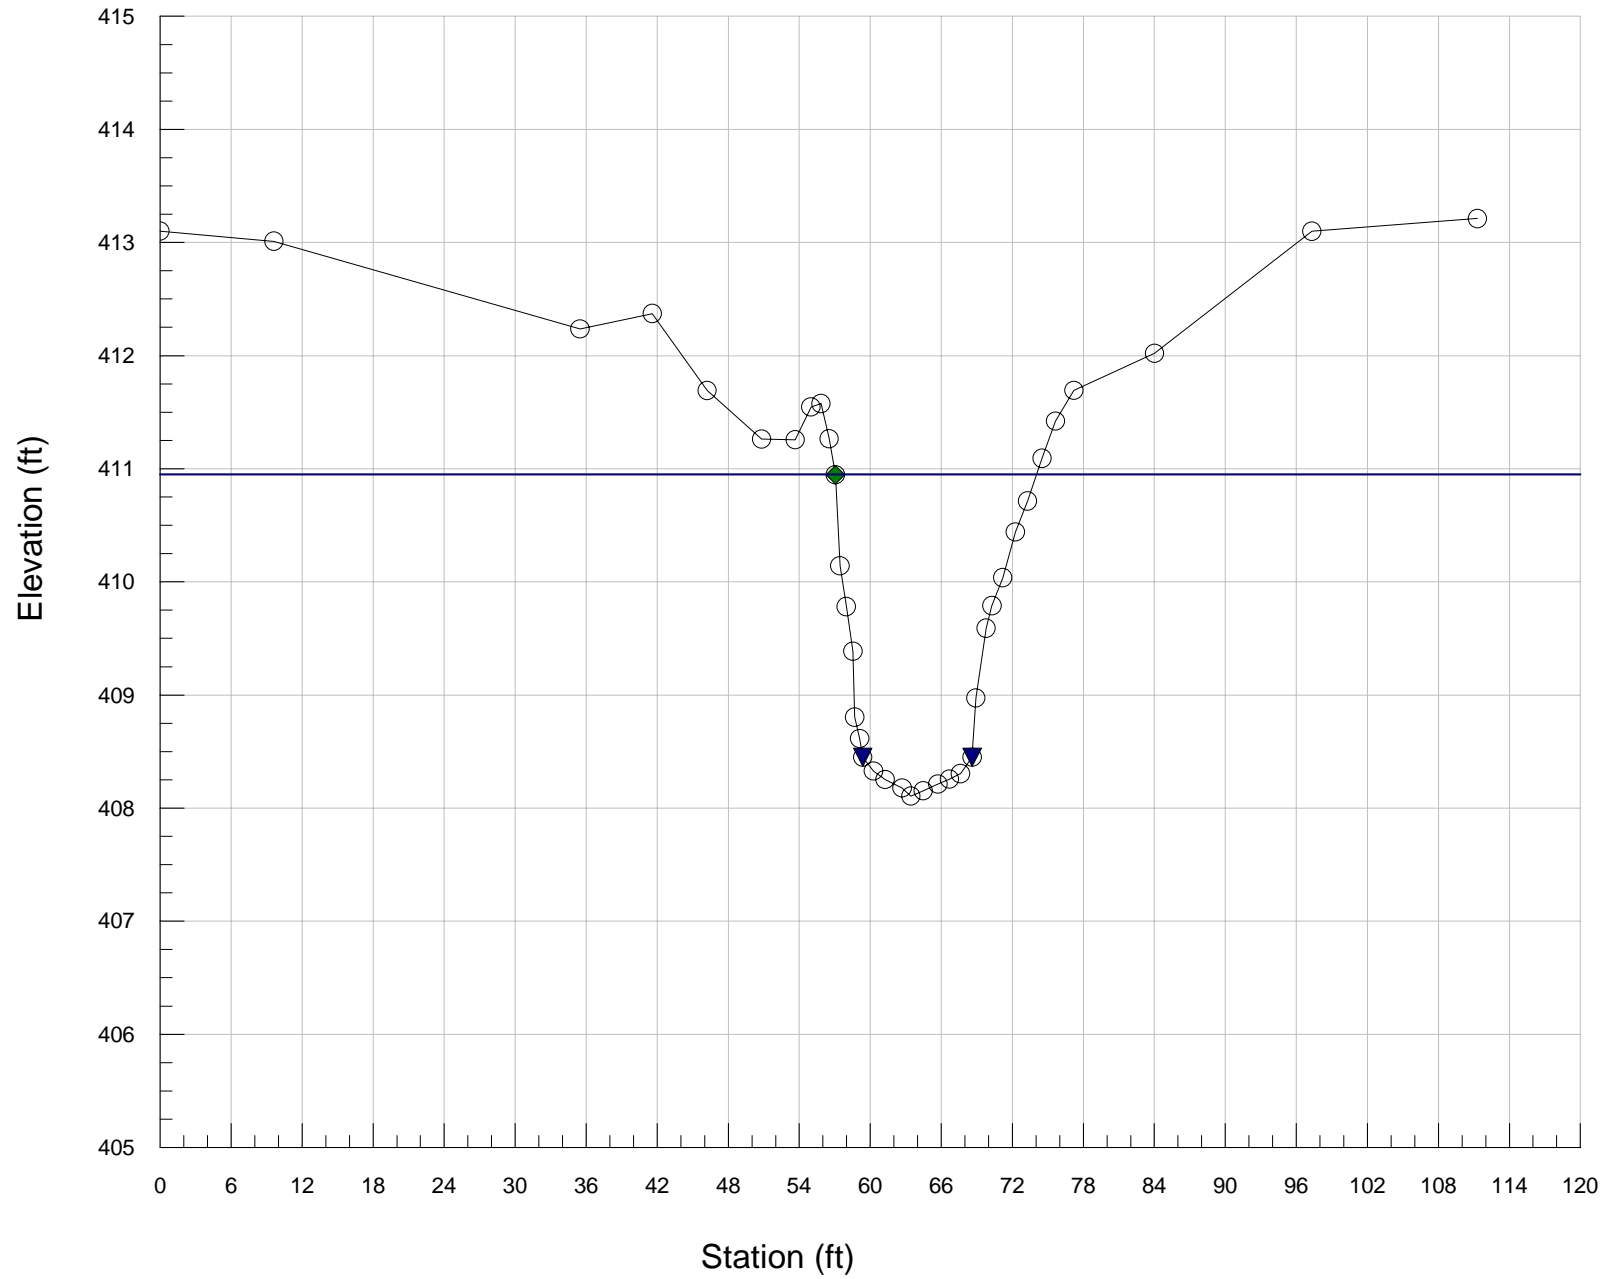
X3 Riffle MS Scaly Bark
RIVERMORPH CROSS SECTION SUMMARY

River Name: Scaly Bark Creek
 Reach Name: Reach 2
 Cross Section Name: Scaly Bark X3 Riffle
 Survey Date: 11/10/09

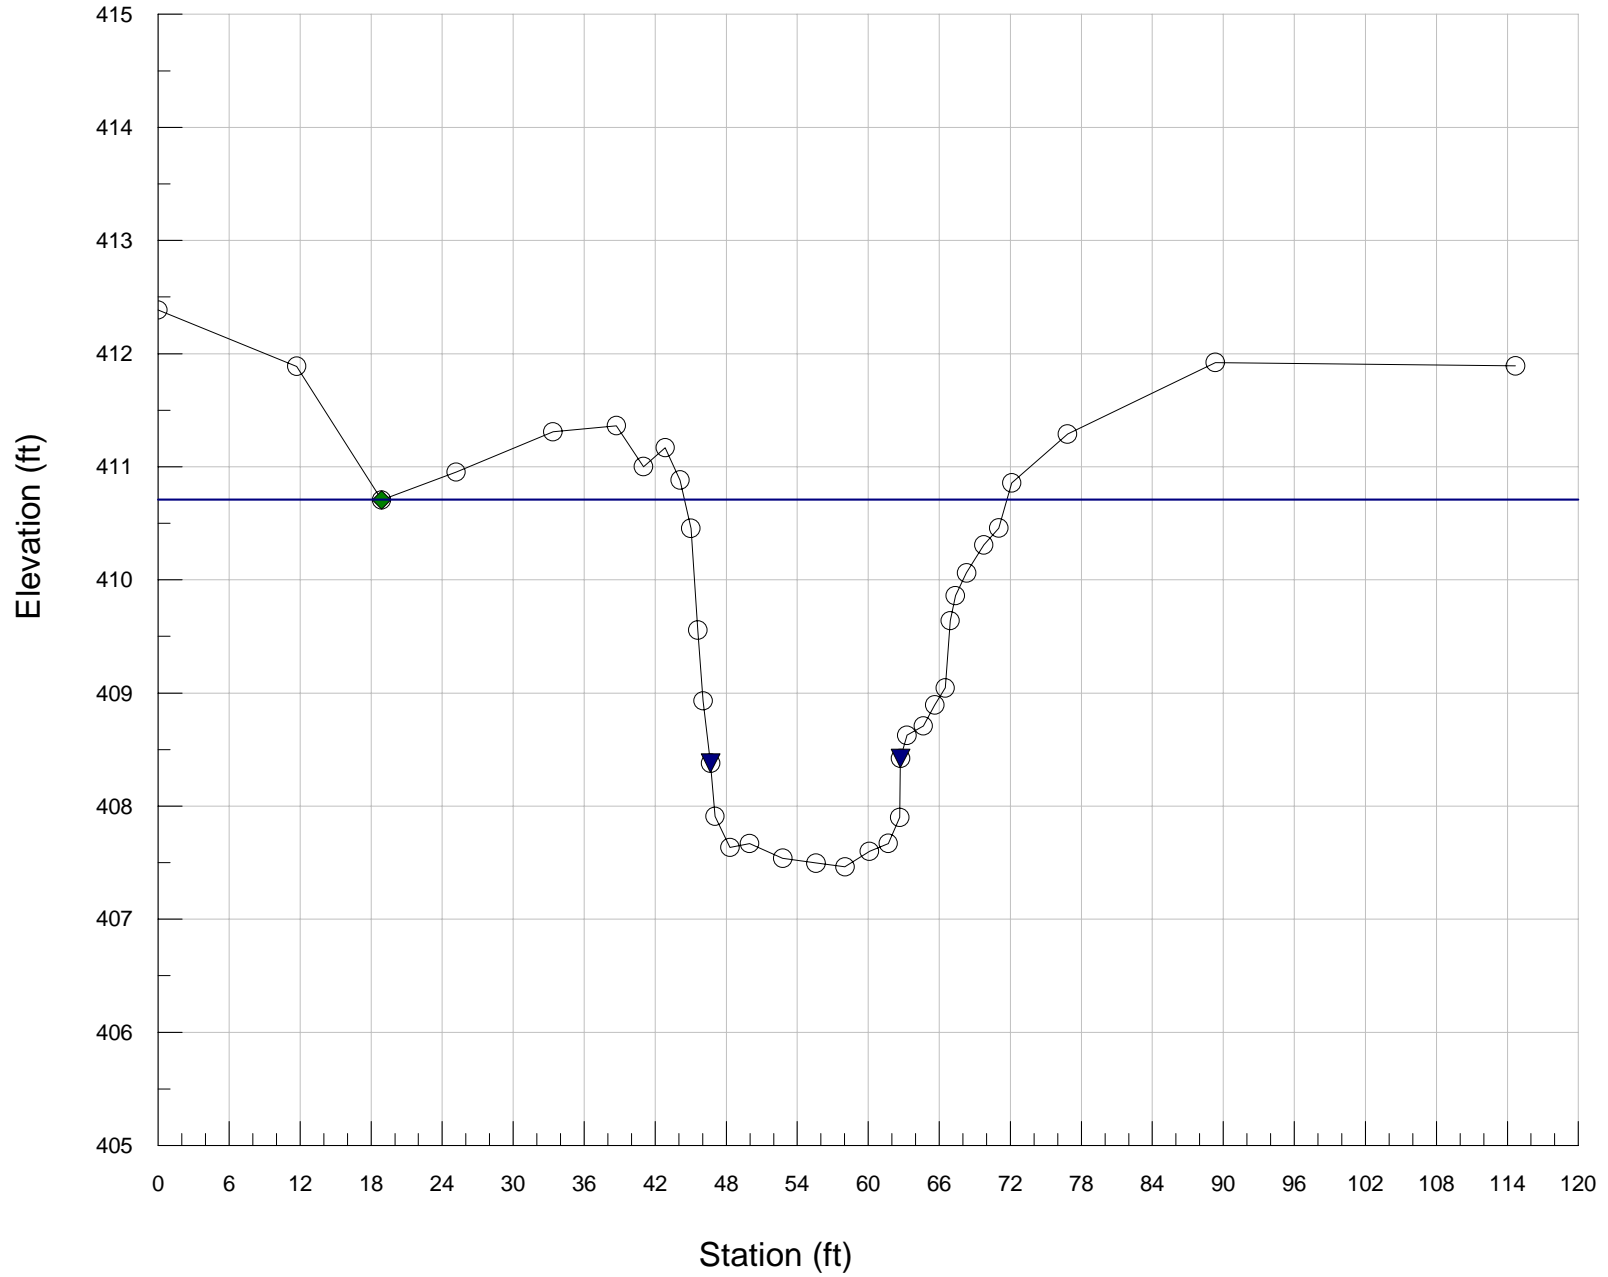
X4 Pool MS Scaly Bark
RIVERMORPH CROSS SECTION SUMMARY

River Name: Scaly Bark Creek
 Reach Name: Reach 2
 Cross Section Name: Scaly Bark X4 Pool
 Survey Date: 11/10/09

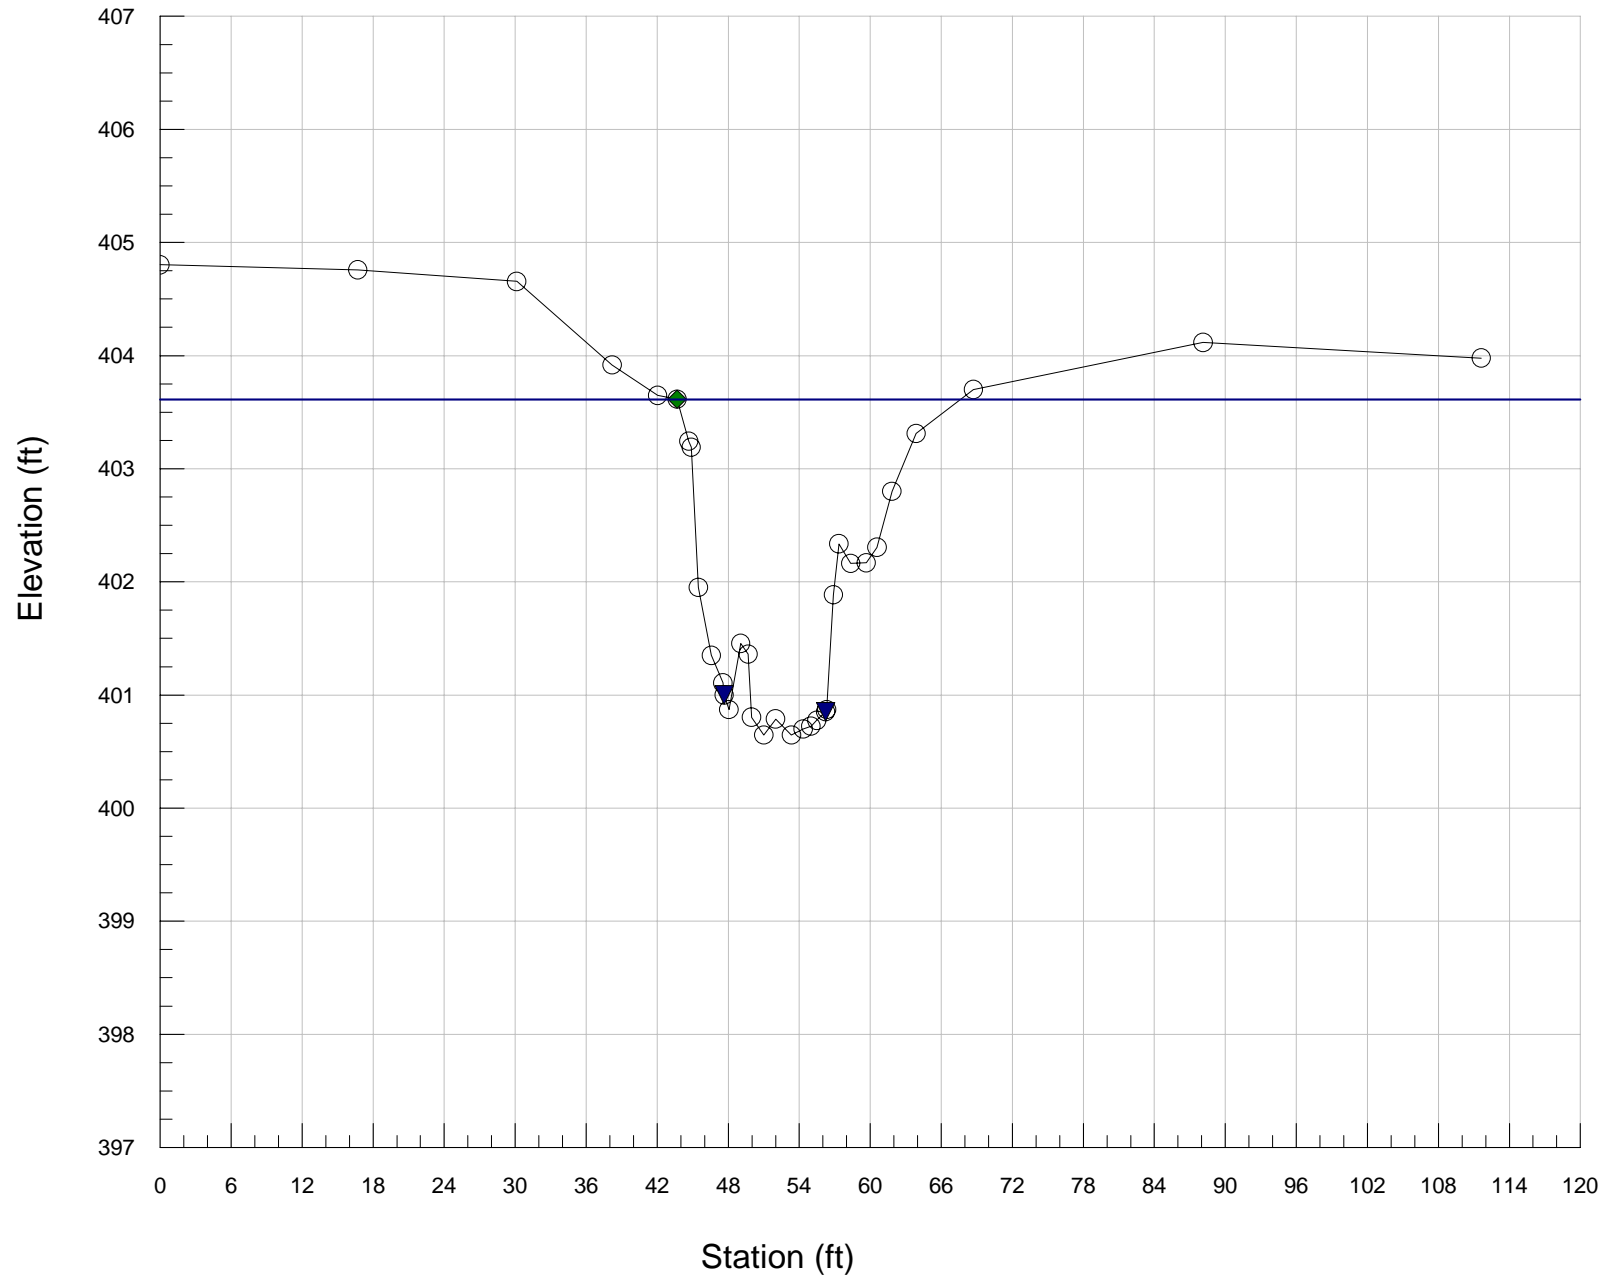
X5 Riffle DS Scaly Bark
RIVERMORPH CROSS SECTION SUMMARY

River Name: Scaly Bark Creek
 Reach Name: Reach 3
 Cross Section Name: Scaly Bark X5 Riffle
 Survey Date: 11/10/09

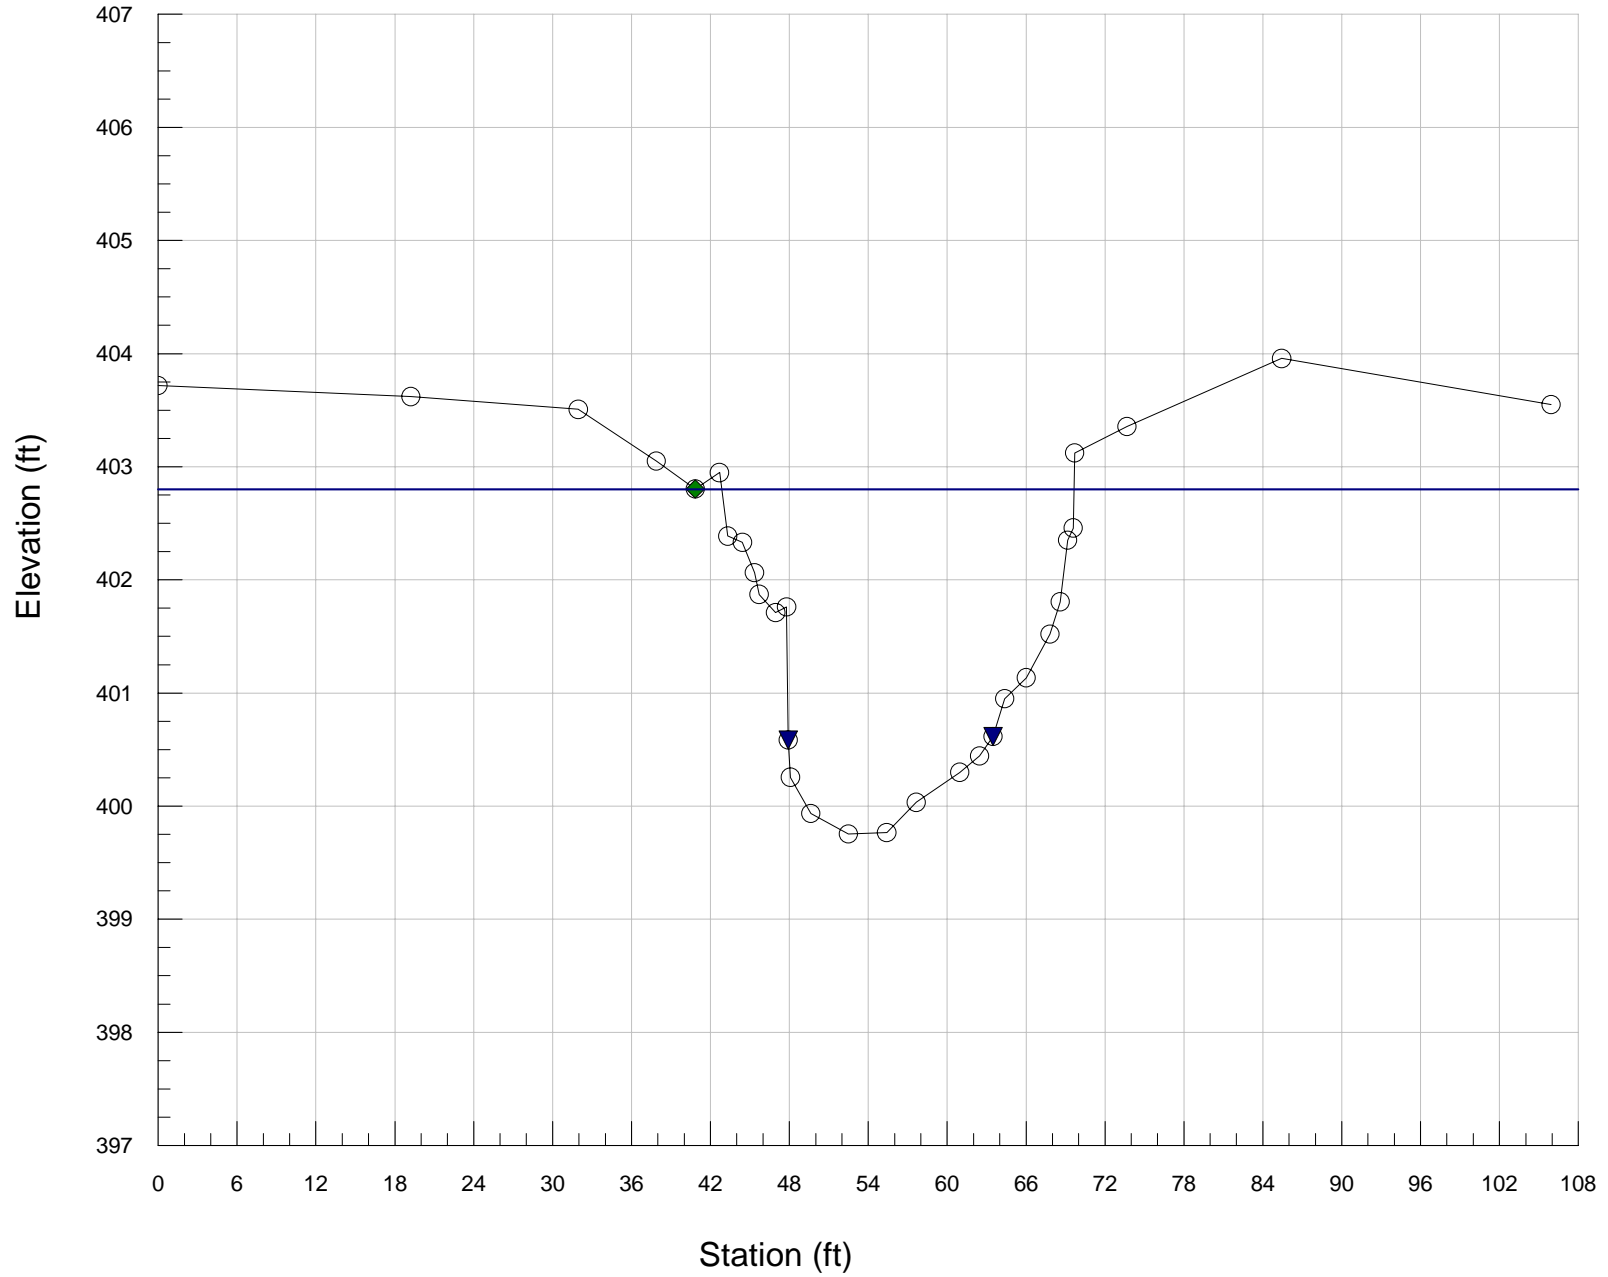
X6 Pool DS Scaly Bark
RIVERMORPH CROSS SECTION SUMMARY

River Name: Scaly Bark Creek
 Reach Name: Reach 3
 Cross Section Name: Scaly Bark X6 Pool
 Survey Date: 11/10/09

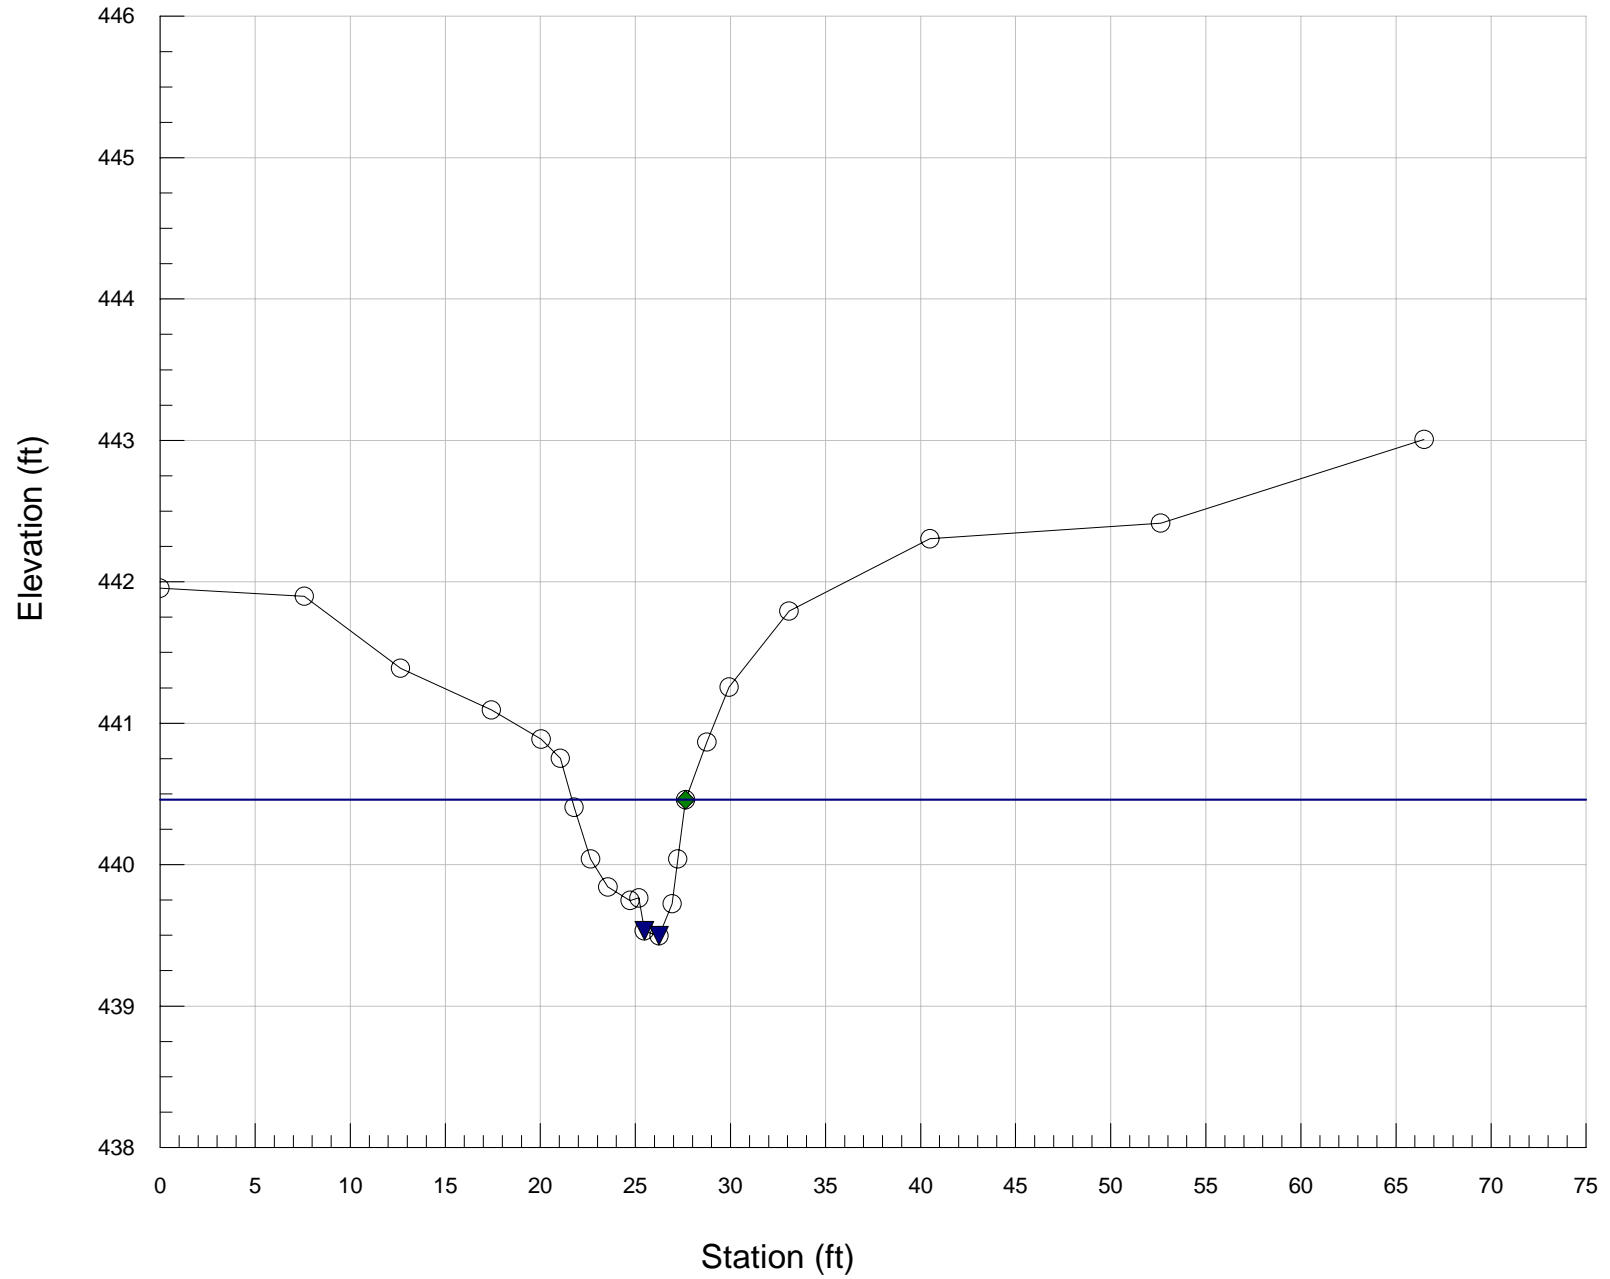
X7 Rifle UT1a
RIVERMORPH CROSS SECTION SUMMARY

River Name: UT1
 Reach Name: UT1a
 Cross Section Name: UT1a X7 Rifle
 Survey Date: 11/05/09

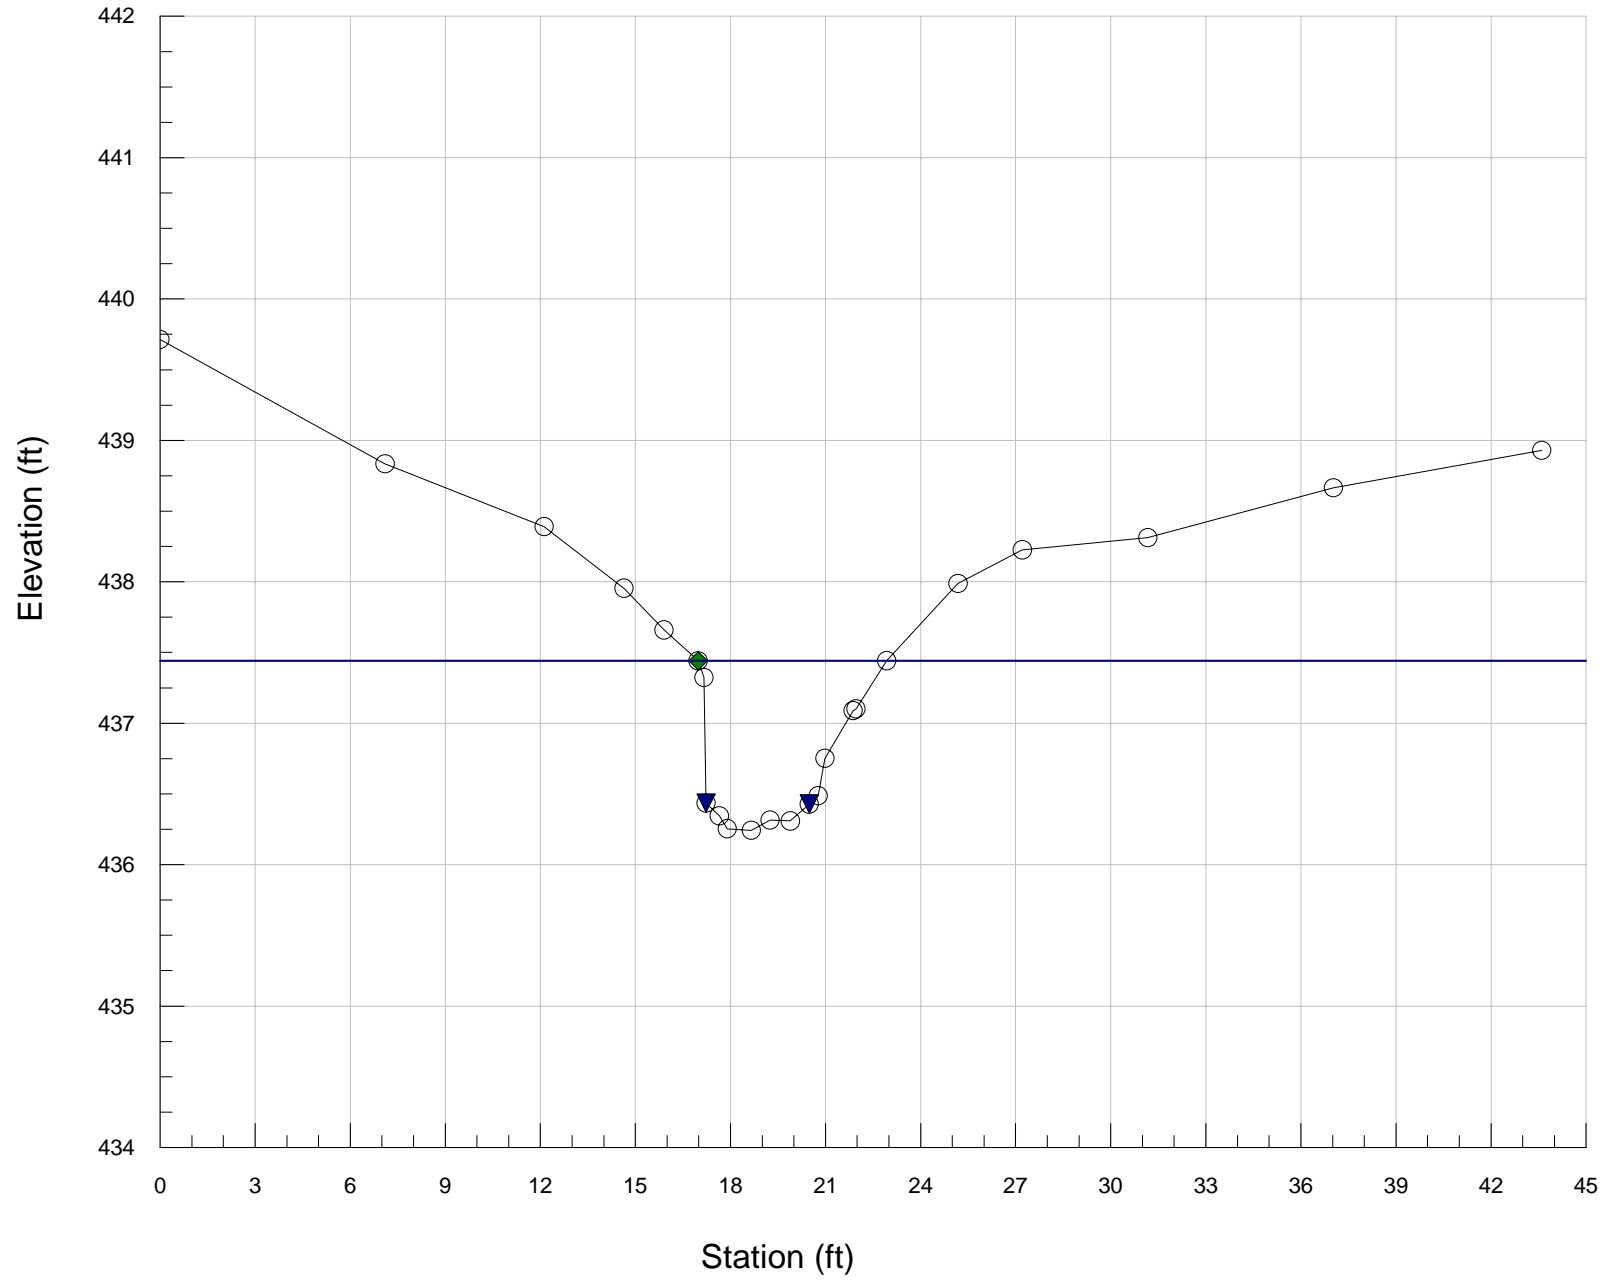
X8 Riffle US UT1
RIVERMORPH CROSS SECTION SUMMARY

River Name: UT1
 Reach Name: Reach 1 (Enhancement)
 Cross Section Name: UT1 X8 Riffle
 Survey Date: 11/09/09

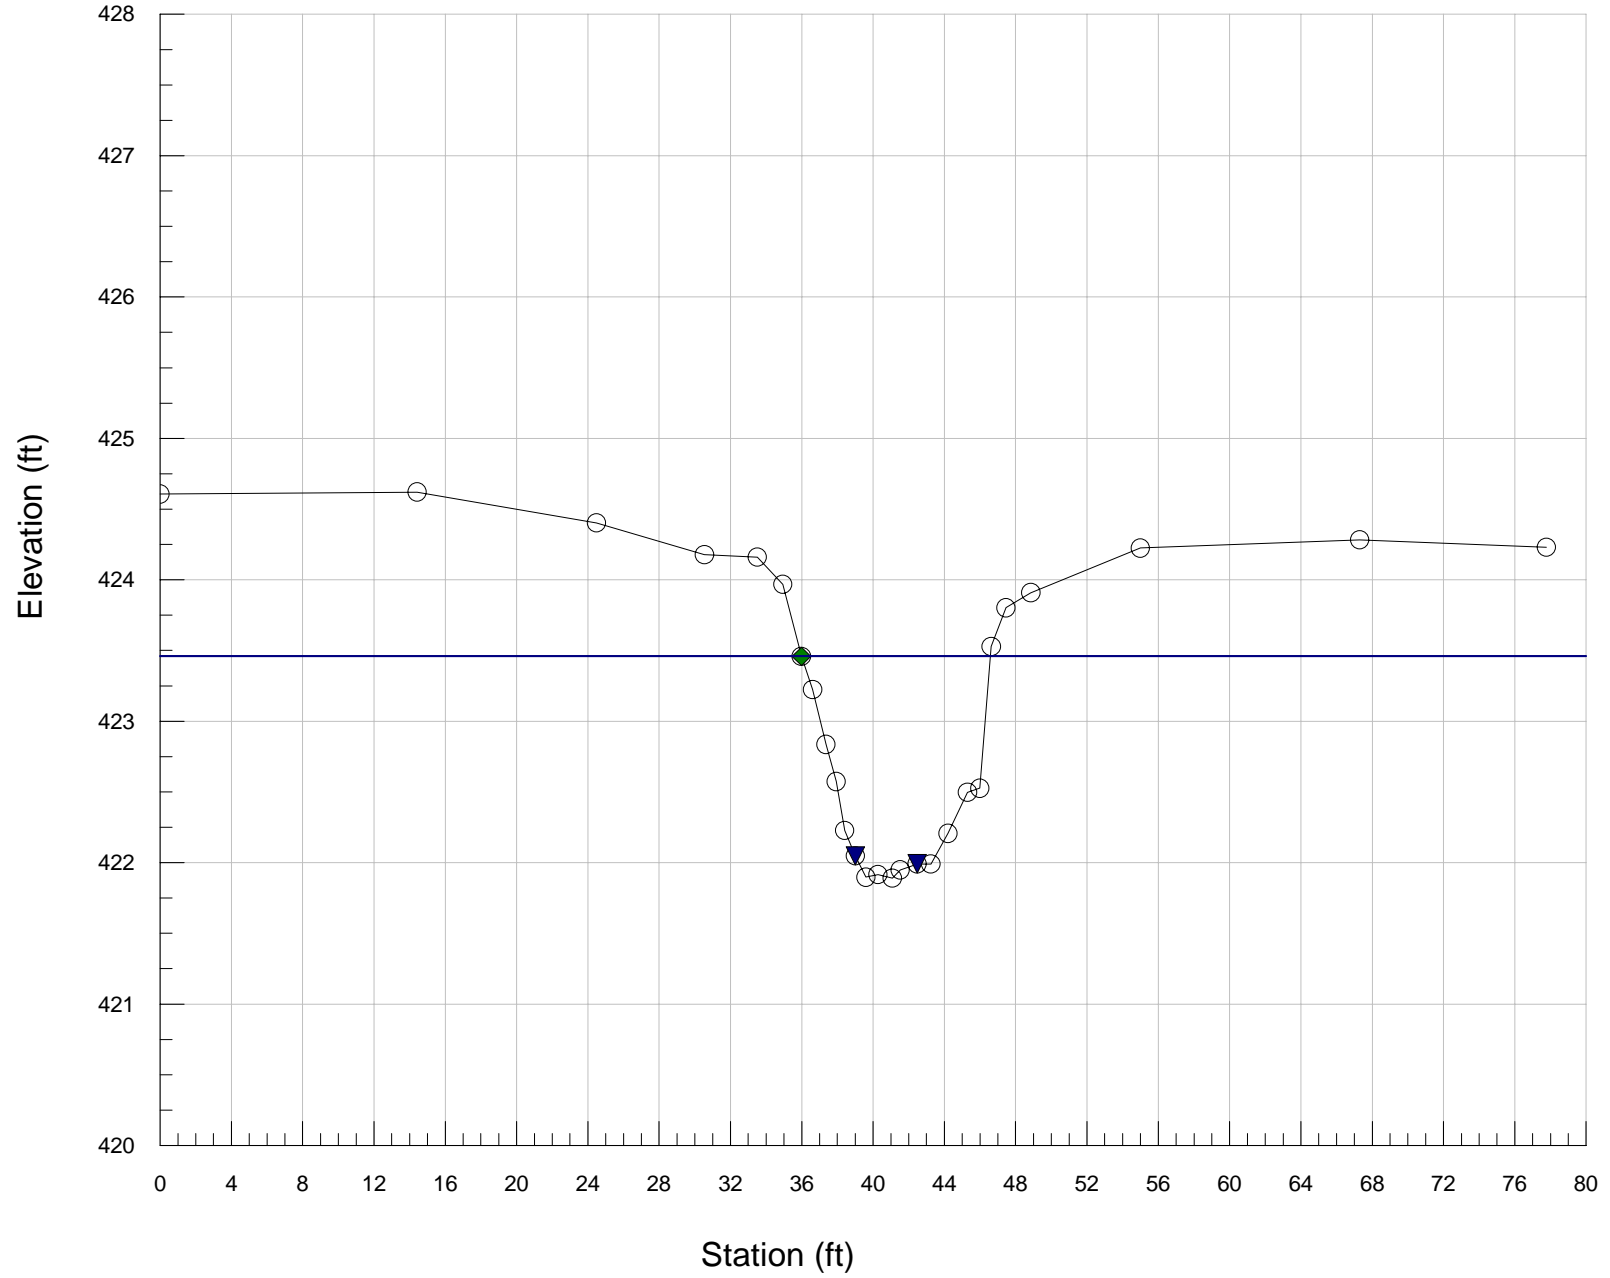
X9 Riffle DS UT1
RIVERMORPH CROSS SECTION SUMMARY

River Name: UT1
 Reach Name: Reach 2 (Restoration)
 Cross Section Name: UT1 X9 Riffle
 Survey Date: 11/09/09

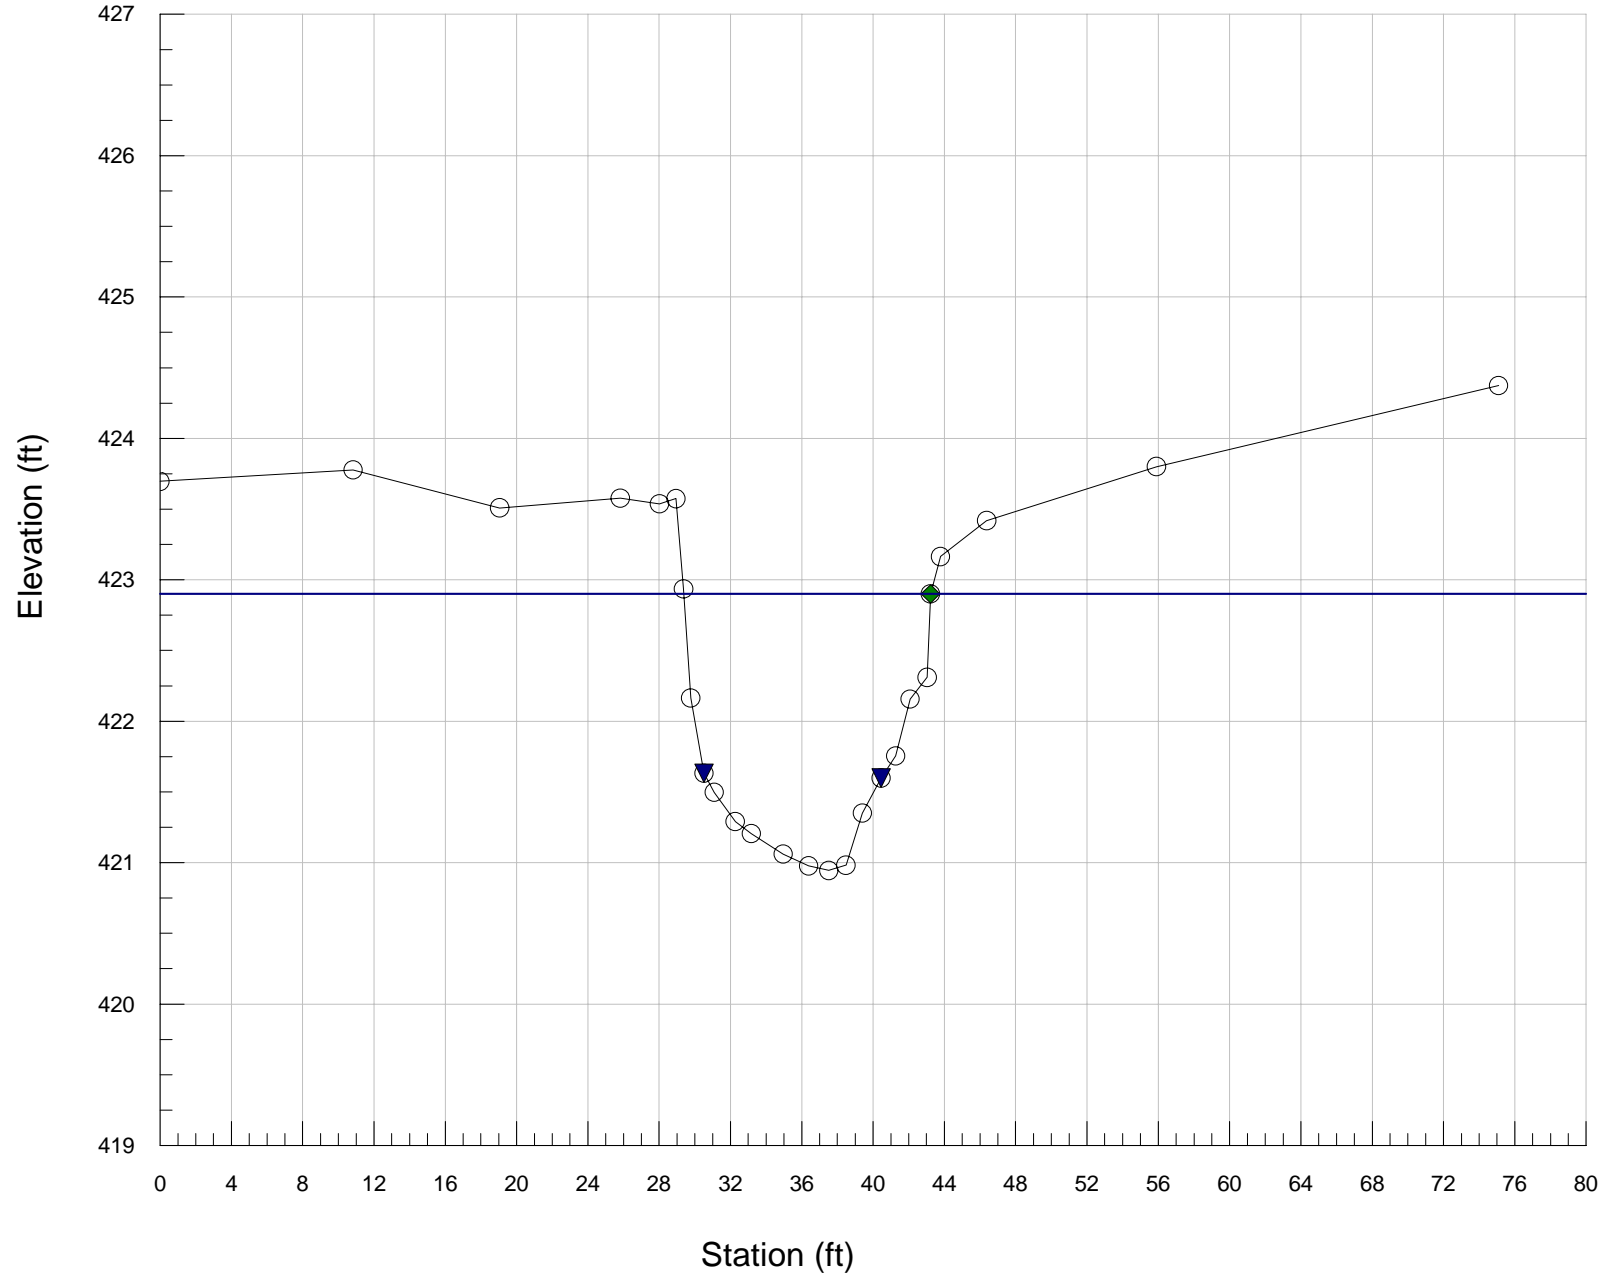
X10 Pool DS UT1
RIVERMORPH CROSS SECTION SUMMARY

River Name: UT1
 Reach Name: Reach 2 (Restoration)
 Cross Section Name: UT1 X10 Pool
 Survey Date: 11/09/09

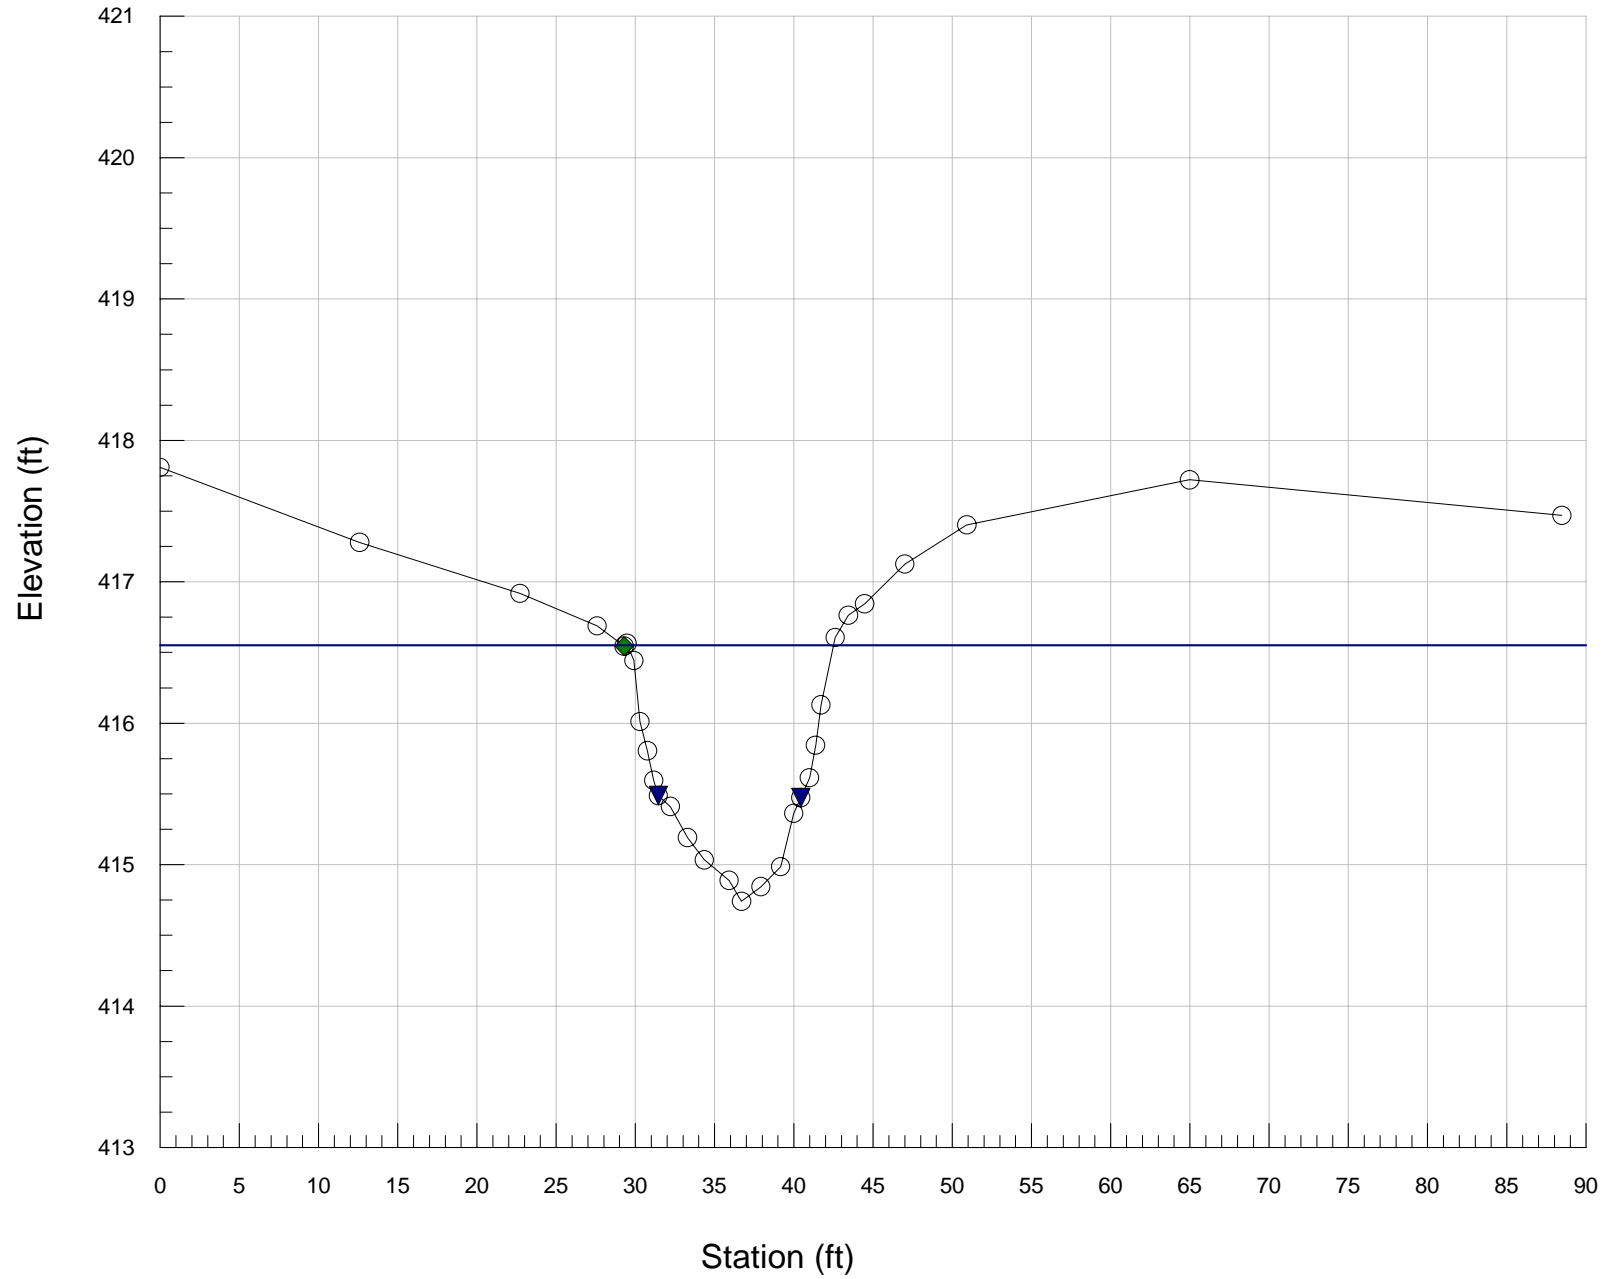
X11 Pool UT2
RIVERMORPH CROSS SECTION SUMMARY

River Name: UT2
 Reach Name: Reach 1
 Cross Section Name: UT2 X11 Pool
 Survey Date: 11/10/09
