SCALY BARK CREEK MITIGATION SITE
Stanly County, NC
DENR Contract 002030

Restoration Plan
May 14, 2010

SCALY BARK CREEK MITIGATION SITE Restoration Plan

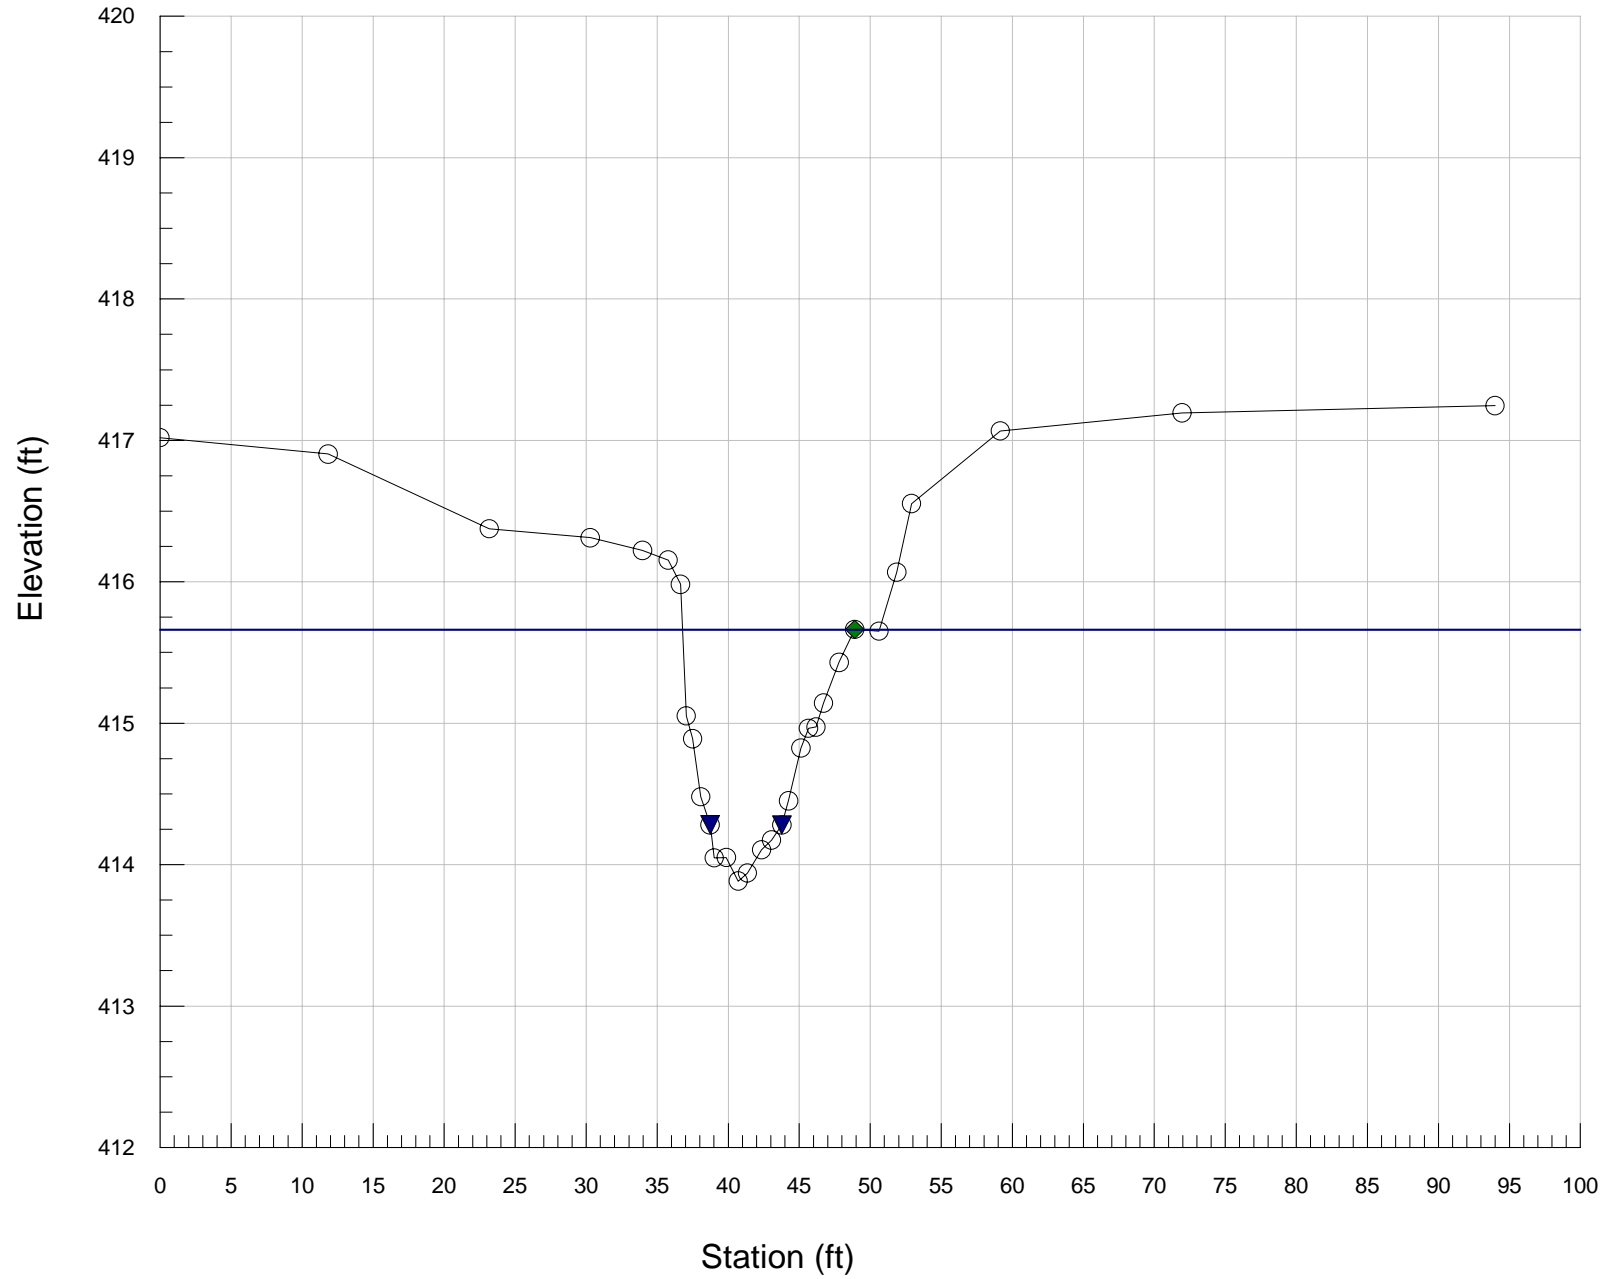
X12 Rifle UT2
RIVERMORPH CROSS SECTION SUMMARY

River Name: UT2
 Reach Name: Reach 1
 Cross Section Name: UT2 X12 Rifle
 Survey Date: 11/10/09

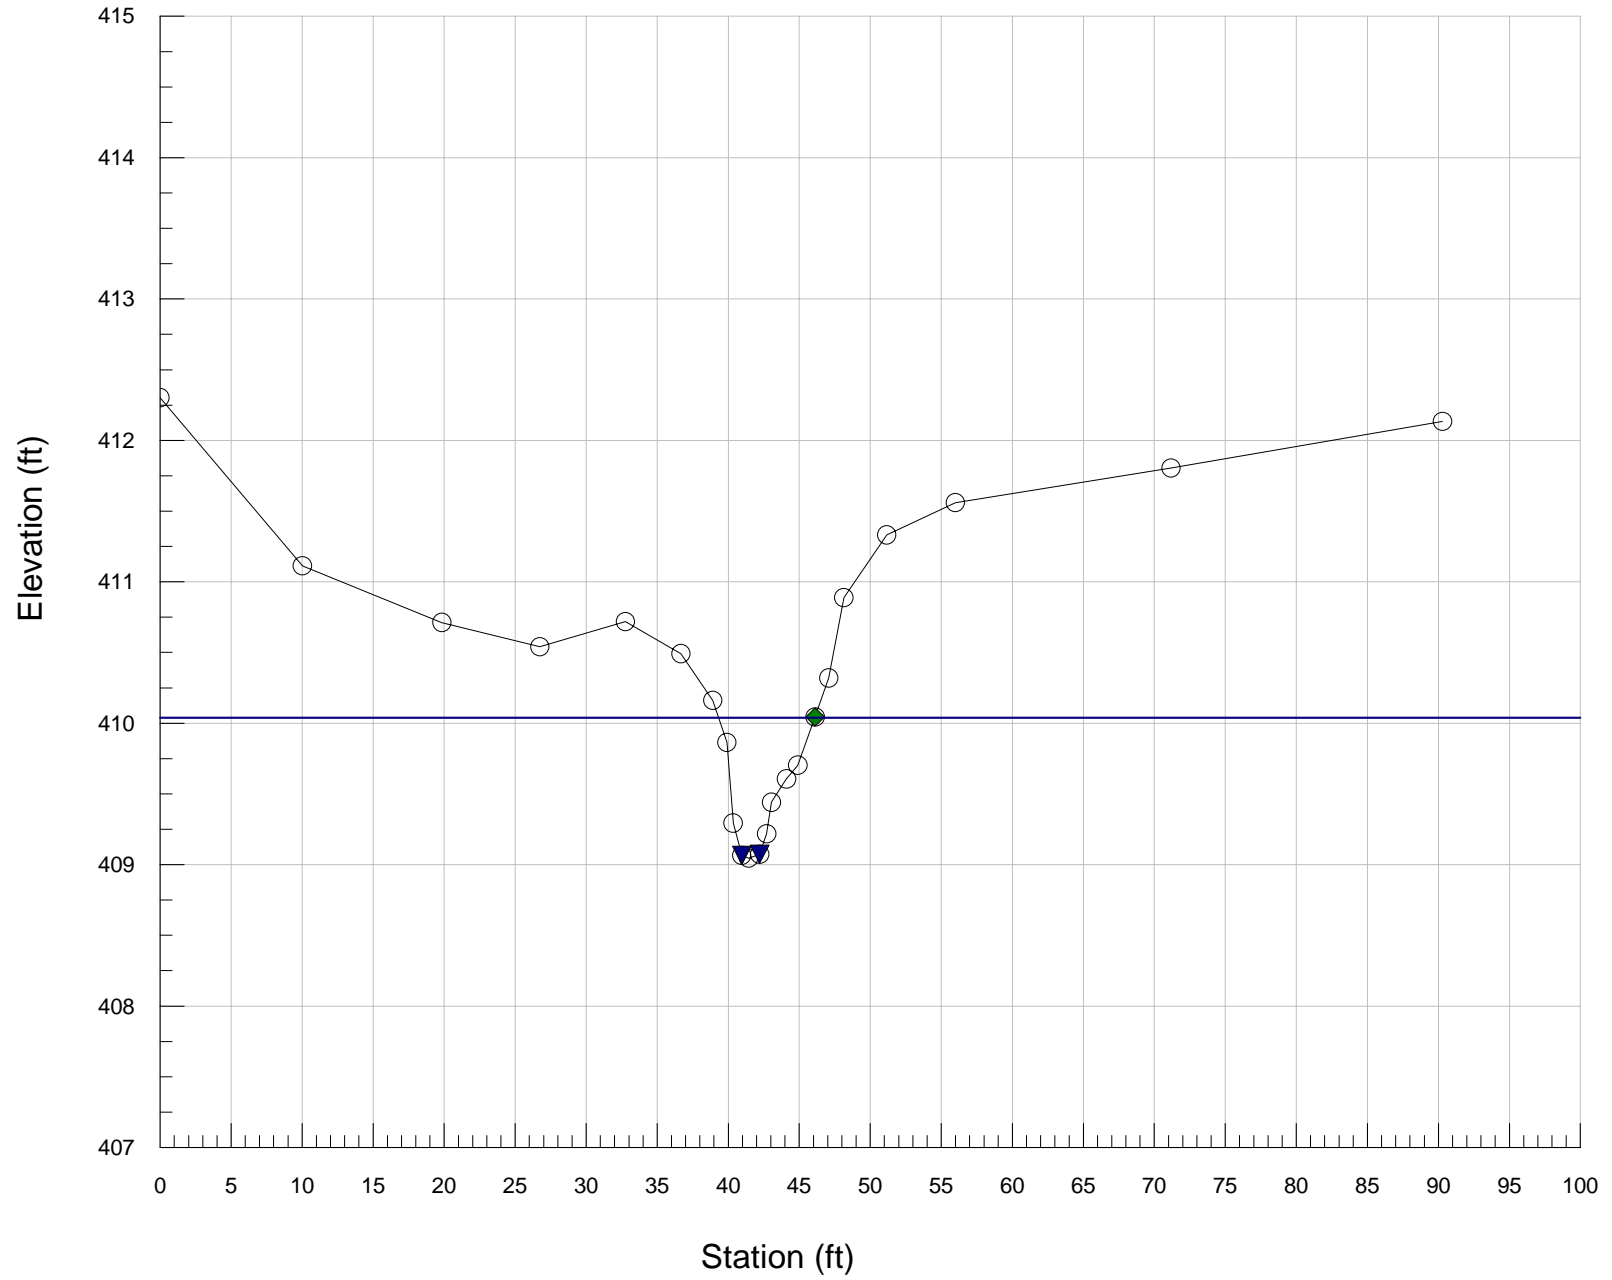
X13 Riffle UT3
RIVERMORPH CROSS SECTION SUMMARY

River Name: UT3
 Reach Name: Reach 1
 Cross Section Name: UT3 X13 Riffle
 Survey Date: 11/09/09

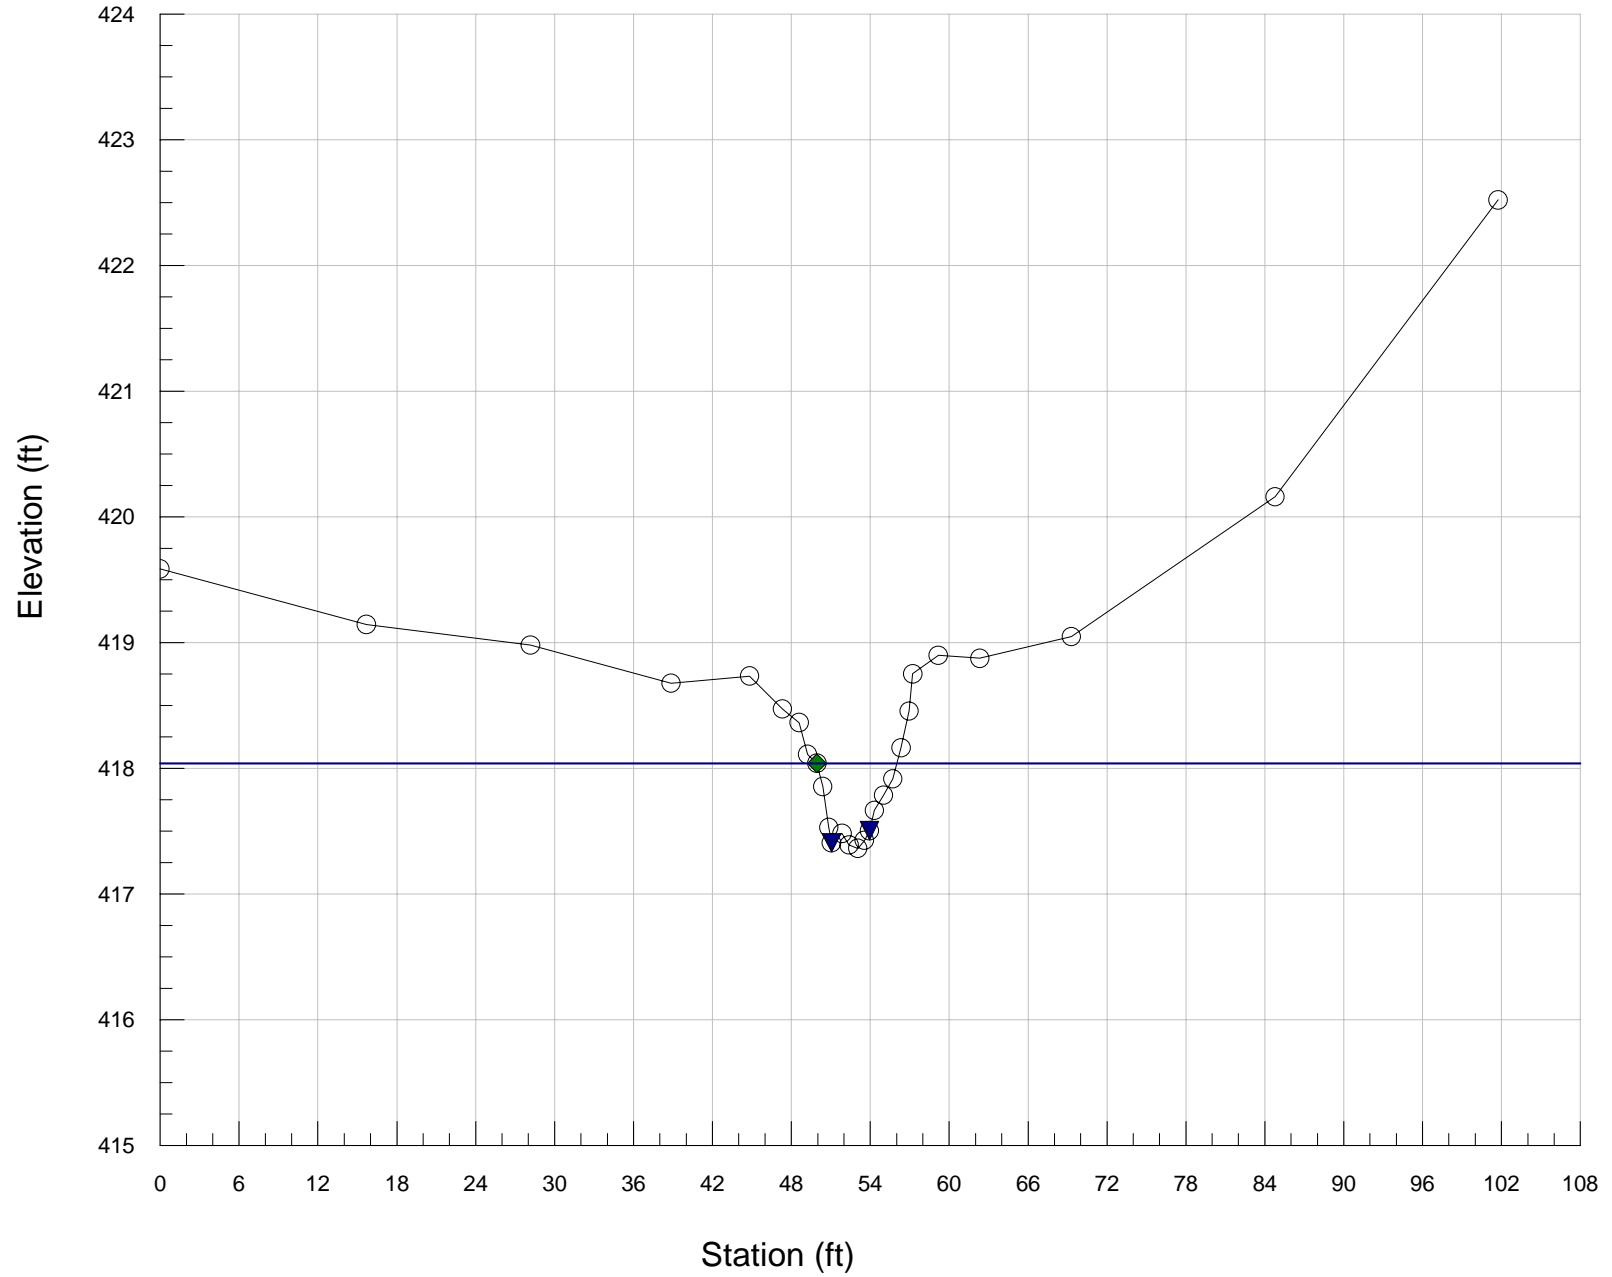
X14 Riffle DS UT4
RIVERMORPH CROSS SECTION SUMMARY

River Name: UT4
 Reach Name: Reach 1
 Cross Section Name: UT4 X14 Riffle
 Survey Date: 11/09/09

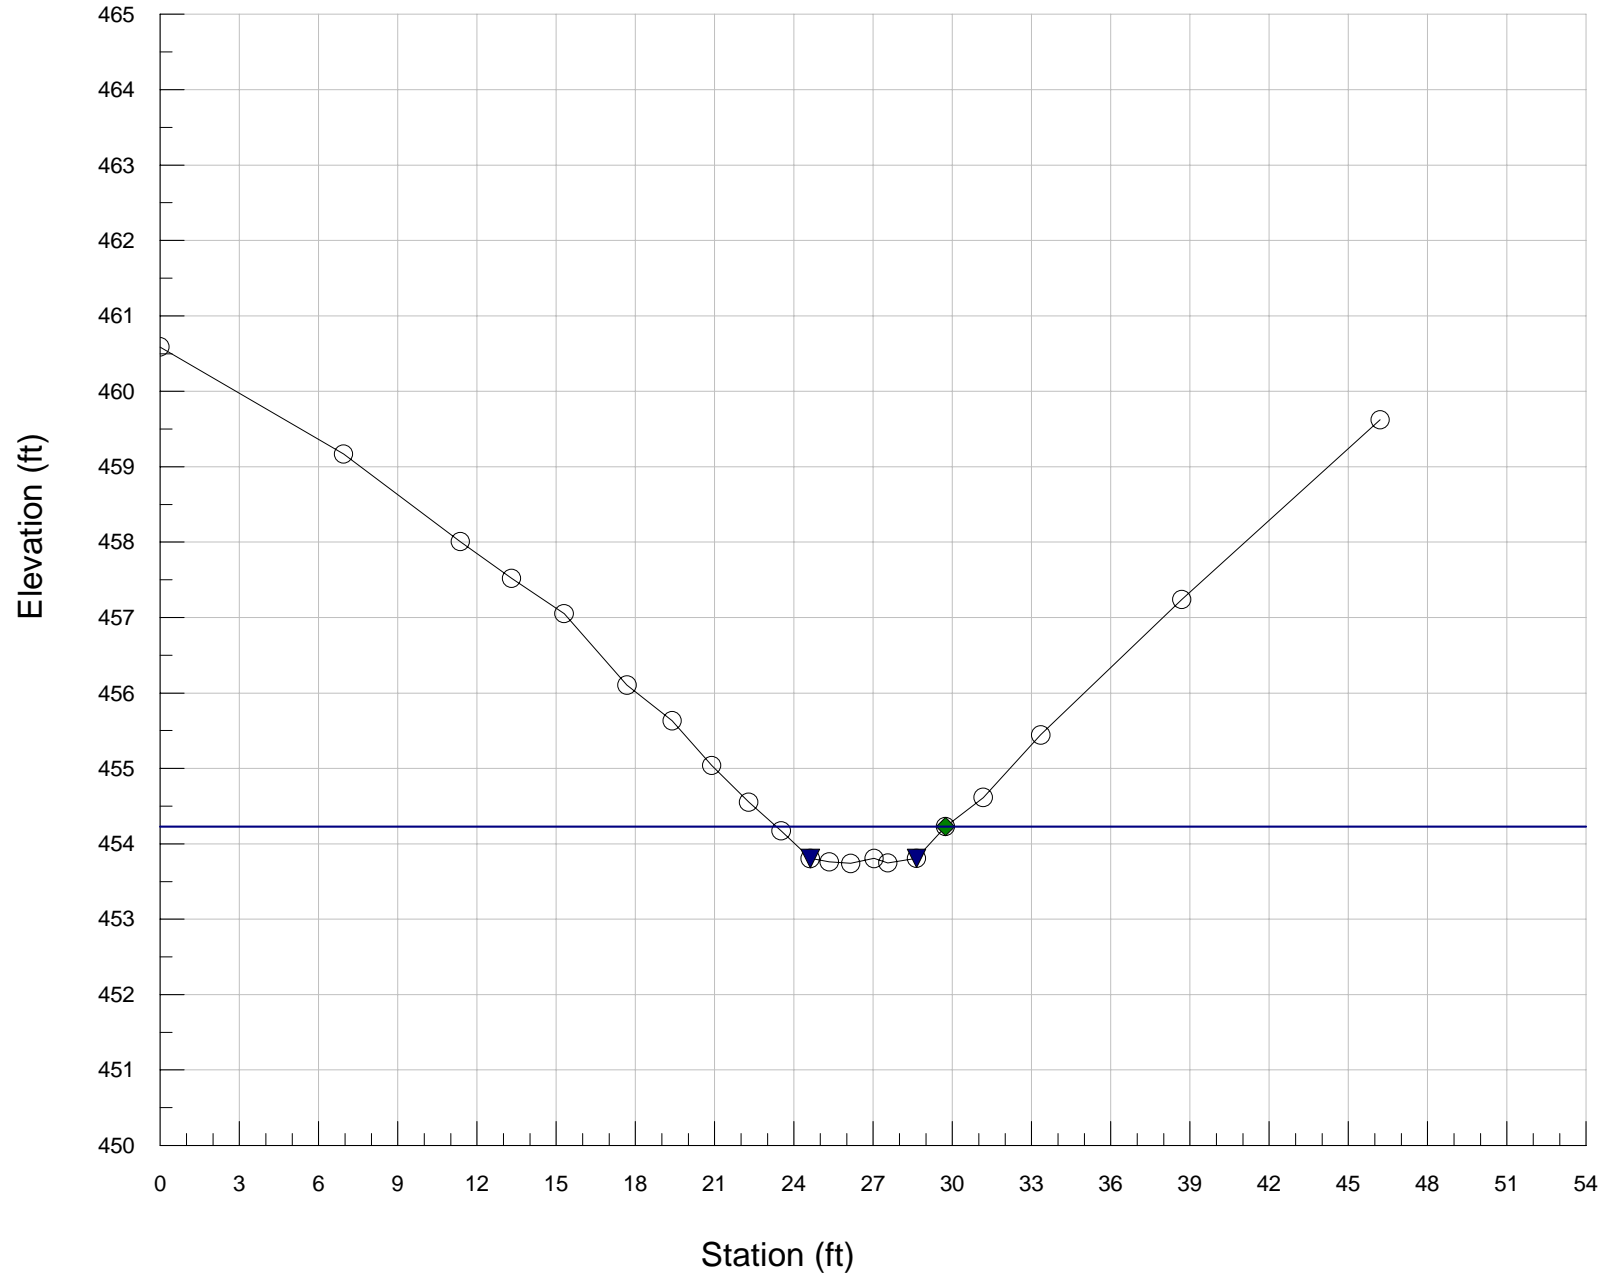
X15 Riffle US UT4
RIVERMORPH CROSS SECTION SUMMARY

River Name: UT4
 Reach Name: Reach 1
 Cross Section Name: UT4 X15 Riffle
 Survey Date: 11/09/09

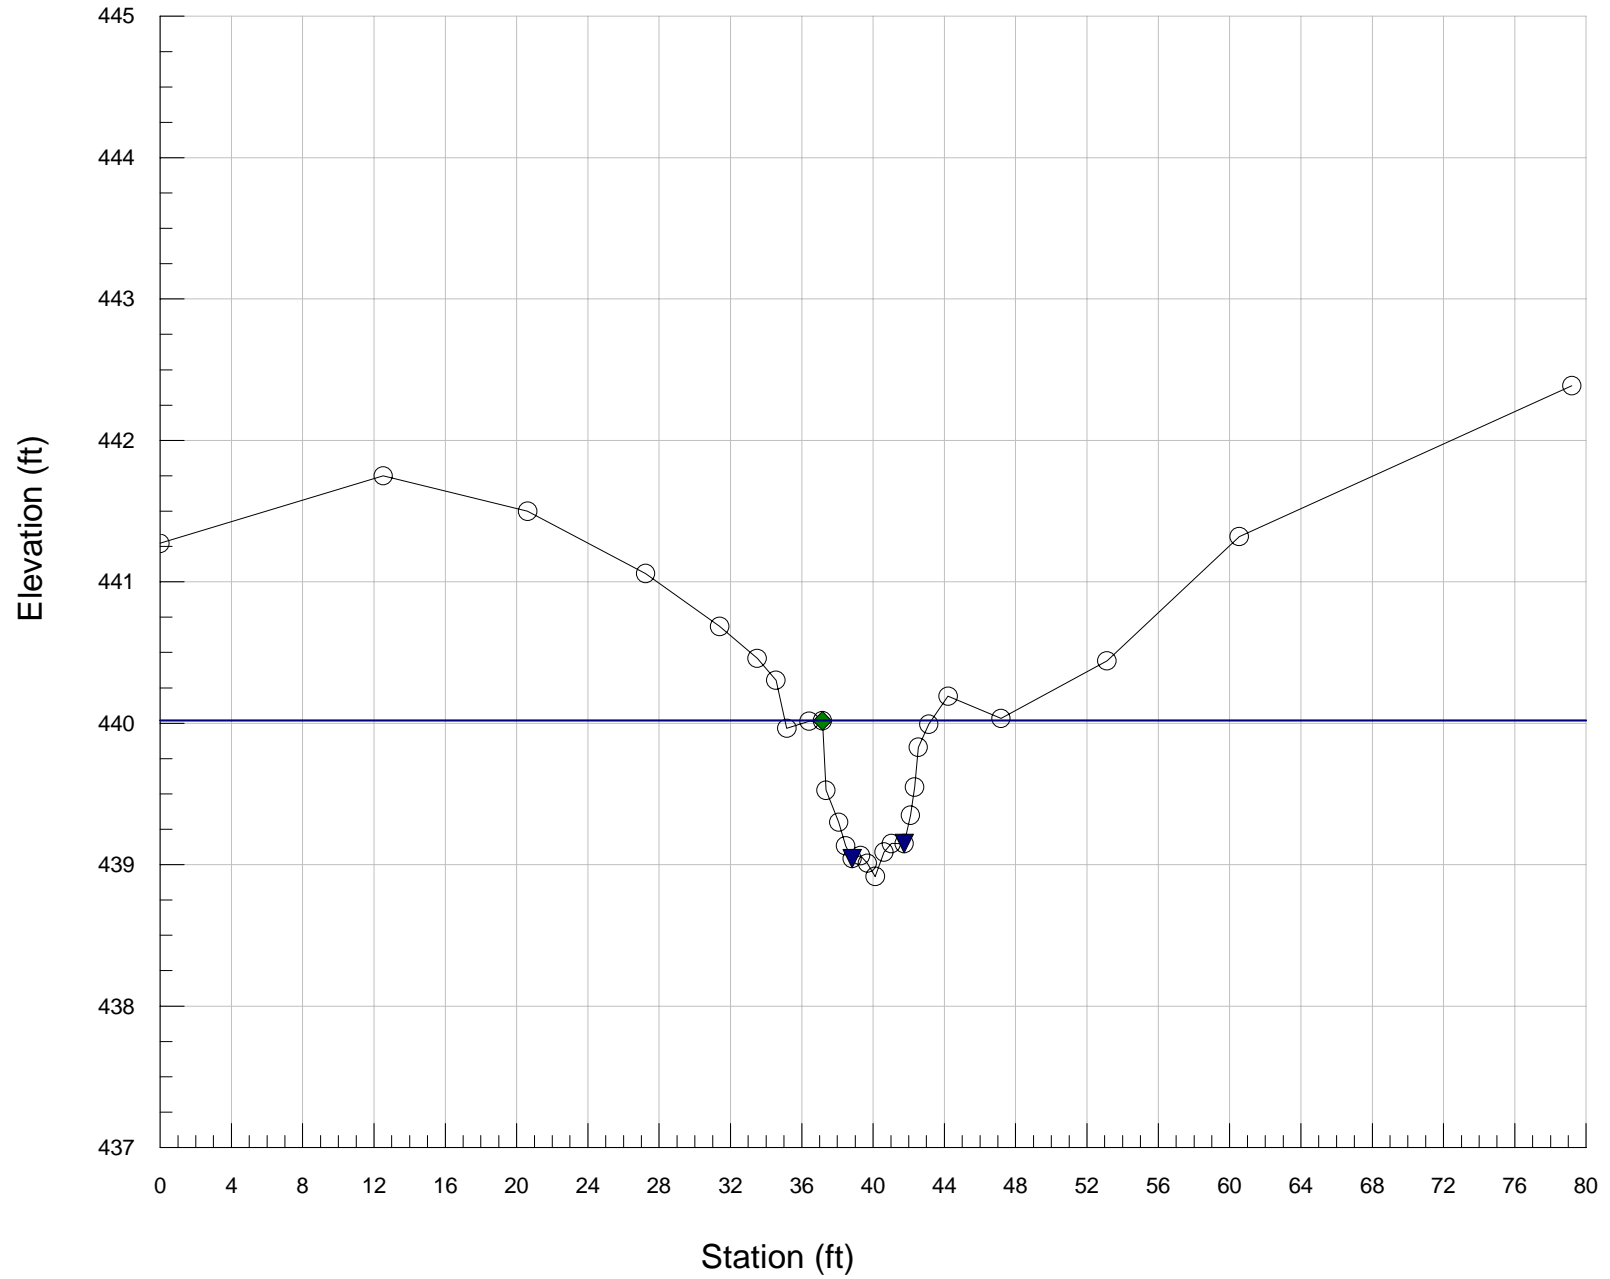
X16 Riffle UT1b
RIVERMORPH CROSS SECTION SUMMARY

River Name: UT1
 Reach Name: UT1b
 Cross Section Name: UT1b X16 Riffle
 Survey Date: 10/29/09

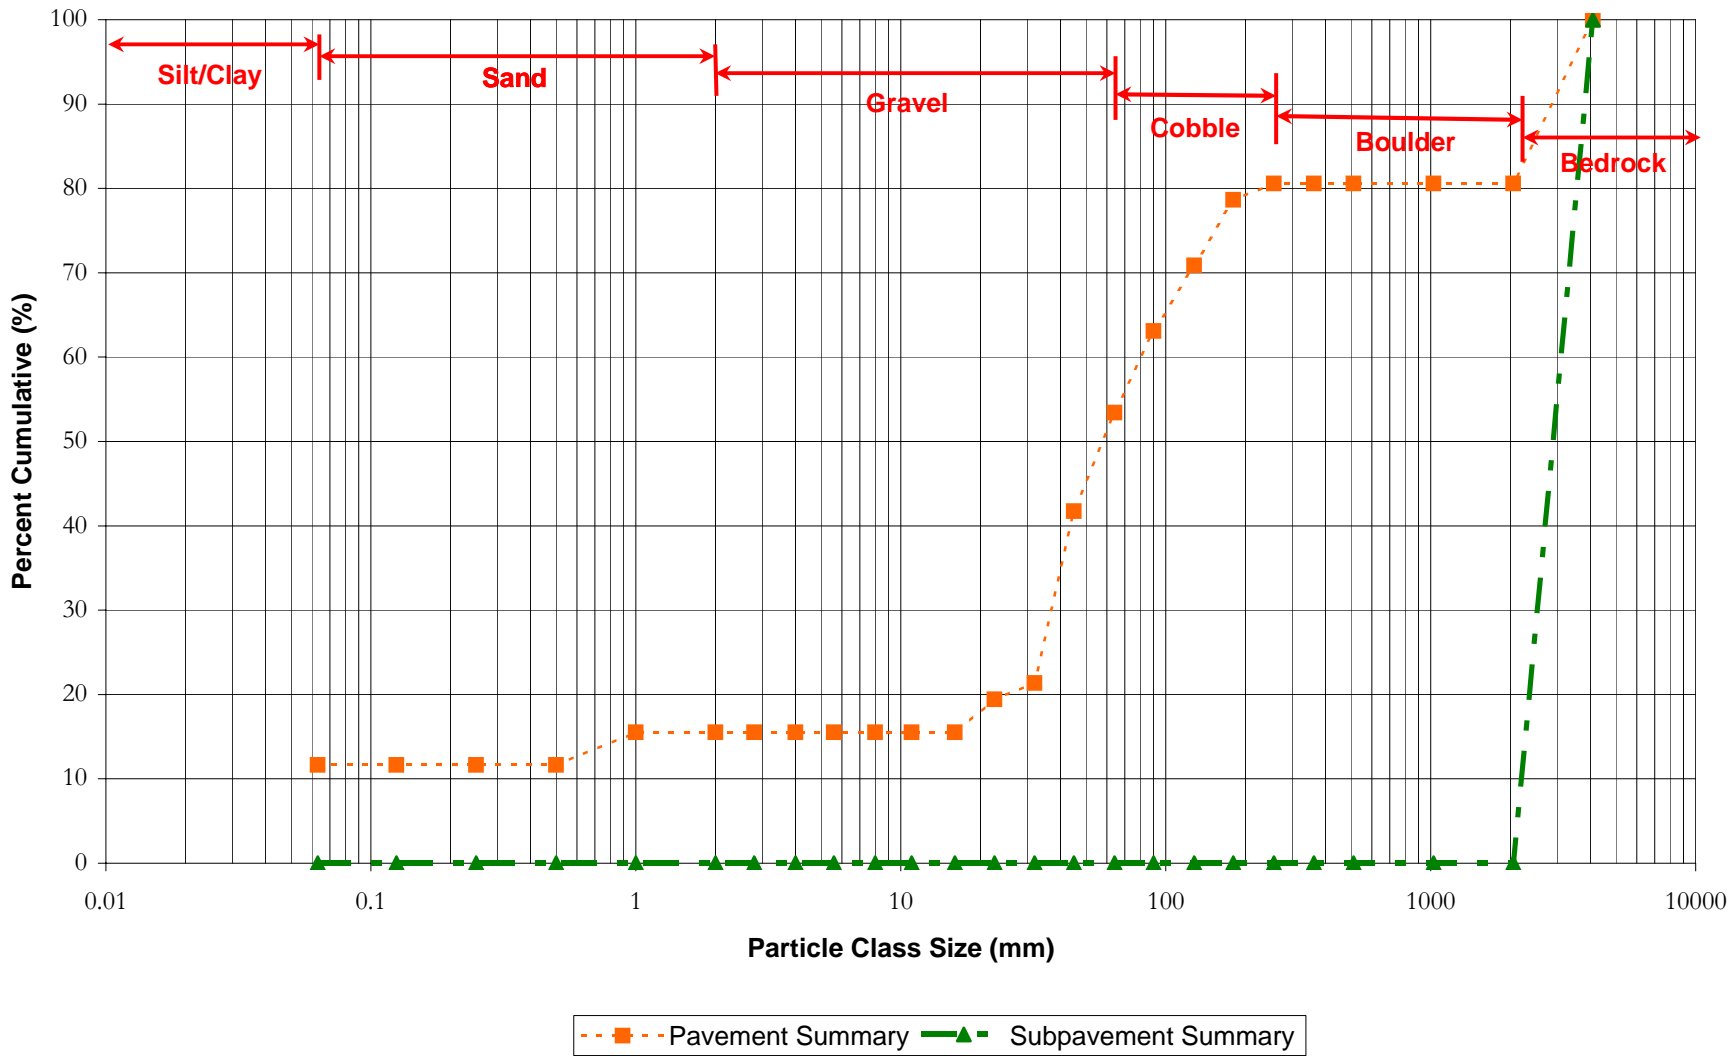
Scaly Bark Creek - X2 Riffle Pavement & Subpavement Particle Distribution

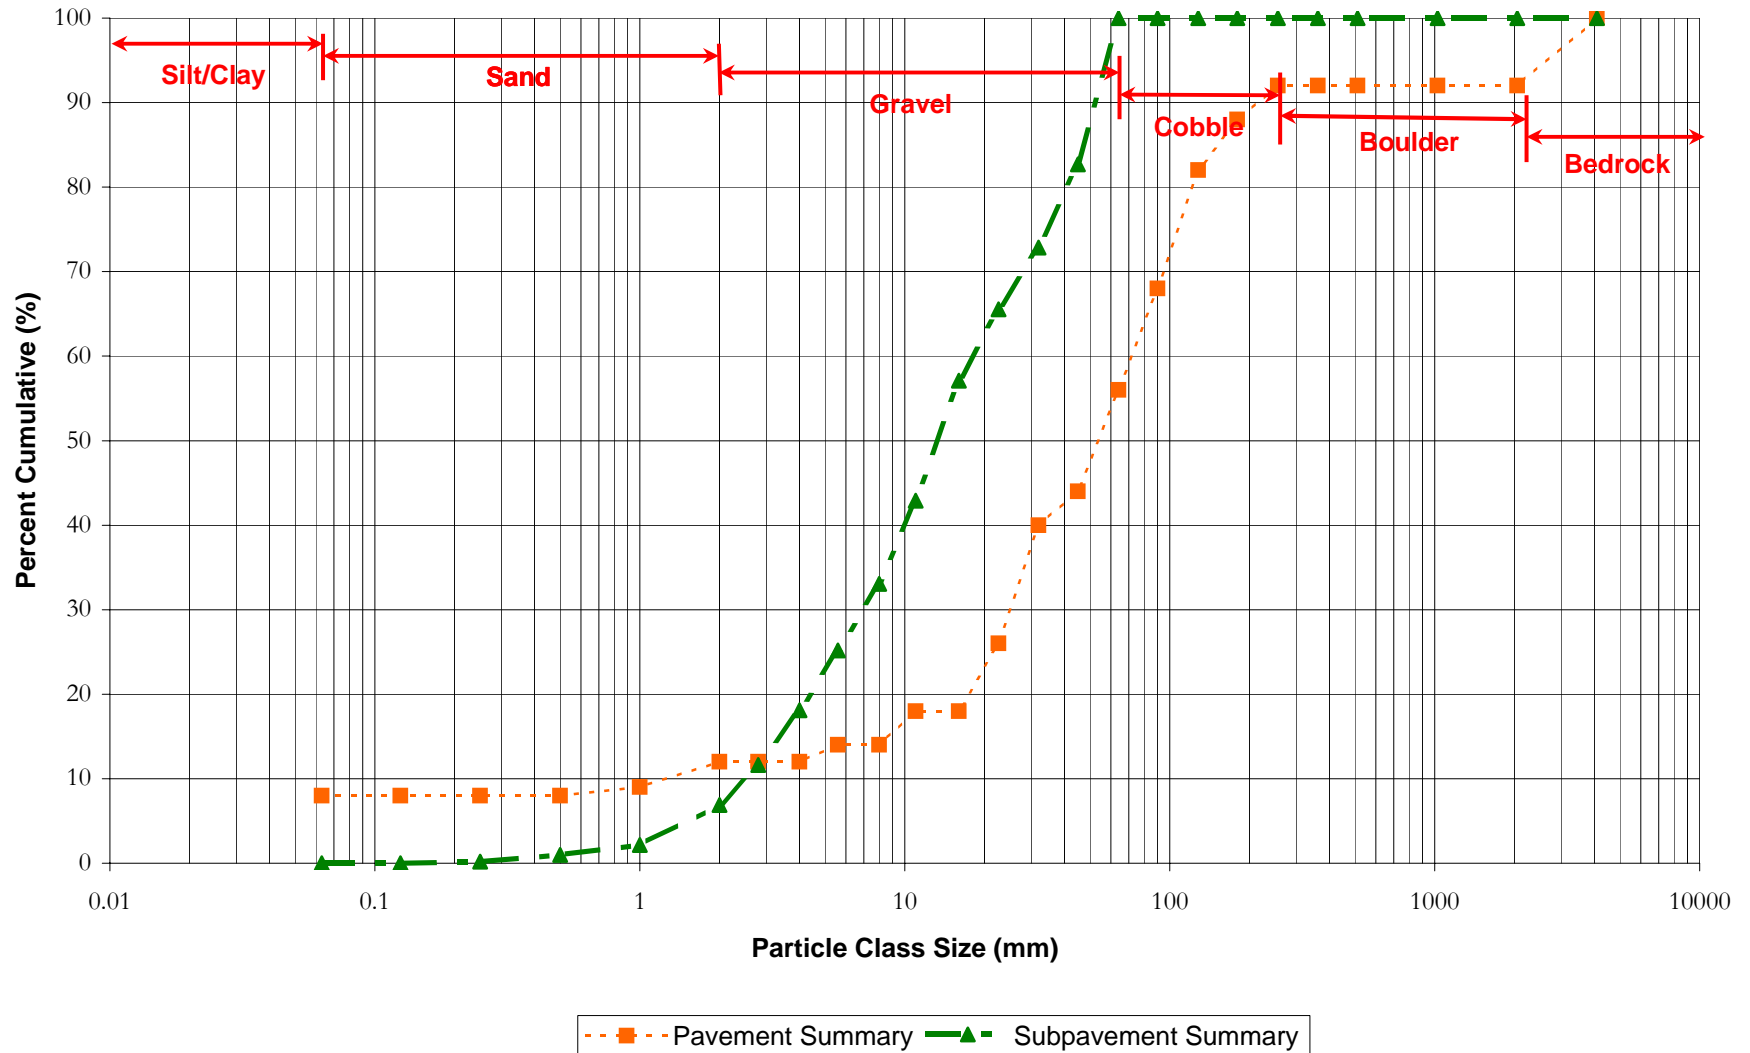
Scaly Bark Creek - X5 Riffle Pavement & Subpavement Particle Distribution

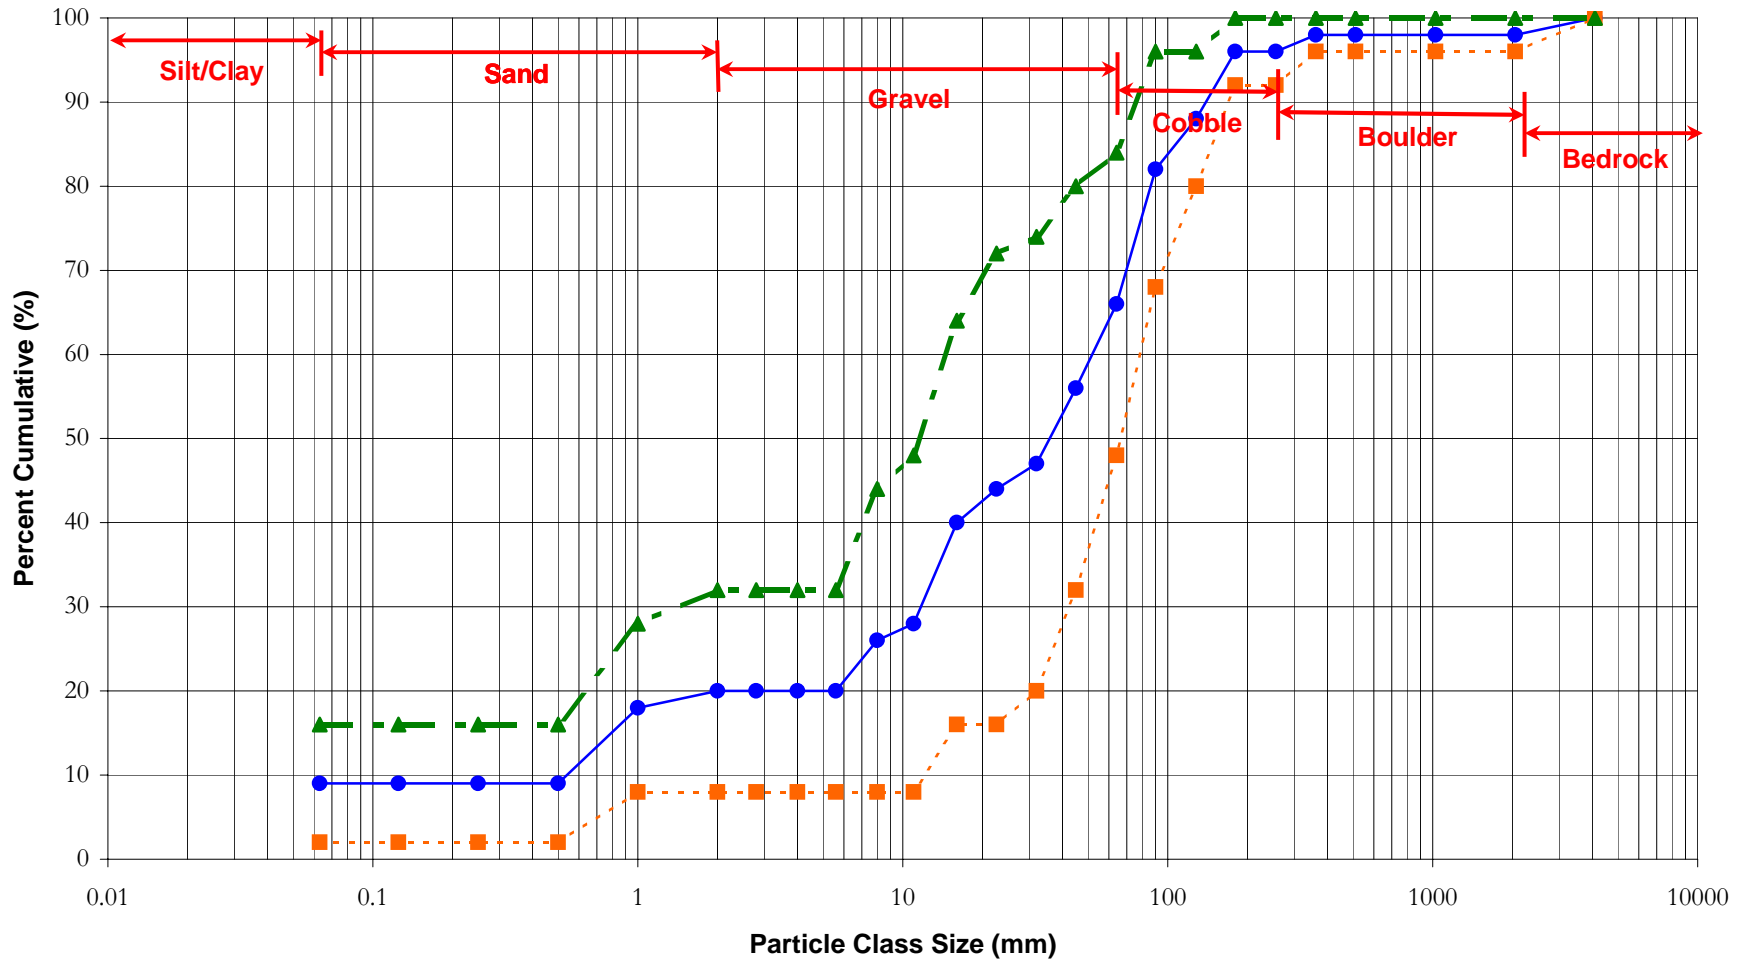
Scaly Bark Creek Reach-Wide Pebble Count Particle Distribution
