MITIGATION PLAN

SHAKE RAG MITIGATION SITE

Madison County, NC
NCDEQ Contract No. 7190
DMS ID No. 100018

French Broad River Basin
HUC 06010105

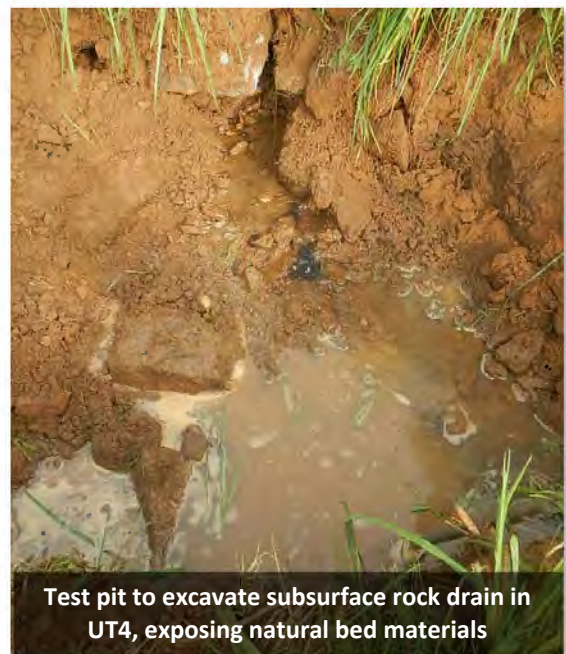
Test pit to excavate subsurface rock drain in UT4, exposing natural bed materials

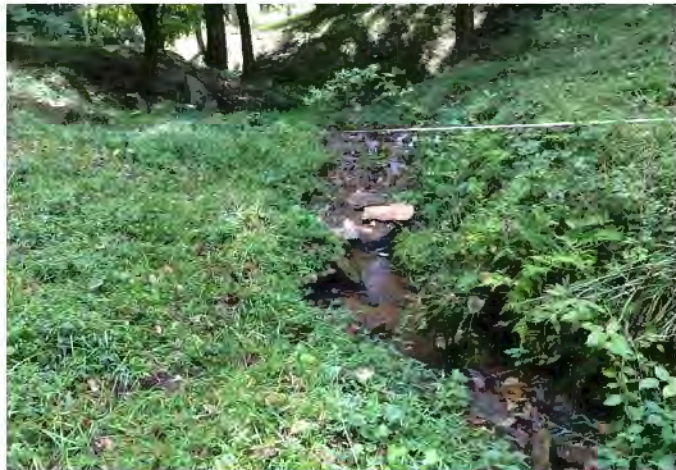
4.7	x-section area (ft.sq.)
5.1	width (ft)
0.9	mean depth (ft)
1.4	max depth (ft)
6.5	wetted perimeter (ft)
0.7	hyd radi (ft)
5.6	width-depth ratio
15.7	W flood prone area (ft)
3.1	entrenchment ratio
1.0	low bank height ratio

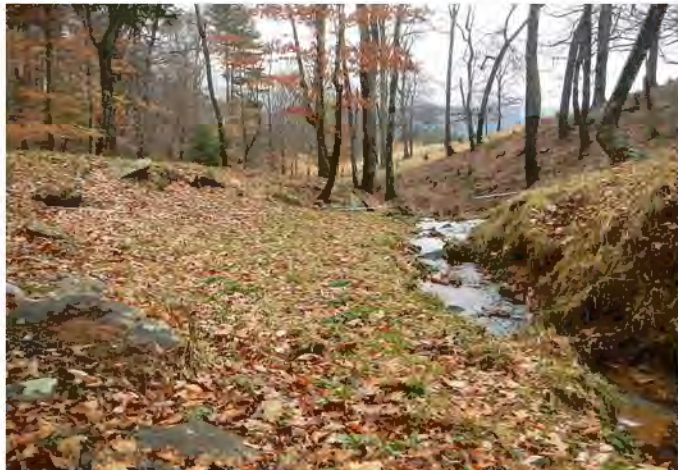
4.3	x-section area (ft.sq.)
5.3	width (ft)
0.8	mean depth (ft)
1.0	max depth (ft)
6.2	wetted perimeter (ft)
0.7	hyd radi (ft)
6.4	width-depth ratio
15.7	W flood prone area (ft)
3.0	entrenchment ratio
1.0	low bank height ratio

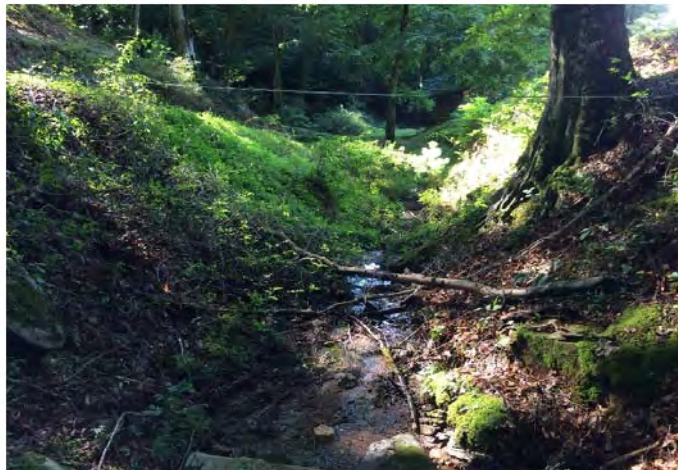
Cross Section 3, UT1 Reach 1

- 1.4 x-section area (ft.sq.)
- 4.6 width (ft)
- 0.3 mean depth (ft)
- 0.4 max depth (ft)
- 4.8 wetted perimeter (ft)
- 0.3 hyd radi (ft)
- 15.8 width-depth ratio
- 5.6 W flood prone area (ft)
- 1.2 entrenchment ratio
- 2.0 low bank height ratio

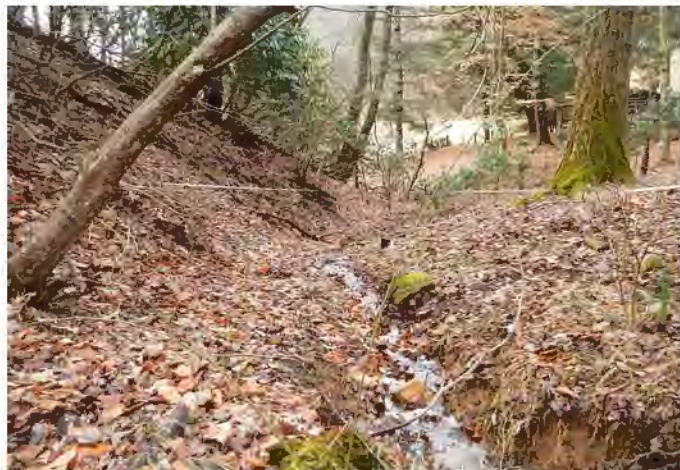
- 1.2 x-section area (ft.sq.)
- 2.9 width (ft)
- 0.4 mean depth (ft)
- 0.7 max depth (ft)
- 3.3 wetted perimeter (ft)
- 0.4 hyd radi (ft)
- 6.9 width-depth ratio
- 9.9 W flood prone area (ft)
- 3.5 entrenchment ratio
- 1.0 low bank height ratio

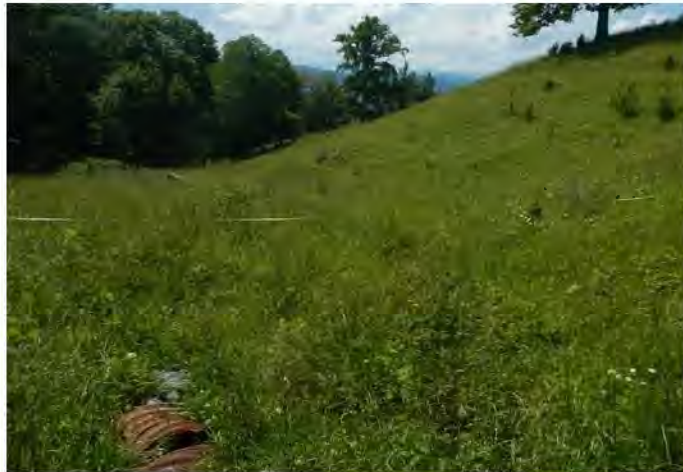
- 1.6 x-section area (ft.sq.)
- 3.1 width (ft)
- 0.5 mean depth (ft)
- 1.3 max depth (ft)
- 4.6 wetted perimeter (ft)
- 0.3 hyd radi (ft)
- 6.0 width-depth ratio
- 21.6 W flood prone area (ft)
- 7.0 entrenchment ratio
- 1.0 low bank height ratio

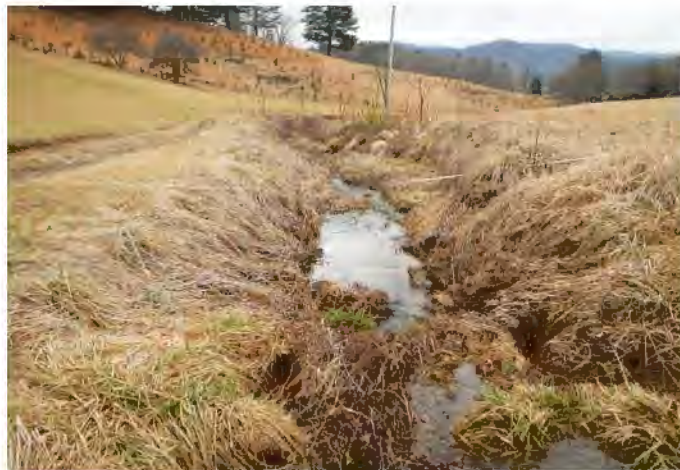
- 7.5 x-section area (ft.sq.)
- 6.3 width (ft)
- 1.2 mean depth (ft)
- 1.8 max depth (ft)
- 8.3 wetted perimeter (ft)
- 0.9 hyd radi (ft)
- 5.2 width-depth ratio
- 27.2 W flood prone area (ft)
- 4.4 entrenchment ratio
- 1.9 low bank height ratio

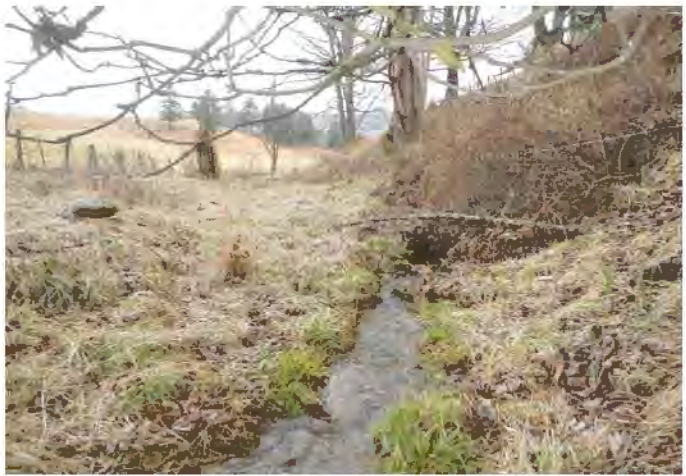
Cross Section 9, Shake Rag Branch Reach 4

2.9	x-section area (ft.sq.)
5.1	width (ft)
0.6	mean depth (ft)
0.9	max depth (ft)
5.6	wetted perimeter (ft)
0.5	hyd radi (ft)
9.0	width-depth ratio
14.6	W flood prone area (ft)
2.9	entrenchment ratio
1.0	low bank height ratio

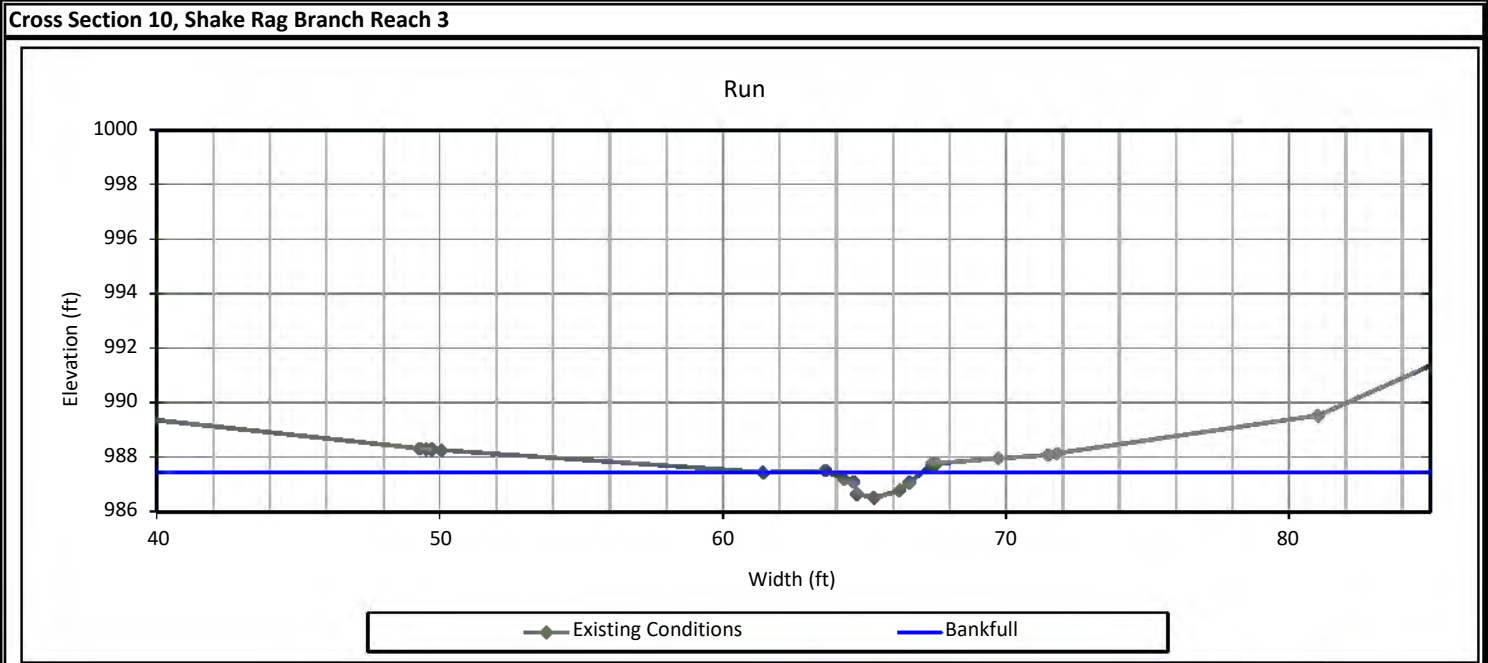
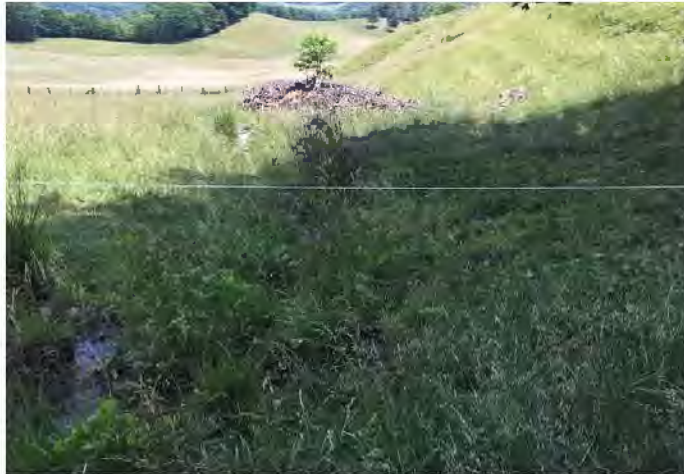
1.7	x-section area (ft.sq.)
3.3	width (ft)
0.5	mean depth (ft)
0.9	max depth (ft)
4.0	wetted perimeter (ft)
0.4	hyd radi (ft)
6.2	width-depth ratio
24.6	W flood prone area (ft)
7.5	entrenchment ratio
1.1	low bank height ratio

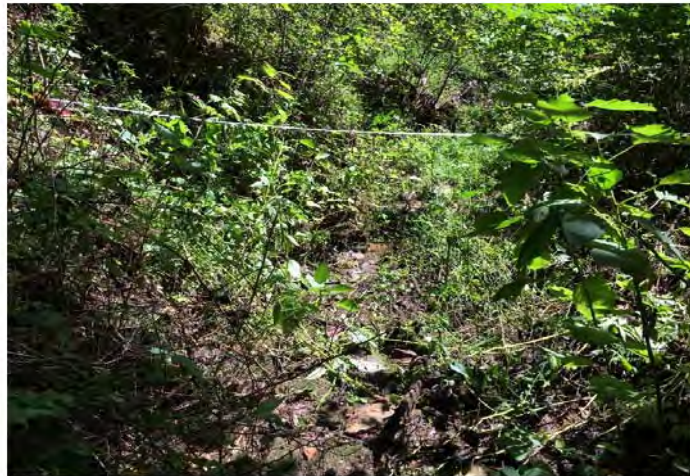
Cross Section 11, Shake Rag Branch Reach 2

- 1.2 x-section area (ft.sq.)
- 3.7 width (ft)
- 0.3 mean depth (ft)
- 0.5 max depth (ft)
- 4.0 wetted perimeter (ft)
- 0.3 hyd radi (ft)
- 11.6 width-depth ratio
- 6.7 W flood prone area (ft)
- 1.8 entrenchment ratio
- 1.0 low bank height ratio

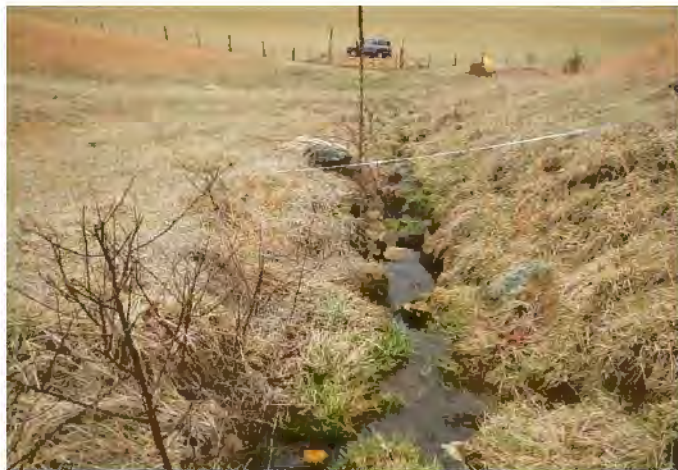
Cross Section 12, UT3 Reach 2

- 2.9 x-section area (ft.sq.)
- 3.3 width (ft)
- 0.9 mean depth (ft)
- 1.2 max depth (ft)
- 4.4 wetted perimeter (ft)
- 0.6 hyd radi (ft)
- 3.9 width-depth ratio
- 5.9 W flood prone area (ft)
- 1.8 entrenchment ratio
- 4.4 low bank height ratio

For the next 330 LF downstream, the channel becomes very incised with vertical, eroding banks. Cross Section 13 (XS13) reported a bank height ratio of 2.7 and the project reach classifies as a Rosgen A4a+ stream type. Grade control, to help minimize the upstream migration of the numerous active headcuts observed throughout this subreach, was scarce. Pools were typically narrower in width than riffles and silted in with eroded sediment.

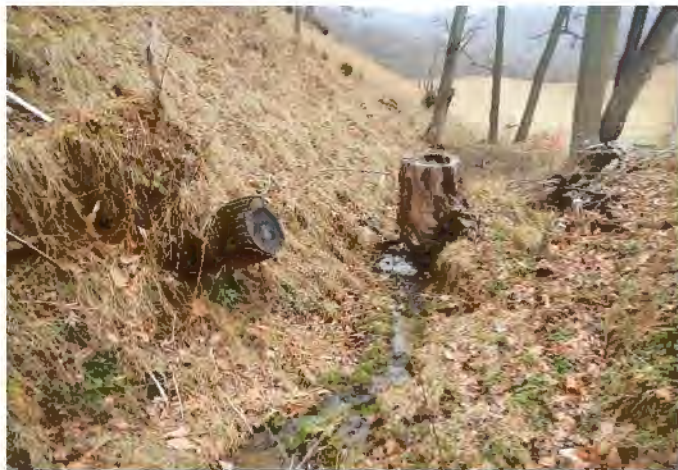
1.0	x-section area (ft.sq.)
4.0	width (ft)
0.2	mean depth (ft)
0.5	max depth (ft)
4.3	wetted perimeter (ft)
0.2	hyd radi (ft)
16.3	width-depth ratio
5.6	W flood prone area (ft)
1.4	entrenchment ratio
1.0	low bank height ratio

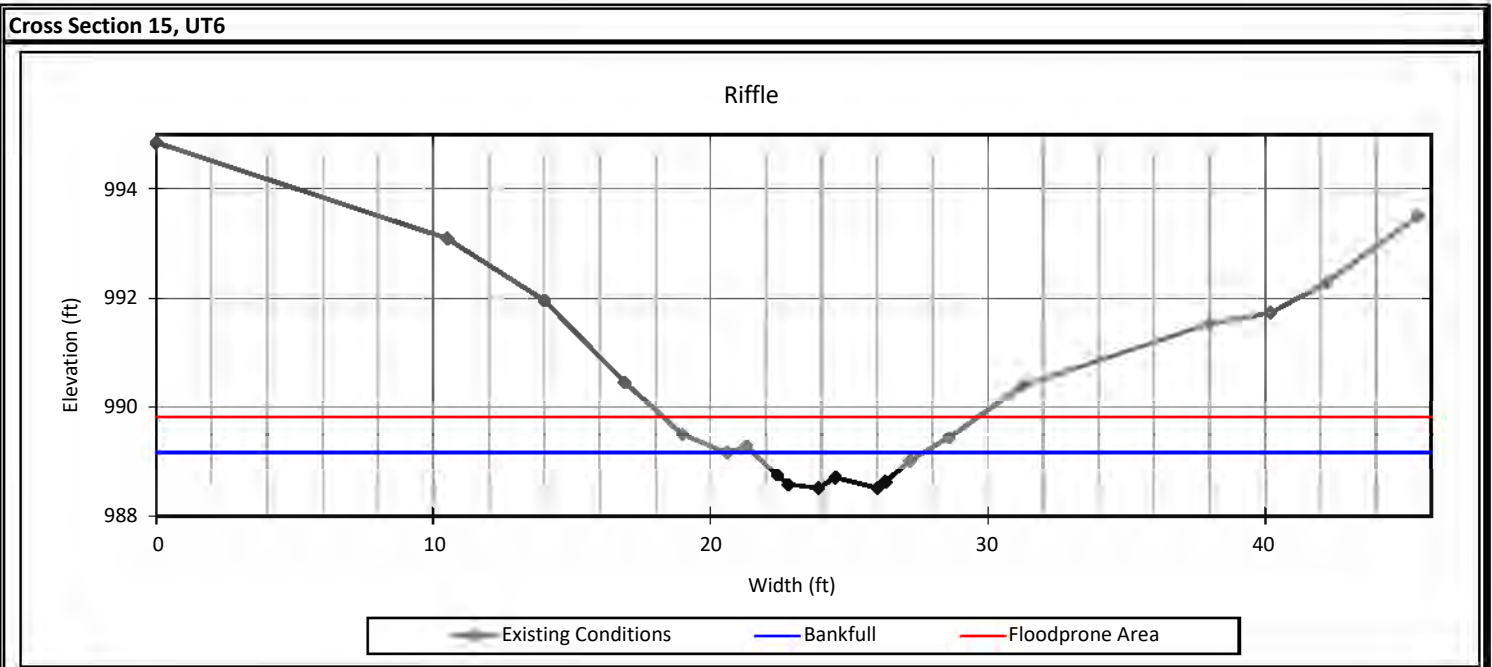
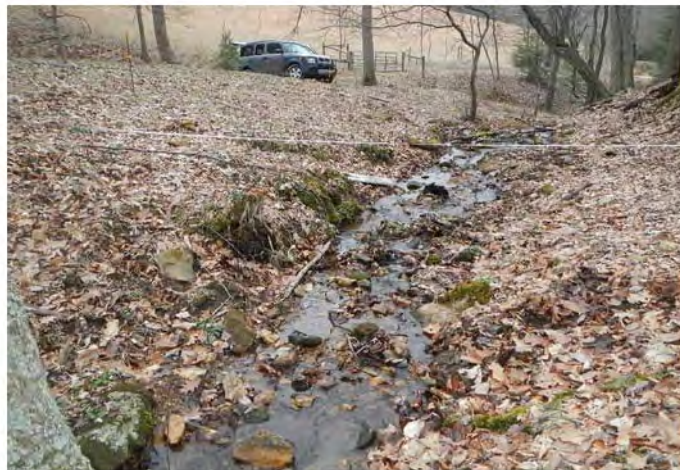
- 2.7 x-section area (ft.sq.)
- 6.1 width (ft)
- 0.4 mean depth (ft)
- 0.6 max depth (ft)
- 6.4 wetted perimeter (ft)
- 0.4 hyd radi (ft)
- 13.7 width-depth ratio
- 11.4 W flood prone area (ft)
- 1.9 entrenchment ratio
- 2.9 low bank height ratio

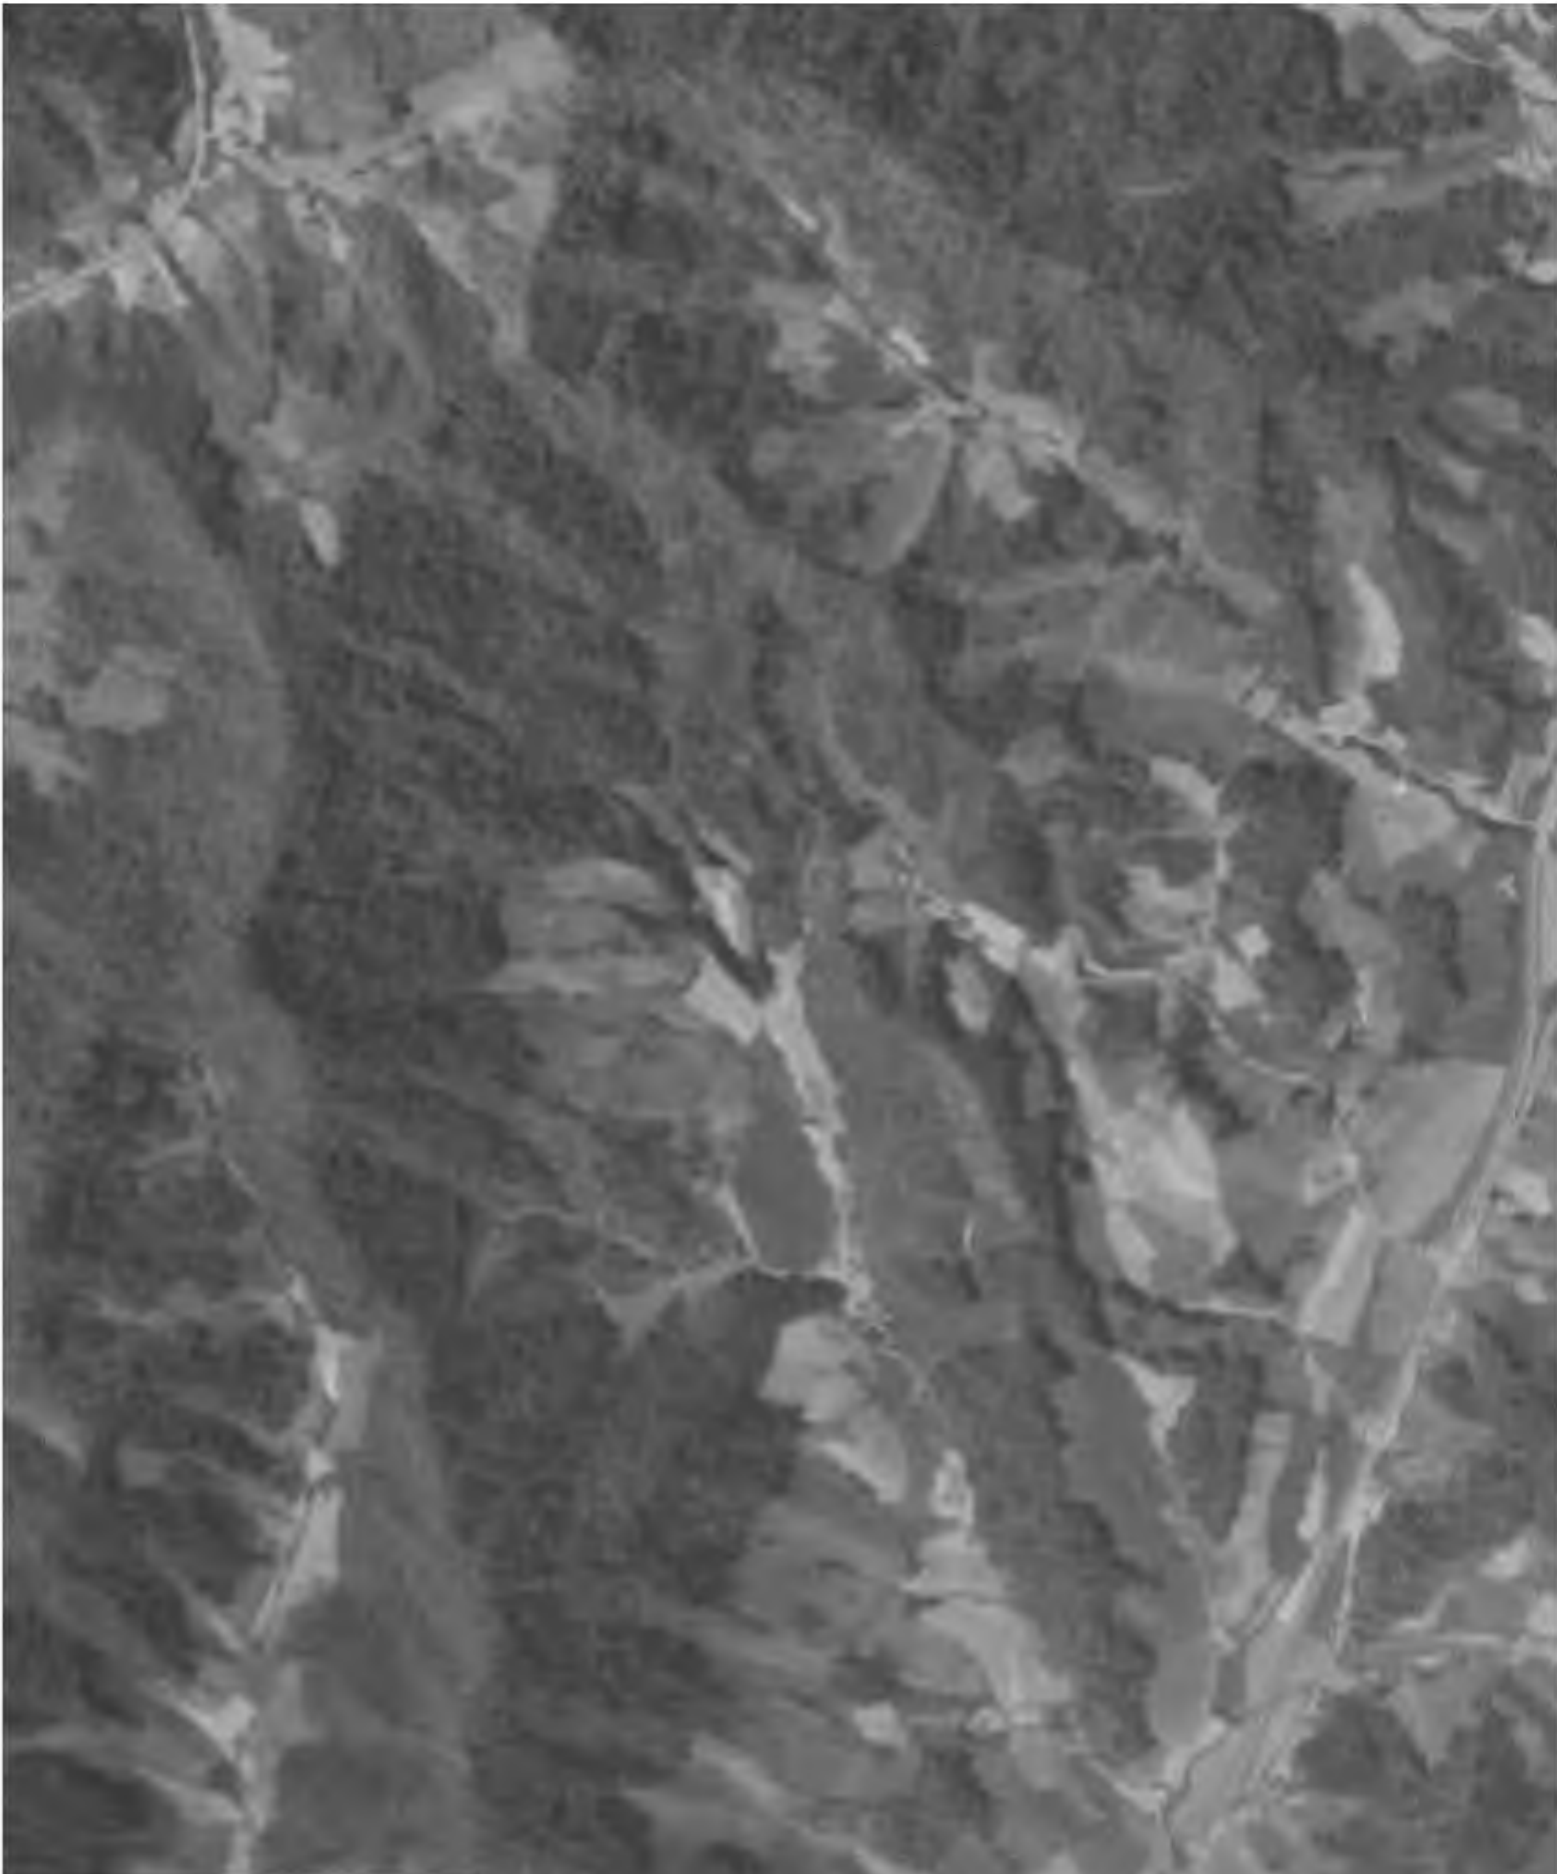
1965 aerial image from USGS Earth Explorer
