**SHEPHERDS TREE MITIGATION PLAN  
IREDELL COUNTY, NORTH CAROLINA**

**STATE PROJECT NO. 6.769001T  
TIP NO R-2239**

**NORTH CAROLINA DEPARTMENT OF  
TRANSPORTATION**

# SHEPHERDS TREE MITIGATION PLAN

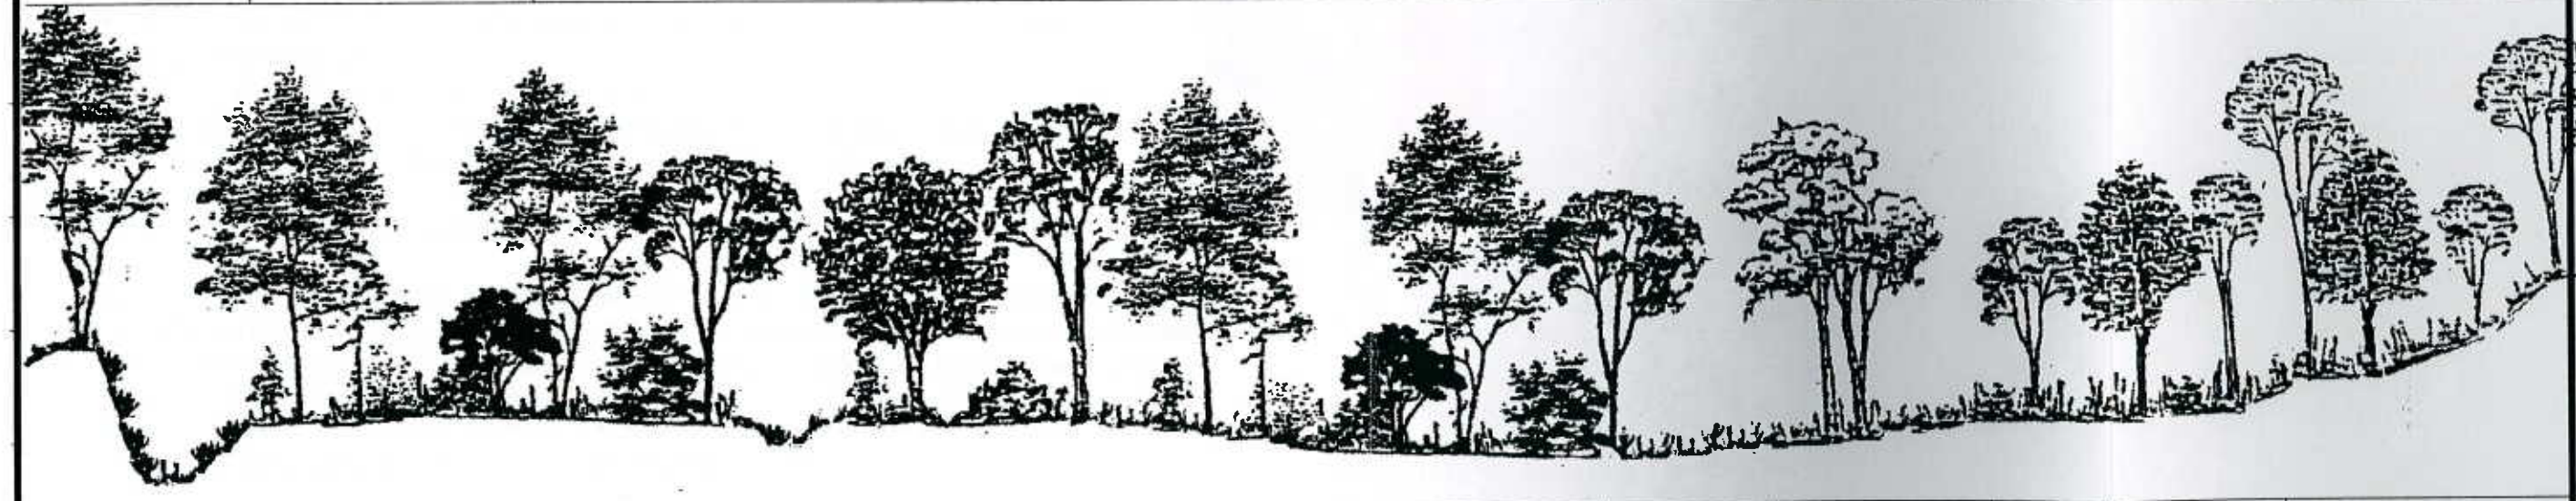
TYPICAL COMMUNITY DISTRIBUTION

TARGET ASSOCIATION	PIEDMONT/MOUNTAIN LEVEE FOREST	PIEDMONT/MOUNTAIN BOTTOMLAND FOREST	PIEDMONT/MOUNTAIN SWAMP FOREST	FLOODPLAIN POOL	PIEDMONT/MOUNTAIN SWAMP FOREST	LOW ELEVATION SEEP	MESIC MIXED HARDWOOD FOREST PIEDMONT SUBTYPE
SITE SPECIFIC SPECIES	GREEN ASH BOXELDER YELLOW POPLAR SYCAMORE RIVER BIRCH  VARIANT SPECIES	YELLOW POPLAR CHERRY BARK OAK GREEN ASH WILLOW OAK WATER OAK SHAGBARK HICKORY  VARIANT SPECIES	CHERRY BARK OAK GREEN ASH WILLOW OAK  VARIANT SPECIES	BUTTON BUSH PICKERAL WEED DUCK POTATO	CHERRY BARK OAK GREEN ASH WILLOW OAK  VARIANT SPECIES	WILLOW OAK  VARIANT SPECIES	WHITE OAK NORTHERN RED OAK YELLOW POPLAR  VARIANT SPECIES
	SPICE BUSH BUCKEYE YELLOW ROOT ELDERBERRY	SILKY DOGWOOD RED CHOKEBERRY ELDERBERRY VIRGINIA WILLOW	SILKY DOGWOOD BLACK WILLOW ELDERBERRY VIRGINIA WILLOW		SILKY DOGWOOD BLACK WILLOW ELDERBERRY VIRGINIA WILLOW	SILKY DOGWOOD ELDERBERRY	BLACK CHERRY RED CEDER WINTER BERRY

SOILS	CONGAREE (TYPIC UDIFLUVENTS)	CHEWACLA (FLUVAQUENTIC DYSTROCHREPTS)  WEHADKEE (TYPIC FLUVAQUENTS)	WEHADKEE (TYPIC FLUVAQUENTS)	WEHADKEE (TYPIC FLUVAQUENTS)	WEHADKEE (TYPIC FLUVAQUENTS)	WEHADKEE (TYPIC FLUVAQUENTS)  INCLUSIONS OF:  WORSHAM (TYPIC OCHRAQUULT)	ALTAYISTA (AQUIC HAPUDULT)  COLFAX (AQUIC FRAGIUDULTS)  WILKES (TYPIC HAPLUDALFS)
-------	---------------------------------	--	---------------------------------	---------------------------------	---------------------------------	--	--

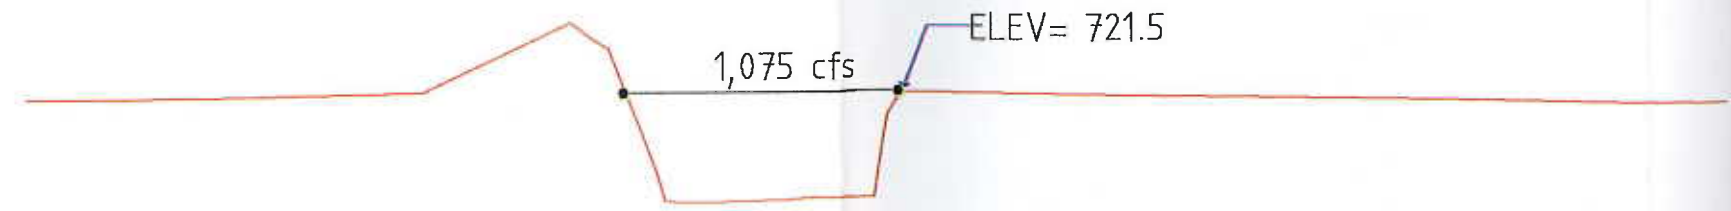
THIRD CREEK  
DISCHARGE  
ELEVATIONS

STATION 40+00  
EXISTING CONDITIONS

PROPOSED

**Berm Breaching:** The berm adjacent to Third Creek varies from 8 to 15 feet above the stream invert. Based on preliminary calculations, this feature restricts access to the floodplain for flows up to 2075 cfs (Figure 14). In order to allow flooding of the site for flows above bank full (1075cfs), removal of portions of the berm sufficient to allow Third Creek to access its floodplain will be necessary. Four to six breaches will be established and stabilized. Additional breaches may be added to achieve the goal of periodic flooding without excessive deposition of alluvial materials.
