**YEAR 1 (2012)**  
**ANNUAL MONITORING REPORT**

**SLIVER MOON NON-RIPARIAN WETLAND MITIGATION SITE**

CRAVEN COUNTY, NORTH CAROLINA  
EEP PROJECT # 95017

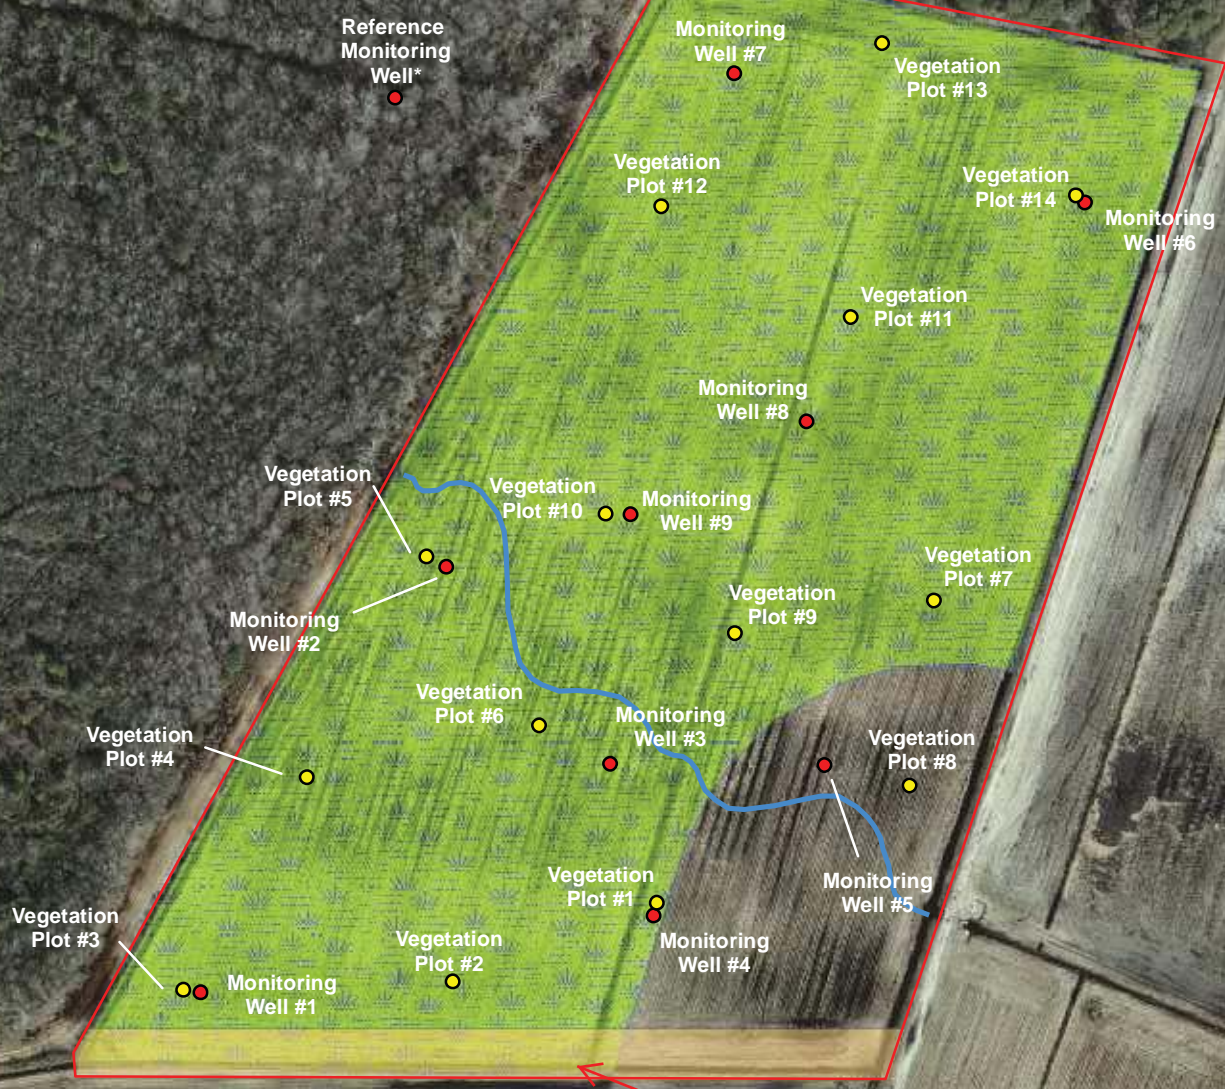
Dwn. by. KRJ	<b>FIGURE</b>  <b>2</b>
Date: Dec. 2012	
Project: 10-001

Area of Ag. Encroachment. .35 acres

\*The Reference Monitoring Well's position was re-referenced at the end of the 2012 monitoring season with a more accurate GPS device resulting in a new, more accurate location than what was reported on 'Sheet D: Monitoring Plan' of the Sliver Moon Baseline Monitoring Document and As-Built Report Dated July 2012.

Agricultural encroachment in the southern margins of the Site occurred in the spring of 2012, after site planting had occurred. Carolina Silvics, who originally planted the Site, will replant the encroached area with approximately 50, 1 gallon containerized blackgums (*Nyssa sylvatica*), during the dormant season between 2012 and 2013. Photographic evidence of planting will accompany the 2013 (year 2) monitoring report. Additionally, the southern boundary was marked more visibly to alleviate further encroachment into the Site.

Planted Acreage – 17.01 acres (Entire Easement)						
Vegetation Category		Mapped Acreage	CCPV Symbol	Number of Polygons	% of planted Acreage	Plan of Action
Areas of Encroachment	Post planting, the tenant farmer encroached ~ 50' along the southern boundary	.35ac	translucent orange rectangle	1	2%	The area will be replanted during the dormant season with bare root and containerized trees
Areas of Concern	No areas of vegetation concern observed at the Site during 2012 monitoring.	NA	NA	NA	0%	
Exotic Invasive Species	No invasive species observed at the Site during 2012 monitoring.	NA	NA	NA	<1%

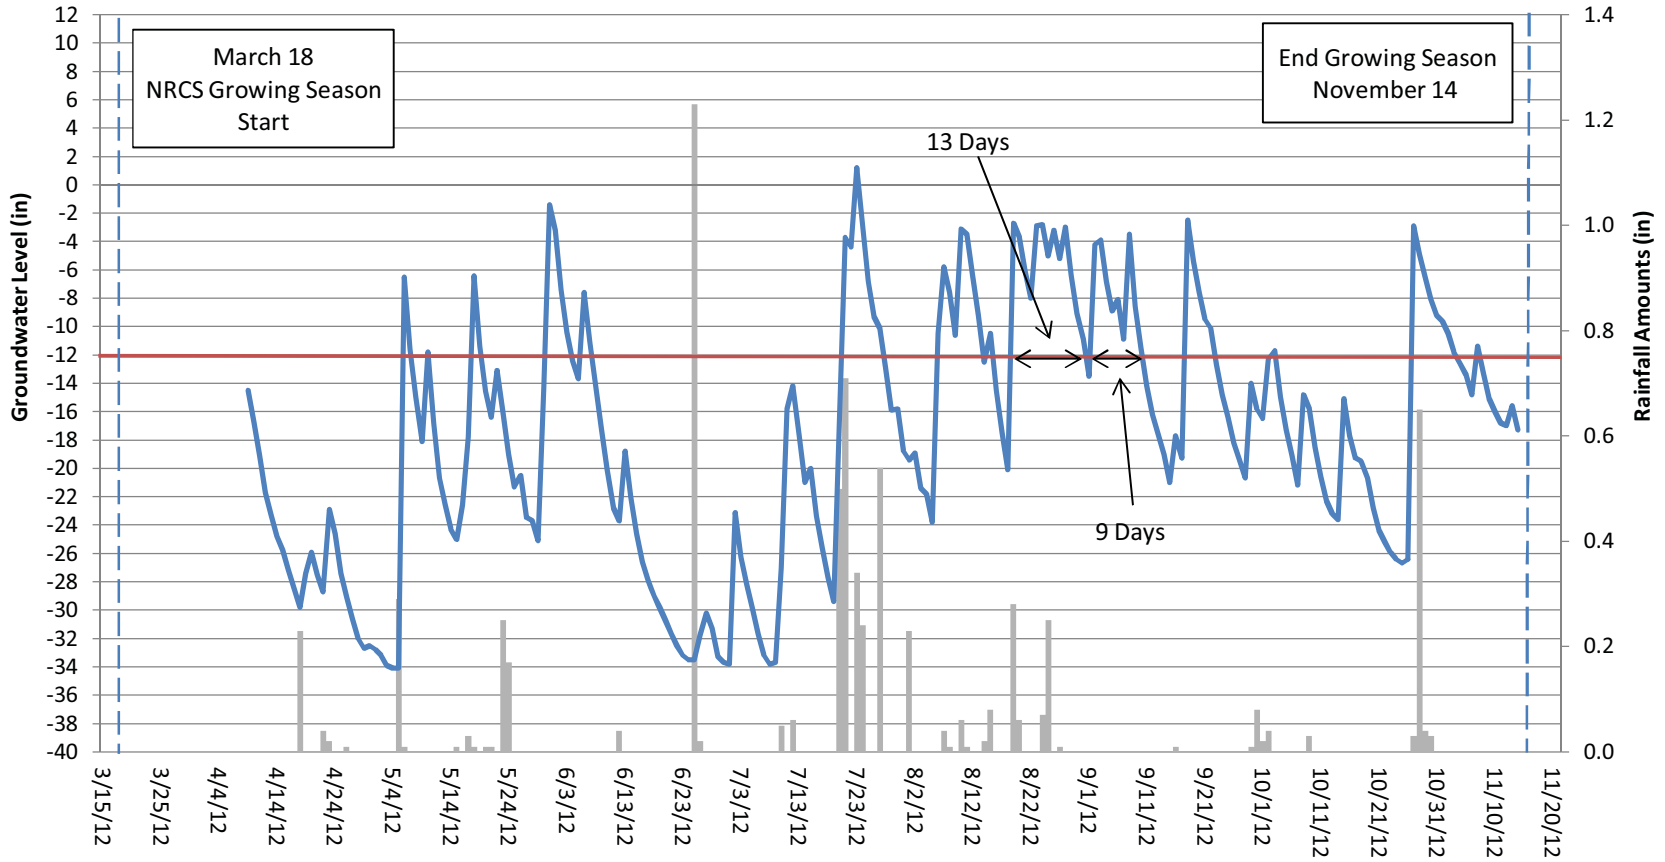
# Sliver Moon Groundwater Gauge 4 Year 1 (2012 Data)

Eight of the nine monitored gauges within restoration areas were inundated / saturated within 12 inches of the surface for greater than 7.5 percent of the growing season (18 days), which extends from March 18 to November 14 (242 days). Gauge 4 was just shy of success criteria with consecutive inundation/saturation for 5.4 percent of the growing season. Gauge 4 malfunctioned at the beginning of the growing season and began recording on April 9, 2012, missing the early portion of the growing season. Gauge 4 was within 12 inches of the ground surface for 13 days midway through the growing season, then dipped below 12 inches of the ground surface for only 1 day, and was again within 12 inches of the ground surface for 9 days. Gauge 4 met hydrologic criteria for 22 of 23 consecutive days and would be expected to make hydrology success criteria during future monitoring years.
