YEAR 4 (2015)
ANNUAL MONITORING REPORT
SLIVER MOON NON-RIPARIAN WETLAND MITIGATION SITE

CRAVEN COUNTY, NORTH CAROLINA
DMS PROJECT ID: 95017

December 2015

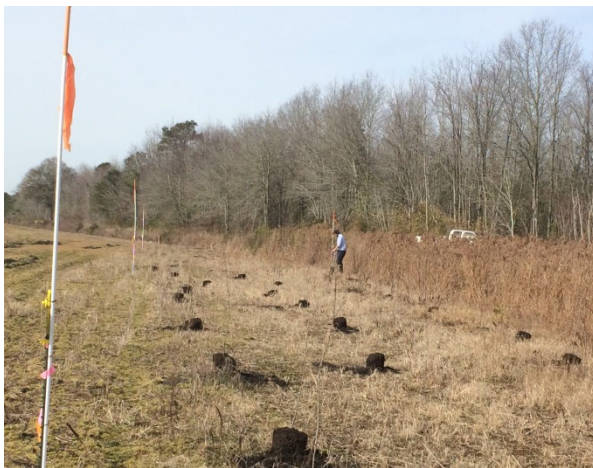
An approximately 0.25-acre area along the southern margins of the Site was mowed in the spring of 2014. The southern boundary was remarked with new t-posts, 10-foot pvc pipes, and DMS signs every 100 feet. In addition, this area was replanted in the winter of 2014/2015 with 150-3 gallon black gums (*Nyssa sylvatica* var. *sylvatica*) (see photo to left).

An approximately 0.25-acre area along the southern margins of the Site was mowed in the spring of 2014. The southern boundary was remarked with new t-posts, 10-foot pvc pipes, and DMS signs every 100 feet. In addition, this area was replanted in the winter of 2014/2015 with 150 3-gallon black gums (*Nyssa sylvatica* var. *sylvatica*).

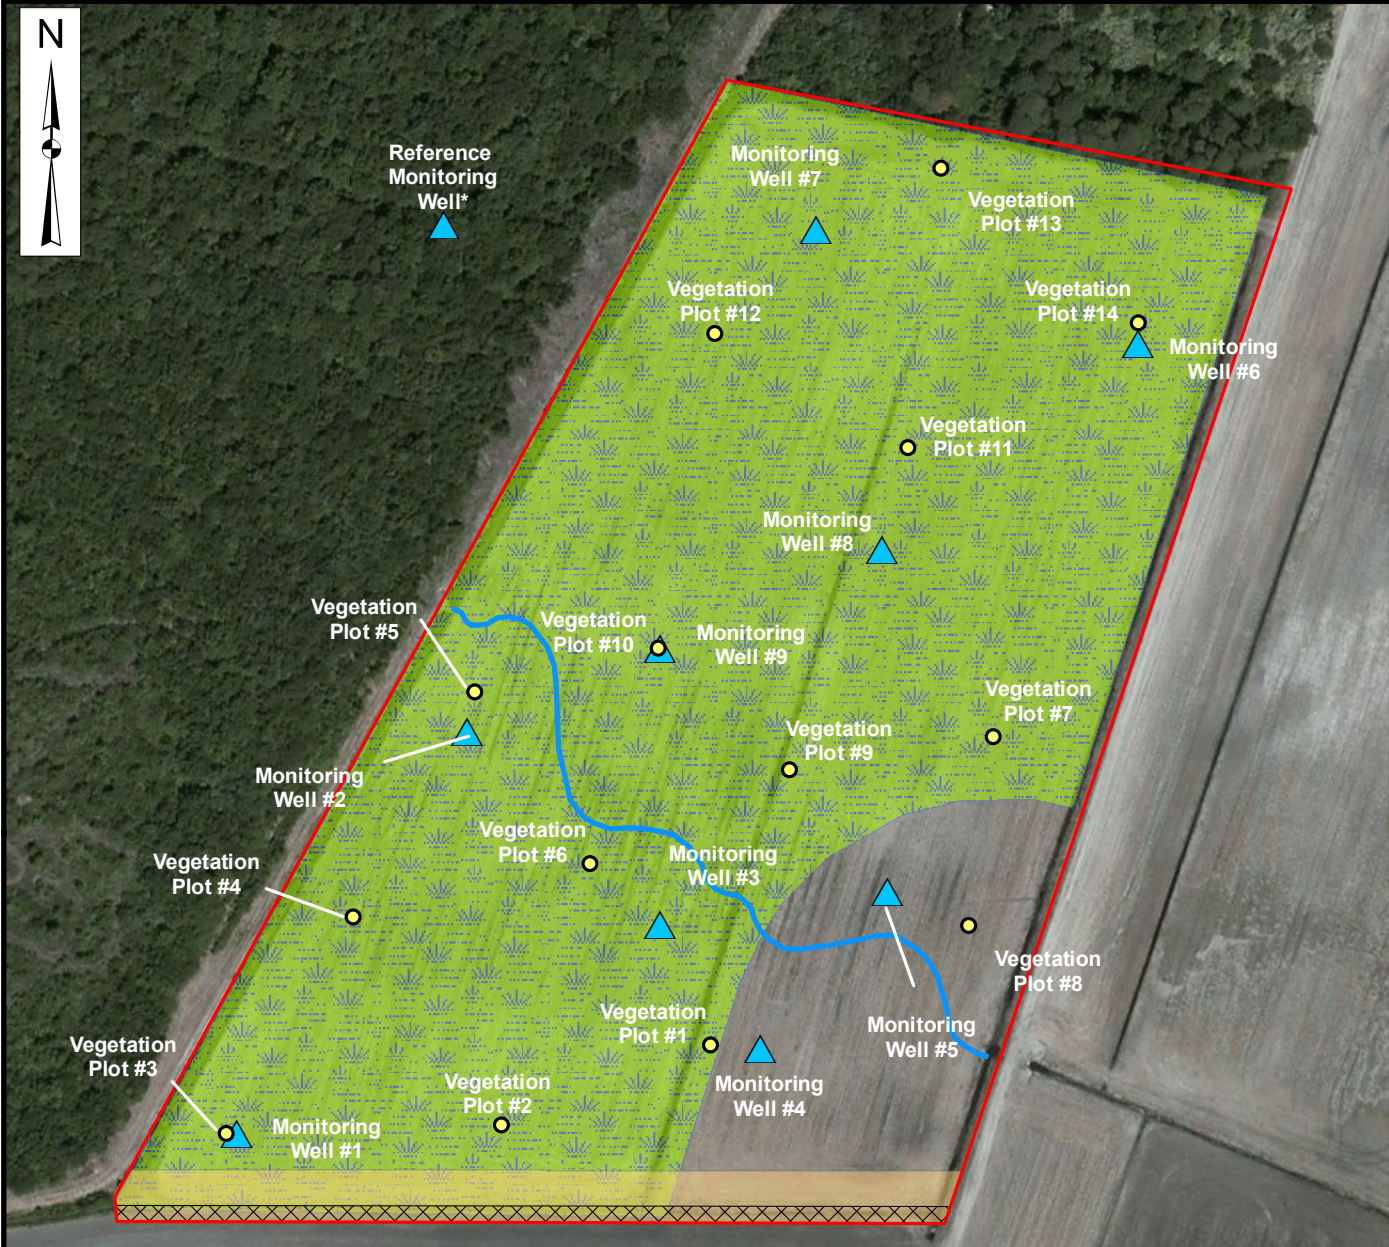
Figure 2. Current Condition Plan View

Monitoring features (vegetation plots and groundwater gauges) are depicted in Figure 2 (Appendix B). Tables 1 through 3 summarize project components and mitigation credits, project activities and reporting history, and project contacts, respectively (Appendix A).

Monitoring of restoration efforts will be performed for a minimum of 7 years or until success criteria are fulfilled. The detailed monitoring plan is depicted in Figure 2 (Appendix B).

CURRENT CONDITIONS PLAN VIEW
SLIVER MOON WETLAND RESTORATION SITE
Craven County, North Carolina

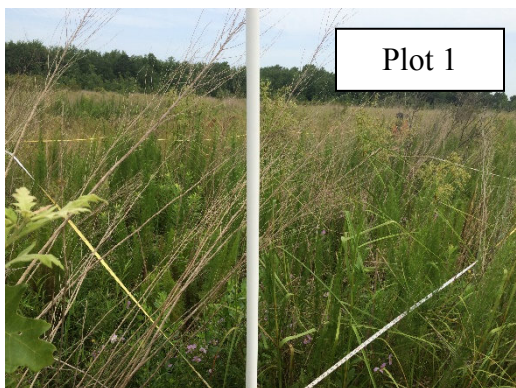
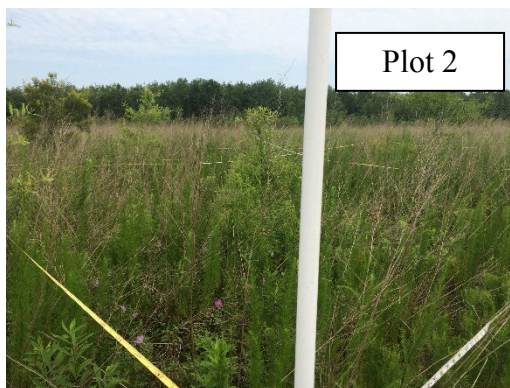
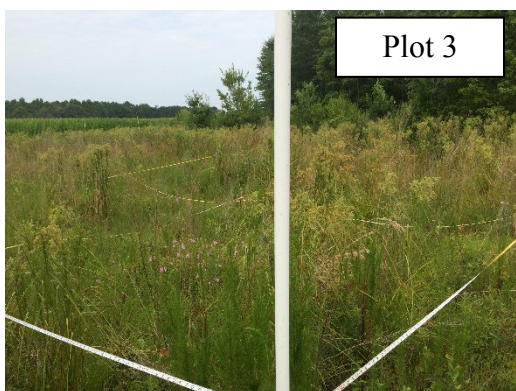
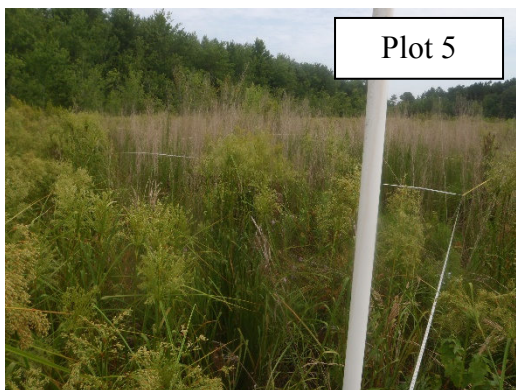
**Sliver Moon
2015 (Year 4) Vegetation Monitoring Photographs
Taken July 2015**

Fourteen vegetation plots (10-meter by 10-meter in size) were established and permanently monumented. These plots were surveyed in July 2015 for the Year 4 (2015) monitoring period. Vegetation sampled across the Site exceeded the required average density with 480 planted stems-per-acre surviving. In addition, each individual plot exceeded success criteria based on planted stems alone with the exception of Plot 5; however, when including naturally recruited red maple (*Acer rubrum*) this plot was well-above success criteria. The area surrounding Plot 5 is very wet, with standing water year-round. This likely contributed to planted stem mortality in this area.

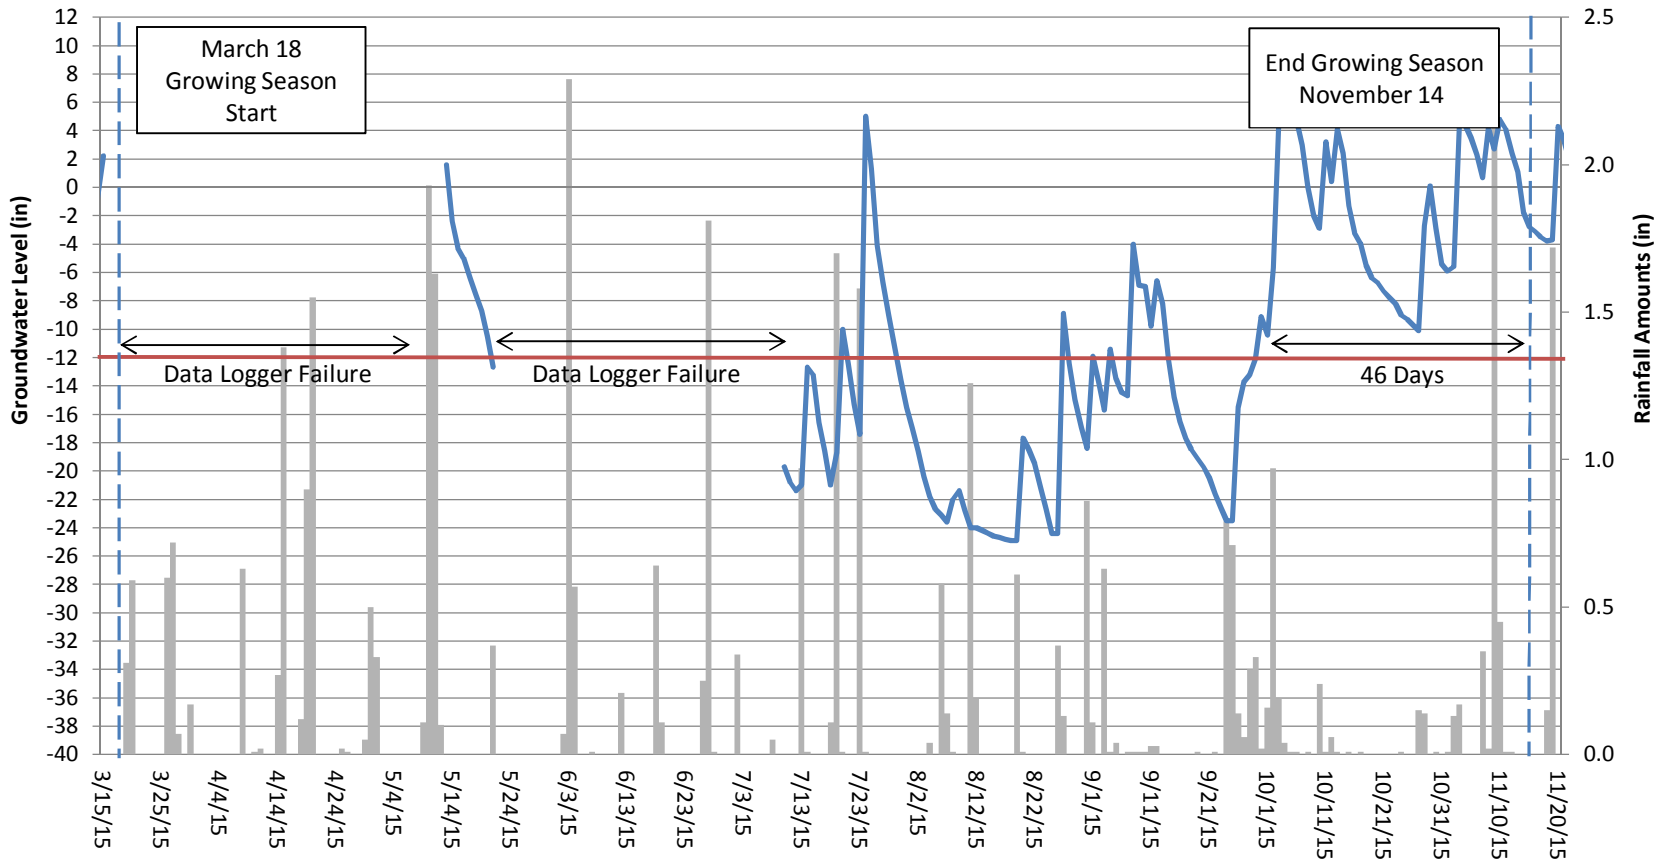
Sliver Moon Groundwater Gauge 7 Year 4 (2015 Data)

| Gauge | Success Criteria Achieved/Max Consecutive Days During Growing Season (Percentage) | | | | |
|---|--|---|--|--|---|
| 7 | Yes/40 Days (16.5 percent) | Yes/93 days (33.1 percent) | Yes/53 Days (22 percent) | Yes/46 Days (19 percent) | |
