*Restoration
Plan*

Smith and Austin Creeks Stream Mitigation Plan & Design Wake Forest, North Carolina

BUCK
ENGINEERING

June 2001

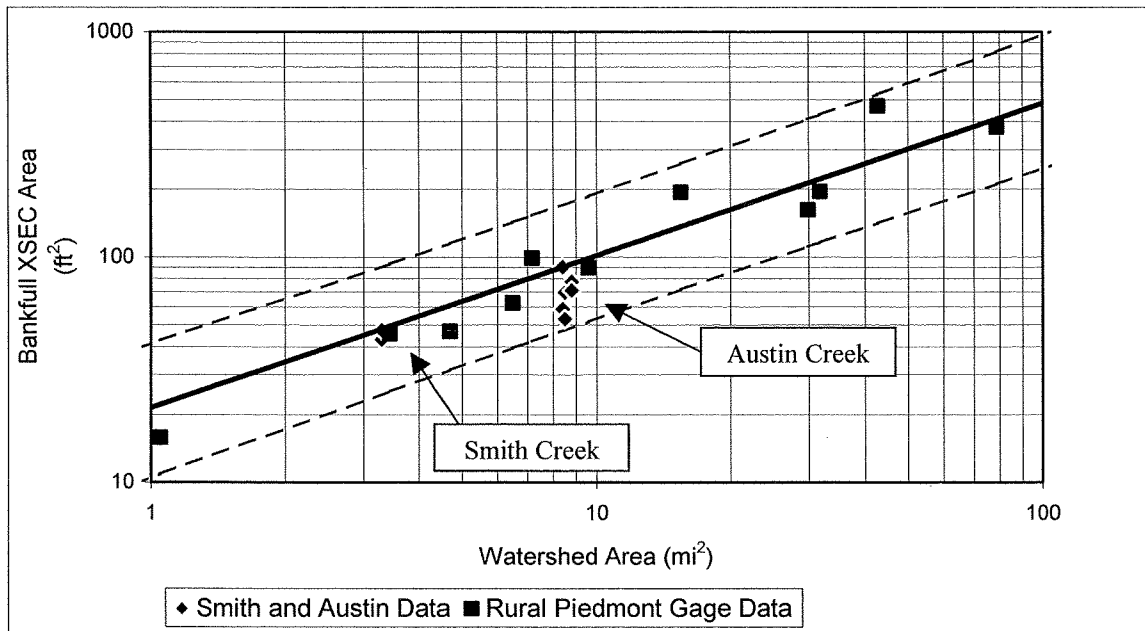
Figure 3.1 Rural Piedmont Regional Curve with surveyed bankfull cross-section areas for Smith and Austin Creeks. Data points for Smith and Austin Creeks were not used in determining the regression line.

The bankfull indicators for Smith Creek and Austin Creek included the back of a depositional bench, a scour line, and in a few cases, the top of the streambank. These indicators are consistent with other Piedmont streams that are at a Stage IV/V in Simon's Channel Evolution Model. Data for Smith and Austin Creeks are shown on Figure 3.1. The project points match well with other data on the rural Piedmont regional curve, indicating that bankfull was correctly identified. All of the points for Austin Creek are below the regression line. This is likely caused by the upstream Wake Forest water supply reservoir.

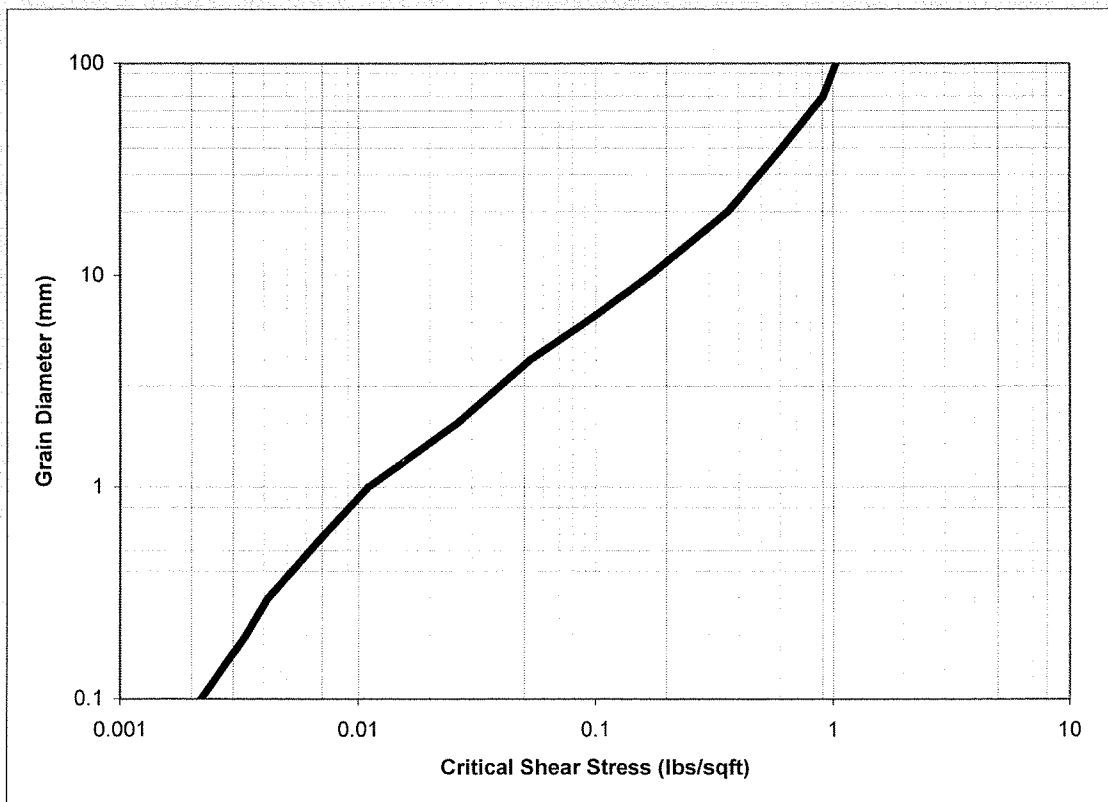
Figure 6.3 Shield's Curve for Grain Diameter of Transported Particle in Relation to Critical Shear Stress.

Boundary shear stresses were calculated for the design cross-sections using Equation 6.3. From Shields diagram (Figure 6.3), these shear stresses values would be able to move particle sizes from 20 to 30 mm for Smith and Austin Creeks, respectively. These numbers are significantly higher than the largest particles sampled, which were 12 mm. Therefore, grade control structures will be required to ensure that the bed does not degrade. Bedrock knickpoints, cross vanes, and existing culverts will be used to provide grade control.

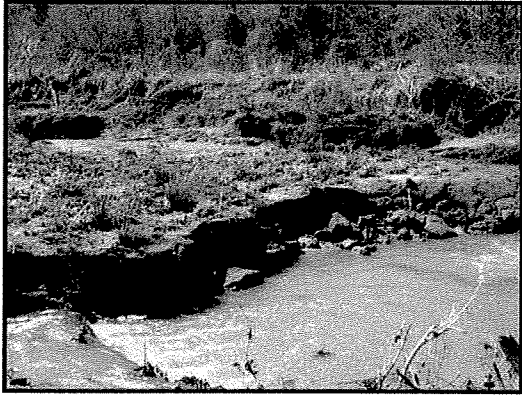
Photo 1 – Eroding bank along SR1

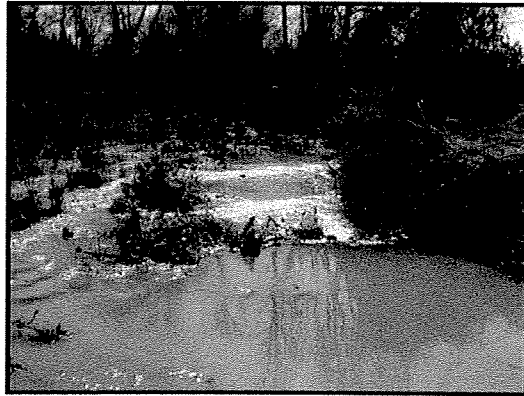
Photo 2 – Over wide section of SR2

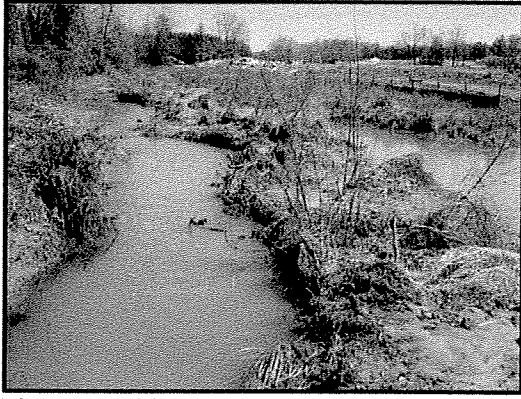
Photo 7 – Mid channel bar on Smith SR2

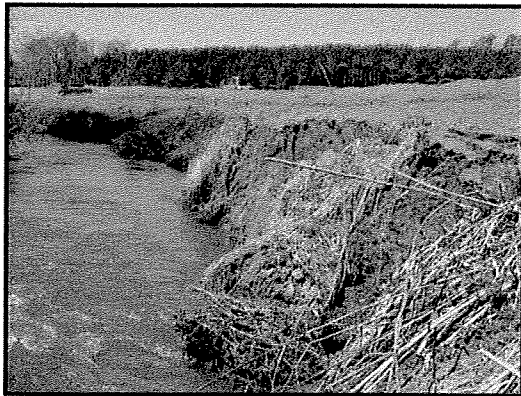
Photo 11 – Streambank erosion along AR1
