# Smith and Austin Stream Restoration 2004 Annual Monitoring Report

April, 2005

## 2004 Smith and Austin Creeks Monitoring Abstract

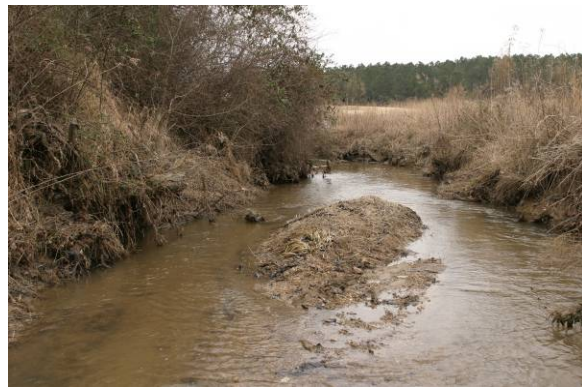
**Issue Photo 2. Mid-Channel Bar STA: 9+75**

- Bank erosion has been noted at six locations on the reaches of Austin Creek due to the formation of mid-channel bars
    - At Station 9+75 there is a mid-channel bar forming that has dimensions of 3ft wide by 20ft along the profile of the stream

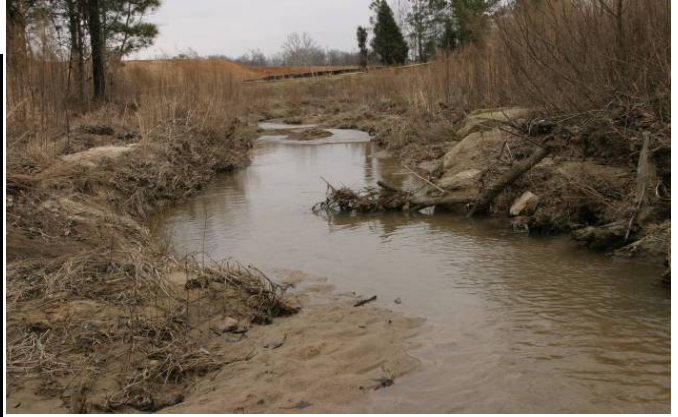
Photo of Cross-Section SR1-2 - Looking Downstream @ STA 9+35

2004	2003	AS-BUILT
Area	55.9	60.8	59.6
Width	25.1	23.6	23.5
Mean Depth	2.2	2.6	2.5
Max Depth	3.1	3.7	3.7
W/D	11.3	9.2	9.3

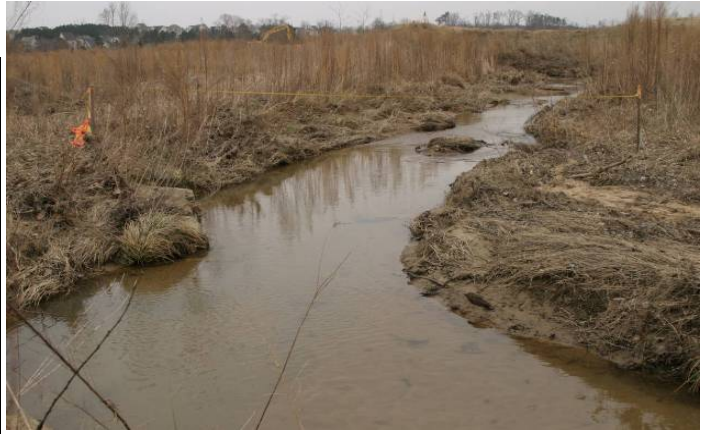
Photo of Cross-Section SRI-3 - Looking Downstream @ STA 11+30

2004	2003	AS-BUILT
Area	36.6	47.5	44.9
Width	25.9	25.6	31.3
Mean Depth	1.4	1.9	1.4
Max Depth	2.4	2.7	2.8
W/D	18.3	13.8	21.8

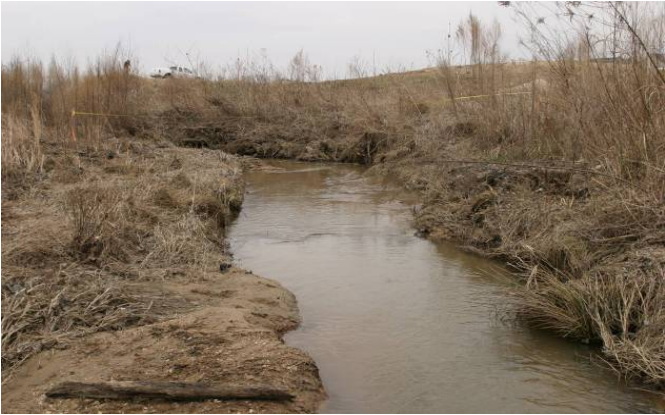
Photo of Cross-Section SR1-4 - Looking Downstream @ STA 12+00

2004	2003	AS-BUILT
Area	43.8	69.3	57.9
Width	45.1	47.4	46.5
Mean Depth	1.0	1.5	1.2
Max Depth	3.7	4.1	3.8
W/D	46.4	32.4	37.3

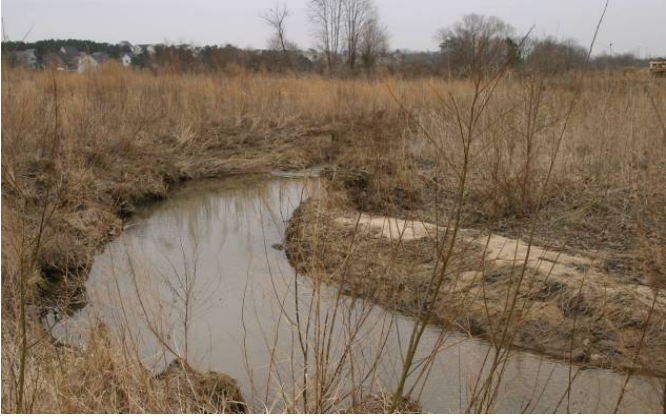
Photo of Cross-Section SR1-5 - Looking Downstream @ STA 16+90

2004	2003	AS-BUILT
Area	78.9	123.2	109.2
Width	43.2	44.2	41.8
Mean Depth	1.8	2.8	2.6
Max Depth	3.1	5.1	4.8
W/D	23.6	15.9	16.0

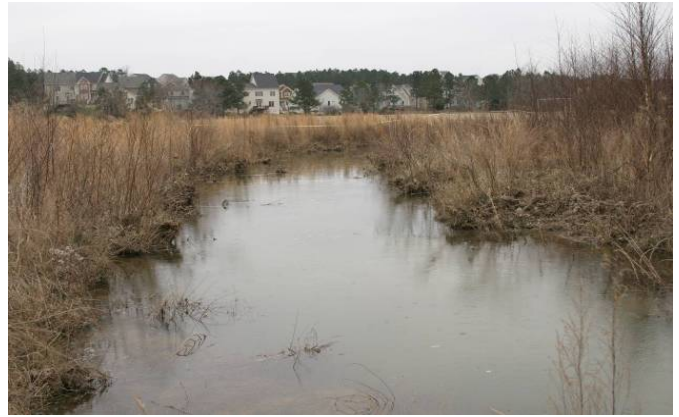
Photo of Cross-Section SR2-1 - Looking Downstream @ STA 24+30

2004	2003	AS-BUILT
Area	44.9	45.9	46.5
Width	20.0	20.2	33.2
Mean Depth	2.2	2.3	1.4
Max Depth	3.9	3.3	3.1
W/D	8.9	8.9	23.7

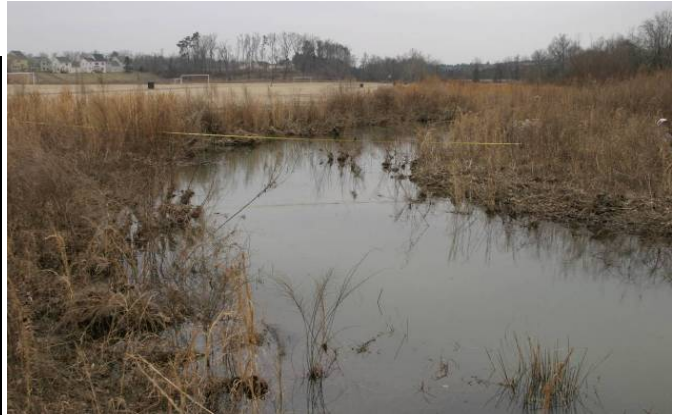
Photo of Cross-Section SR2-2 - Looking Downstream @ STA 24+87

2004	2003	AS-BUILT
Area	60.8	59.2	48.5
Width	25.7	26.2	26.9
Mean Depth	2.4	2.3	1.8
Max Depth	4.6	3.8	3.8
W/D	10.9	11.6	14.9

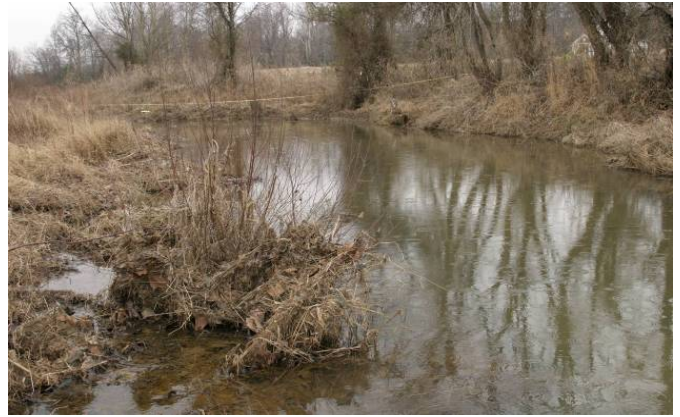
Photo of Cross-Section SR2-3 - Looking Downstream @ STA 31+25

2004	2003	AS-BUILT
Area	52.4	59.6	64.0
Width	36.3	37.7	39.1
Mean Depth	1.4	1.6	1.6
Max Depth	3.4	4.2	4.1
W/D	25.1	23.8	23.9

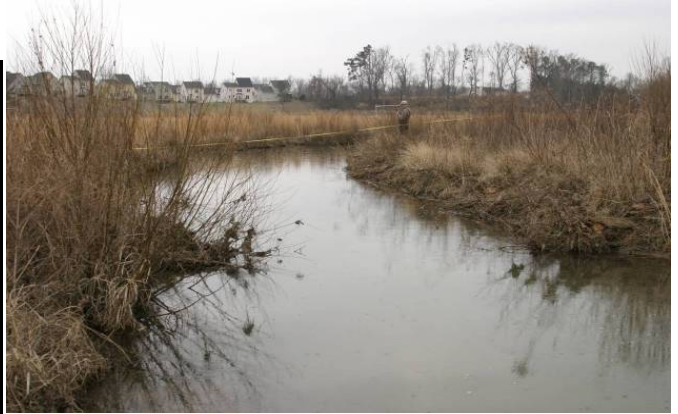
Photo of Cross-Section SR2-4 - Looking Downstream @ STA 32+45

2004	2003	AS-BUILT
Area	38.4	42.7	38.9
Width	18.4	18.9	18.7
Mean Depth	2.1	2.3	2.1
Max Depth	3.2	3.3	3.1
W/D	8.8	8.4	9.0

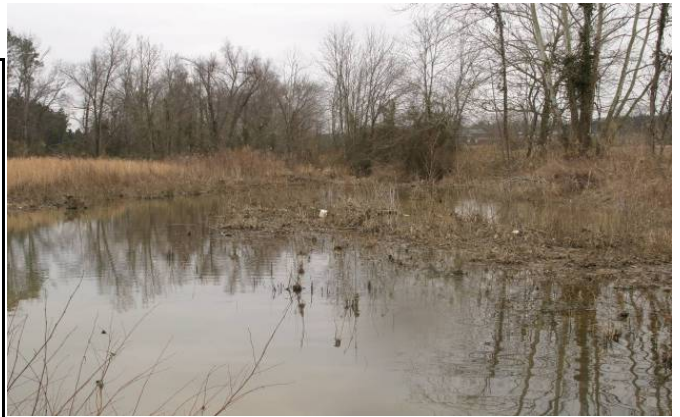
Photo of Cross-Section SR2-5 - Looking Downstream @ STA 39+20

2004	2003	AS-BUILT
Area		35.8	37.2
Width		16.9	18.4
Mean Depth		2.1	2.0
Max Depth		3.0	3.0
W/D		8.0	9.1

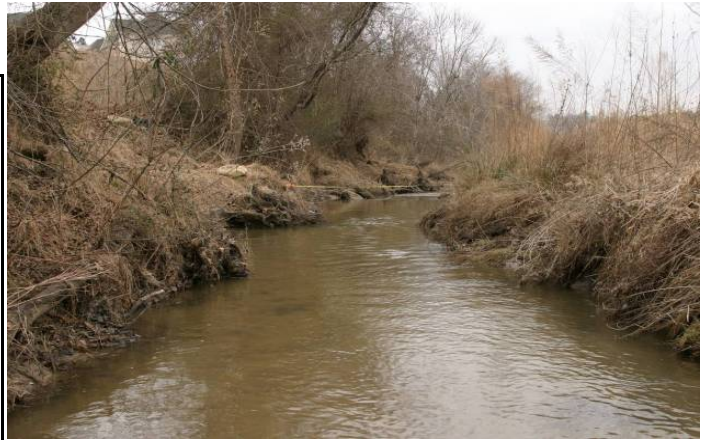
Photo of Cross-Section AR1-2 - Looking Downstream @ STA 4+42

2004	2003	AS-BUILT
Area	62.4	51.2	49.0
Width	29.5	31.1	32.4
Mean Depth	2.1	1.6	1.5
Max Depth	4.0	3.8	3.9
W/D	14.0	18.9	21.4

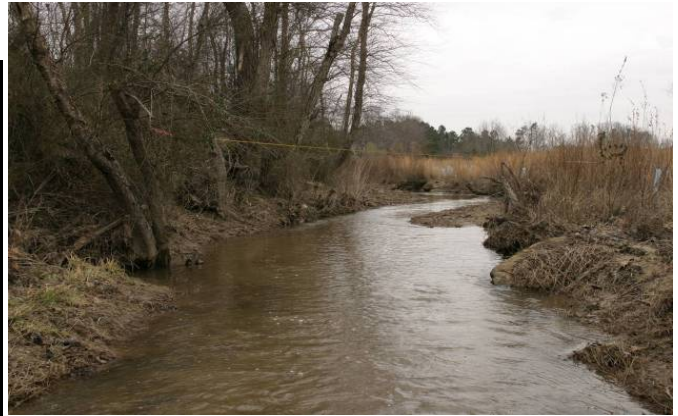
Photo of Cross-Section AR2-2 - Looking Downstream @ STA 28+35

2004	2003	AS-BUILT
Area	43.9	36.9	37.1
Width	17.3	19.7	21.3
Mean Depth	2.5	1.9	1.7
Max Depth	3.4	3.5	3.6
W/D	6.8	10.5	12.2

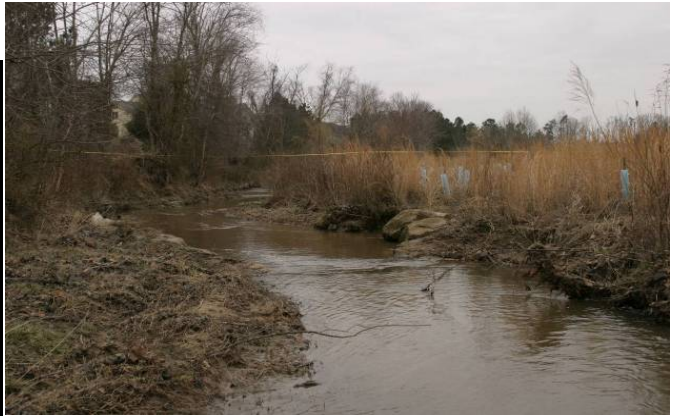
Photo of Cross-Section AR2-3 - Looking Downstream @ STA 30+45

2004	2003	AS-BUILT
Area	53.9	56.4	54.4
Width	24.1	24.0	24.9
Mean Depth	2.2	2.4	2.2
Max Depth	3.2	3.2	3.1
W/D	10.8	10.2	11.4

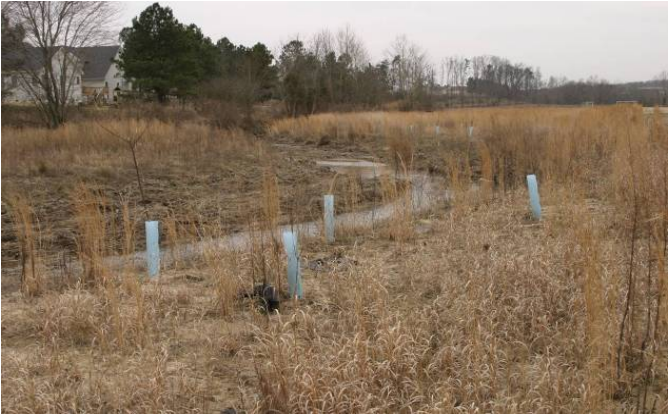
Photo of Cross-Section AR3-1 - Looking Downstream @ STA 34+55

2004	2003	AS-BUILT
Area	72.7	87.5	97.1
Width	39.6	41.2	37.3
Mean Depth	1.8	2.1	2.6
Max Depth	3.8	4.8	4.8
W/D	21.6	19.4	14.3

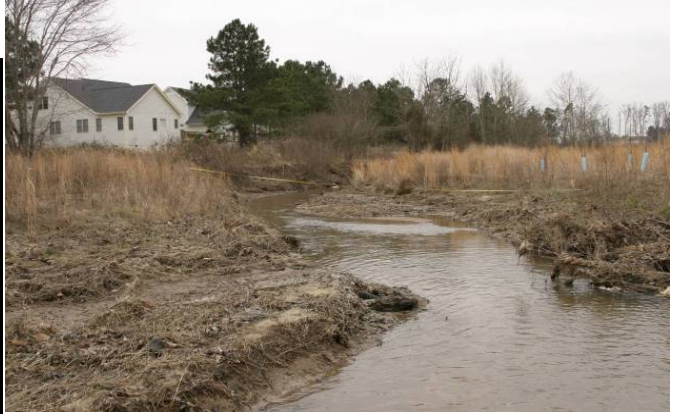
Photo of Cross-Section AR3-2 - Looking Downstream @ STA 35+15

2004	2003	AS-BUILT
Area	97.1	125.1	126.5
Width	35.5	37.2	38.4
Mean Depth	2.7	3.4	3.3
Max Depth	3.8	5.3	5.3
W/D	13.0	11.1	11.7

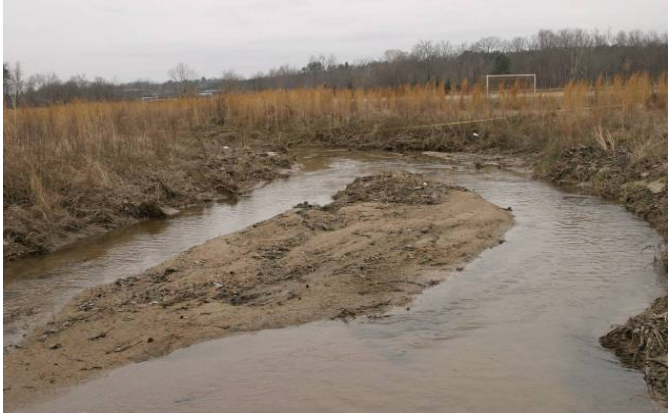
Photo of Cross-Section AR3-3 - Looking Downstream @ STA 38+15

2004	2003	AS-BUILT
Area	93.0	151.2	153.8
Width	39.1	39.4	38.5
Mean Depth	2.4	3.8	4.0
Max Depth	3.8	7.1	7.1
W/D	16.4	10.3	9.6

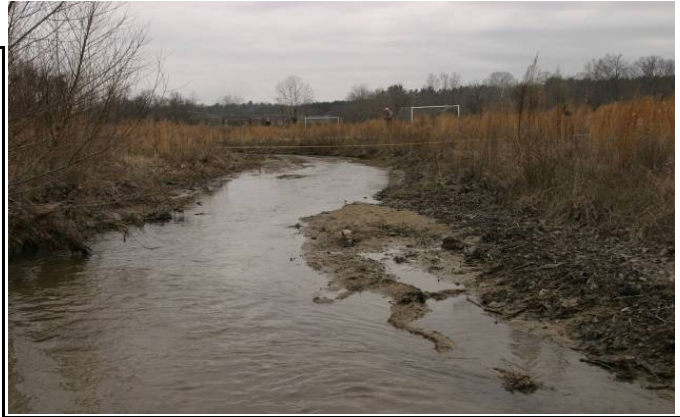
Photo of Cross-Section AR3-4 - Looking Downstream @ STA 41+00

2004	2003	AS-BUILT
Area	63.7	77.4	78.8
Width	35.1	34.1	31.6
Mean Depth	1.8	2.3	2.5
Max Depth	3.3	4.0	4.0
W/D	19.3	15.0	12.7

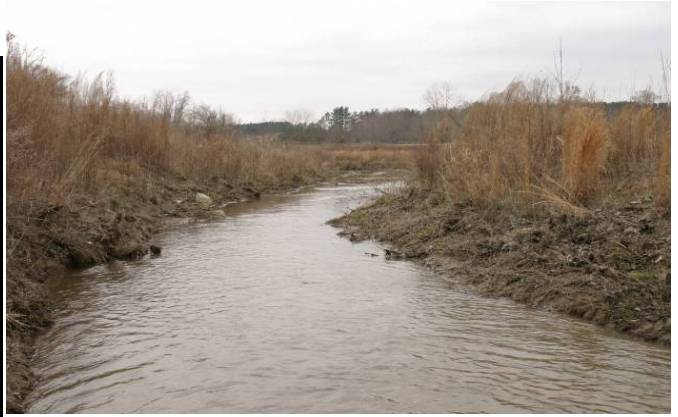
Photo of Cross-Section AR3-5 - Looking Downstream @ STA 46+40

2004	2003	AS-BUILT
Area	88.9	116.0	99.9
Width	35.6	39.1	34.3
Mean Depth	2.5	3.0	2.9
Max Depth	3.9	4.7	4.2
W/D	14.2	13.2	11.8

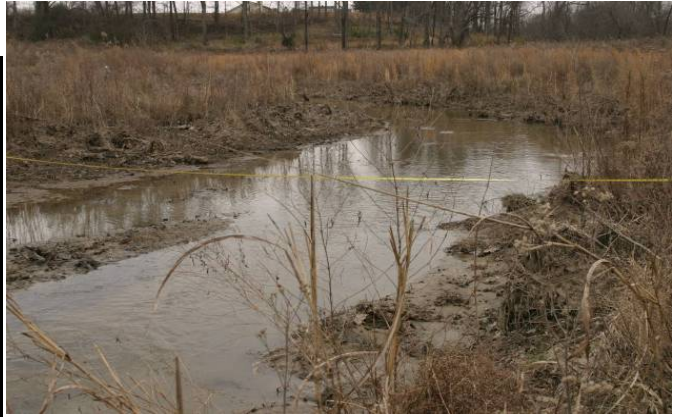
Photo of Cross-Section AR3-6 - Looking Downstream @ STA 48+20

2004	2003	AS-BUILT
Area	70.0	108.9	135.7
Width	56.9	58.4	58.3
Mean Depth	1.2	1.9	2.3
Max Depth	3.4	6.7	6.9
W/D	46.2	31.3	25.0
