Smith and Austin Stream Restoration Annual Monitoring Report

Monitoring Year: 2005

NCEEP Project Number: 343

SMITH AND AUSTIN STREAM RESTORATION 2005 MONITORING REPORT

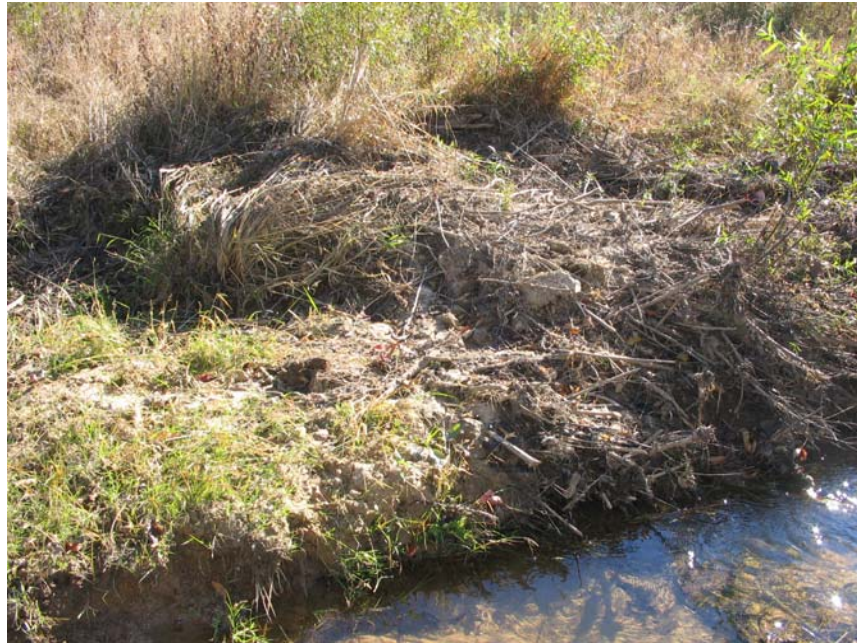
VPA1. Smith Creek Station 41+50. Beaver Dam remnants on bank.

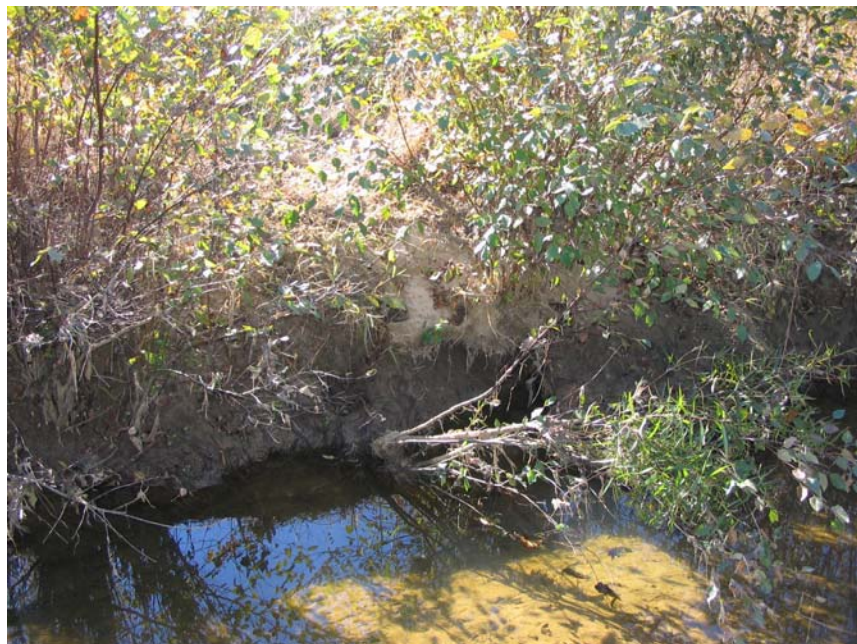
VPA2. Smith Creek Station 40+40. Un-vegetated Bank

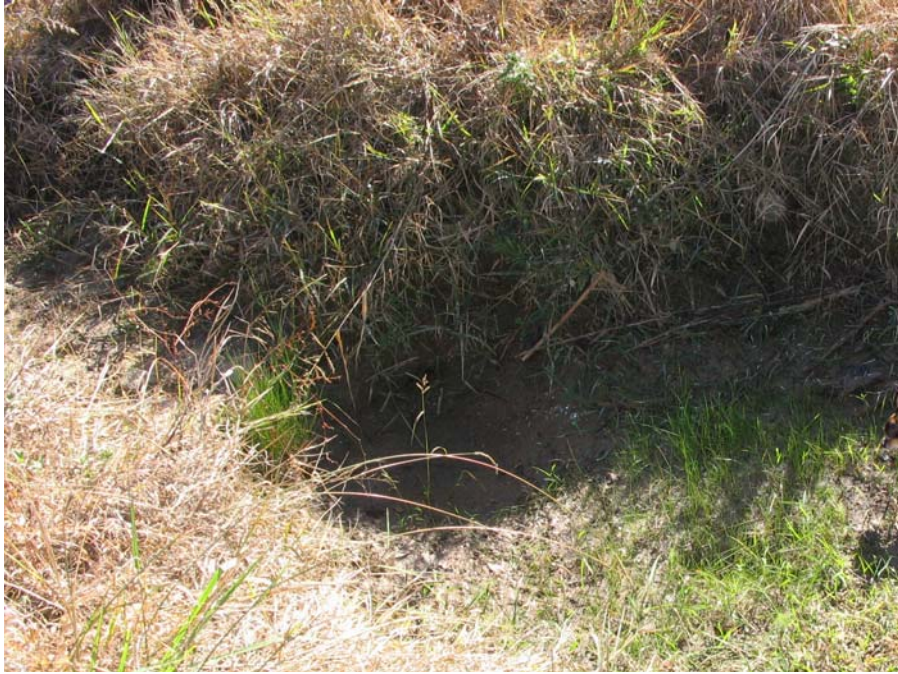
VPA3 Smith Creek Station 38+60. Gully in floodplain from overland flow.

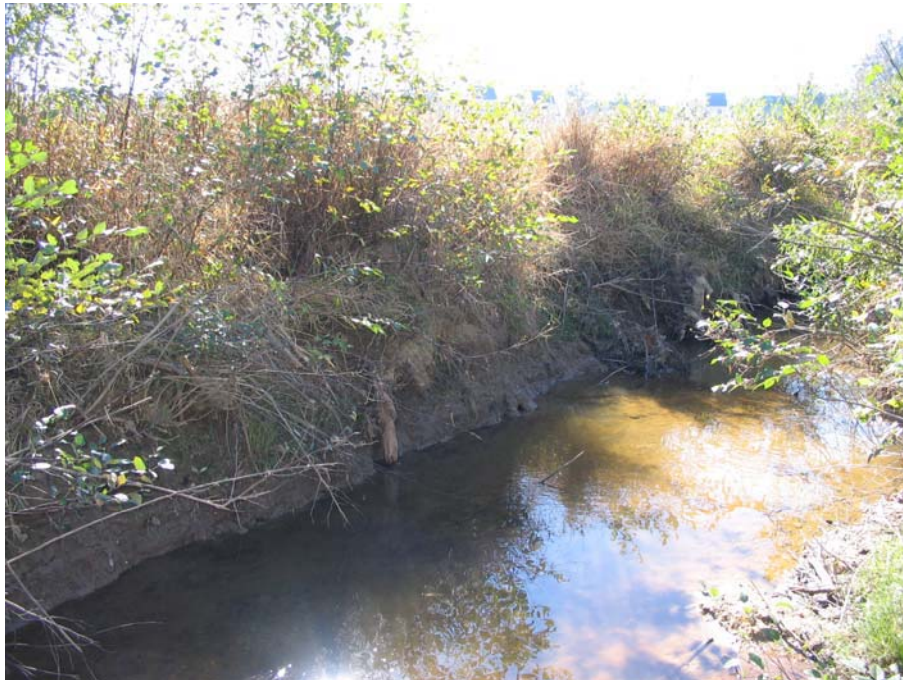
VPA4. Smith Creek Station 36+60. Un-vegetated Bank

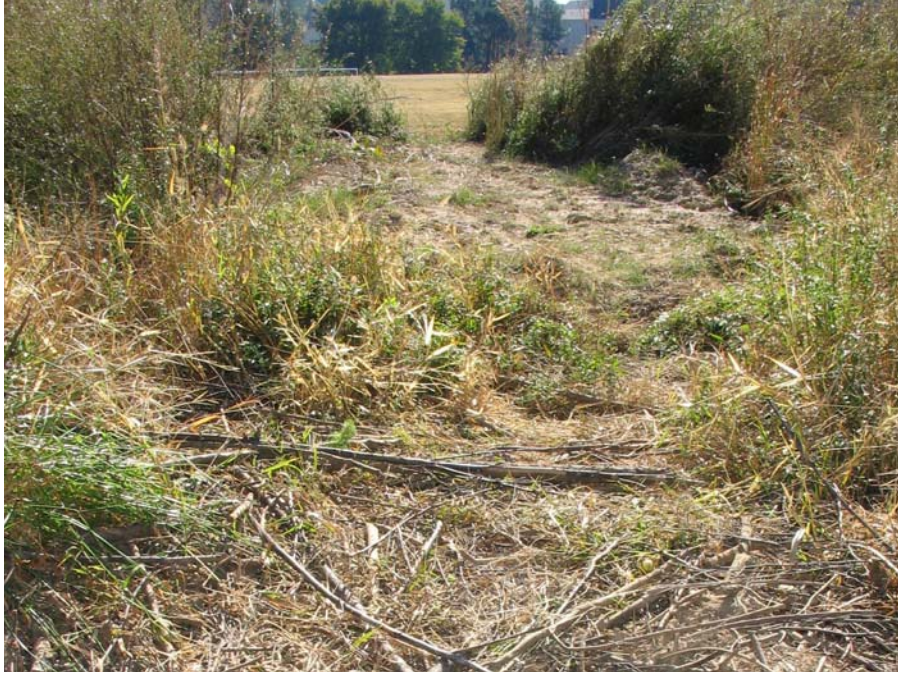
VPA5. Smith Creek Station X+XX. Mowing in floodplain

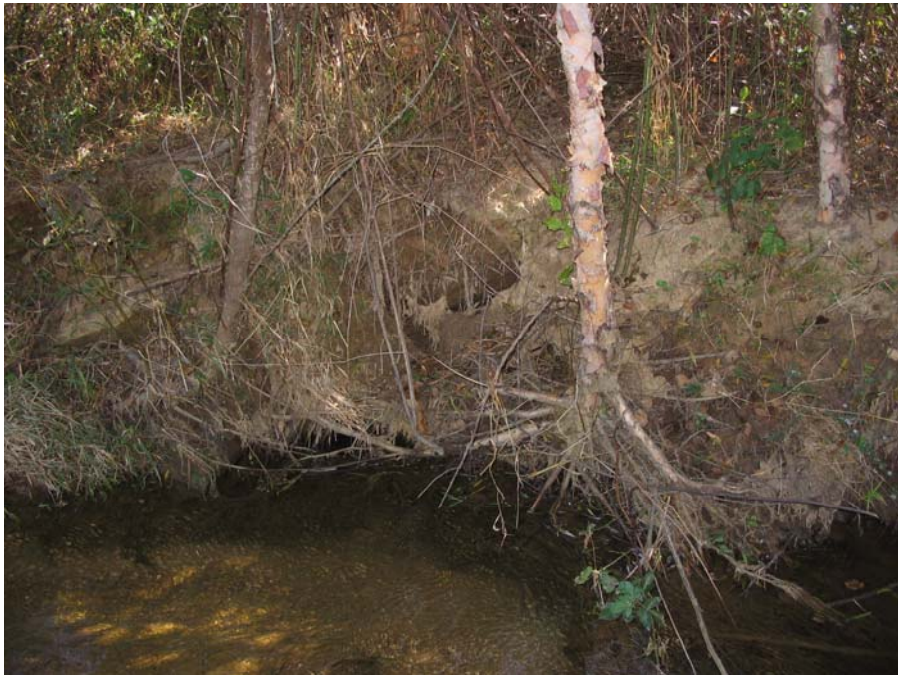
VPA6. Smith Creek Station X+XX. Un-vegetated Bank

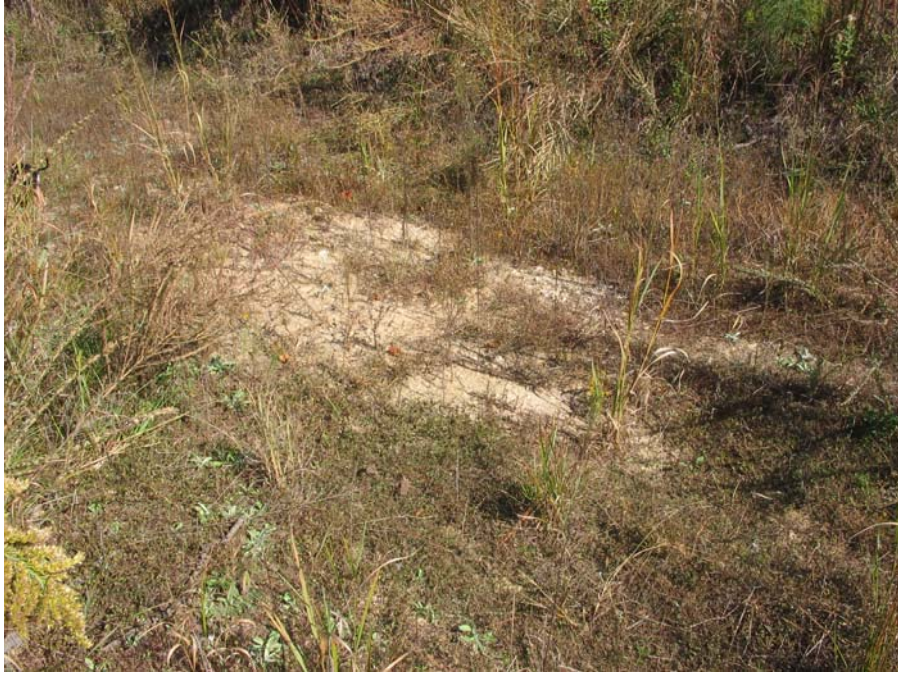
VPA7. Austin Creek Station 21+30. Bare floodplain

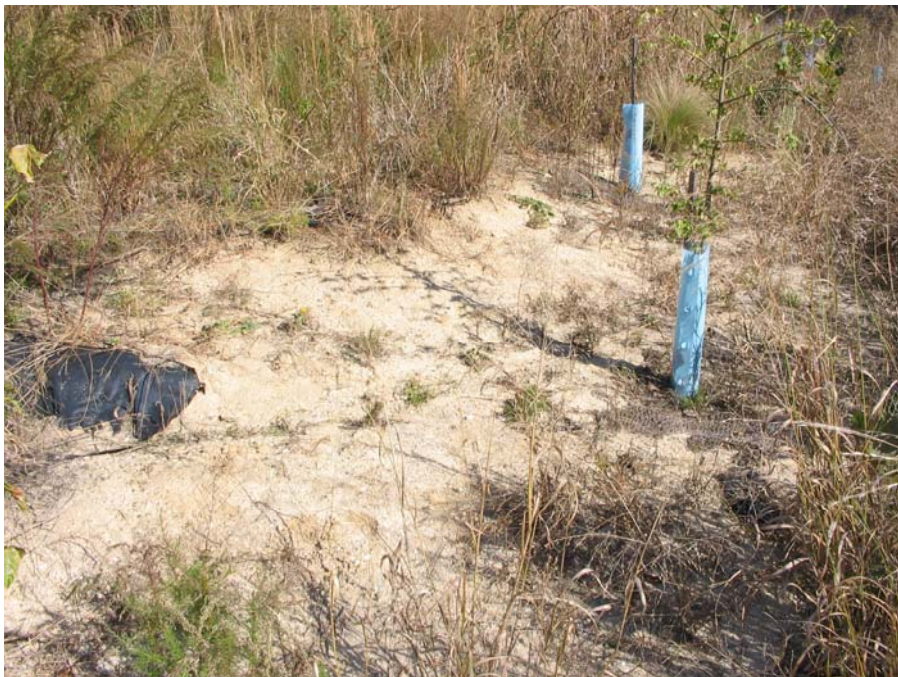
VPA8. Austin Creek Station 14+25. Bare floodplain

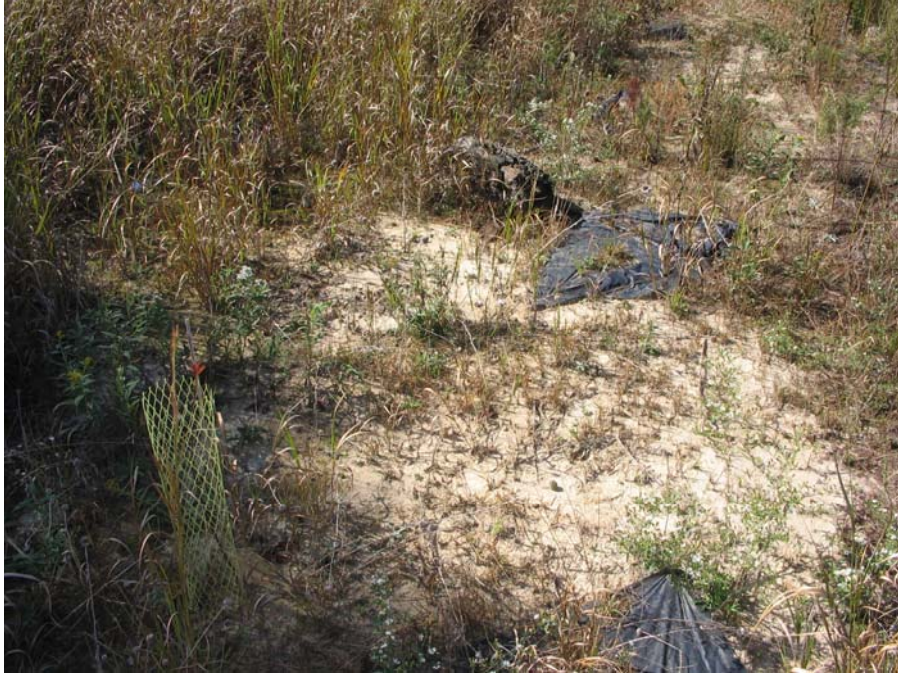
VPA9. Austin Creek Station 14+30. Bare floodplain.

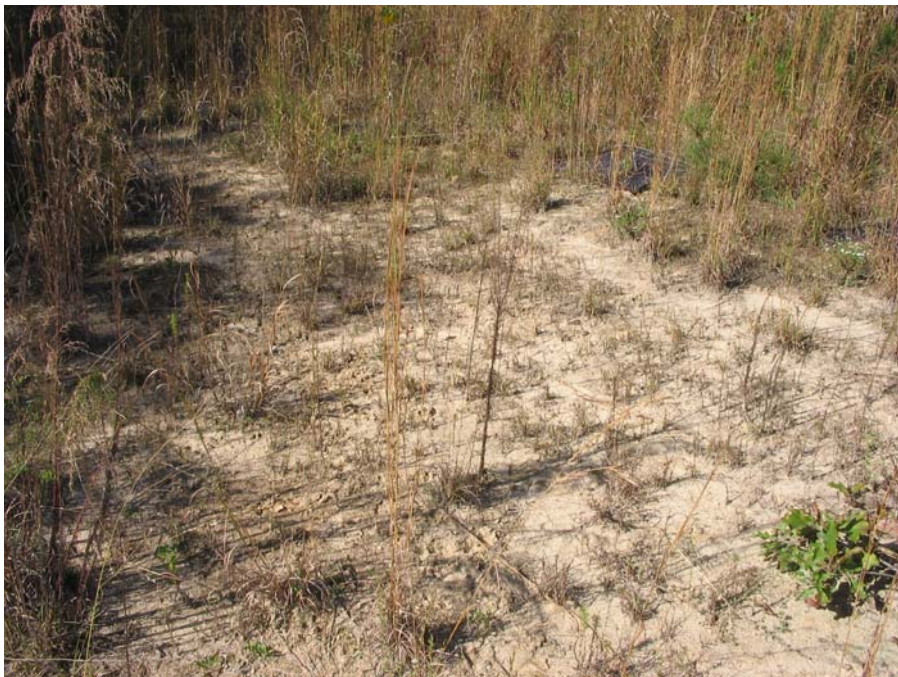
VPA10. Austin Creek Station 9+70. Bare floodplain

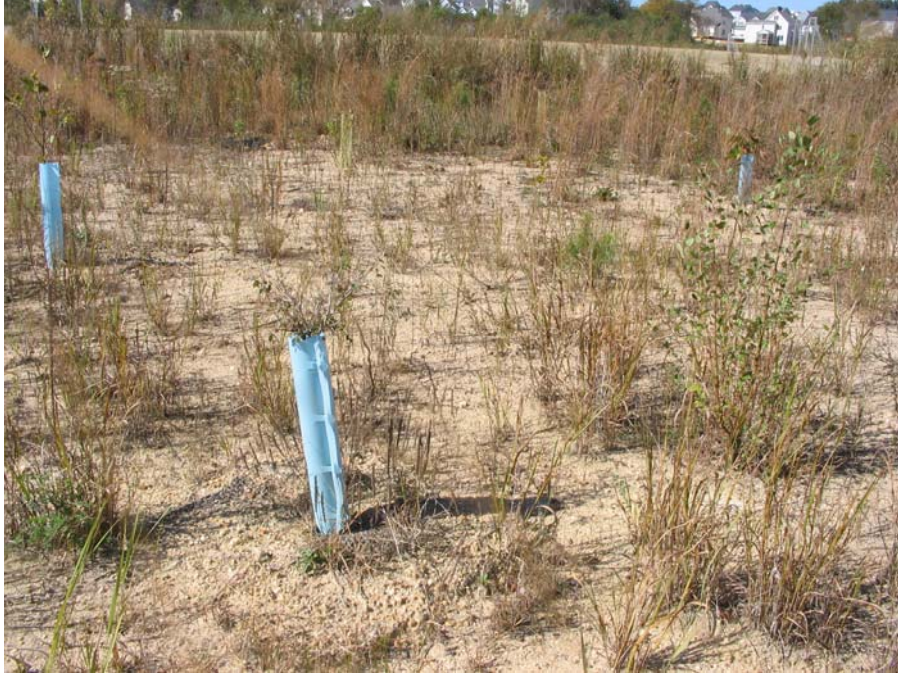
VPA11. Austin Creek Station 1+30. Bare floodplain.

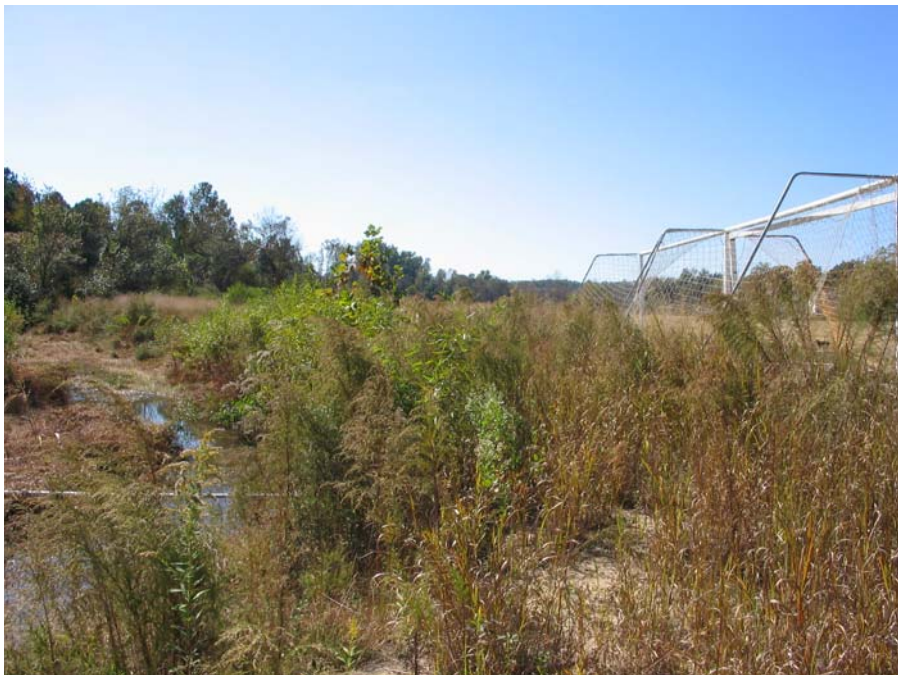
VPA12. Austin Creek Station 32+00. Bare floodplain.

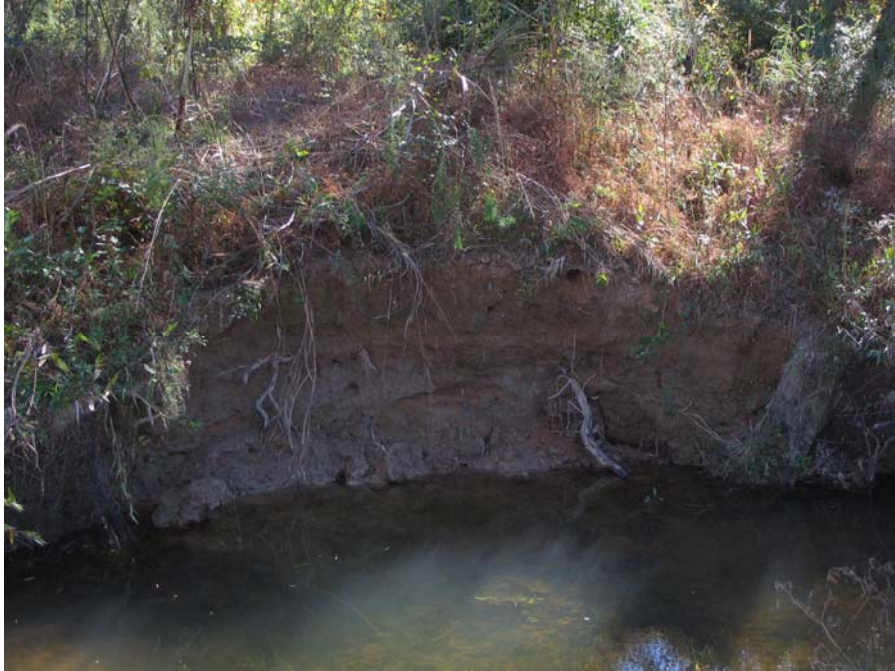
VPA13. Austin Creek Station 34+00. Bare bank.

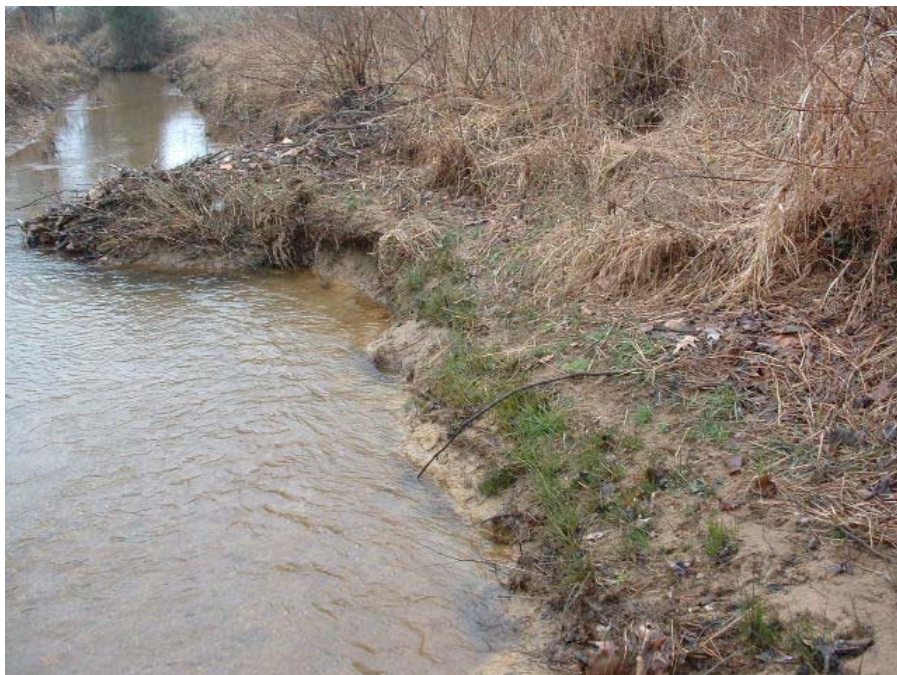
VPA 14. Smith Creek Station 26+50. Previous bare bank behind beaver dam removed. Now a hardy stand of *Juncus sp.* is establishing. Not a problem location.

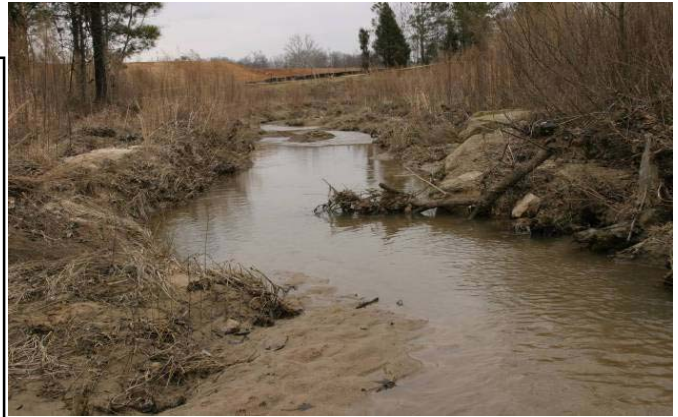
Photo of Cross-Section SR1-2 - Looking Downstream @ STA 9+35

2005	2004	2003	AS-BUILT
Area	54.6	55.9	60.8	59.6
Width	26.1	25.1	23.6	23.5
Mean Depth	2.1	2.2	2.6	2.5
Max Depth	3.2	3.1	3.7	3.7
W/D	12.5	11.3	9.2	9.3

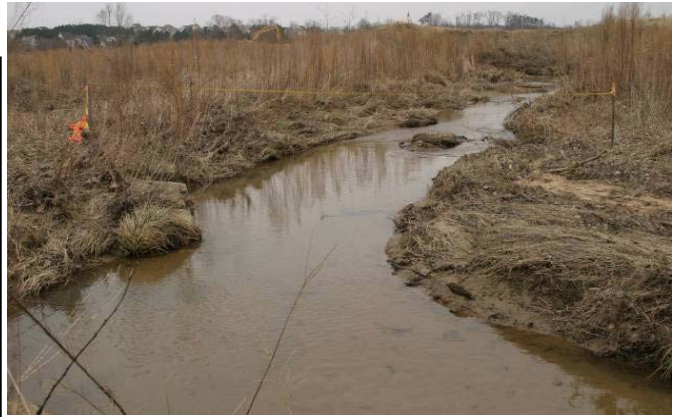
Photo of Cross-Section SR1-3 - Looking Downstream @ STA 11+30

2005	2004	2003	AS-BUILT
Area	41.3	36.6	47.5	44.9
Width	25.8	25.9	25.6	31.3
Mean Depth	1.6	1.4	1.9	1.4
Max Depth	2.7	2.4	2.7	2.8
W/D	16.1	18.3	13.8	21.8

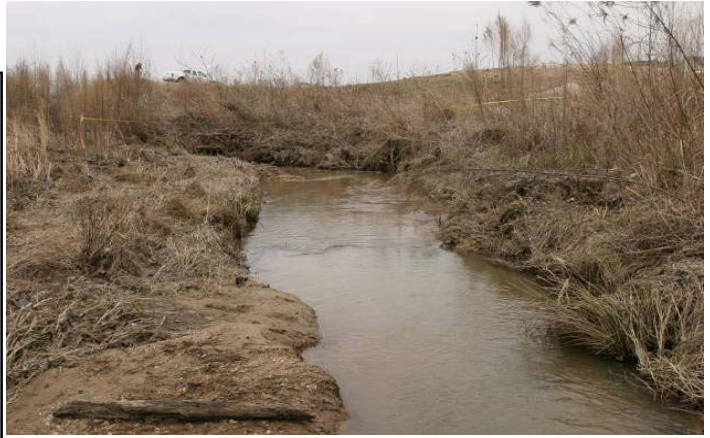
Photo of Cross-Section SR1-4 - Looking Downstream @ STA 12+00

2005	2004	2003	AS-BUILT
Area	53.4	43.8	69.3	57.9
Width	49.7	45.1	47.4	46.5
Mean Depth	1.1	1.0	1.5	1.2
Max Depth	3.8	3.7	4.1	3.8
W/D	46.3	46.4	32.4	37.3

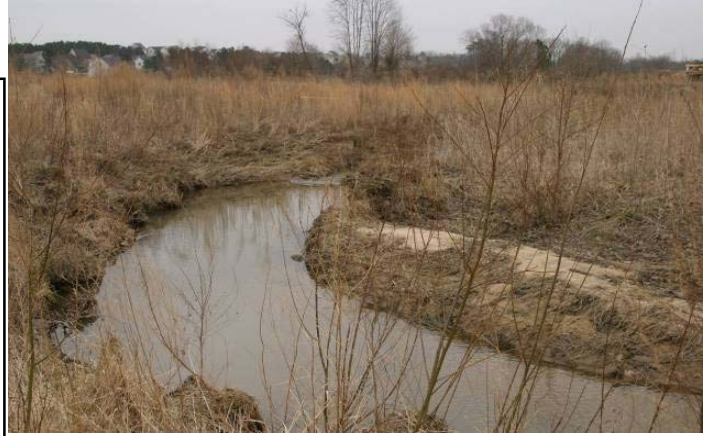
Photo of Cross-Section SR1-5 - Looking Downstream @ STA 16+90

2004	2004	2003	AS-BUILT
Area	55.8	78.9	123.2	109.2
Width	41.4	43.2	44.2	41.8
Mean Depth	1.3	1.8	2.8	2.6
Max Depth	3.6	3.1	5.1	4.8
W/D	30.7	23.6	15.9	16.0

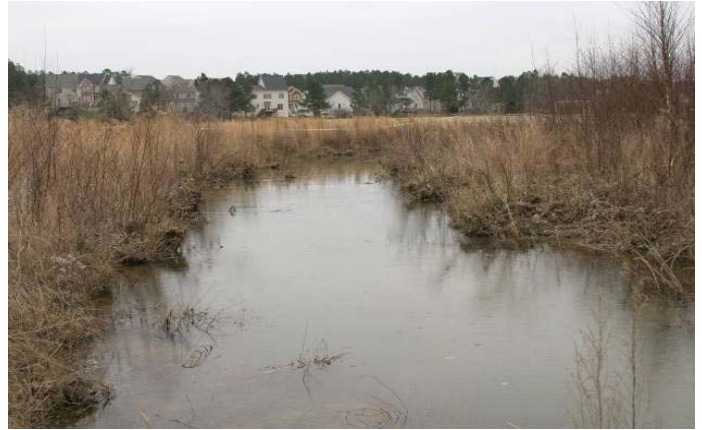
Photo of Cross-Section SR2-1 - Looking Downstream @ STA 24+30

2005	2004	2003	AS-BUILT
Area	51.3	44.9	45.9	46.5
Width	20.2	20.0	20.2	33.2
Mean Depth	2.5	2.2	2.3	1.4
Max Depth	3.6	3.9	3.3	3.1
W/D	7.9	8.9	8.9	23.7

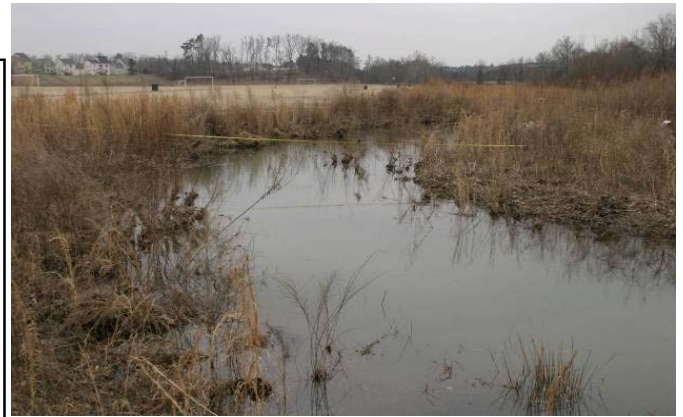
Photo of Cross-Section SR2-2 - Looking Downstream @ STA 24+87

2005	2004	2003	AS-BUILT
Area	64.5	60.8	59.2	48.5
Width	26.1	25.7	26.2	26.9
Mean Depth	2.5	2.4	2.3	1.8
Max Depth	4.6	4.6	3.8	3.8
W/D	10.5	10.9	11.6	14.9

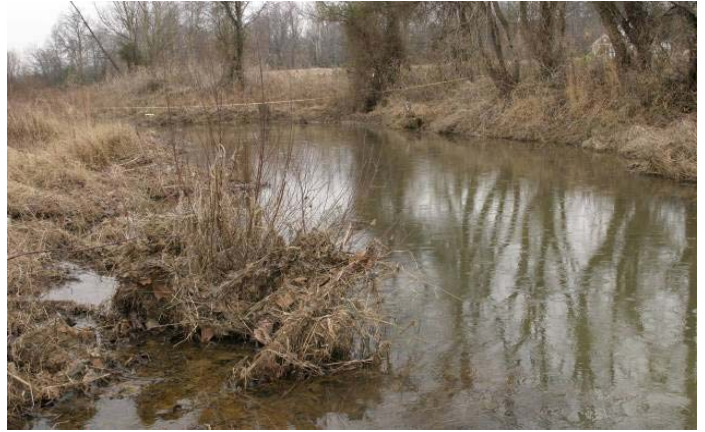
Photo of Cross-Section SR2-3 - Looking Downstream @ STA 31+25

2005	2004	2003	AS-BUILT
Area	49.4	52.4	59.6	64.0
Width	35.1	36.3	37.7	39.1
Mean Depth	1.4	1.4	1.6	1.6
Max Depth	3.6	3.4	4.2	4.1
W/D	25.0	25.1	23.8	23.9

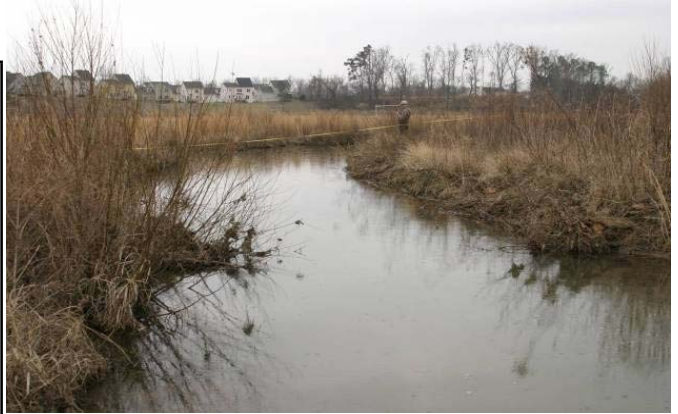
Photo of Cross-Section SR2-4 - Looking Downstream @ STA 32+45

2005	2004	2003	AS-BUILT
Area	39.5	38.4	42.7	38.9
Width	17.6	18.4	18.9	18.7
Mean Depth	2.2	2.1	2.3	2.1
Max Depth	2.8	3.2	3.3	3.1
W/D	7.8	8.8	8.4	9.0

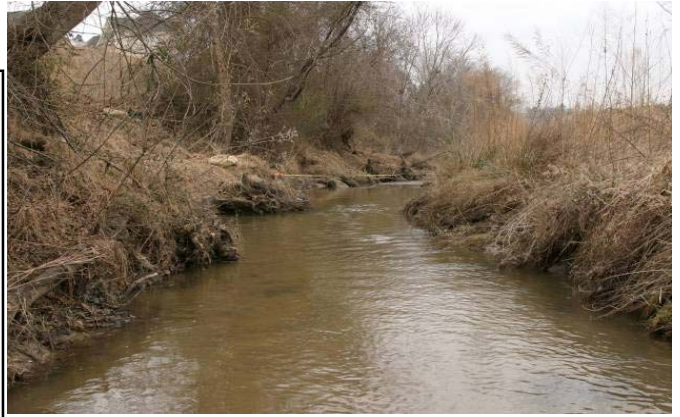
Photo of Cross-Section AR1-2 - Looking Downstream @ STA 4+42

2005	2004	2003	AS-BUILT
Area	63.5	62.4	49.0	49.0
Width	27.3	29.5	32.4	32.4
Mean Depth	2.3	2.1	1.5	1.5
Max Depth	4.8	4.0	3.9	3.9
W/D	11.7	14.0	21.4	21.4

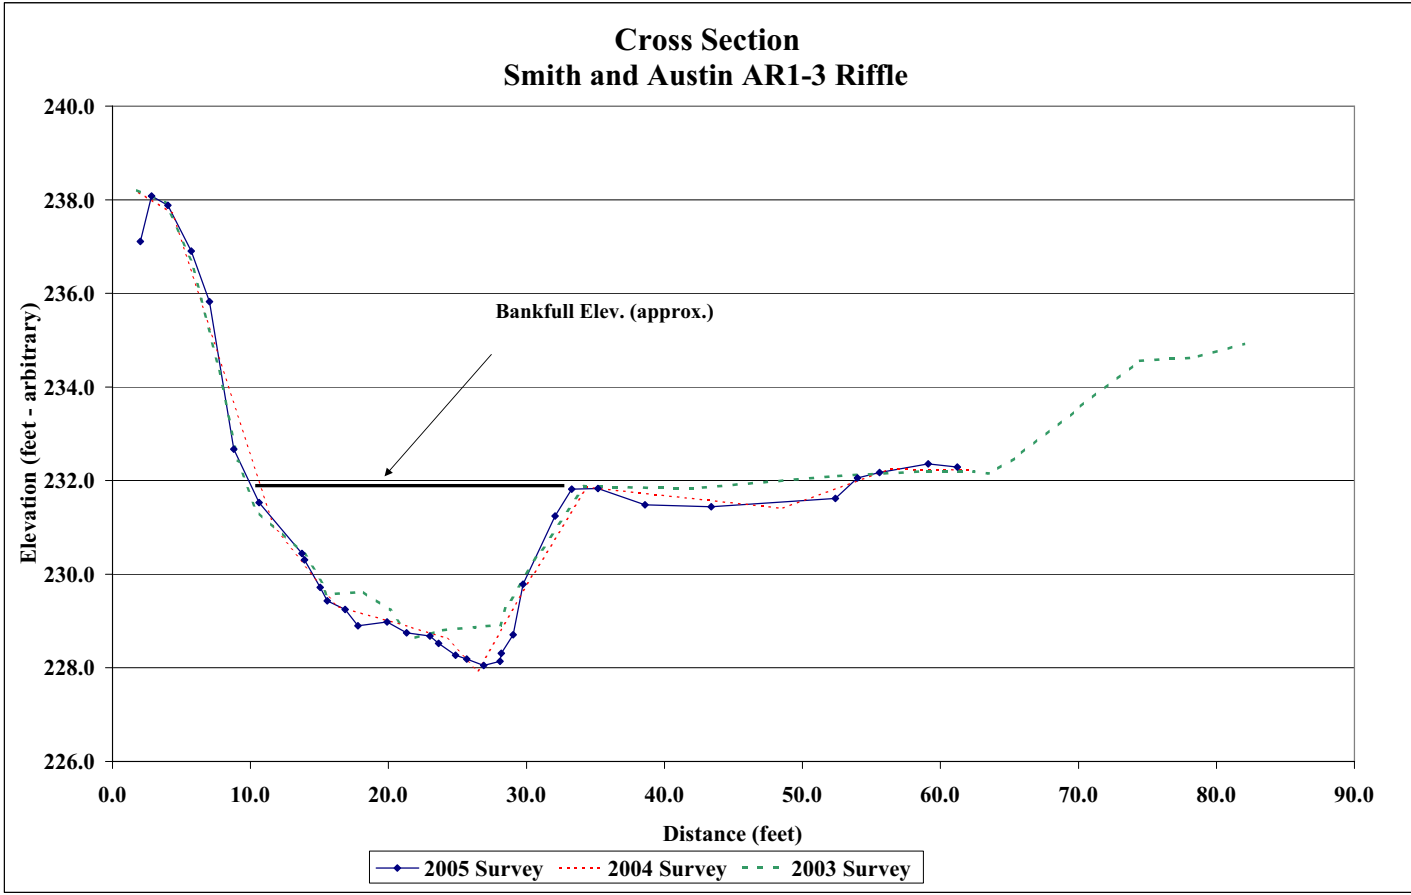
Project Name	Smith and Austin
Cross Section	AR1-3
Feature	Riffle
Date	6/2/05
Crew	Bidelspach, Clinton

2005	2004	2003	AS-BUILT
Area	54.7	52.7	51.2	49.8
Width	23.5	22.8	23.8	24.4
Mean Depth	2.3	2.3	2.2	2.0
Max Depth	3.8	3.9	3.2	3.2
W/D	10.1	9.9	11.1	12.0

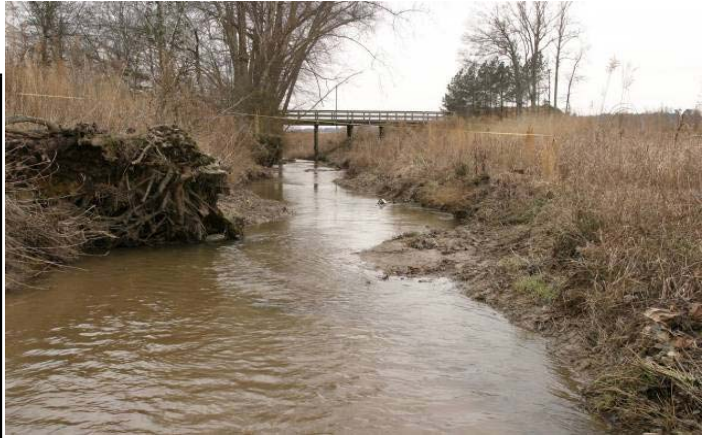
Photo of Cross-Section AR1-4 - Looking Downstream @ STA 20+90

2005	2004	2003	AS-BUILT
Area	34.0	38.3	38.5	38.2
Width	21.4	22.7	22.5	23.3
Mean Depth	1.6	1.7	1.7	1.6
Max Depth	2.7	2.8	2.5	2.5
W/D	13.4	13.5	13.1	14.2

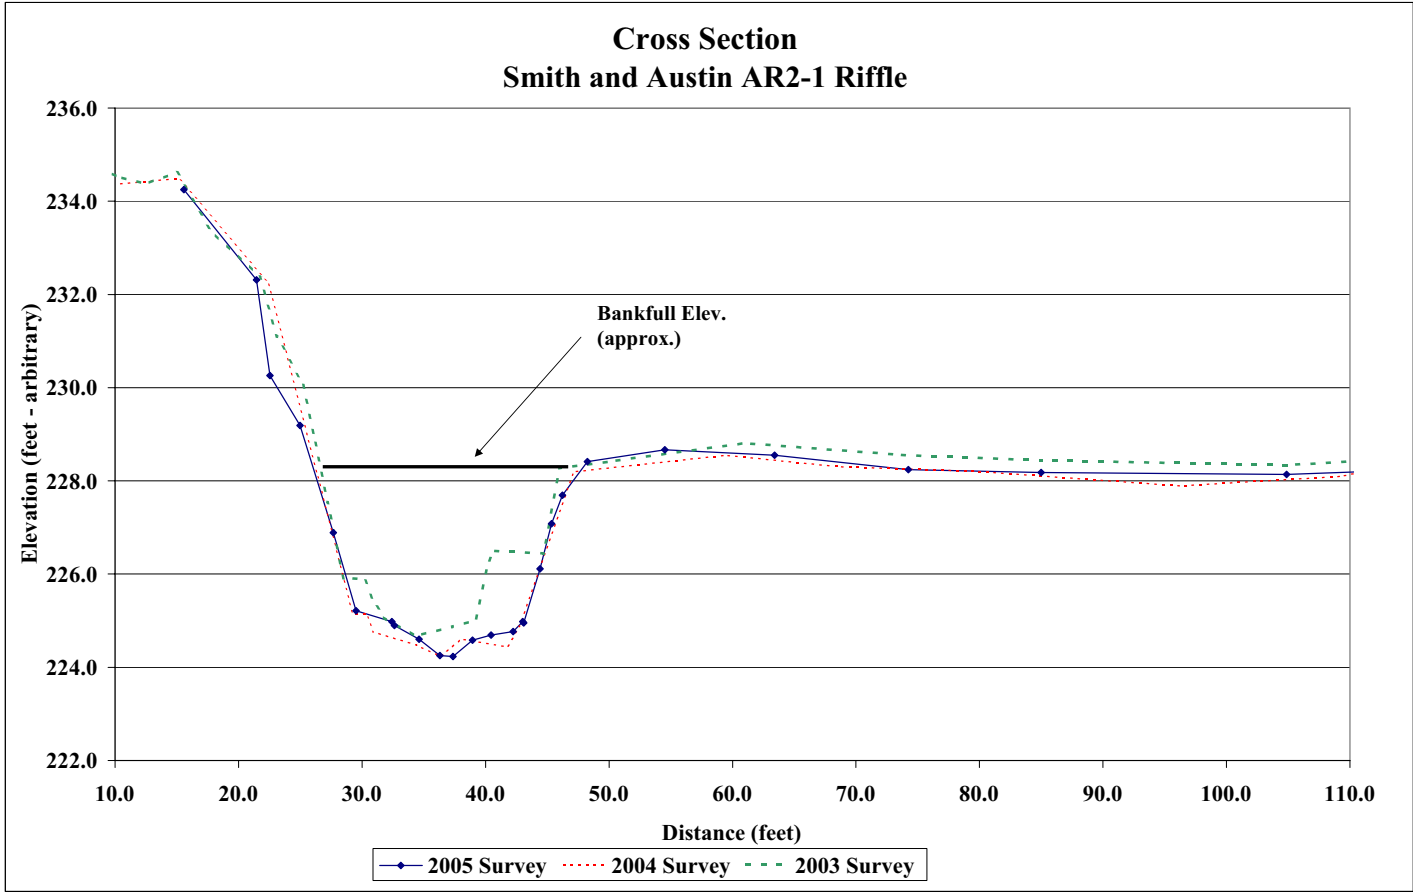
Project Name	Smith and Austin
Cross Section	AR2-1
Feature	Riffle
Date	6/2/05
Crew	Bidelspach, Clinton

2005	2004	2003	AS-BUILT
Area	56.1	62.1	45.4	48.1
Width	20.6	20.8	18.8	19.3
Mean Depth	2.7	3.0	2.4	2.5
Max Depth	4.0	4.0	3.6	3.6
W/D	7.5	7.0	7.8	7.7

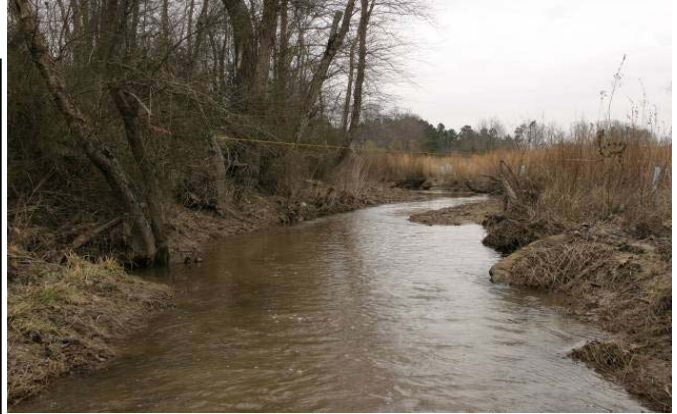
Photo of Cross-Section AR2-2 - Looking Downstream @ STA 28+35

2005	2004	2003	AS-BUILT
Area	43.0	43.9	36.9	37.1
Width	18.2	17.3	19.7	21.3
Mean Depth	2.4	2.5	1.9	1.7
Max Depth	3.3	3.4	3.5	3.6
W/D	7.7	6.8	10.5	12.2

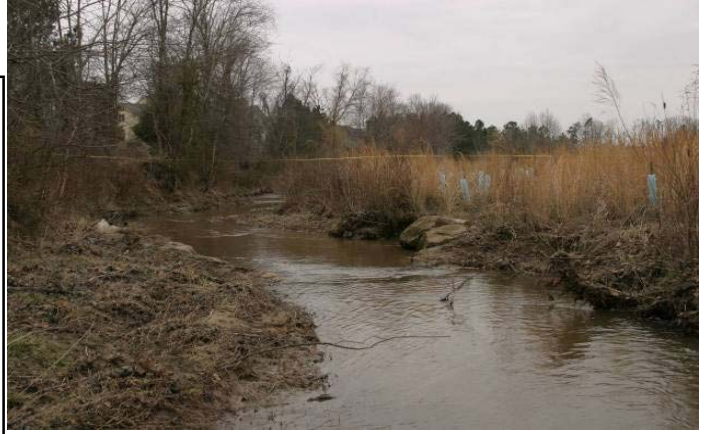
Photo of Cross-Section AR2-3 - Looking Downstream @ STA 30+45

2005	2004	2003	AS-BUILT
Area	53.4	53.9	56.4	54.4
Width	25.1	24.1	24.0	24.9
Mean Depth	2.1	2.2	2.4	2.2
Max Depth	3.1	3.2	3.2	3.1
W/D	11.8	10.8	10.2	11.4

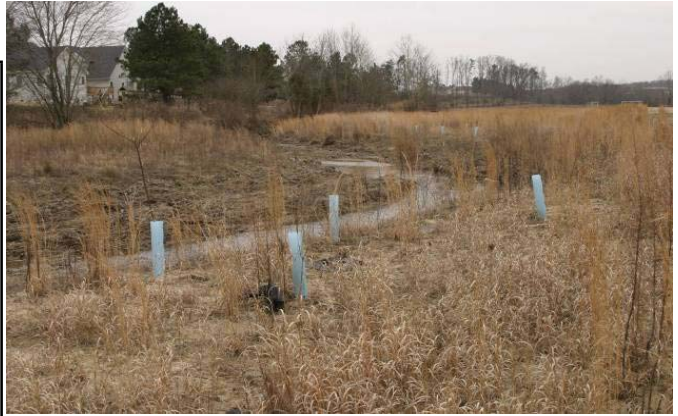
Photo of Cross-Section AR3-1 - Looking Downstream @ STA 34+55

2005	2004	2003	AS-BUILT
Area	77.7	72.7	87.5	97.1
Width	38.5	39.6	41.2	37.3
Mean Depth	2.0	1.8	2.1	2.6
Max Depth	4.2	3.8	4.8	4.8
W/D	19.0	21.6	19.4	14.3

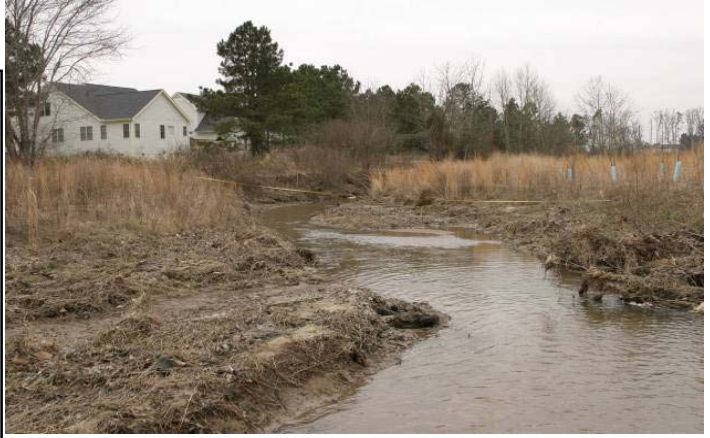
Photo of Cross-Section AR3-2 - Looking Downstream @ STA 35+15

2005	2004	2003	AS-BUILT	BENCH
Area	91.5	97.1	125.1	126.5	10.2
Width	37.6	35.5	37.2	38.4	12.8
Mean Depth	2.4	2.7	3.4	3.3	0.8
Max Depth	3.8	3.8	5.3	5.3	1.3
W/D	15.4	13.0	11.1	11.7	16.1

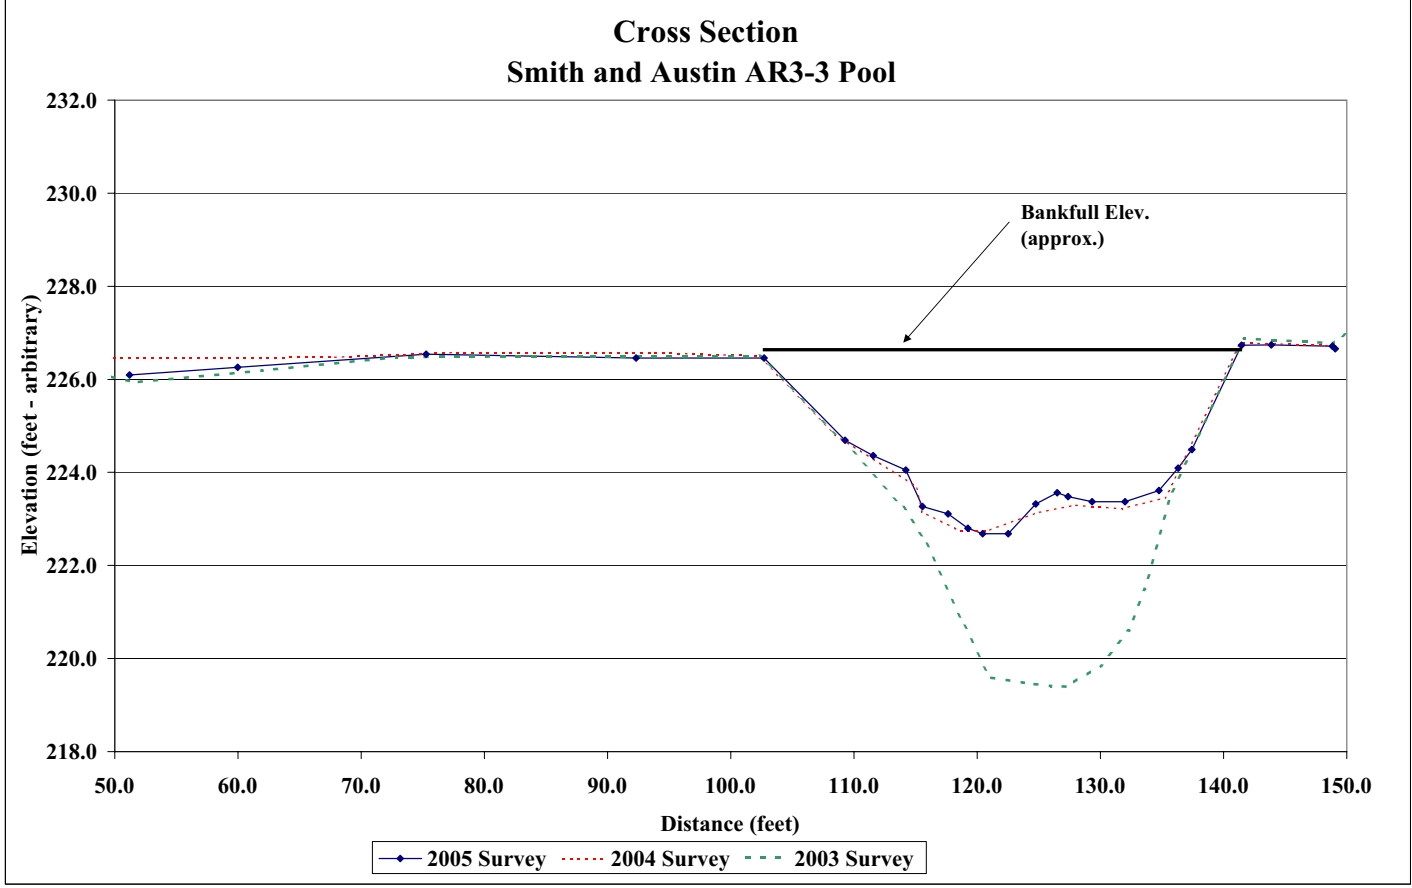
Project Name	Smith and Austin
Cross Section	AR3-3
Feature	Pool
Date	6/2/05
Crew	Bidelspach, Clinton

2005	2004	2003	AS-BUILT	BENCH
Area	90.5	93.0	151.2	153.8	11.7
Width	38.8	39.1	39.4	38.5	12.3
Mean Depth	2.3	2.4	3.8	4.0	1.0
Max Depth	3.8	3.8	7.1	7.1	1.3
W/D	16.6	16.4	10.3	9.6	12.9

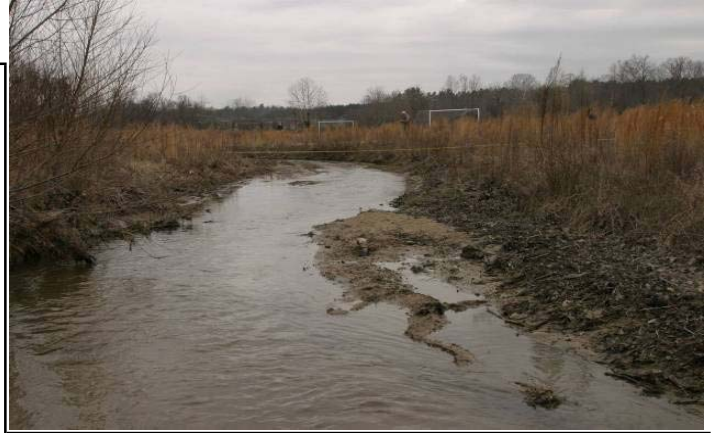
Photo of Cross-Section AR3-4 - Looking Downstream @ STA 41+00

2005	2004	2003	AS-BUILT	BENCH
Area	61.0	63.7	77.4	78.8	10.3
Width	32.7	35.1	34.1	31.6	20.0
Mean Depth	1.9	1.8	2.3	2.5	0.5
Max Depth	3.2	3.3	4.0	4.0	1.1
W/D	17.6	19.3	15.0	12.7	38.8

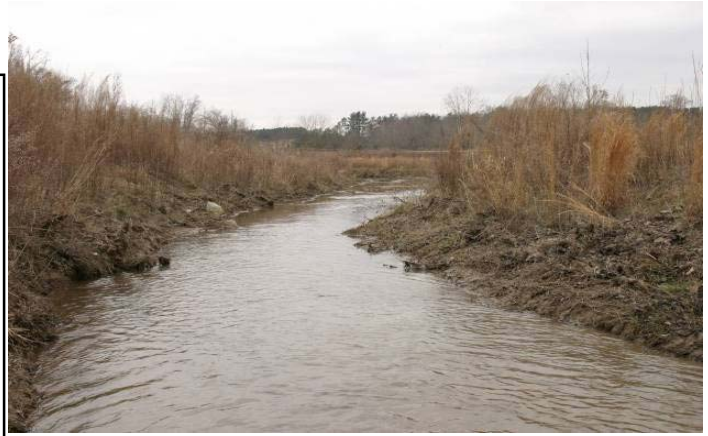
Photo of Cross-Section AR3-5 - Looking Downstream @ STA 46+40

2005	2004	2003	AS-BUILT
Area	93.4	94.0	116.0	99.9
Width	36.4	35.6	39.1	34.3
Mean Depth	2.6	2.6	3.0	2.9
Max Depth	3.9	4.0	4.7	4.2
W/D	14.2	13.2	13.2	11.8

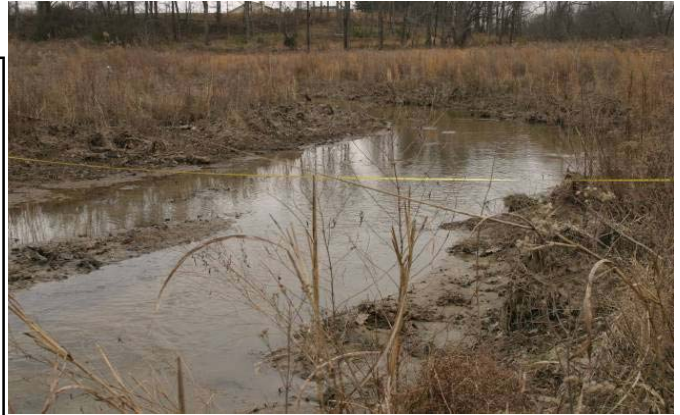
Photo of Cross-Section AR3-6 - Looking Downstream @ STA 48+20

2005	2004	2003	AS-BUILT
Area	63.7	70.0	108.9	135.7
Width	39.1	56.9	58.4	58.3
Mean Depth	1.6	1.2	1.9	2.3
Max Depth	3.2	3.4	6.7	6.9
W/D	24.0	46.2	31.3	25.0

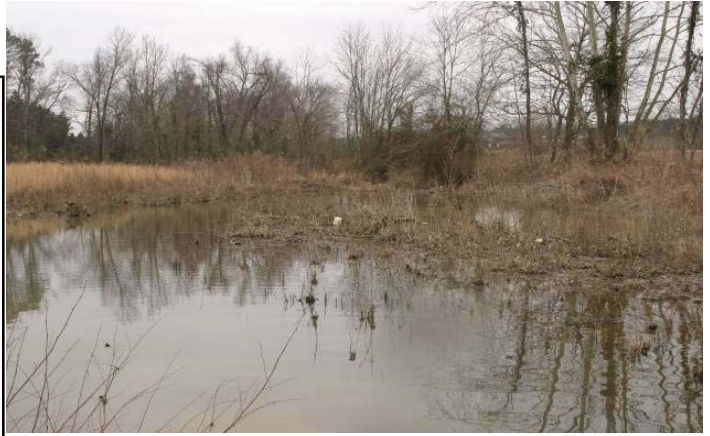
Photo of Cross-Section SR2-5 - Looking Downstream @ STA 39+20

2005	2004	2003	AS-BUILT
Area	31.4		35.8	37.2
Width	16.4		16.9	18.4
Mean Depth	1.9		2.1	2.0
Max Depth	2.8		3.0	3.0
W/D	8.6		8.0	9.1
