# ANNUAL MONITORING REPORT SMITH AND AUSTIN CREEKS

**STREAM RESTORATION  
WAKE COUNTY, NORTH CAROLINA  
(EEP Project Number 343)  
Monitoring Year 4 of 5 (2006)**

January 2007

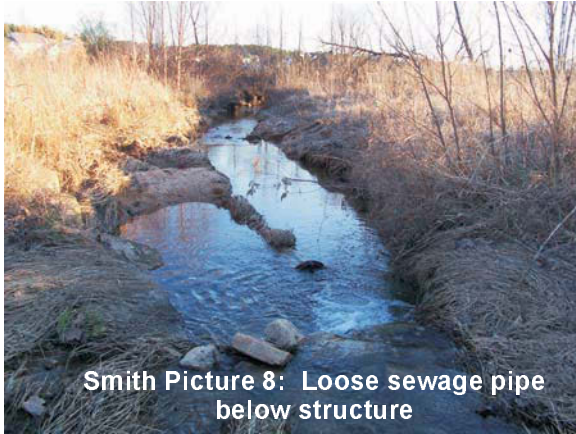
Smith Picture 8: Loose sewage pipe below structure

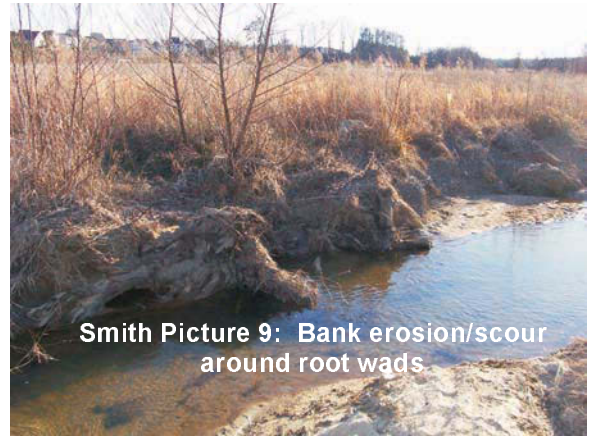
Smith Picture 9: Bank erosion/scour around root wads

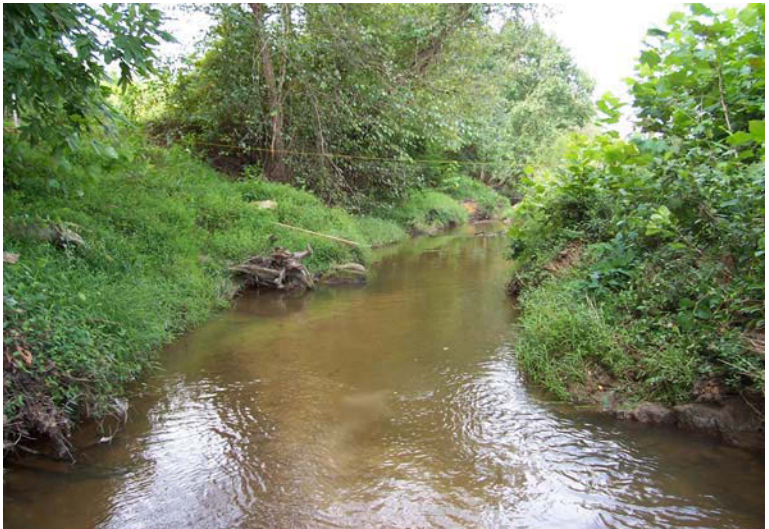
Photo of Cross-Section AR1-2 - Looking Downstream @ STA 4+42

**Project Name** Smith and Austin  
**Cross Section** AR1-2  
**Feature** Riffle  
**Date** 9/18/06  
**Crew** Lewis, Jeffers

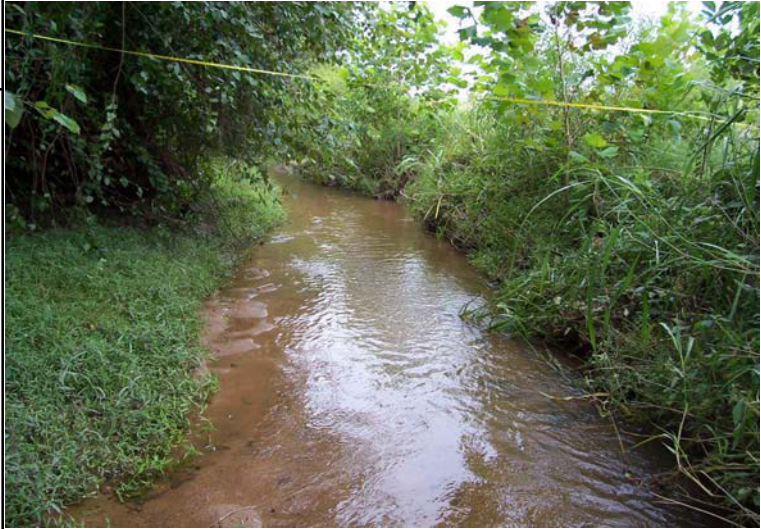
Photo of Cross-Section AR1-3 - Looking Downstream @ STA 13+95

**Project Name** Smith and Austin  
**Cross Section** AR1-3  
**Feature** Riffle  
**Date** 9/18/06  
**Crew** Lewis, Jeffers

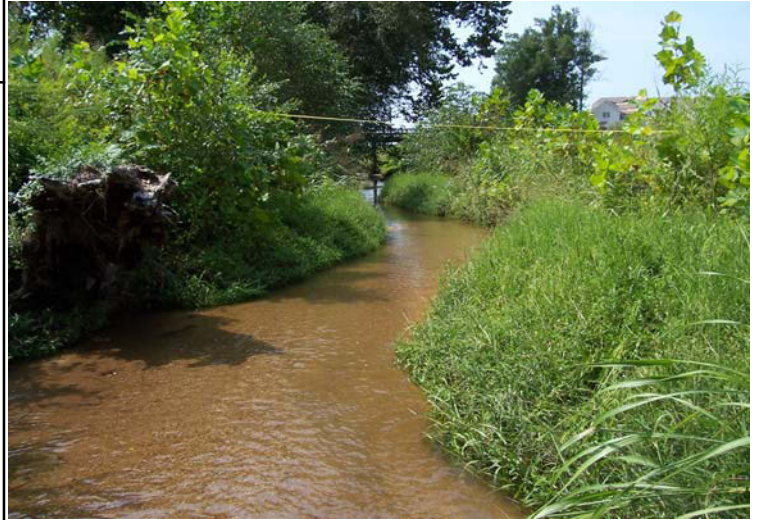
Photo of Cross-Section AR1-4 - Looking Downstream @ STA 20+90

**Project Name** Smith and Austin  
**Cross Section** AR1-4  
**Feature** Pool  
**Date** 9/18/05  
**Crew** Lewis, Jeffers

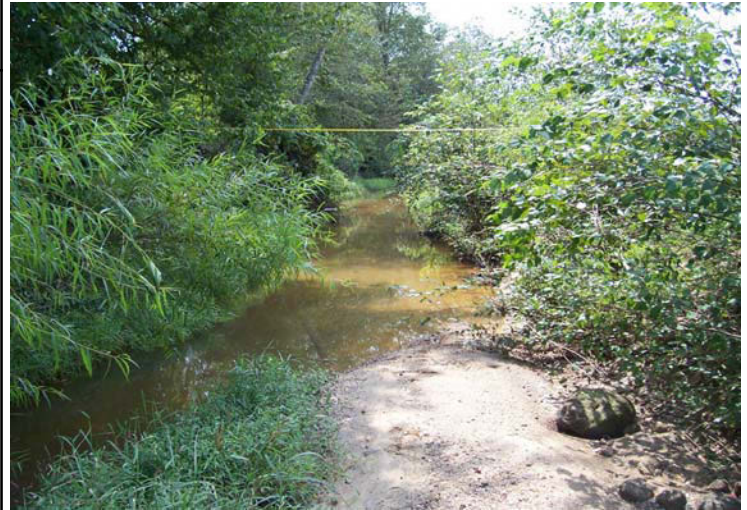
Photo of Cross-Section AR2-1 - Looking Downstream @ STA 27+90

**Project Name** Smith and Austin  
**Cross Section** AR2-1  
**Feature** Riffle  
**Date** 9/18/06  
**Crew** Lewis, Jeffers

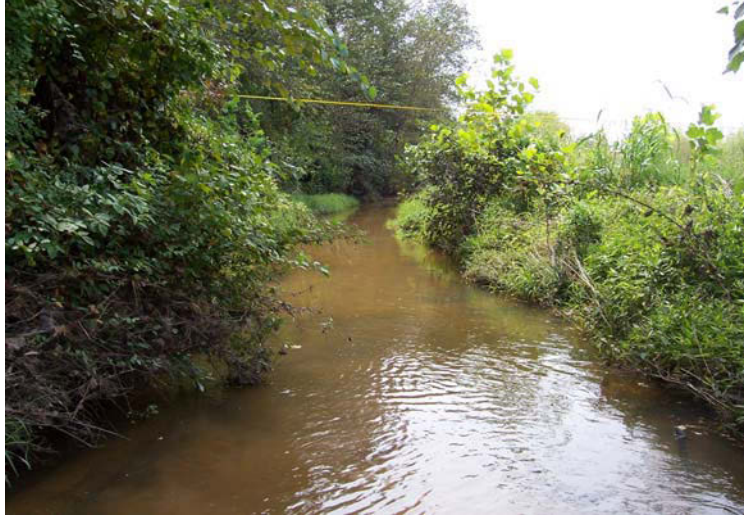
Photo of Cross-Section AR2-2 - Looking Downstream @ STA 28+35

**Project Name** Smith and Austin  
**Cross Section** AR2-2  
**Feature** Pool  
**Date** 9/18/06  
**Crew** Lewis, Jeffers

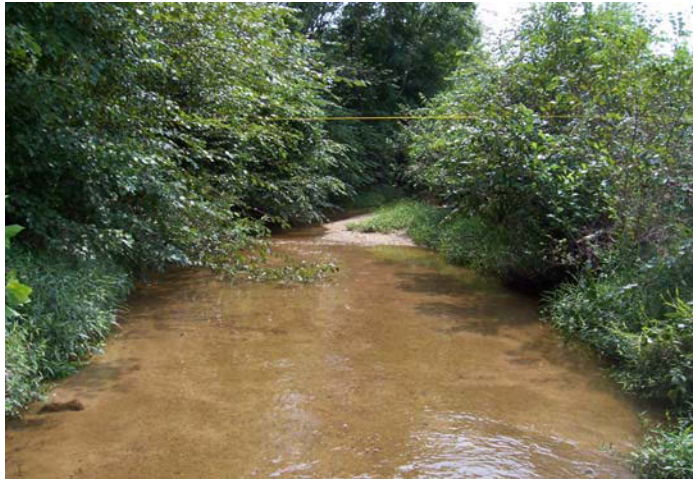
Photo of Cross-Section AR2-3 - Looking Downstream @ STA 30+45

Project Name	Smith and Austin
Cross Section	AR2-3
Feature	Riffle
Date	9/18/06
Crew	Lewis, Jeffers

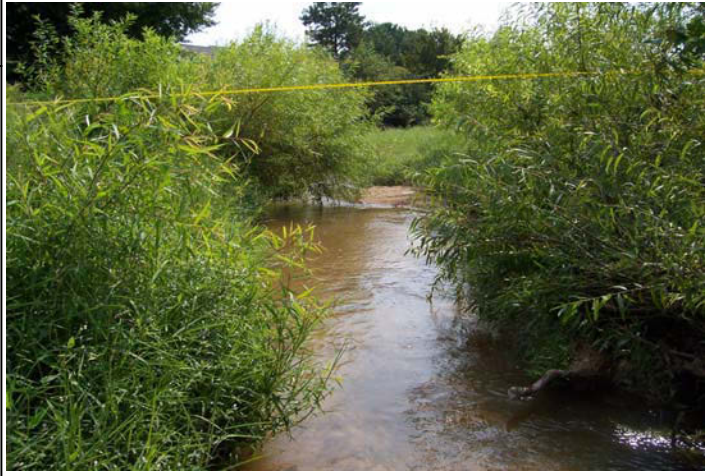
Photo of Cross-Section AR3-1 - Looking Downstream @ STA 34+55

**Project Name** Smith and Austin  
**Cross Section** AR3-1  
**Feature** Pool  
**Date** 9/19/06  
**Crew** Lewis, Jeffers

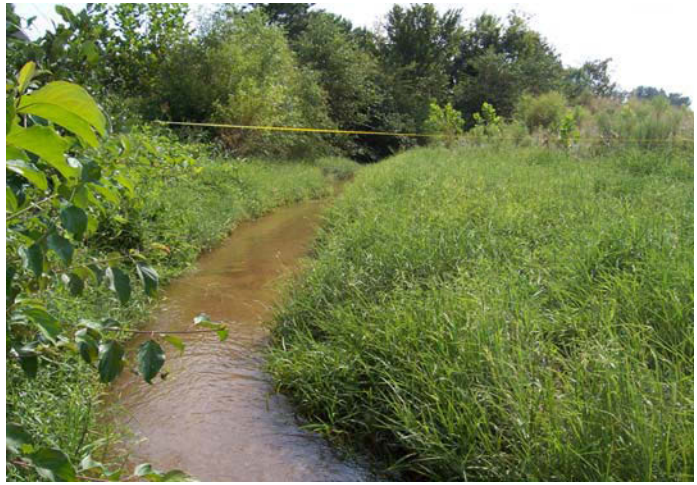
Photo of Cross-Section AR3-2 - Looking Downstream @ STA 35+15

**Project Name** Smith and Austin  
**Cross Section** AR3-2  
**Feature** Riffle  
**Date** 9/19/06  
**Crew** Lewis, Jeffers

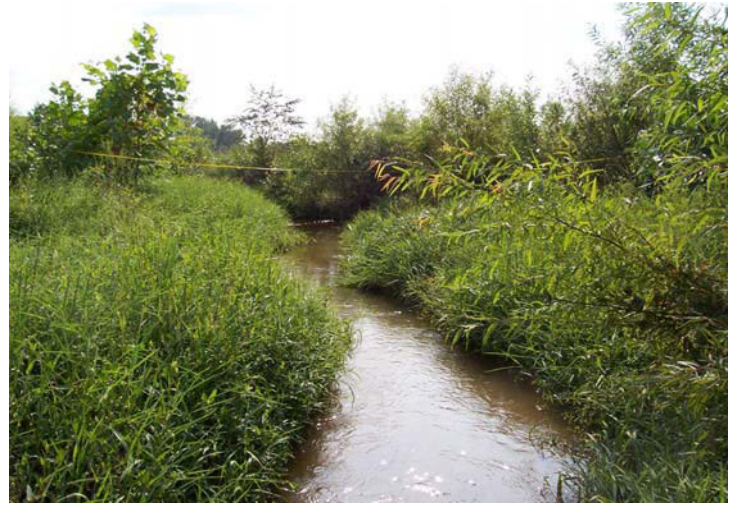
Photo of Cross-Section AR3-3 - Looking Downstream @ STA 38+15

**Project Name** Smith and Austin  
**Cross Section** AR3-3  
**Feature** Pool  
**Date** 9/19/06  
**Crew** Lewis, Jeffers

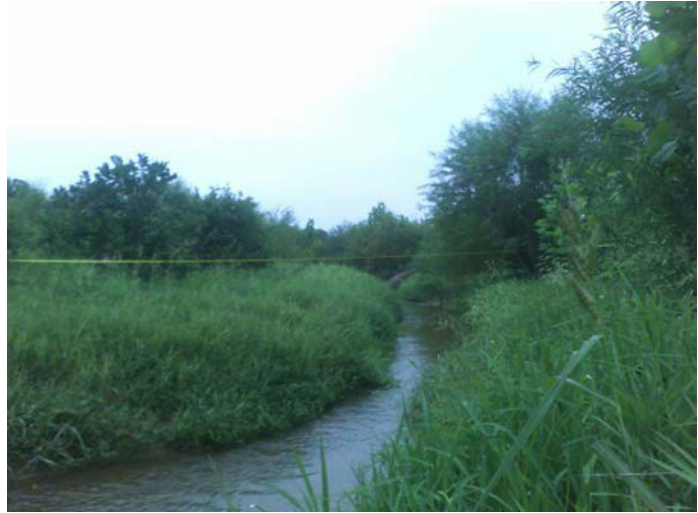
Photo of Cross-Section AR3-4 - Looking Downstream @ STA 41+00

**Project Name** Smith and Austin  
**Cross Section** AR3-4  
**Feature** Riffle  
**Date** 9/18/06  
**Crew** Lewis, Jeffers

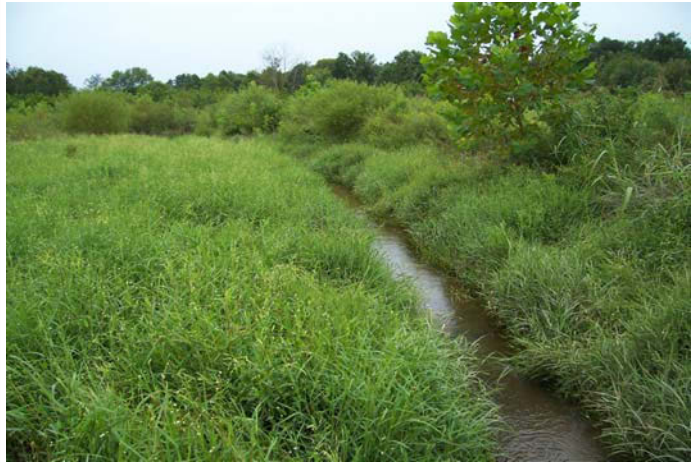
Photo of Cross-Section AR3-5 - Looking Downstream @ STA 46+40

**Project Name** Smith and Austin  
**Cross Section** AR3-5  
**Feature** Riffle  
**Date** 9/18/06  
**Crew** Lewis, Jeffers

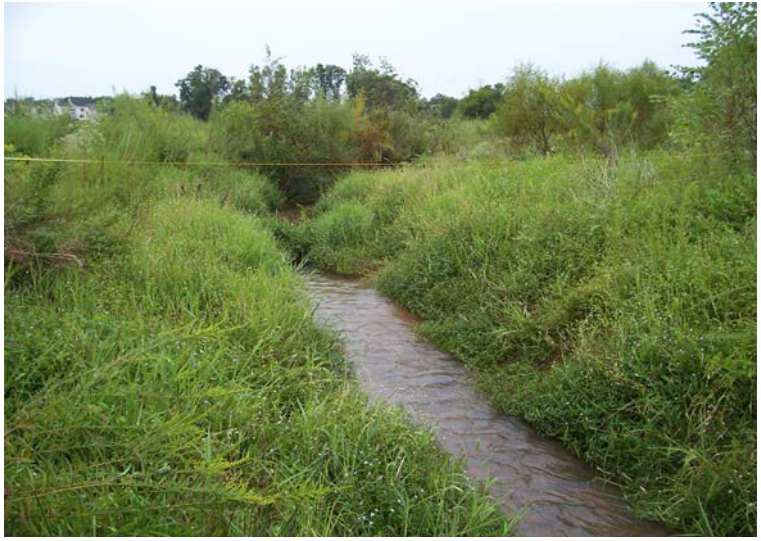
Photo of Cross-Section AR3-6 - Looking Downstream @ STA 48+20

<b>Project Name</b>	Smith and Austin
<b>Cross Section</b>	AR3-6
<b>Feature</b>	Pool
<b>Date</b>	9/18/05
<b>Crew</b>	Lewis, Jeffers

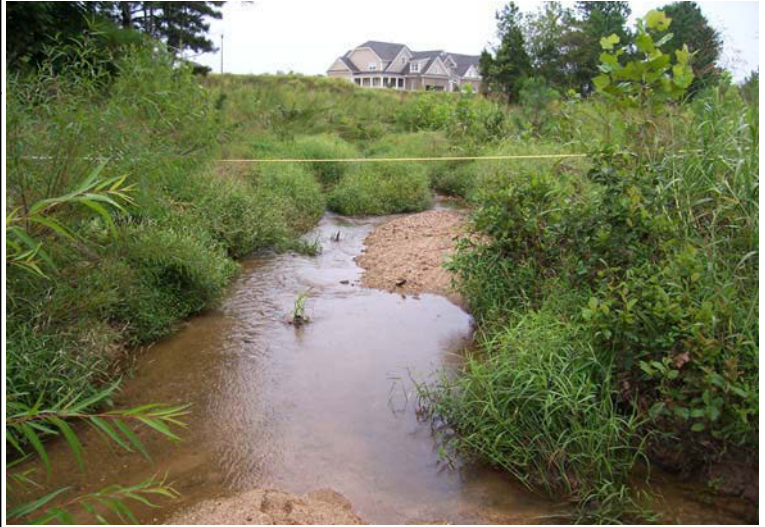
Photo of Cross-Section SR1-2 - Looking Downstream @ STA 9+35

**Project Name** Smith and Austin  
**Cross Section** SR1-2  
**Feature** Riffle  
**Date** 9/18/06  
**Crew** Lewis, Jeffers

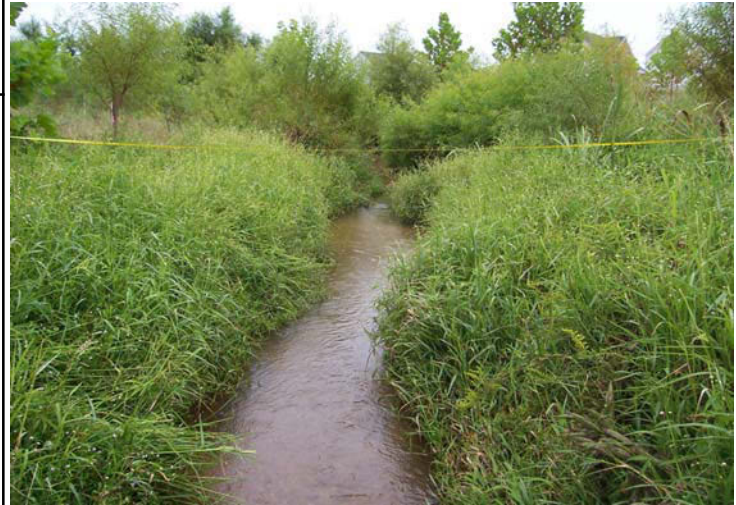
Photo of Cross-Section SR1-3 - Looking Downstream @ STA 11+30

**Project Name** Smith and Austin  
**Cross Section** SR1-3  
**Feature** Riffle  
**Date** 9/18/06  
**Crew** Lewis, Jeffers

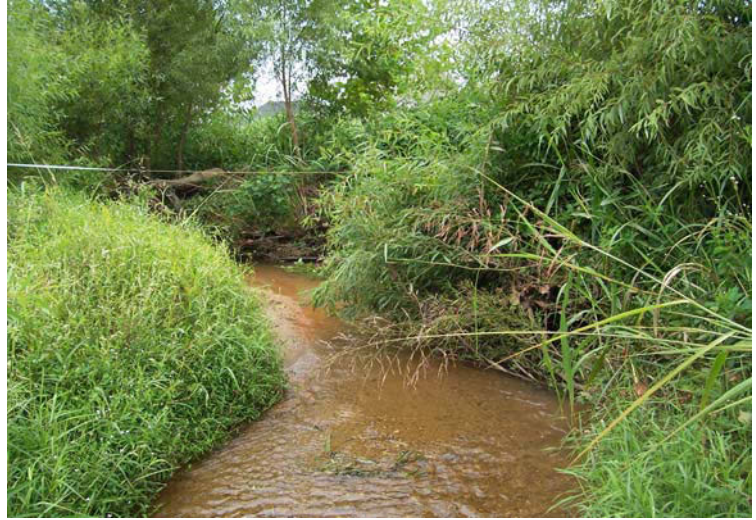
Photo of Cross-Section SR1-4 - Looking Downstream @ STA 12+00

**Project Name** Smith and Austin  
**Cross Section** SR1-4  
**Feature** Pool  
**Date** 9/18/06  
**Crew** Lewis, Jeffers

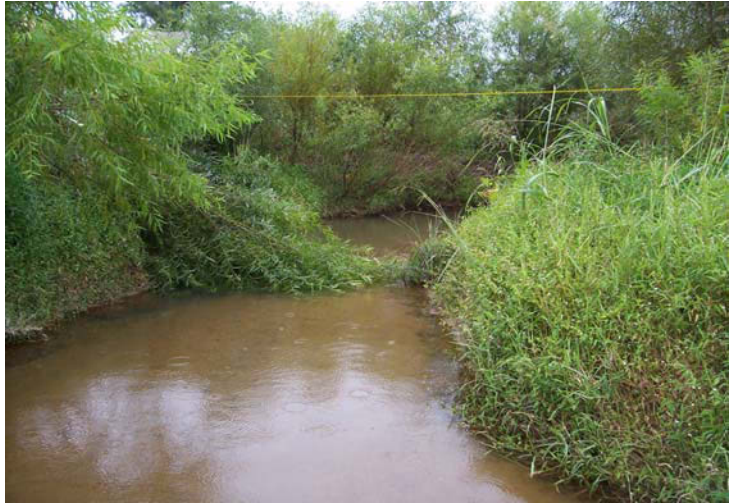
Photo of Cross-Section SR1-5 - Looking Downstream @ STA 16+90

**Project Name** Smith and Austin  
**Cross Section** SR1-5  
**Feature** Pool  
**Date** 9/18/06  
**Crew** Lewis, Jeffers

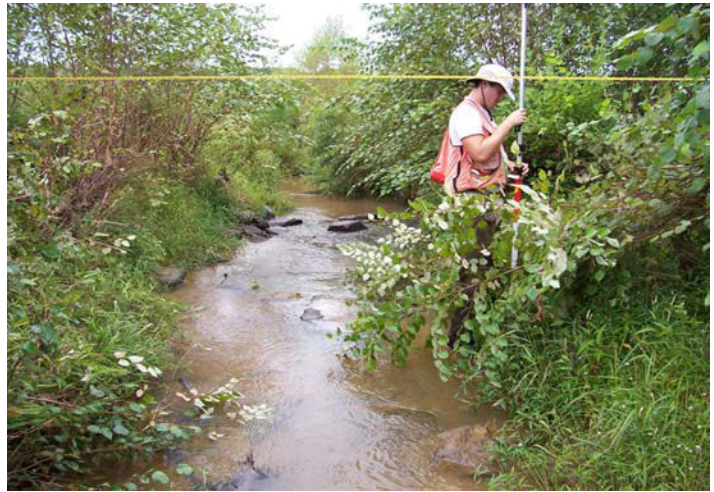
Photo of Cross-Section SR2-1 - Looking Downstream @ STA 24+30

**Project Name** Smith and Austin  
**Cross Section** SR2-1  
**Feature** Riffle  
**Date** 9/18/06  
**Crew** Lewis, Jeffers

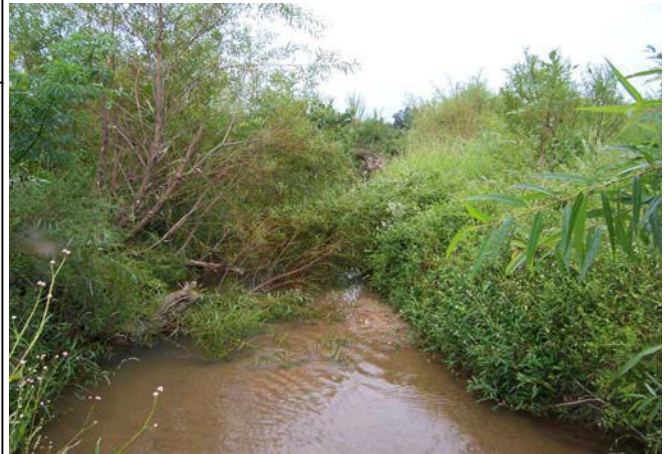
Photo of Cross-Section SR2-2 - Looking Downstream @ STA 24+87

Project Name Smith and Austin  
 Cross Section SR2-2  
 Feature Pool  
 Date 9/18/05  
 Crew Lewis, Jeffers

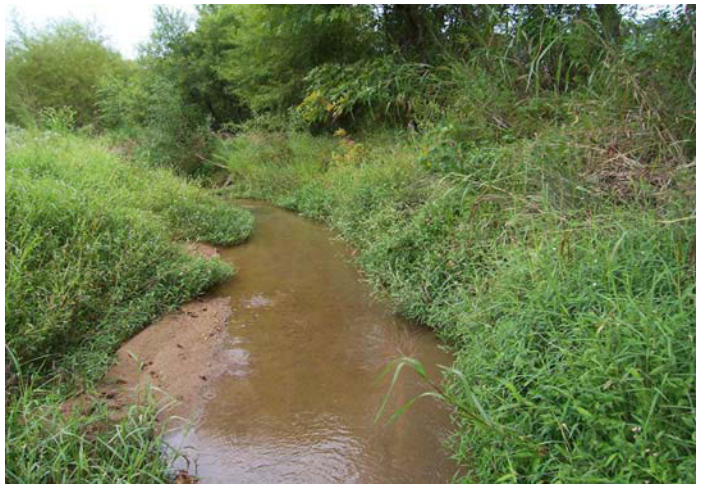
Photo of Cross-Section SR2-3 - Looking Downstream @ STA 31+25

<b>Project Name</b>	Smith and Austin
<b>Cross Section</b>	SR2-3
<b>Feature</b>	Pool
<b>Date</b>	9/18/06
<b>Crew</b>	Lewis, Jeffers

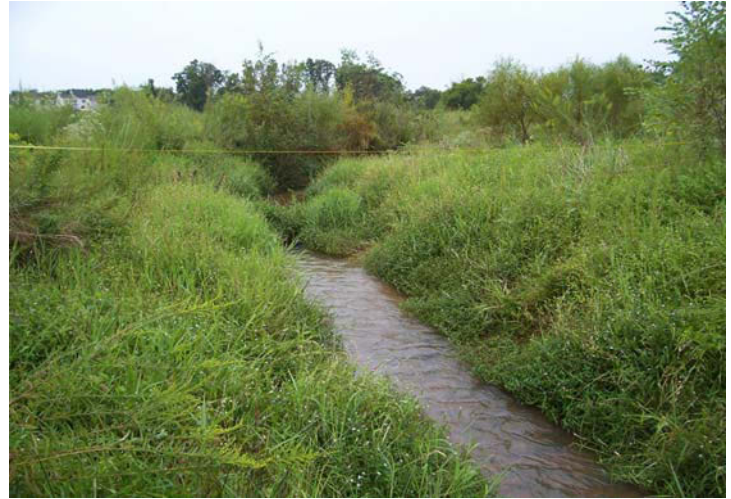
Photo of Cross-Section SR2-4 - Looking Downstream @ STA 32+45

**Project Name** Smith and Austin  
**Cross Section** SR2-4  
**Feature** Riffle  
**Date** 9/18/06  
**Crew** Lewis, Jeffers
