# **Snow Creek Stream Restoration Design Report**

**Stokes County, North Carolina**

**North Carolina Wetland Restoration Program**

**EcoLogic Associates, PC**

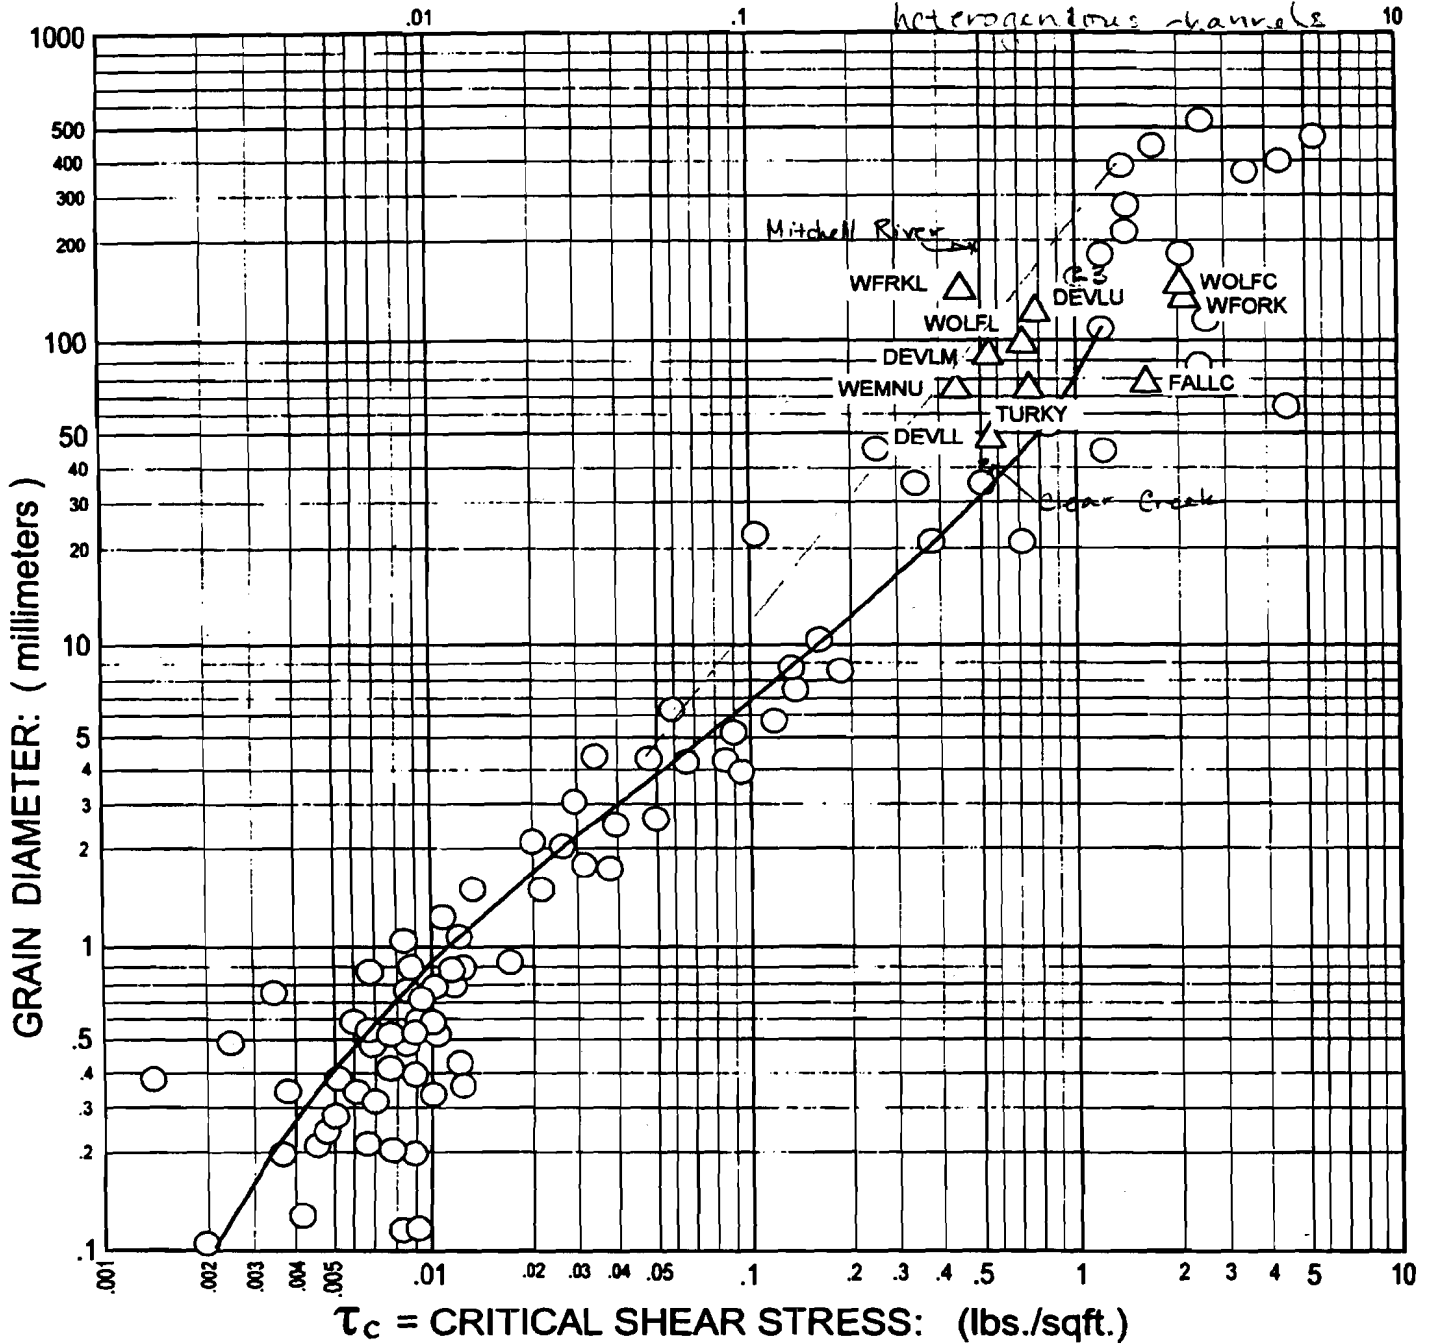
Figure 6. Critical Dimensionless Shear Stress Required to Initiate Movement of Grains

Laboratory and field data on critical shear stress required to initiate movement of grains (Leopold, Wolman, & Miller 1964). The solid line is the Shields curve of the *threshold of motion*; transposed from the  $\theta$  versus  $R_*$  form into the present form, in which critical shear stress is plotted as a function of grain diameter.

The calculated bankfull shear stress for the proposed Snow Creek channel is 0.58 pounds per square foot (psf). Based on the Shields diagram, bankfull flow can move a particle greater than 37 mm in diameter. However, using a revised curve generated by Dave Rosgen based on competence of natural rivers to move particles, a shear stress of 0.59 psf corresponds to moving a particle closer to 130 mm in diameter. This is consistent with the 90-mm and 128-mm particles found in the pavement and subpavement samples.

The calculated bankfull shear stress for the proposed tributary channel is 0.49 psf. Based on the Shields diagram, bankfull flow can move a particle 30 mm in diameter. However, using a revised curve generated by Dave Rosgen based on competence of natural rivers to move particles, a shear stress of 0.59 psf corresponds to moving a particle closer to 110 mm in diameter. This is consistent with a 73-mm to 138-mm particles found in the pavement and subpavement samples. Since the subpavement particles were larger than the particles in the pavement, the largest particles found in the pavement were used in the entrainment calculations.

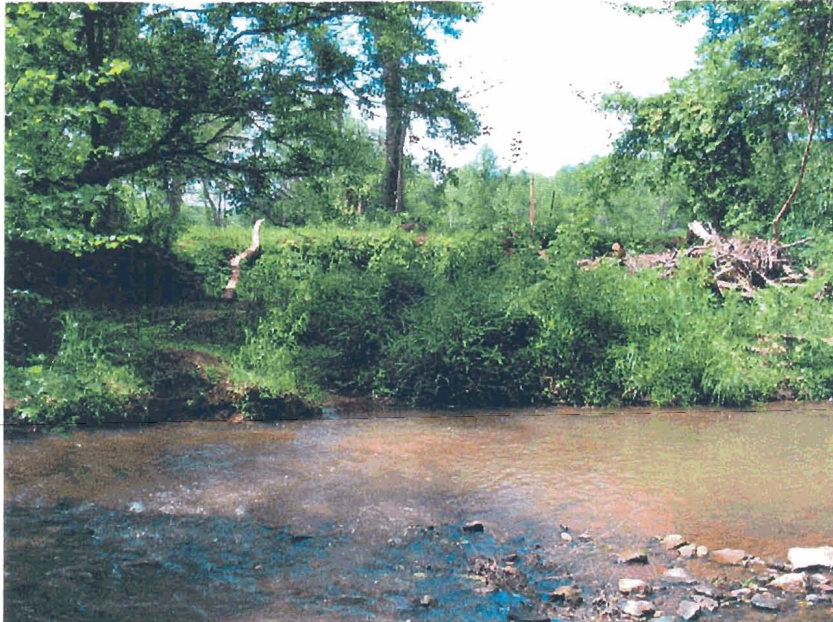
Riparian zone lacking woody vegetation

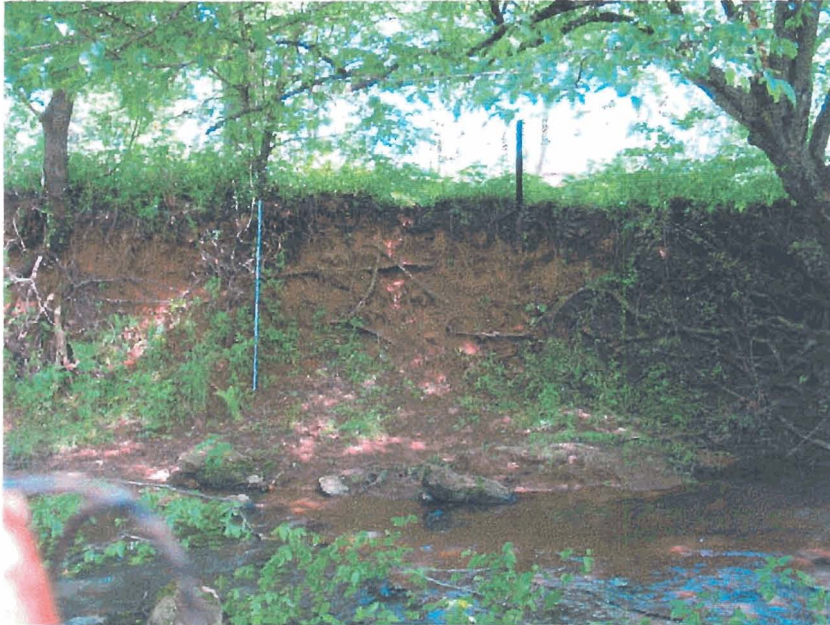
Old pasture fence at top of 8'-10' vertical bank

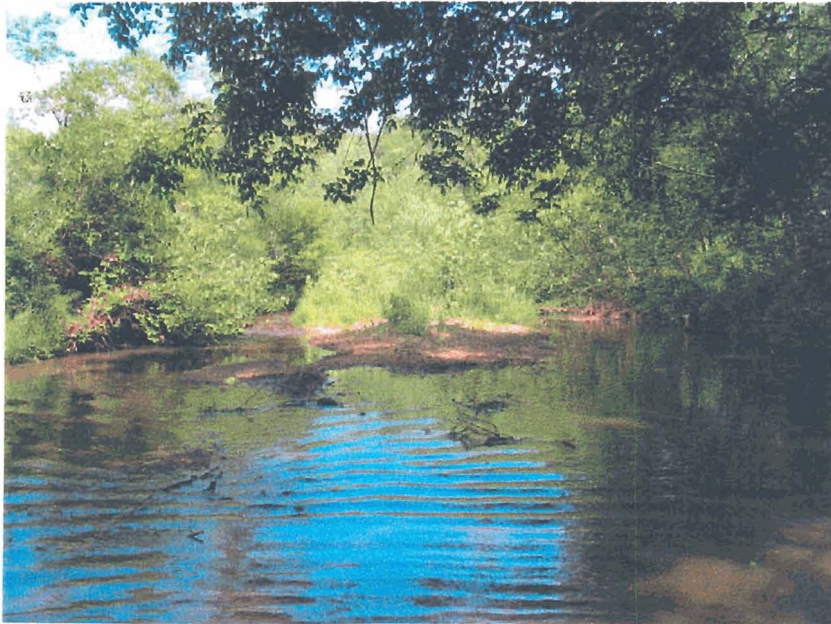
Mid-channel bar

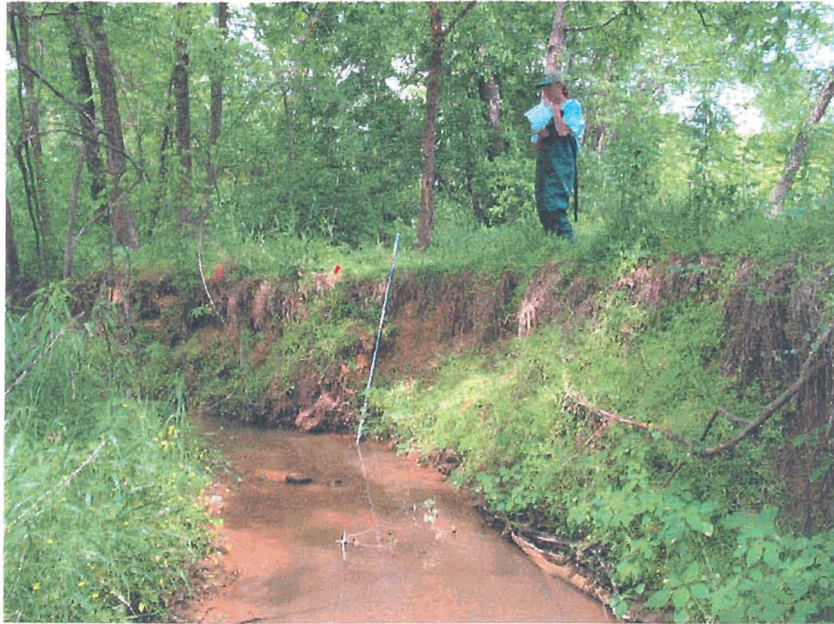
BEHI cross section measured in this area

Additional information not included in the Geomorphology Table includes the Bank Erodibility Hazard Rating of the main channel of Snow Creek and the tributary both of which rated very high. These ratings correlate to 7.4 cubic feet of soil loss per foot of bank in the tributary and 8.0 cubic feet of soil loss per foot of bank on the main channel.

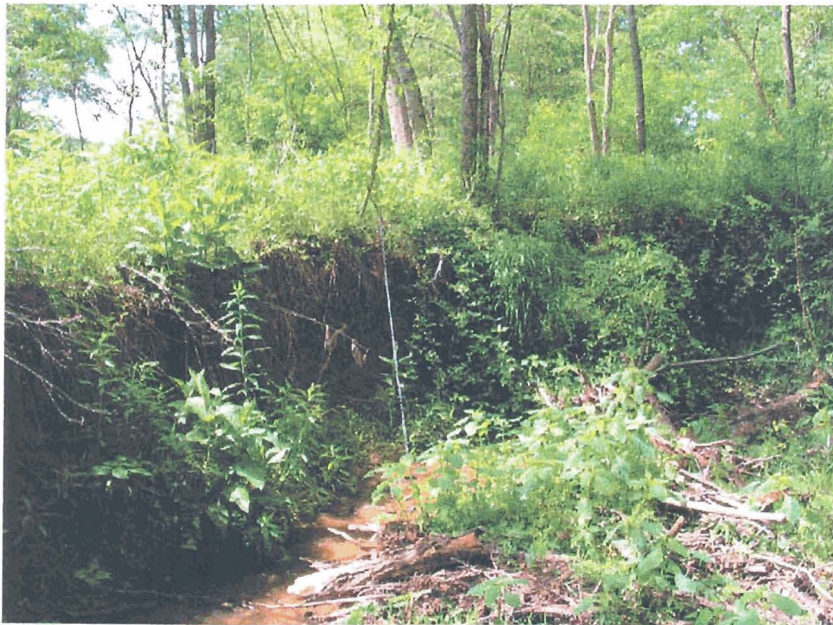
Tight radius of curvature with lots of woody debris

The tributary to be restored has a length of about 500 feet. The start of the reach is just below a section with a good bank height ratio and good woody vegetation. The proposed beginning of the restoration occurs at a point in the channel where the woody vegetation has been removed and the bank height starts to increase dramatically. The sinuosity of this reach is very high at 1.7. This results from the reach having several very sharp bends, with failing banks along the lower end of the channel.

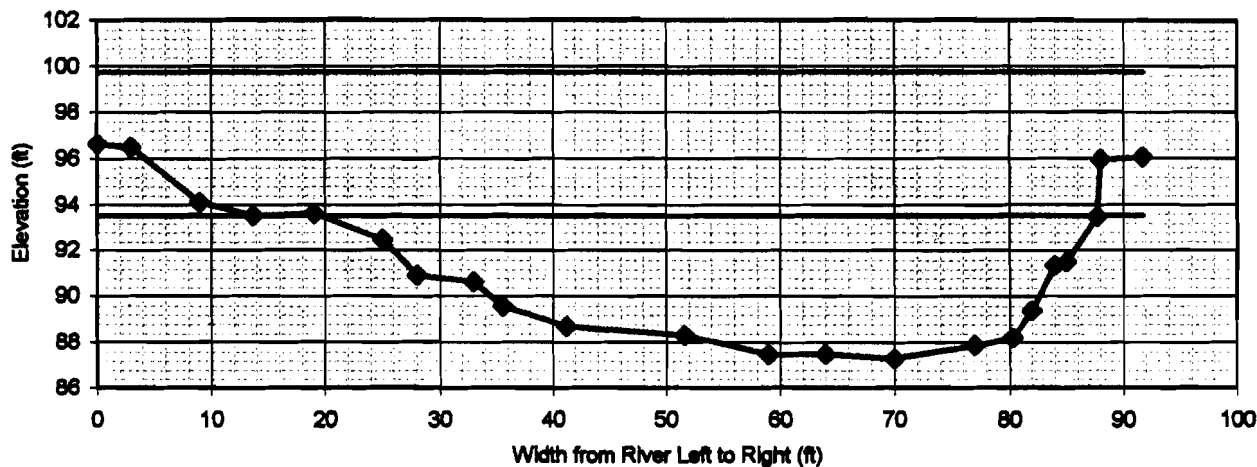
**Riffle Snow Creek**

Riffle  
Snow Creek  
Dan River in Roanoke River Basin

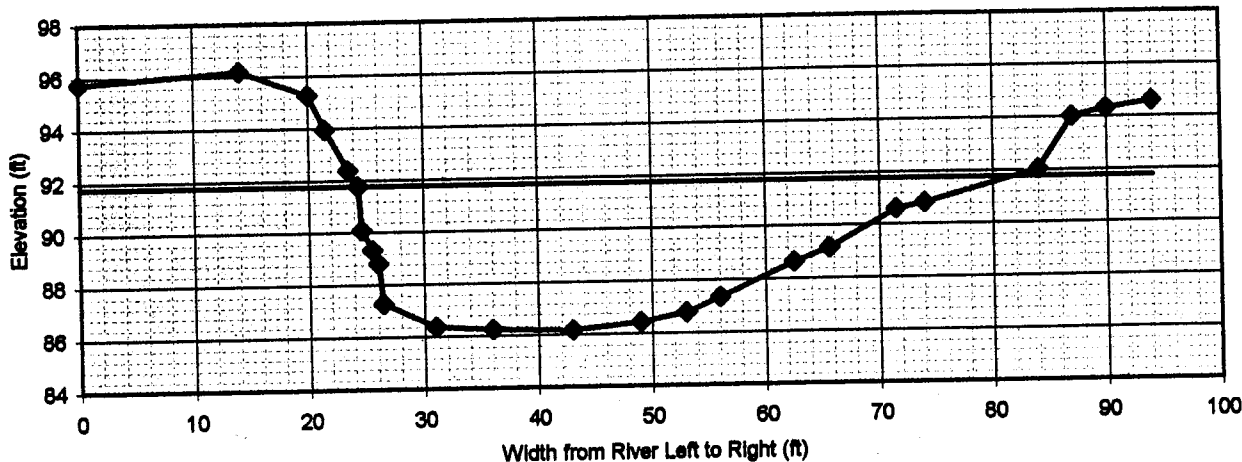
**Pool Snow Creek**

Pool  
Snow Creek  
Dan River in Roanoke River Basin

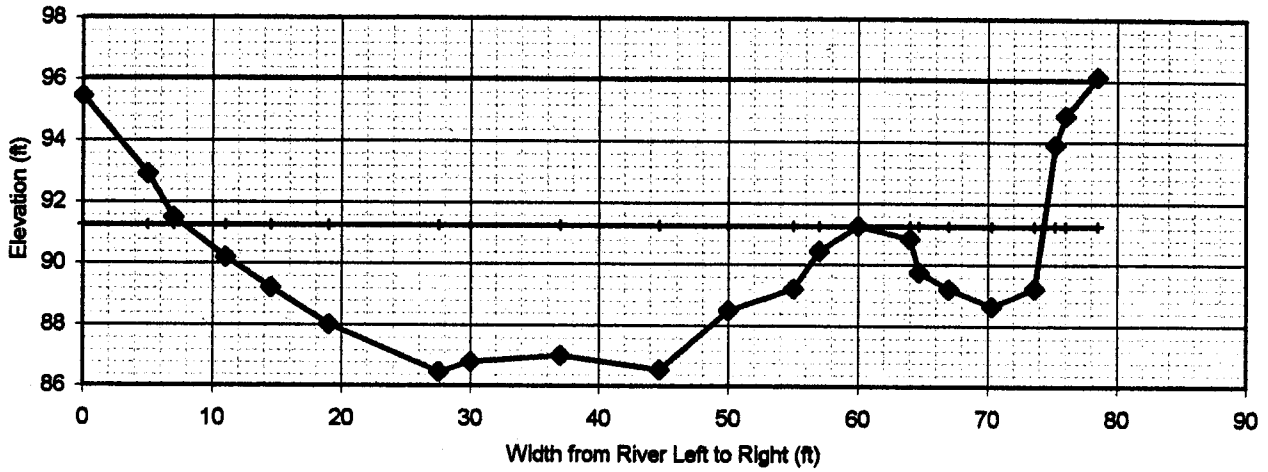
**Glide Snow Creek**

Glide  
Snow Creek  
Dan River in Roanoke River Basin

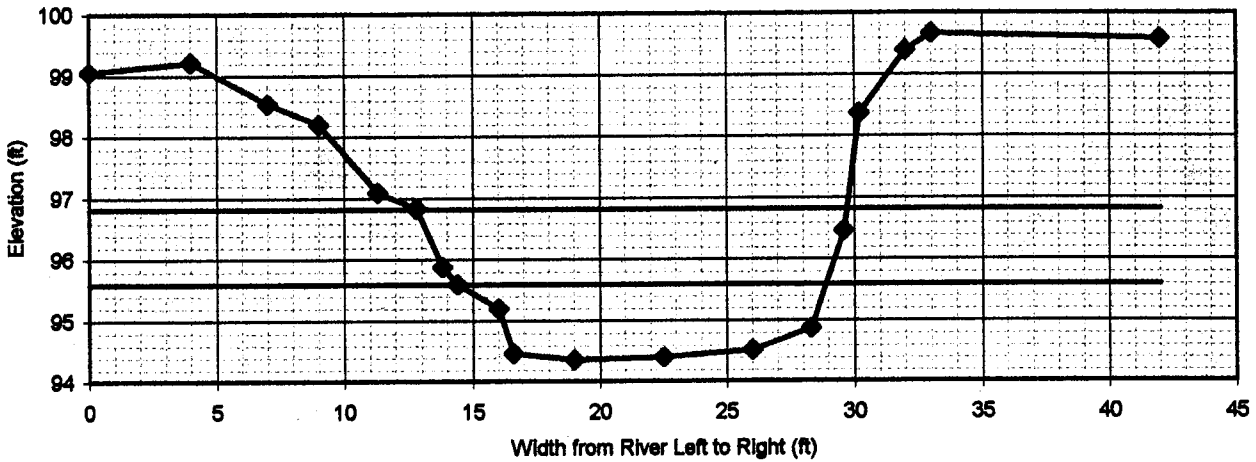
**Riffle Unnamed Tributary to Snow Creek**

Riffle  
 Unnamed Tributary to Snow Creek  
 Roanoke River Basin

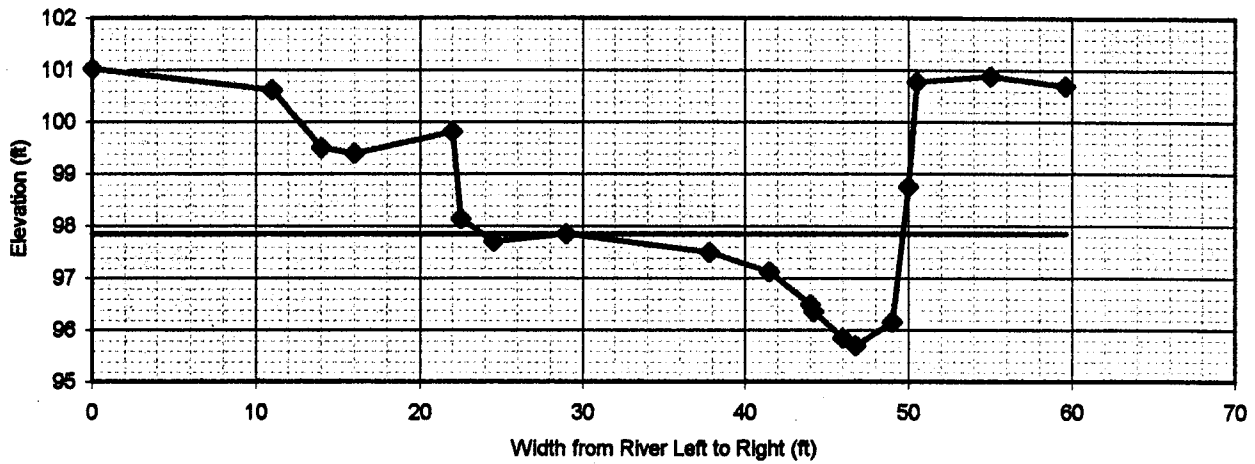
**BEHI section Pool Unnamed Tributary to Snow Creek**

**Pool**  
 Unnamed Tributary to Snow Creek  
 Roanoke River Basin

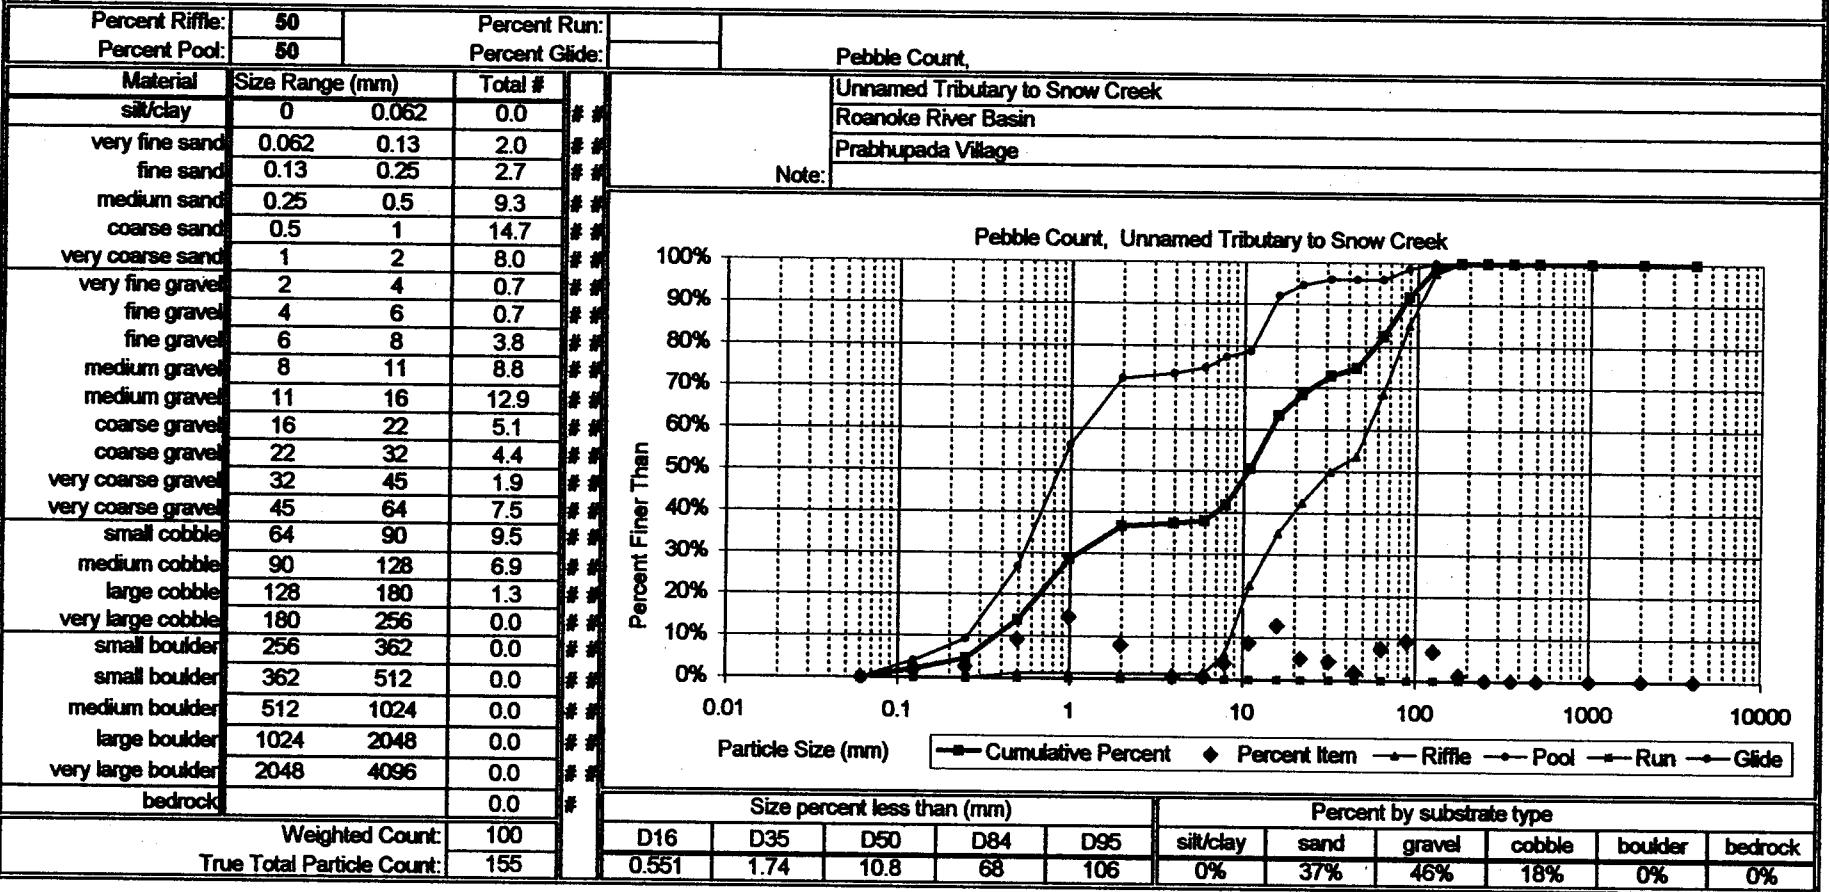
**Weighted Pebble Count**

Percent Riffle:	50	Percent Run:	
Percent Pool:	50	Percent Glide:	
<b>Material</b>	<b>Size Range (mm)</b>	<b>Total #</b>	
silt/clay	0 0.062	0.7	##
very fine sand	0.062 0.13	0.7	##
fine sand	0.13 0.25	3.9	##
medium sand	0.25 0.5	11.8	##
coarse sand	0.5 1	13.4	##
very coarse sand	1 2	3.9	##
very fine gravel	2 4	3.3	##
fine gravel	4 6	3.6	##
fine gravel	6 8	5.2	##
medium gravel	8 11	6.2	##
medium gravel	11 16	9.2	##
coarse gravel	16 22	5.6	##
coarse gravel	22 32	4.9	##
very coarse gravel	32 45	7.9	##
very coarse gravel	45 64	6.2	##
small cobble	64 90	4.9	##
medium cobble	90 128	3.6	##
large cobble	128 180	2.0	##
very large cobble	180 256	0.3	##
small boulder	256 362	0.3	##
small boulder	362 512	0.3	##
medium boulder	512 1024	1.0	##
large boulder	1024 2048	0.3	##
very large boulder	2048 4096	0.0	##
bedrock		0.7	##
Weighted Count:		100	
True Total Particle Count:		305

The pavement and subpavement of the most diagnostic portions of the stream were sampled at one location each for the main channel and the tributary. The typical pavement  $D_{50}$  for Snow Creek was 19.5 mm, with the  $D_{84}$  being 53 mm. The subpavement  $D_{50}$  was 5.7 mm, with a  $D_{84}$  of 36 mm. The typical pavement  $D_{50}$  for the tributary was 127 mm, with a  $D_{84}$  of 161 mm. The subpavement  $D_{50}$  is 32.7 mm and the  $D_{84}$  is 56 mm. EcoLogic believes the smaller particle sizes found in the main channel reflect an excessive number of fines in the system.

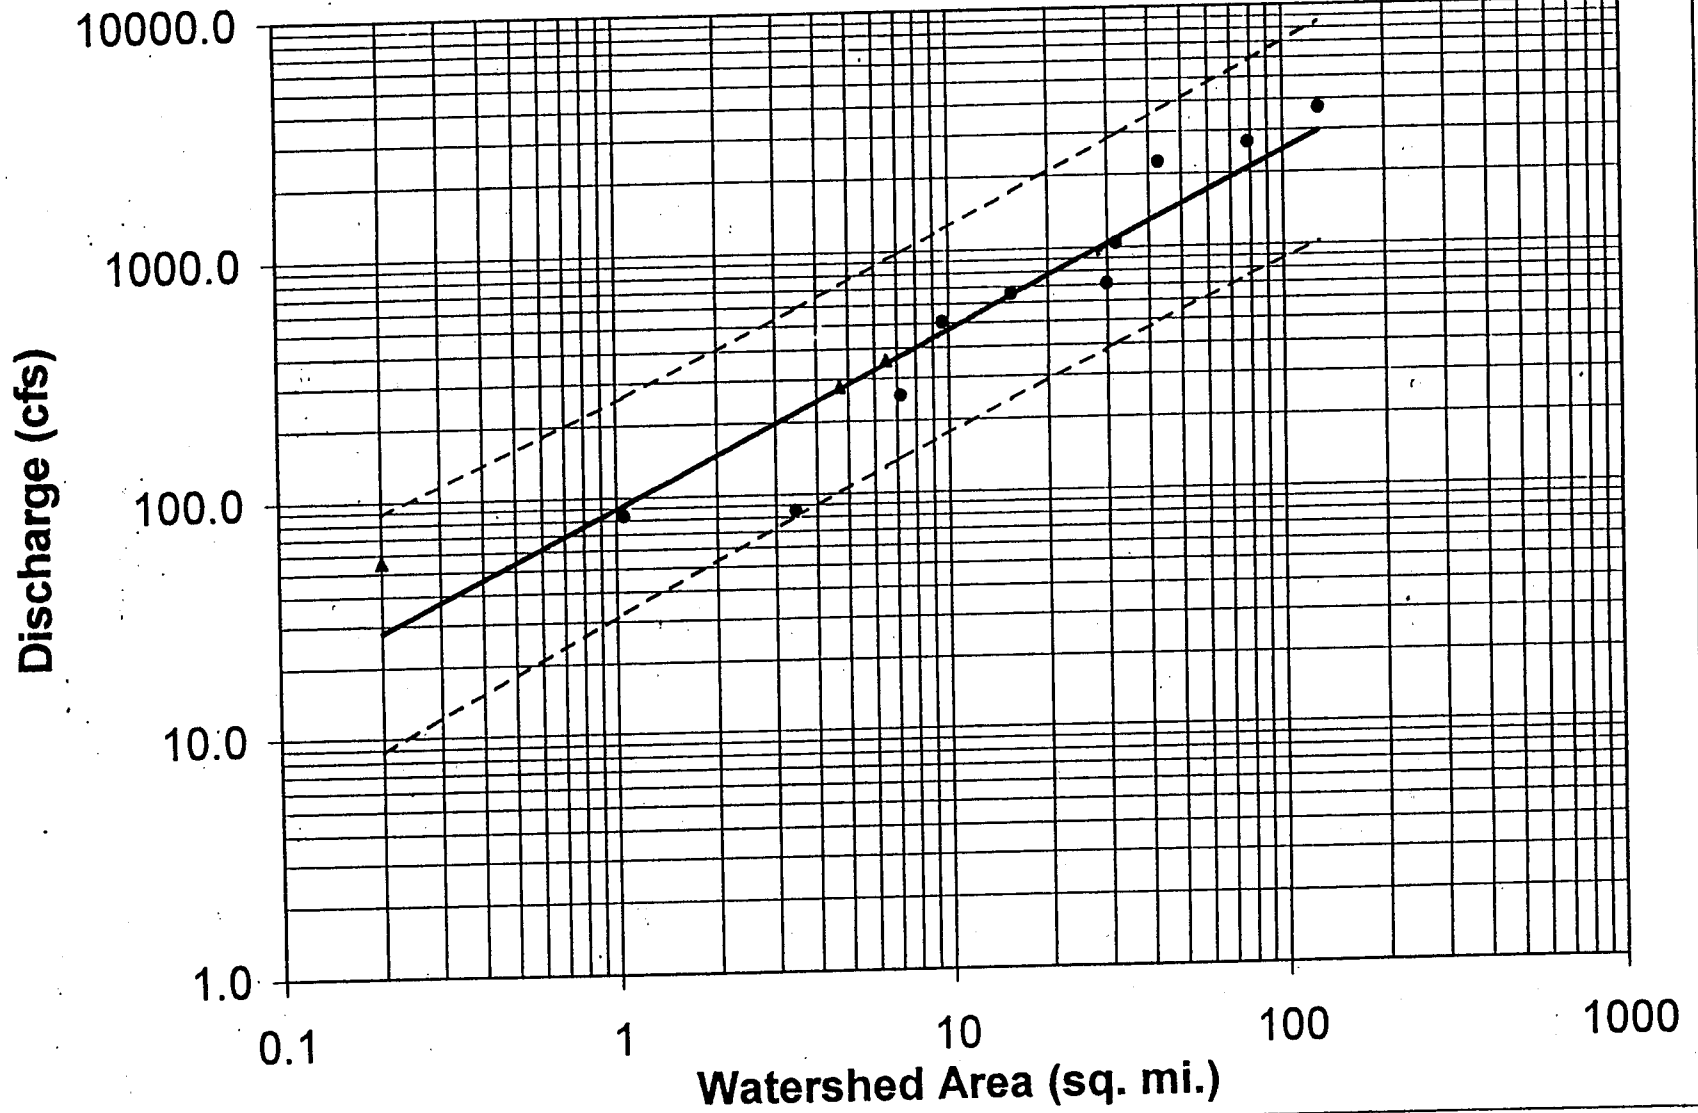
# NC Rural Piedmont Regional Curve

$$y = 89.039x^{0.7223}$$
$$R^2 = 0.9069$$

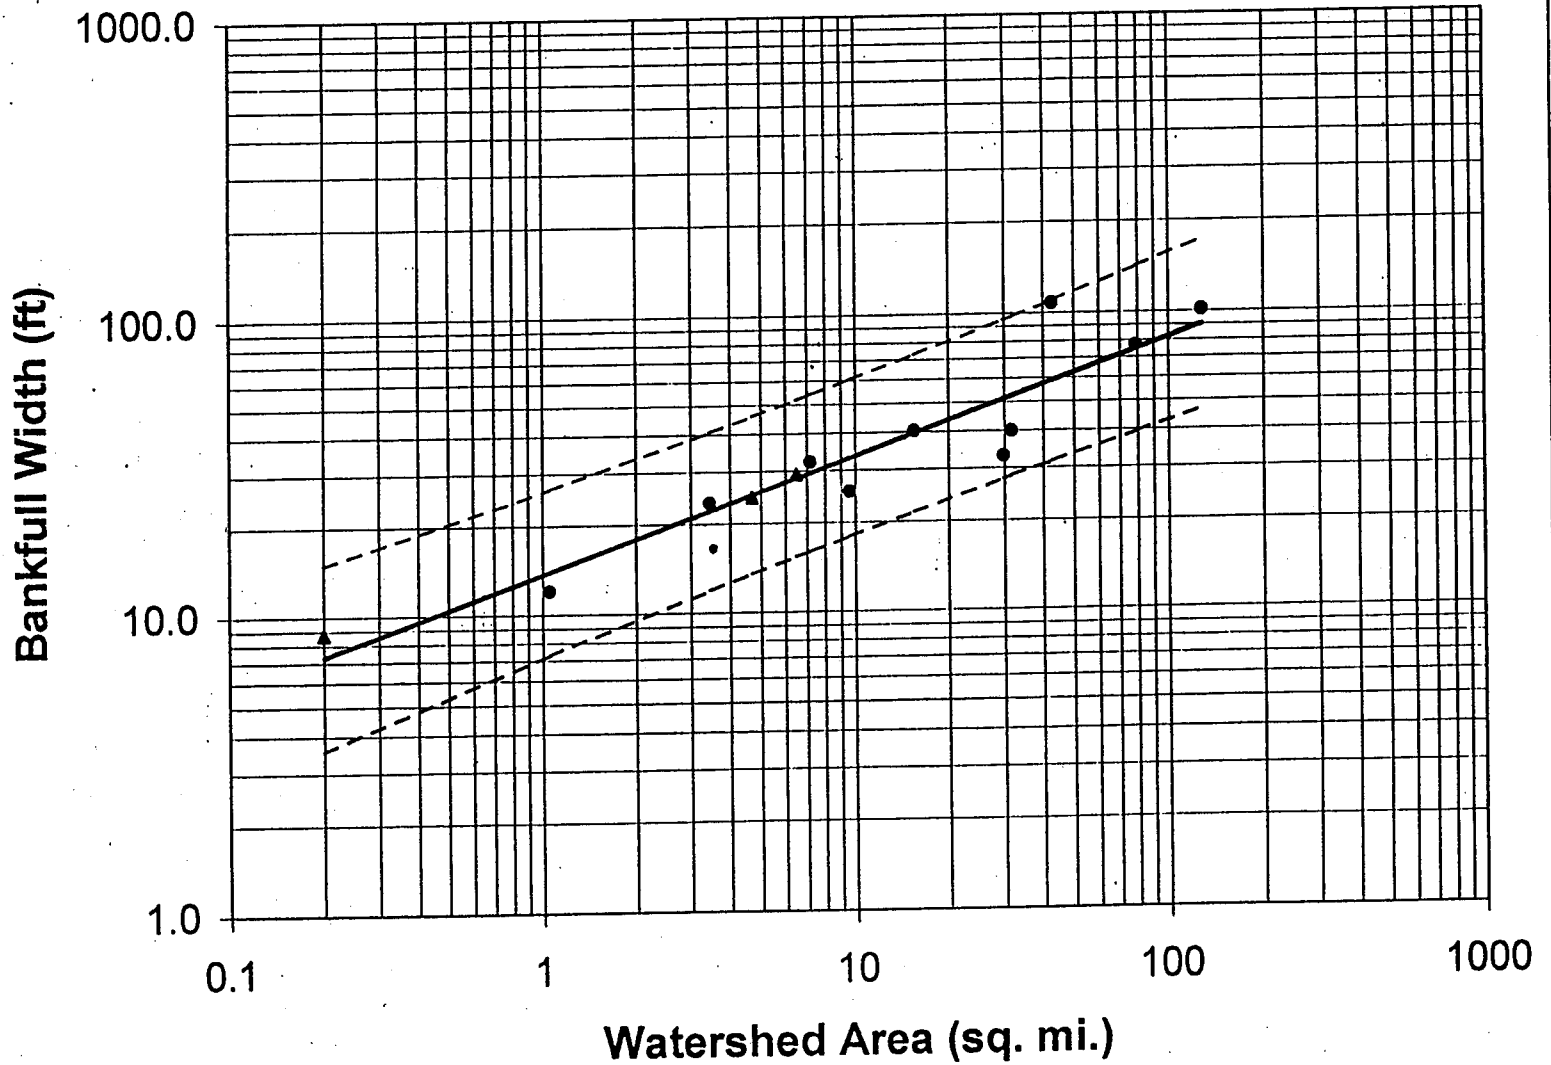
# NC Rural Piedmont Regional Curve

$$y = 13.635x^{0.3894}$$
$$R^2 = 0.8806$$

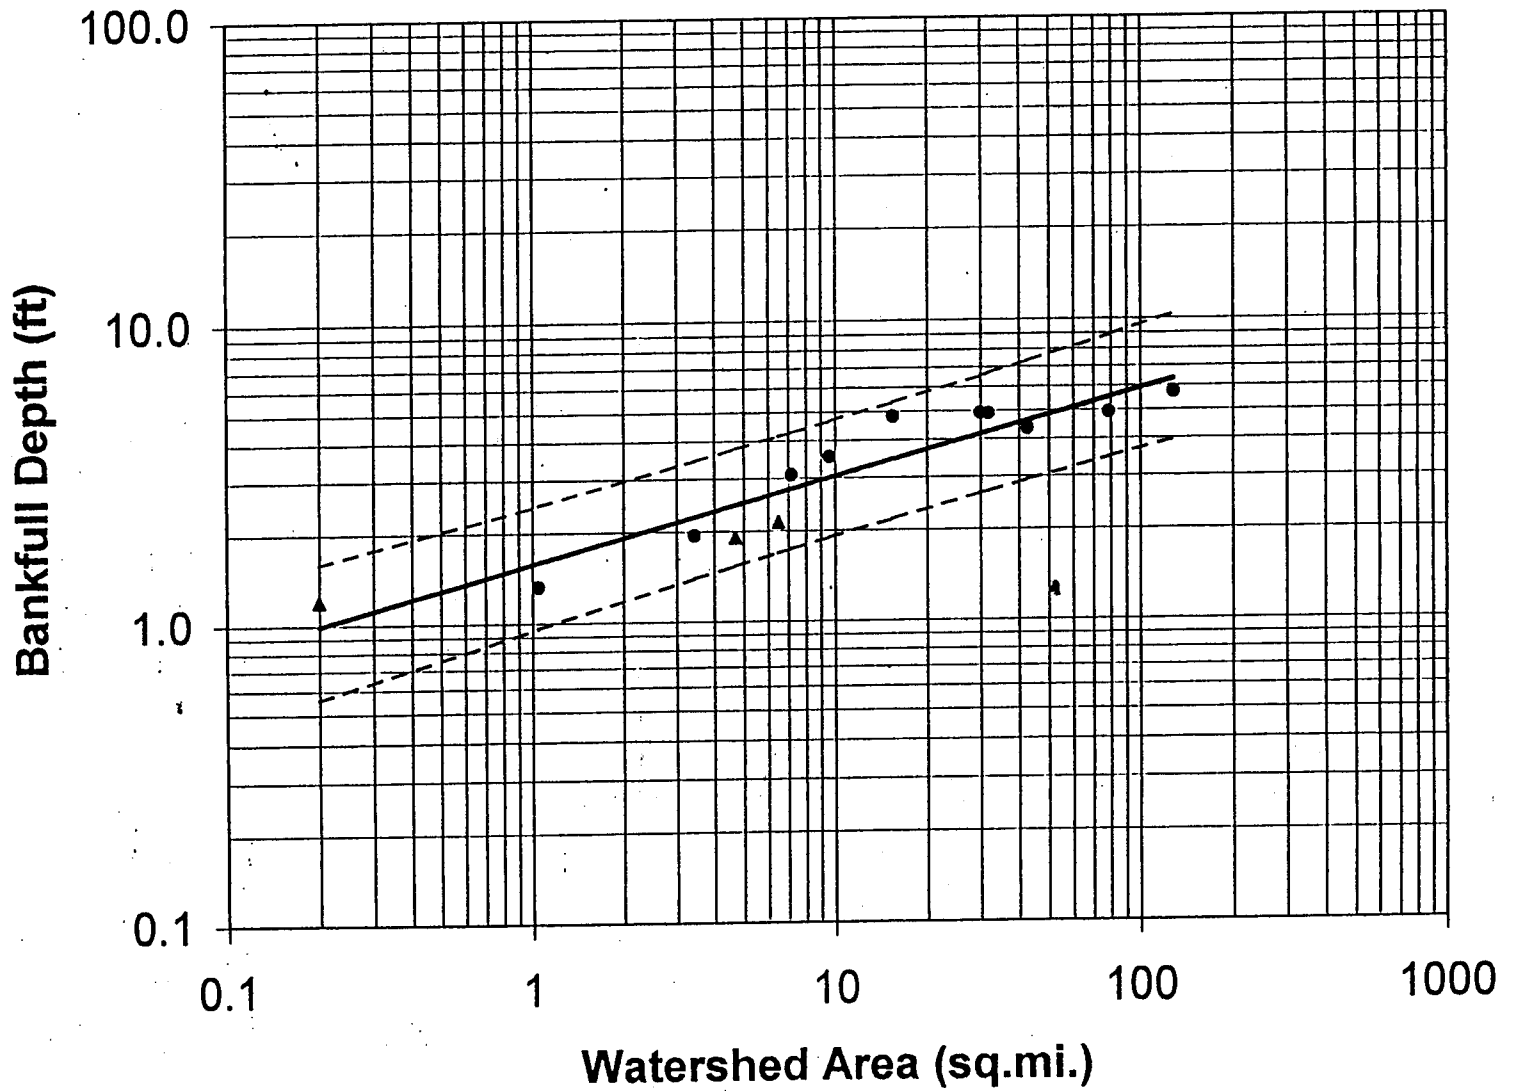
# NC Rural Piedmont Regional Curve

$$y = 1.5719x^{0.2867}$$
$$R^2 = 0.8799$$

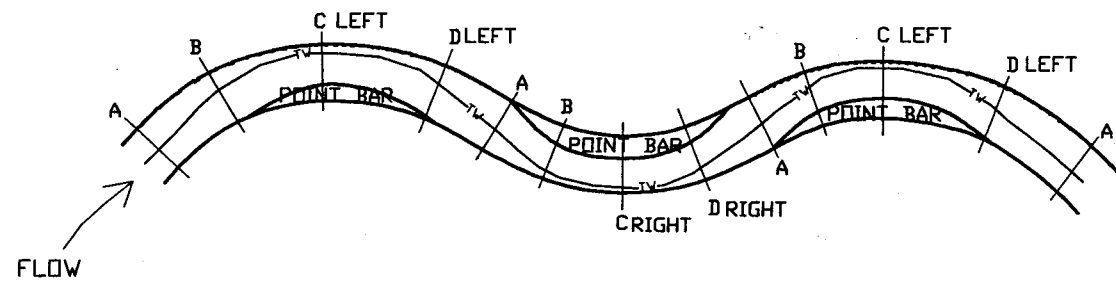
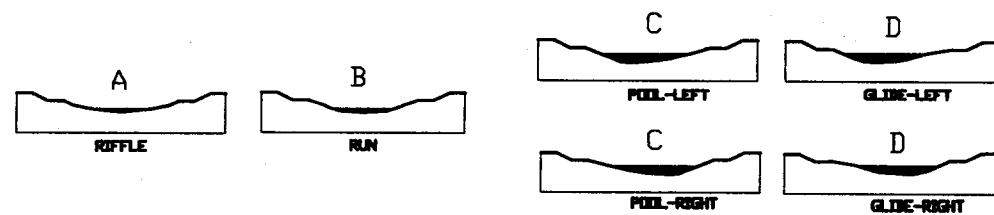
# UNNAMED TRIBUTARY SNOW CREEK TYPICAL CROSS SECTIONS

## BED FEATURE SEQUENCE AND CROSS SECTIONS SEE TYPICAL CROSS SECTIONS AND STATIONING FOR MORE DETAILS.

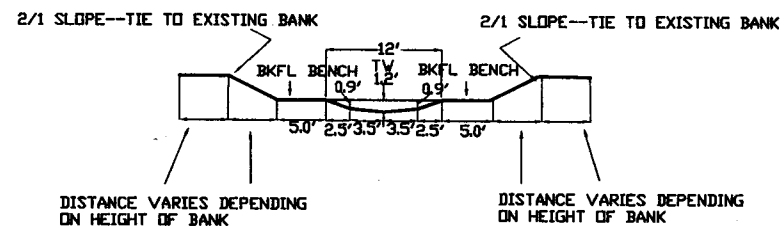
DETAIL 2

TYPICAL SECTION-RIFFLE

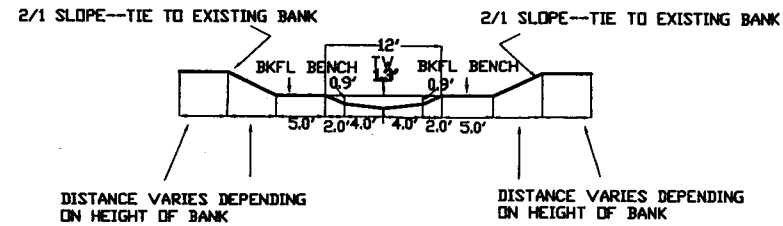
DETAIL 3

TYPICAL SECTION-RUN

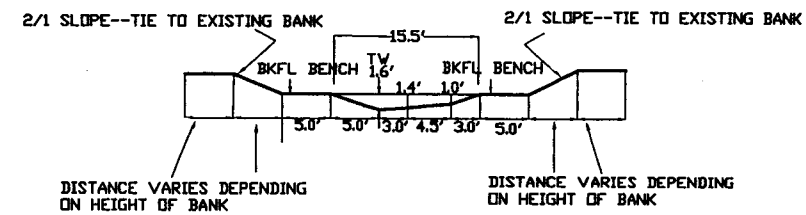
DETAIL 4

TYPICAL SECTION-POOL

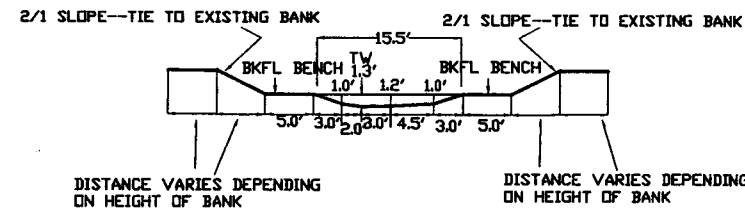
DETAIL 5

TYPICAL SECTION-GLIDE
