# **SOUTH FORK HOPPERS CREEK STREAM AND WETLAND RESTORATION PROJECT**

## **ANNUAL MONITORING REPORT FOR 2010 (YEAR 5)**

**Project Number: D04006-4**

**Prepared by: Michael Baker Engineering, Inc.**

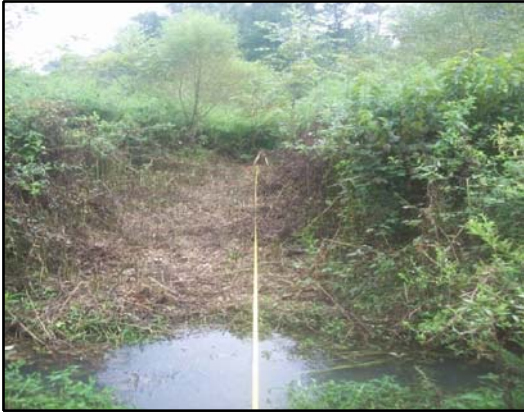
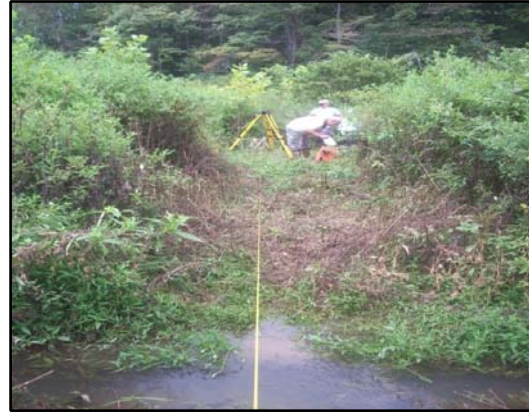
**Permanent Cross Section X1**  
 (Year 5 Monitoring Data - collected September 2010)

Looking at the Left Bank

Looking at the Right Bank

Feature	Stream Type	BKF Area	BKF Width	BKF Depth	Max BKF Depth	W/D	BH Ratio	ER	BKF Elev	TOB Elev
Riffle	C	20.4	19.88	1.03	2.24	19.37	1	3.5	1186.29	1186.29

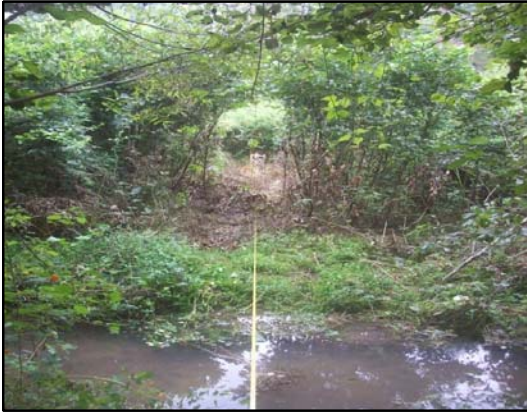
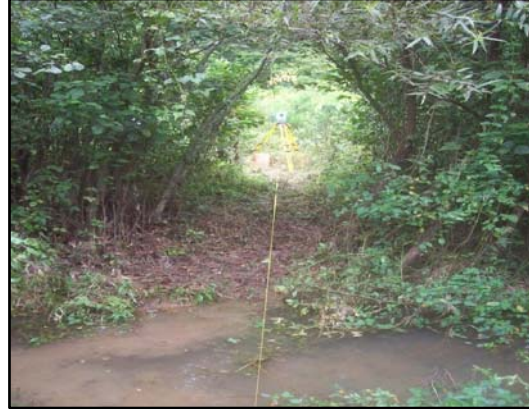
**Permanent Cross Section X2**  
(Year 5 Monitoring Data - collected September 2010)

Looking at the Left Bank

Looking at the Right Bank

Feature	Stream Type	BKF Area	BKF Width	BKF Depth	Max BKF Depth	W/D	BH Ratio	ER	BKF Elev	TOB Elev
Pool		16	12.88	1.24	2.01	10.39	1	5.4	1185.88	1185.88

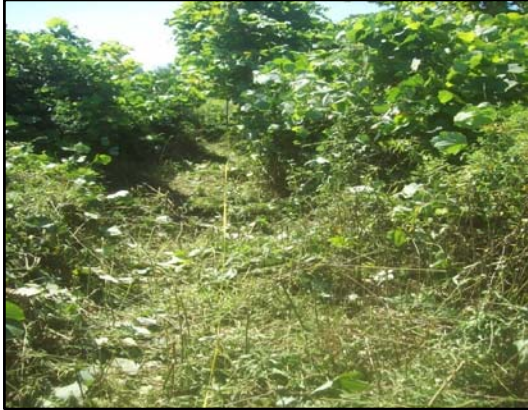
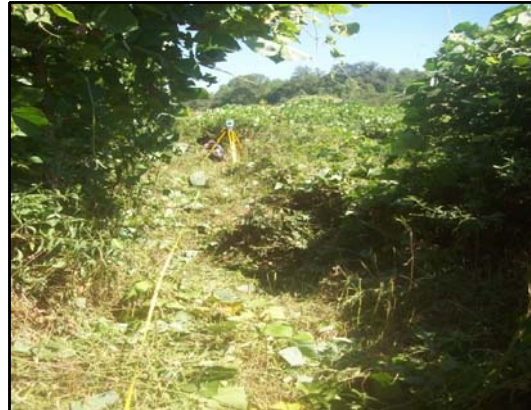
**Permanent Cross Section X3**  
 (Year 5 Monitoring Data - collected September 2010)

**Looking at the Left Bank**

**Looking at the Right Bank**

Feature	Stream Type	BKF Area	BKF Width	BKF Depth	Max BKF Depth	W/D	BH Ratio	ER	BKF Elev	TOB Elev
Riffle	E	20.6	14.39	1.43	2.56	10.06	1	4.9	1190.54	1190.54

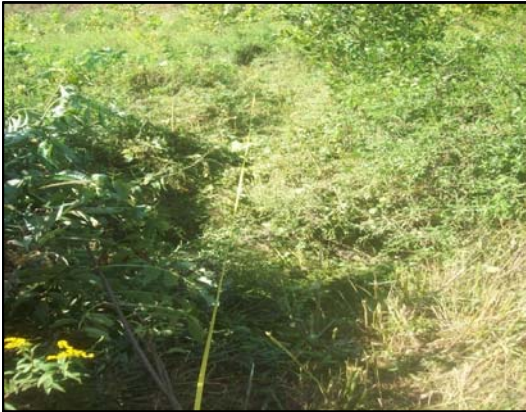
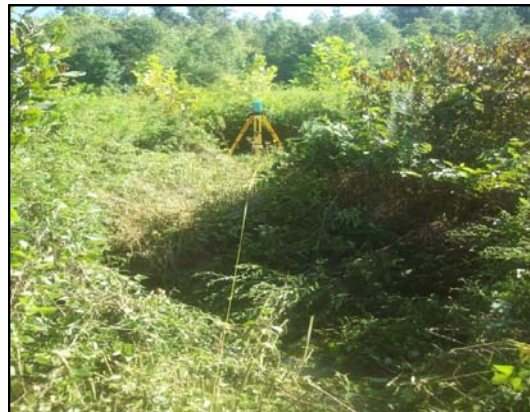
**Permanent Cross Section X4**  
 (Year 5 Monitoring Data - collected September 2010)

Looking at the Left Bank

Looking at the Right Bank

Feature	Stream Type	BKF Area	BKF Width	BKF Depth	Max BKF Depth	W/D	BH Ratio	ER	BKF Elev	TOB Elev
Pool		19.8	15.29	1.3	2.68	11.78	1	4.6	1190.21	1190.21

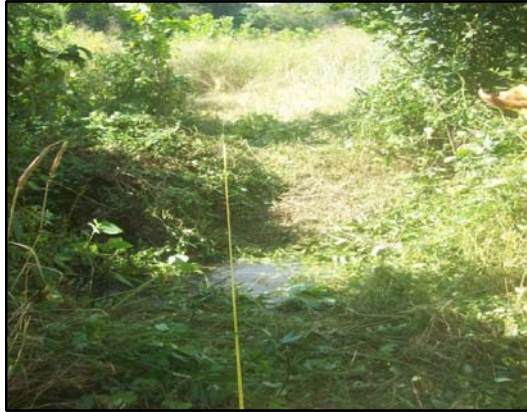
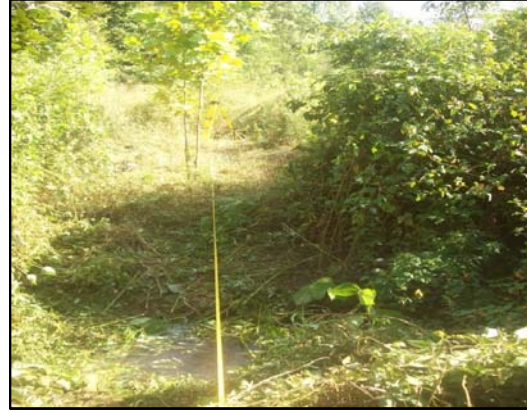
**Permanent Cross Section X5**  
 (Year 5 Monitoring Data - collected September 2010)

Looking at the Left Bank

Looking at the Right Bank

Feature	Stream Type	BKF Area	BKF Width	BKF Depth	Max BKF Depth	W/D	BH Ratio	ER	BKF Elev	TOB Elev
Riffle	C	21.9	16.38	1.33	2.38	12.28	1	4.3	1193.27	1193.27

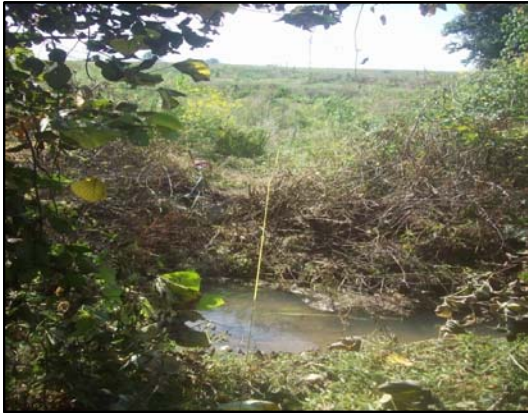
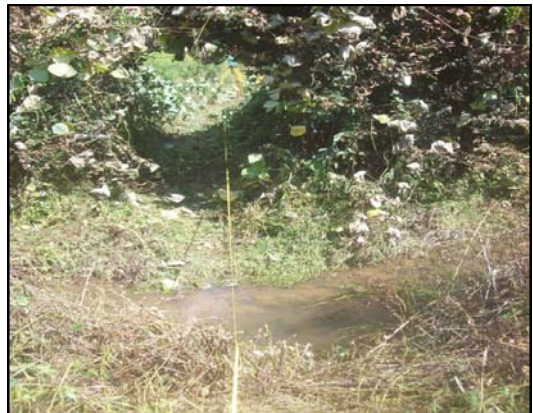
**Permanent Cross Section X6**  
 (Year 5 Monitoring Data - collected October 2010)

Looking at the Left Bank

Looking at the Right Bank

Feature	Stream Type	BKF Area	BKF Width	BKF Depth	Max BKF Depth	W/D	BH Ratio	ER	BKF Elev	TOB Elev
Pool		43.1	26.78	1.61	3.61	16.64	1	2.6	1193.81	1193.81

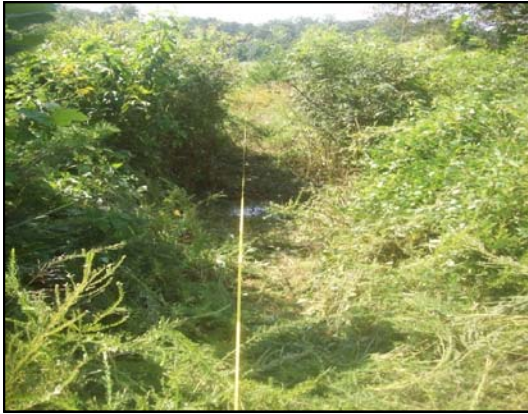
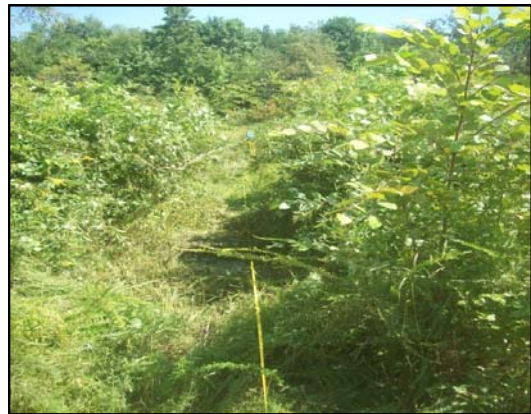
**Permanent Cross Section X7**  
 (Year 5 Monitoring Data - collected September 2010)

Looking at the Left Bank

Looking at the Right Bank

Feature	Stream Type	BKF Area	BKF Width	BKF Depth	Max BKF Depth	W/D	BH Ratio	ER	BKF Elev	TOB Elev
Pool		8.6	8.01	1.08	2.21	7.43	1	8.5	1196.48	1196.48

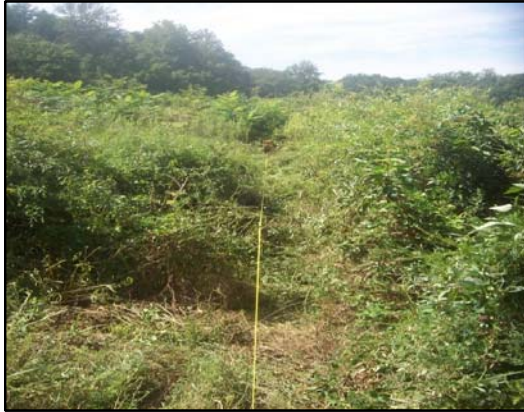
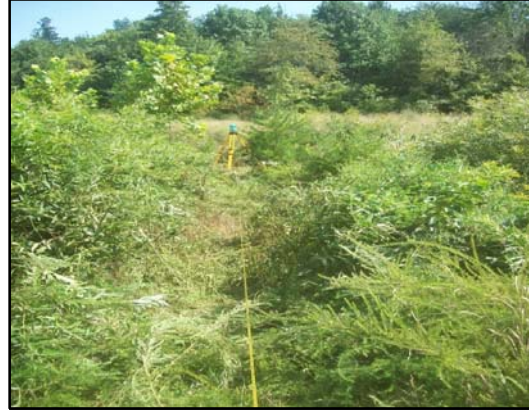
**Permanent Cross Section X8**  
 (Year 5 Monitoring Data - collected September 2010)

Looking at the Left Bank

Looking at the Right Bank

Feature	Stream Type	BKF Area	BKF Width	BKF Depth	Max BKF Depth	W/D	BH Ratio	ER	BKF Elev	TOB Elev
Riffle	C	7.2	13.01	0.56	1.97	23.36	1	4.8	1198.01	1198.02

UT 1 continues to receive influxes of fines to the system from its contributing drainage area. Cross-section 8 (riffle) has continued to coarsen throughout the monitoring period exhibiting its ability to effectively move finer sediments, from the contributing drainage area, through the system. Cross-section 7 did contain more silts and clays in Year 5 than previous years, however, the cross-section's mean and max pool depths are deeper and resemble those of as-built conditions. Therefore, this accumulation of fines is likely to be a temporary influx of silts and clays from the contributing drainage area just prior to sampling.

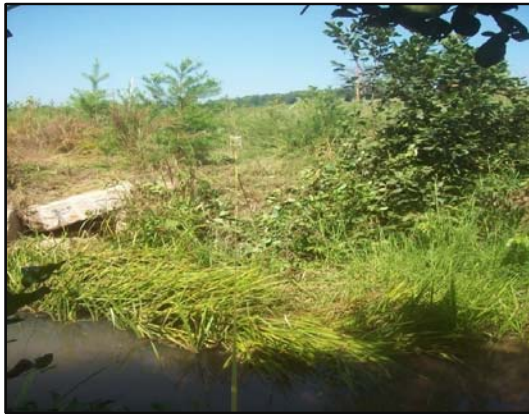
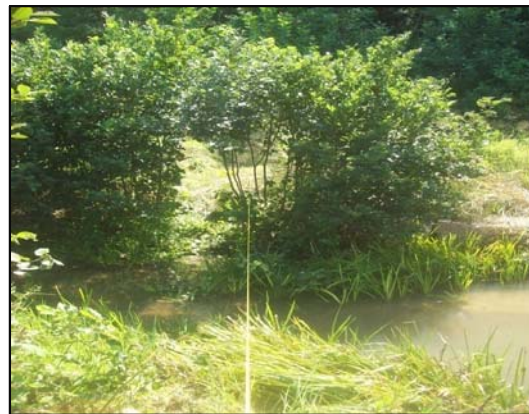
**Permanent Cross Section X9**  
 (Year 5 Monitoring Data - collected September 2010)

Looking at the Left Bank

Looking at the Right Bank

Feature	Stream Type	BKF Area	BKF Width	BKF Depth	Max BKF Depth	W/D	BH Ratio	ER	BKF Elev	TOB Elev
Pool		82.2	30.57	2.69	4.04	11.36	1	2.3	1200.53	1200.53

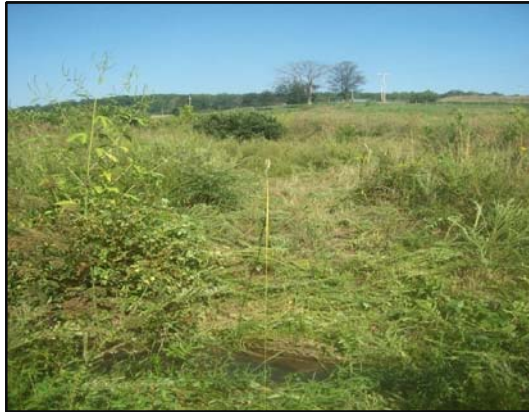
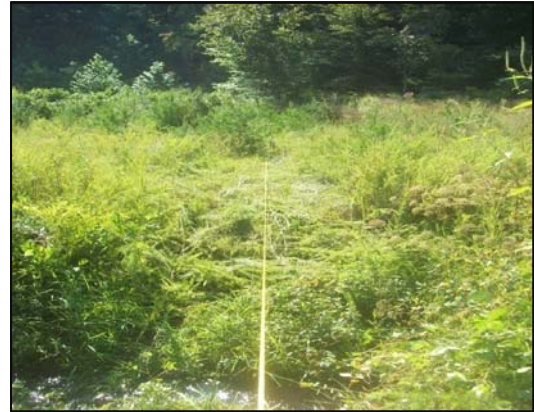
**Permanent Cross Section X10**  
 (Year 5 Monitoring Data - collected September 2010)

Looking at the Left Bank

Looking at the Right Bank

Feature	Stream Type	BKF Area	BKF Width	BKF Depth	Max BKF Depth	W/D	BH Ratio	ER	BKF Elev	TOB Elev
Riffle	C	23.5	16.89	1.39	2.55	12.13	1	4.2	1203.27	1203.27

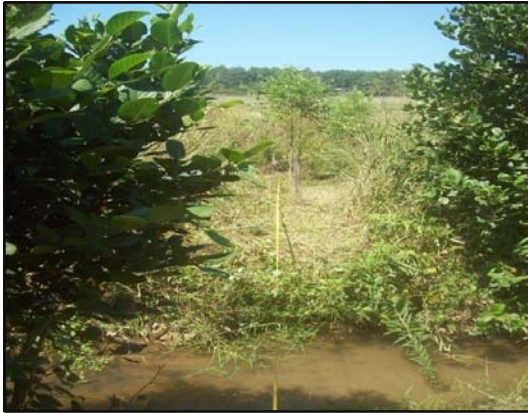
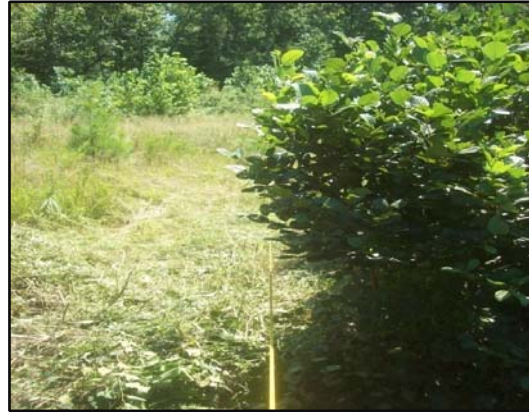
**Permanent Cross Section X11**  
 (Year 5 Monitoring Data - collected September 2010)

Looking at the Left Bank

Looking at the Right Bank

Feature	Stream Type	BKF Area	BKF Width	BKF Depth	Max BKF Depth	W/D	BH Ratio	ER	BKF Elev	TOB Elev
Pool		31.7	29.77	1.06	2.89	27.98	1	2.3	1214.25	1214.25

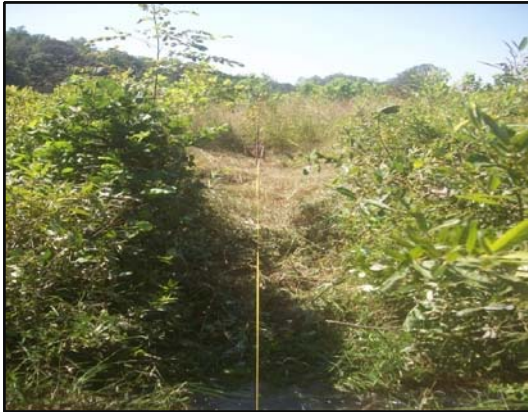
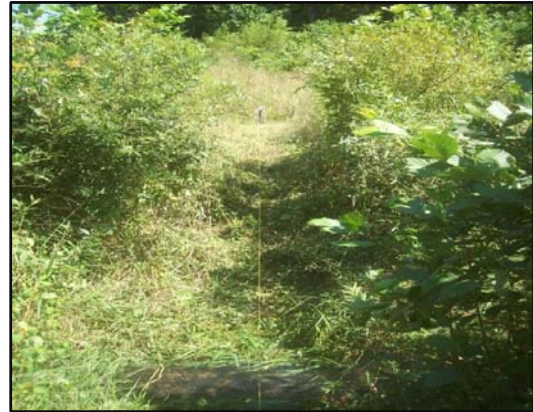
**Permanent Cross Section X12**  
 (Year 5 Monitoring Data - collected September 2010)

Looking at the Left Bank

Looking at the Right Bank

Feature	Stream Type	BKF Area	BKF Width	BKF Depth	Max BKF Depth	W/D	BH Ratio	ER	BKF Elev	TOB Elev
Riffle	C	18.7	17.41	1.07	1.82	16.26	1	4	1214.51	1214.51

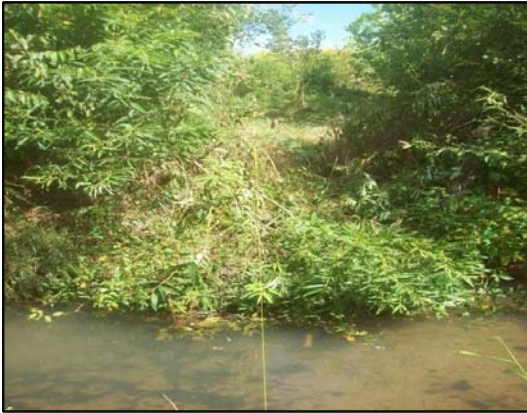
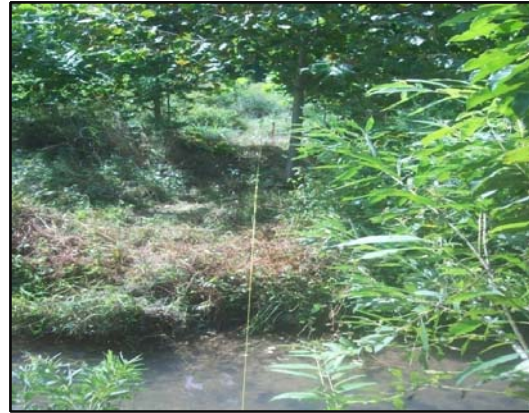
**Permanent Cross Section X13**  
 (Year 5 Monitoring Data - collected September 2010)

Looking at the Left Bank

Looking at the Right Bank

Feature	Stream Type	BKF Area	BKF Width	BKF Depth	Max BKF Depth	W/D	BH Ratio	ER	BKF Elev	TOB Elev
Pool		25.4	12.48	2.04	2.71	6.13	1	5.6	1216.95	1216.95

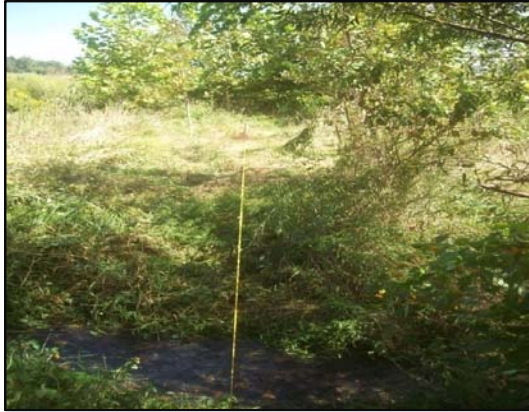
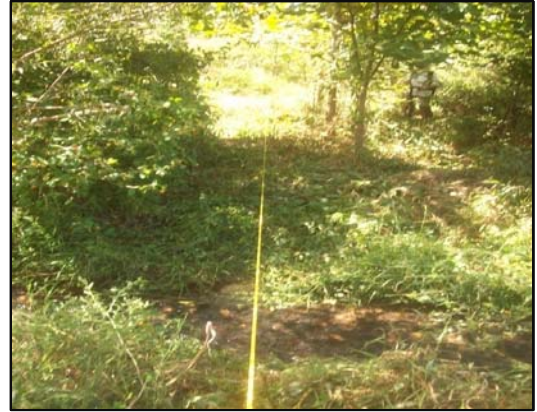
**Permanent Cross Section X14**  
 (Year 5 Monitoring Data - collected September 2010)

Looking at the Left Bank

Looking at the Right Bank

Feature	Stream Type	BKF Area	BKF Width	BKF Depth	Max BKF Depth	W/D	BH Ratio	ER	BKF Elev	TOB Elev
Riffle	C	19.8	20.26	0.98	1.97	20.77	1	3.5	1218.17	1218.17

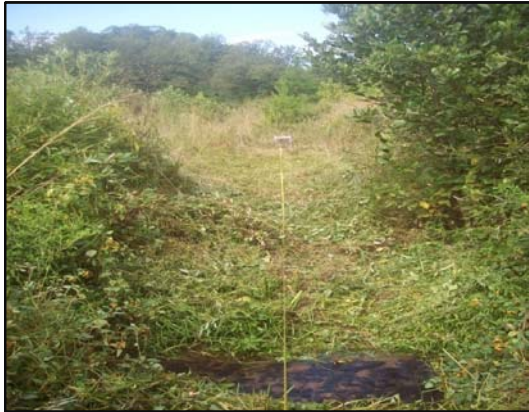
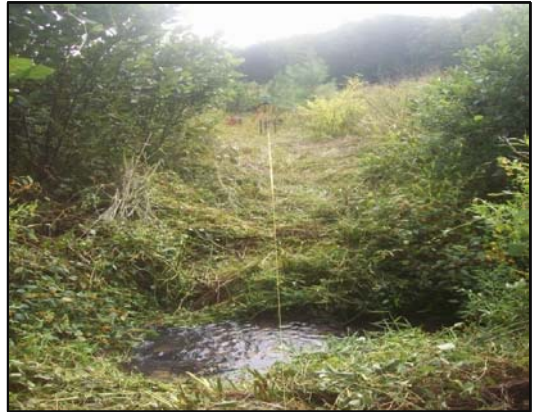
**Permanent Cross Section X15**  
 (Year 5 Monitoring Data - collected September 2010)

Looking at the Left Bank

Looking at the Right Bank

Feature	Stream Type	BKF Area	BKF Width	BKF Depth	Max BKF Depth	W/D	BH Ratio	ER	BKF Elev	TOB Elev
Riffle	C	16.2	17.58	0.92	1.89	19.08	1	4	1222.7	1222.7

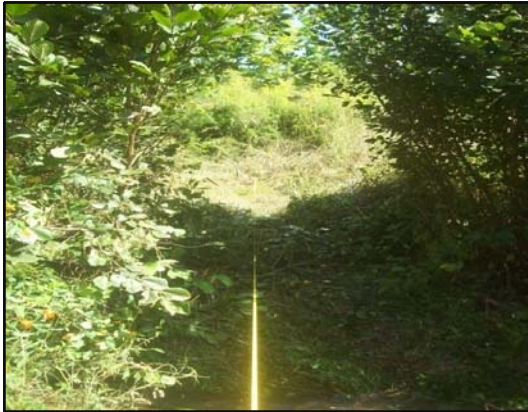
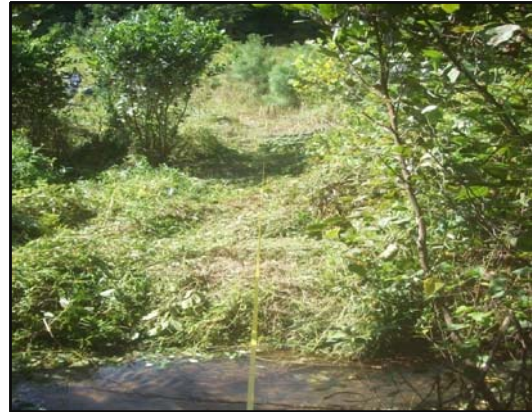
**Permanent Cross Section X16**  
 (Year 5 Monitoring Data - collected September 2010)

Looking at the Left Bank

Looking at the Right Bank

Feature	Stream Type	BKF Area	BKF Width	BKF Depth	Max BKF Depth	W/D	BH Ratio	ER	BKF Elev	TOB Elev
Pool		10.2	8.8	1.16	2.09	7.55	1	8	1223.98	1223.98

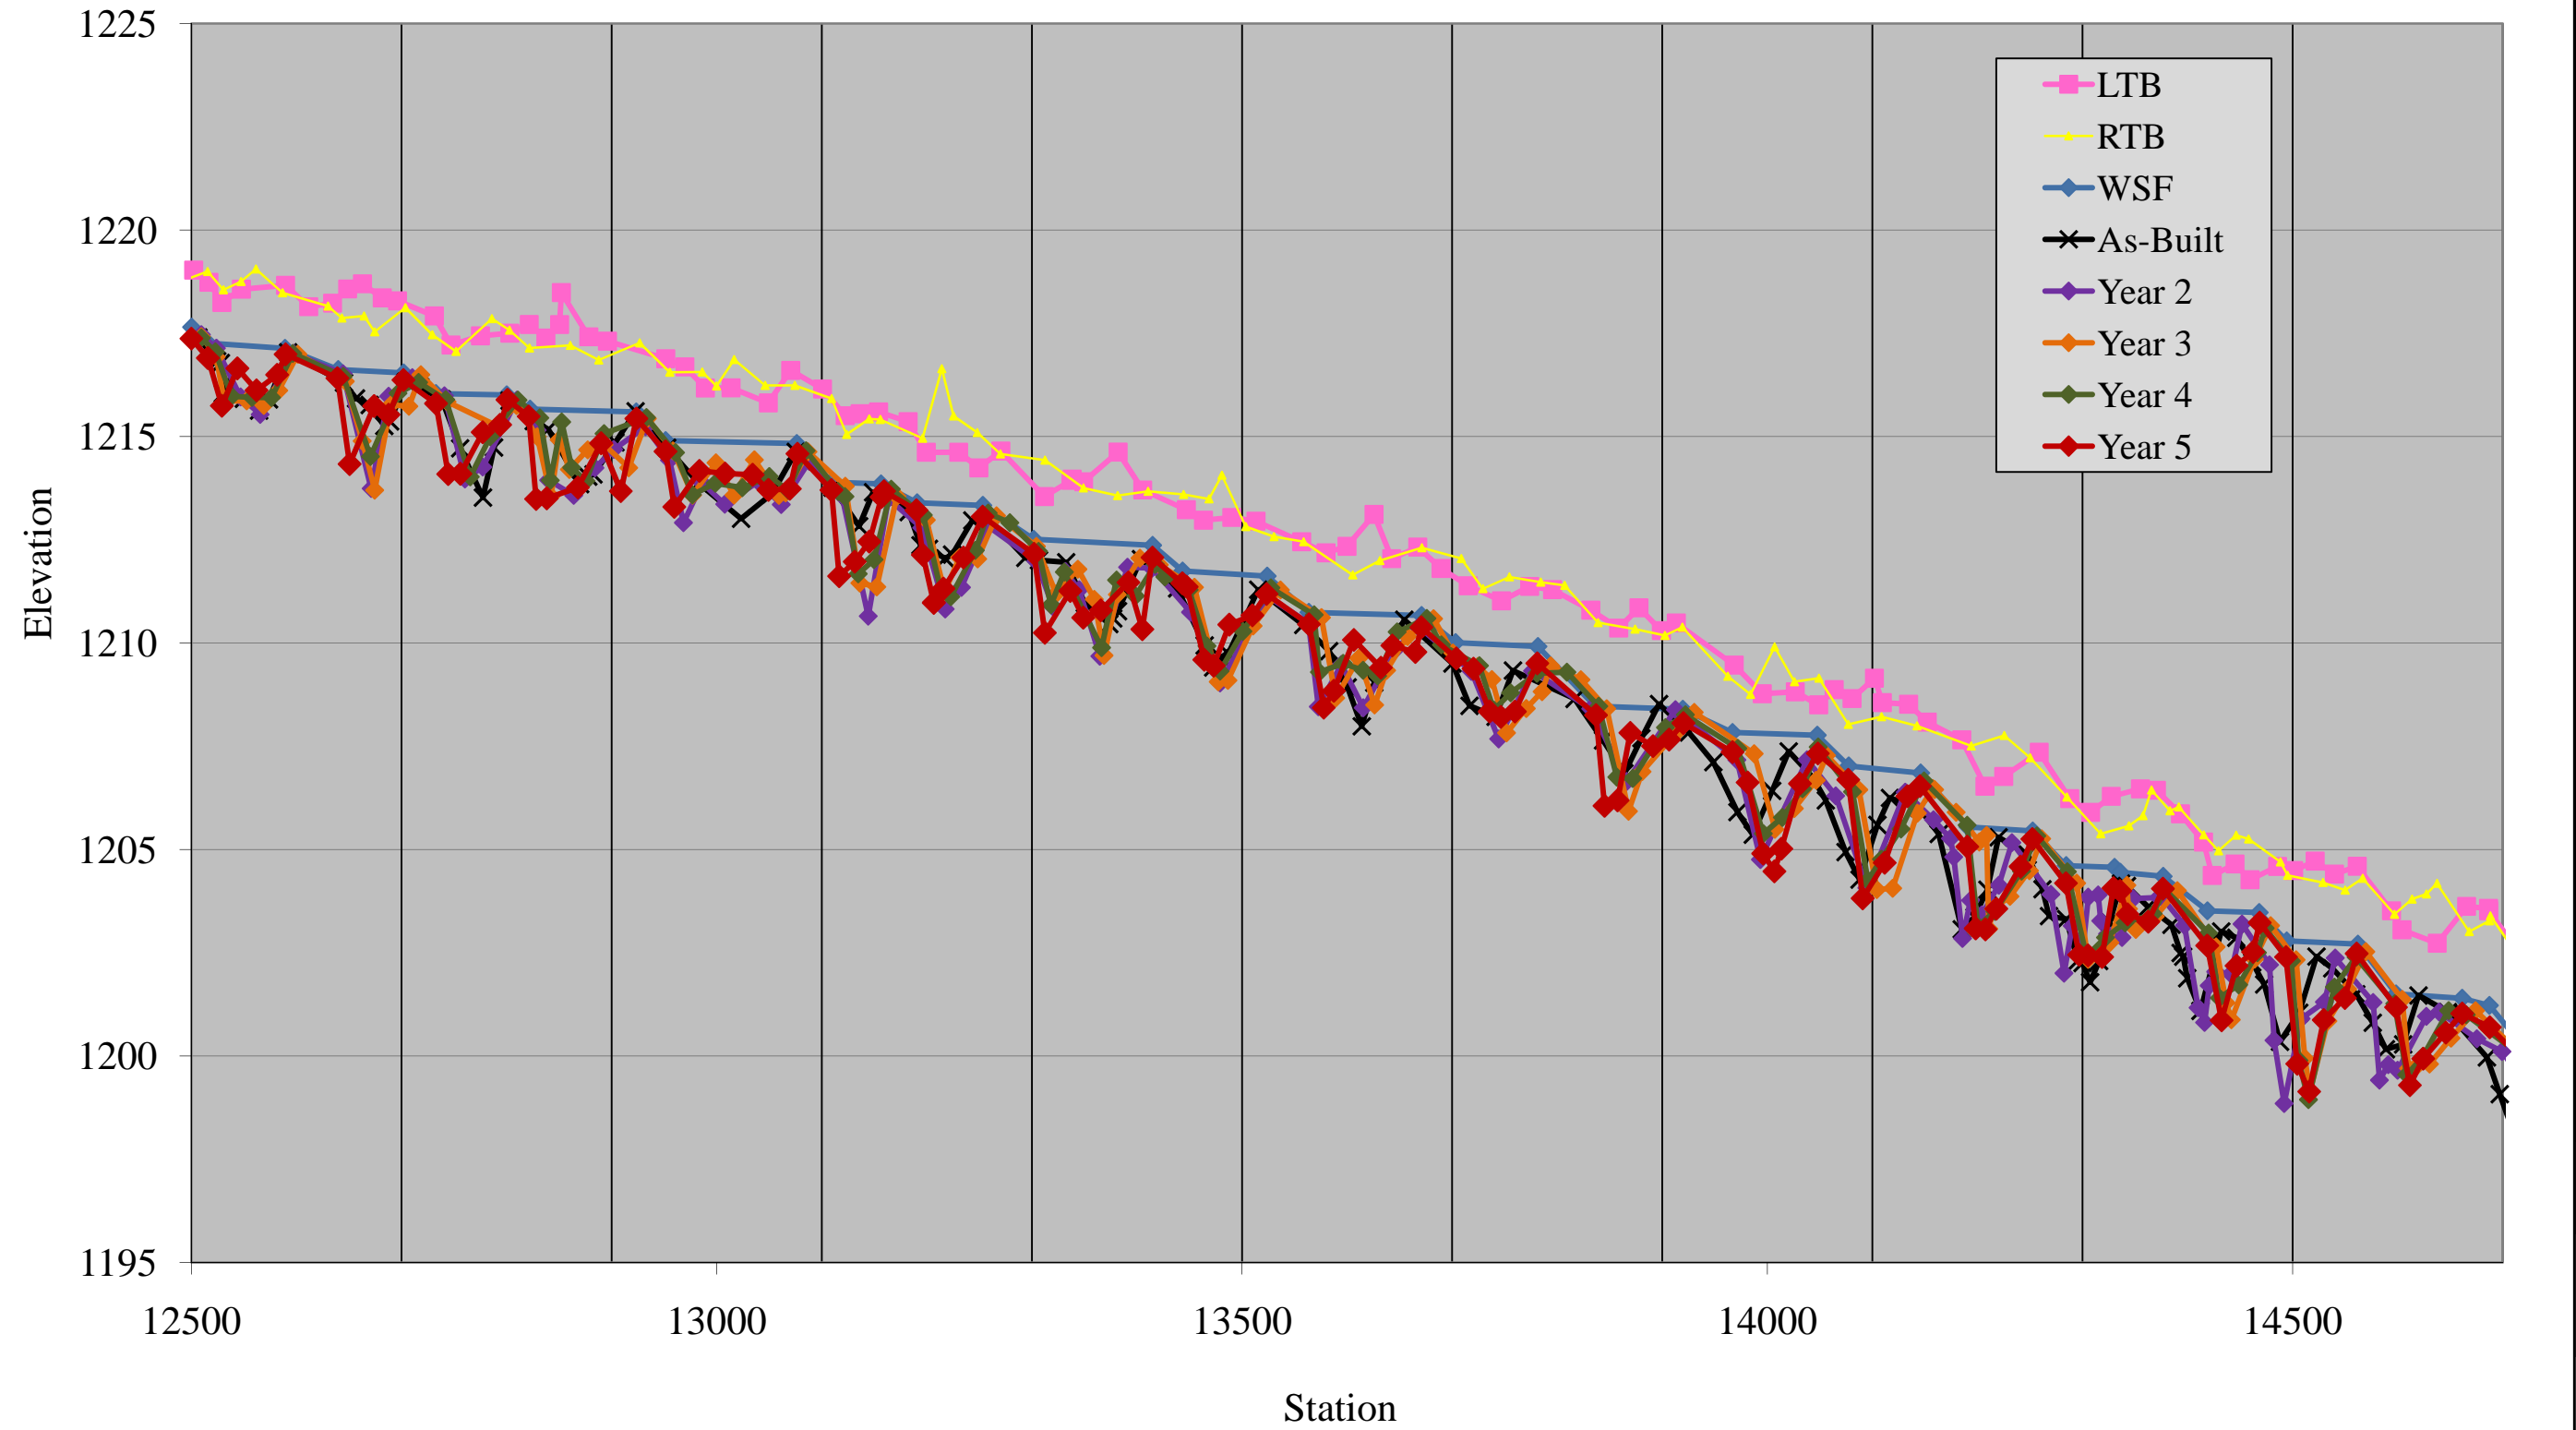
### South Fork Hoppers Creek - Year 5 (2010) Monitoring Profile

The Year 5 longitudinal profile was conducted during September 2010. A representative 3,549 LF section of the channel was surveyed, beginning at As-built Station 125+09 and ending at As-built Station 160+58. The representative longitudinal profile along the restored channel was resurveyed to document stream profile at the end of monitoring Year 5. Placement of the rock cross-vanes upstream of the bridge at Pierce Rd, as well as, natural migration of the thalweg accounts for the 50 LF discrepancy between the post-construction survey length and the as-built conditions.
