**WETLAND MITIGATION
AND STREAM RESTORATION PLAN**

**SPEIGHT BRANCH
Wake County, North Carolina**

State Project No. 8.1402601
TIP Project No. R-2541

North Carolina Department of Transportation
Project Development and Environmental Analysis Branch

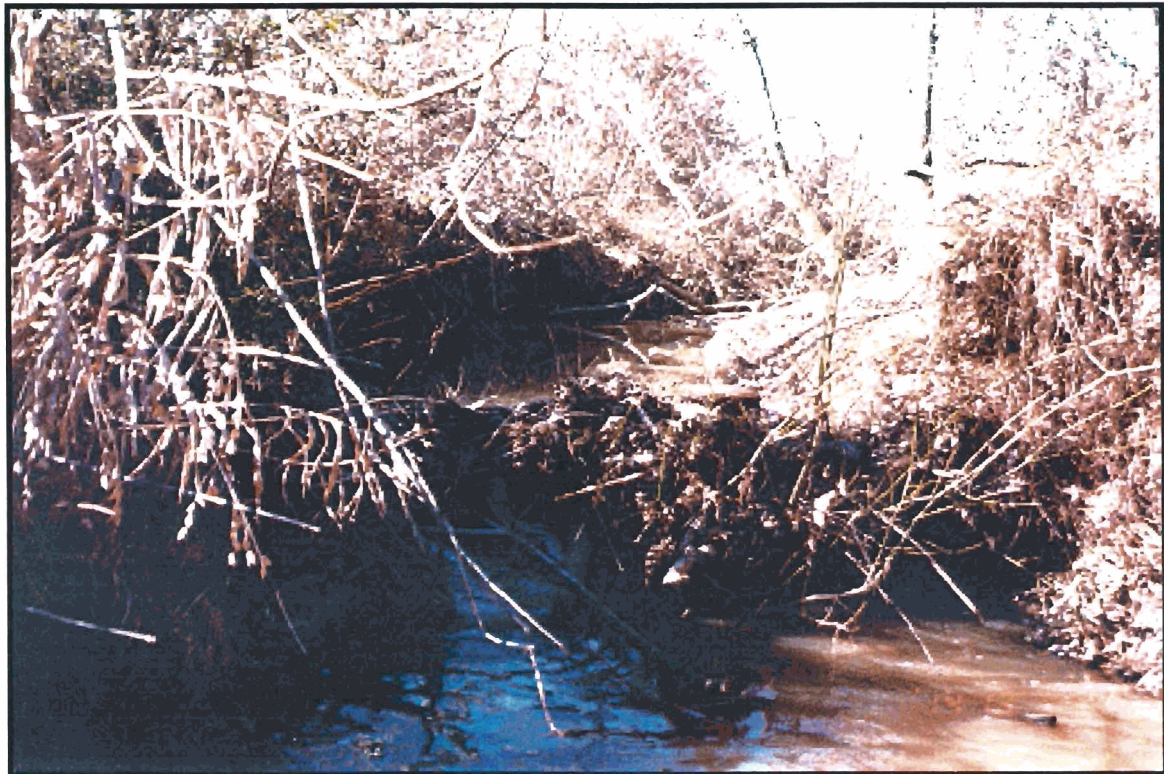
6-Beaver dam 1

Four beaver dams presently exist within the stream and evidence of current beaver activity on the site has been noted. The stream also contains debris from logging activity and past storm damage.

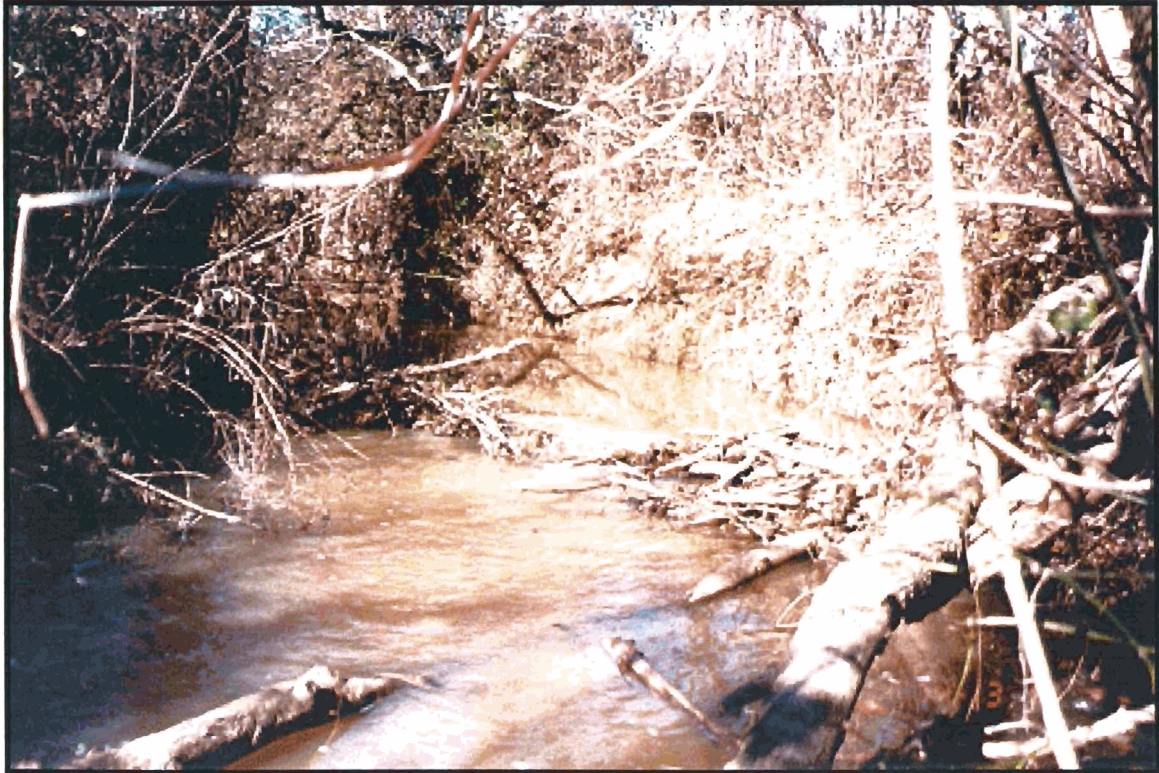
7-Beaver dam 2

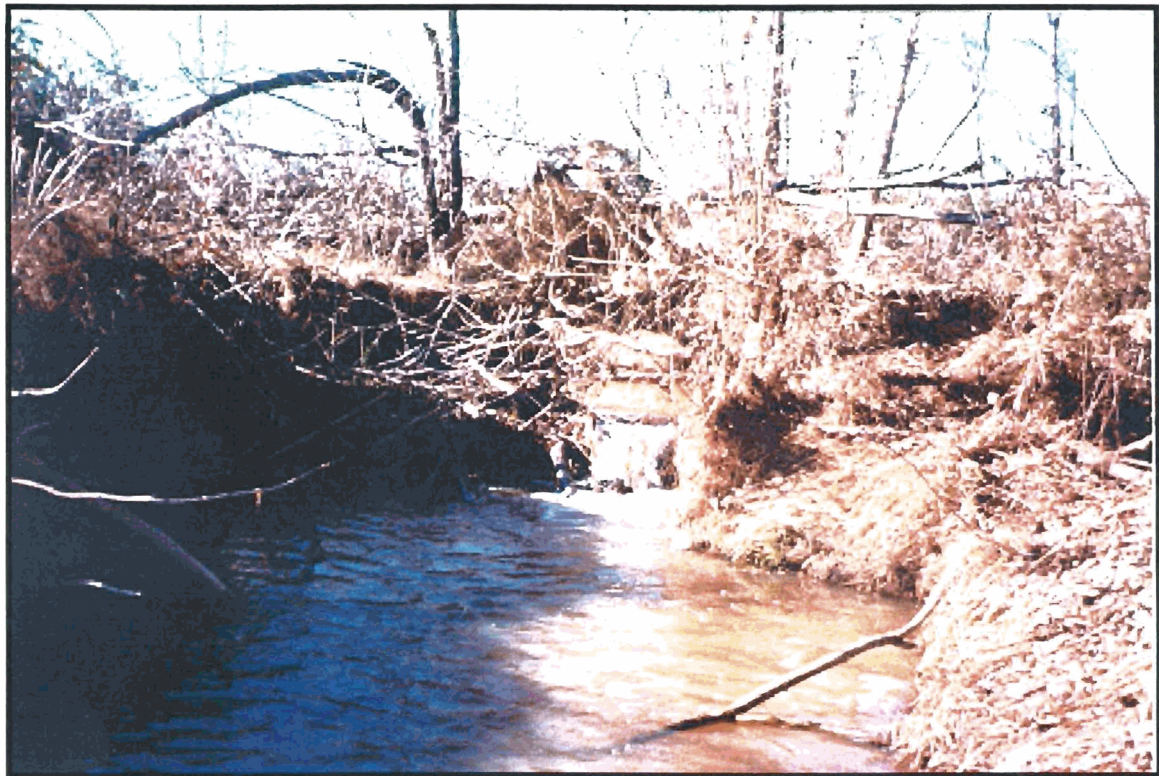
8-Beaver dam 3
