ANNUAL REPORT FOR 2003

Speight Branch Mitigation Site
Wake County
Project No. 8.1402601
TIP No. R-2541 WM

Prepared By:
Office of Natural Environment & Roadside Environmental Unit
North Carolina Department of Transportation
December 2003

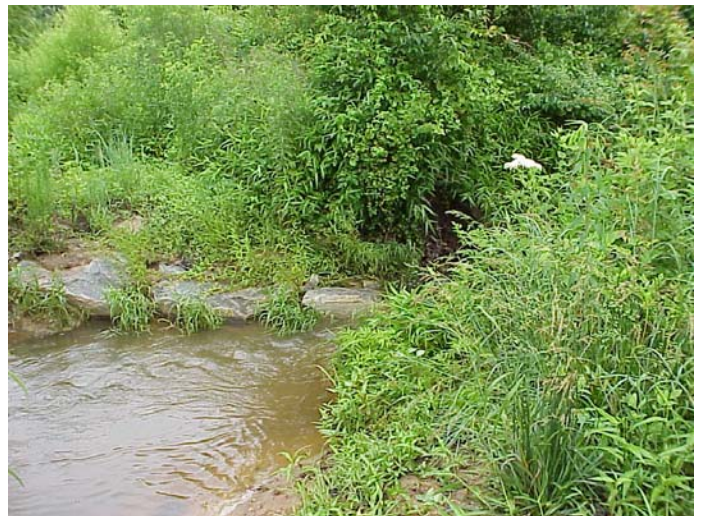
Photo 6 (Stream)

The stream channel was visually inspected during the annual vegetation monitoring on the site. The channel appears to be stable with herbaceous vegetation covering the streambanks throughout the project reach. Photos 6 through 13 show the conditions of the stream. No remedial actions are necessary.
