# STALLINGS STREAM AND WETLAND RESTORATION

## FINAL RESTORATION PLAN

Jones County, North Carolina  
SCO Project Number 050647101

Status of Plan: Revised Final - Version 2  
Submission Date: May 30, 2007

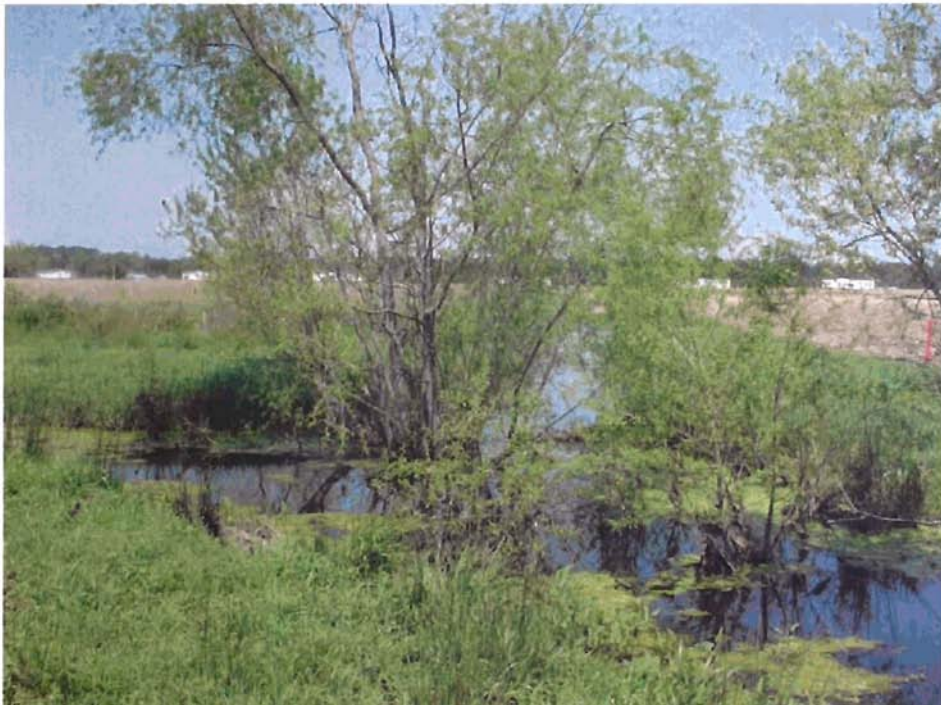
**Reach B, facing downstream  
Note: Reach A runs horizontally in the background.**

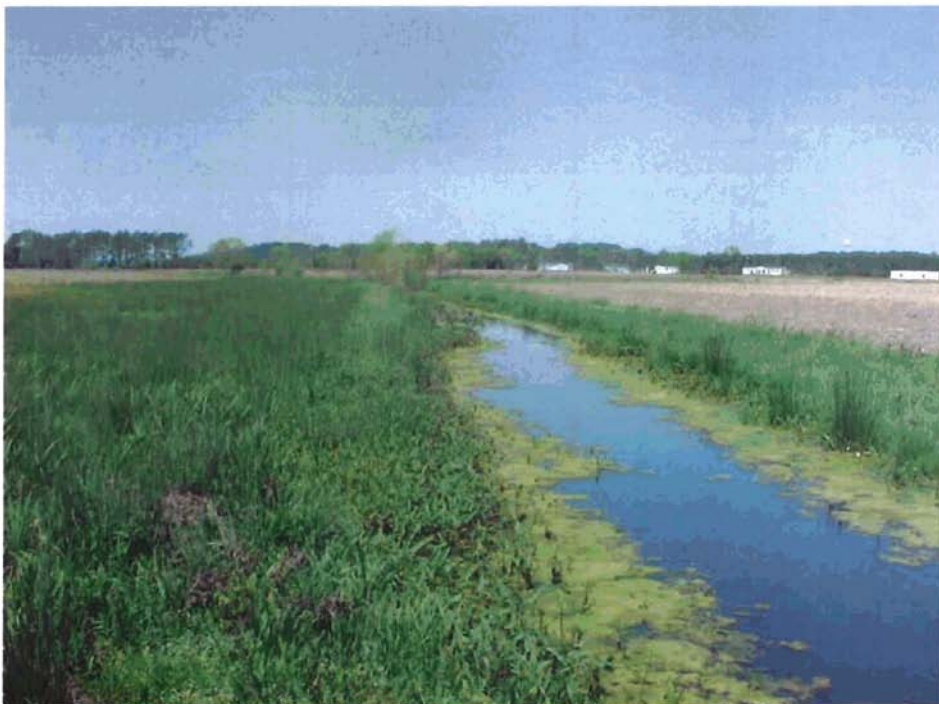
**Confluence of Reaches A (left) and B (right),  
Forming the lower end of Reach A (right foreground), facing upstream**

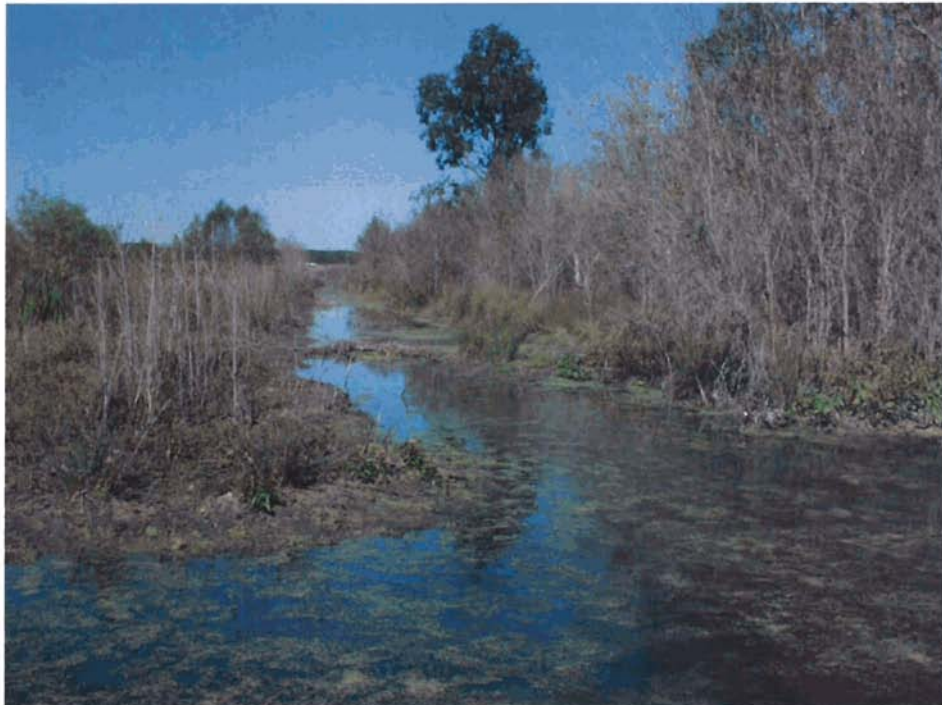
**Lower end of Reach A, facing upstream  
Note: Reaches B and A confluence is at the willow trees in the background.**

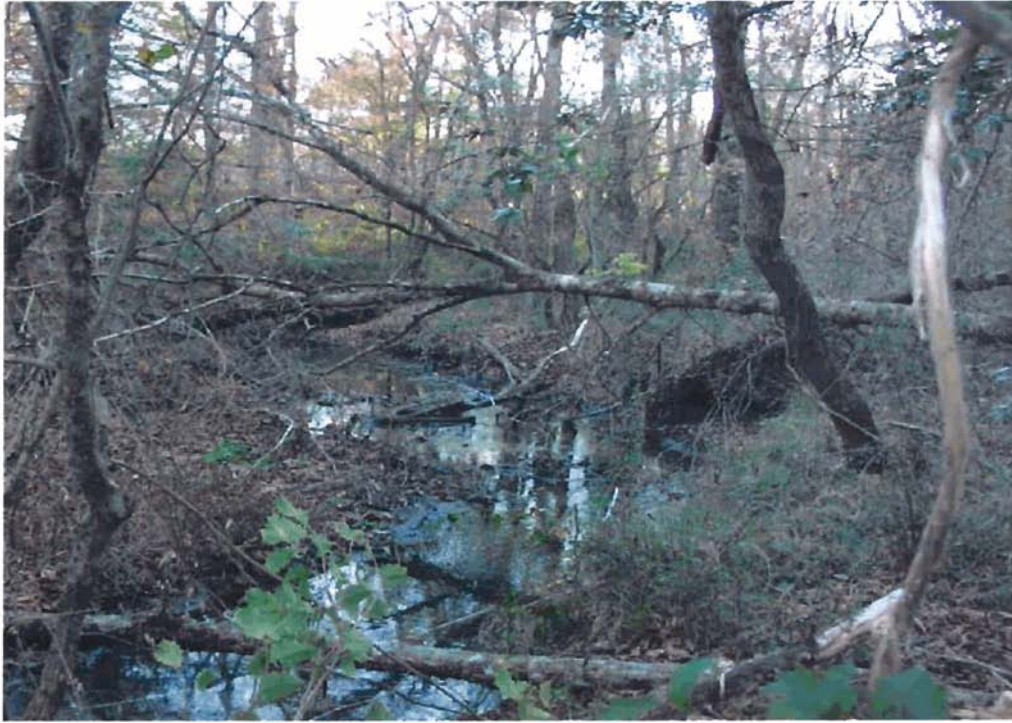
**Beaverdam Branch riffle cross-section facing downstream**

The Beaverdam Branch reference reach is characterized as a C5 stream type. The reach is transporting its sediment supply without aggrading or degrading while maintaining its dimension, pattern and profile. Bankfull width of the reach is approximately 20.3 feet and bankfull depth is approximately 1.1 feet. The reach used for the survey was 301 feet in length. The survey included a longitudinal profile, cross sections, bed material evaluation, buffer characterization, and system stability evaluation.

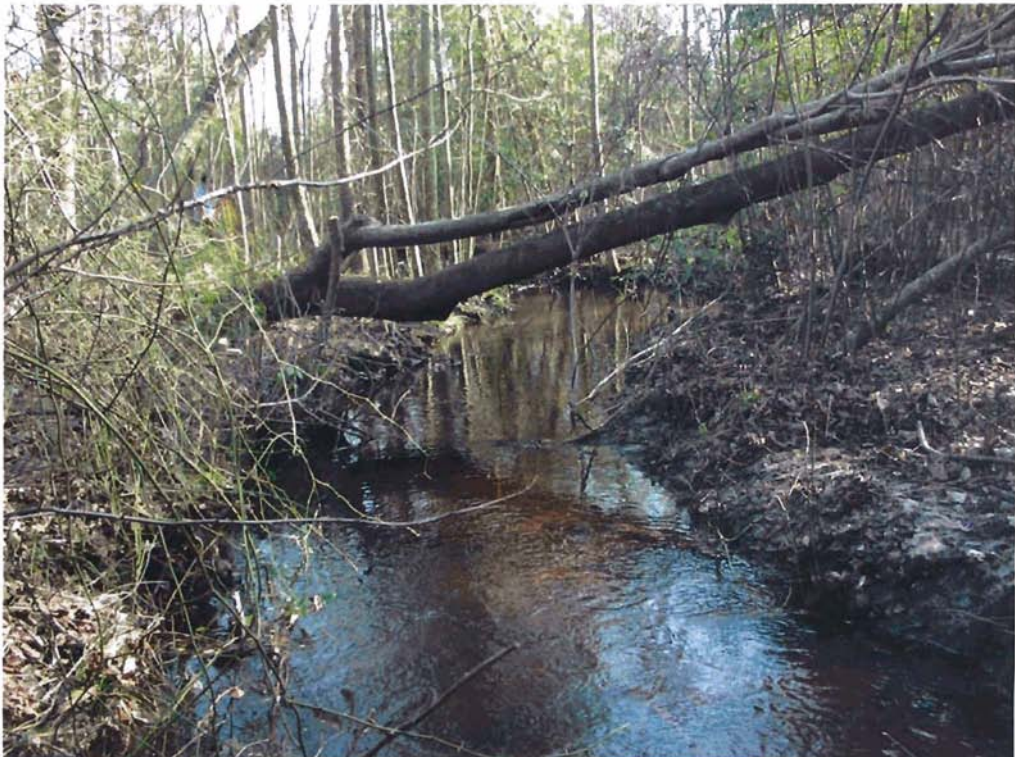
**Beaverdam Branch meander and point bar**

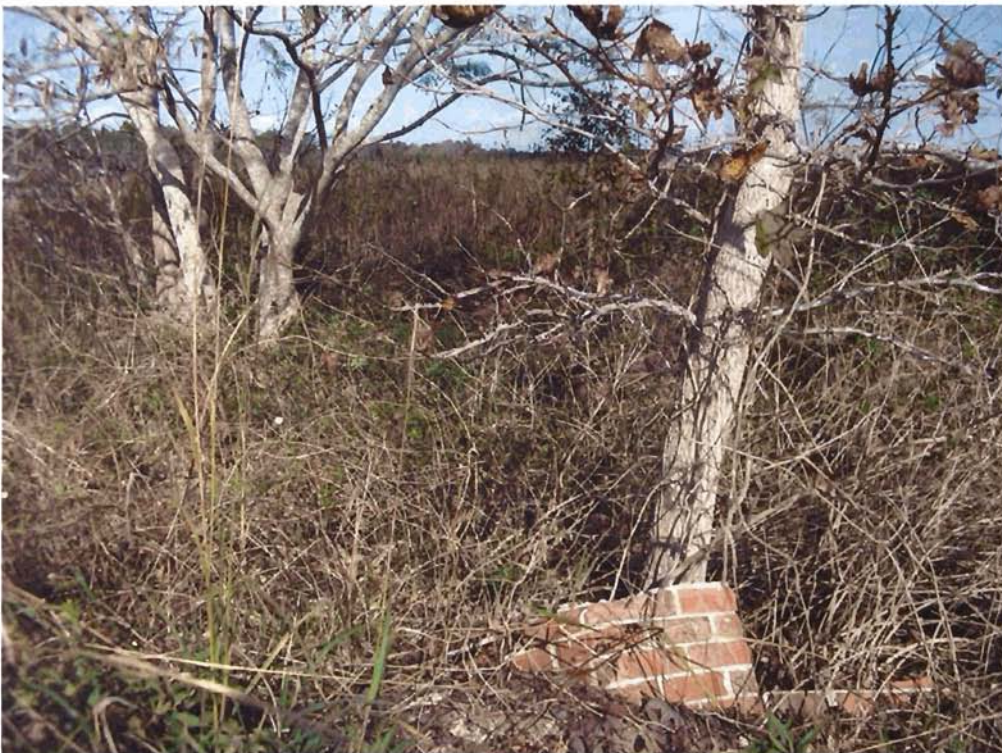
Photo 2: Foundation extends from tree in foreground to tree in background

The Stallings Restoration Site consists of former agricultural fields with no apparent historical or cultural significance. There is a brick foundation, approximately 25 by 40 feet, along Wyse Fork Road near Copeland Farm Road. The foundation is overgrown with vegetation. A letter was sent to the State Historic Preservation Office (SHPO) on November 18, 2005 requesting comments on the project study area and specifically the foundation on the site. A response was received on January 4, 2006 that requested an investigation of the Stallings site because of its proximity to the Civil War Battle of Kinston. An archaeological survey was completed by another firm in mid-2006 and submitted to SHPO for review. As a result of the survey report, SHPO concluded that 'the proposed project would not adversely impact any significant cultural resources' (Appendix 13).

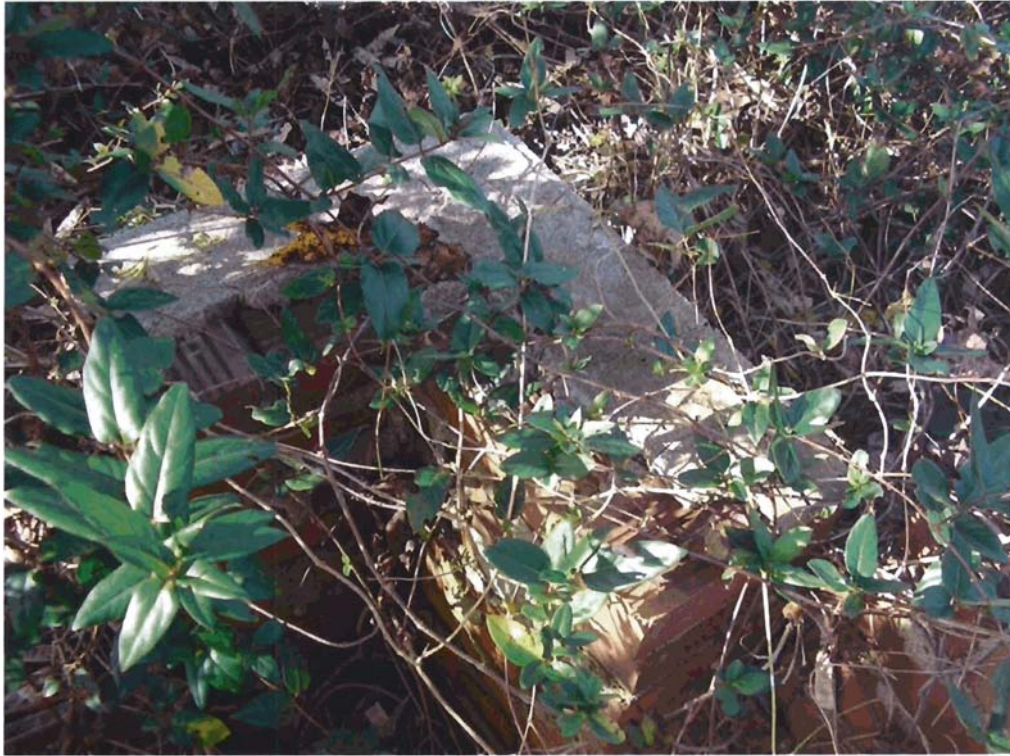
Photo 3: Close up of brick foundation
