**STALLINGS BUFFER RESTORATION SITE -- DMS #357**  
**Jones County NC -- Neuse River HUC# 03020204-010050**  
**MY-1 Annual Monitoring Report (Draft)**

**North Carolina Department of Environment & Natural Resources**  
**Division of Mitigation Services (DENR-DMS) -- Contract # 5765**

**Data Collected: September 2014**

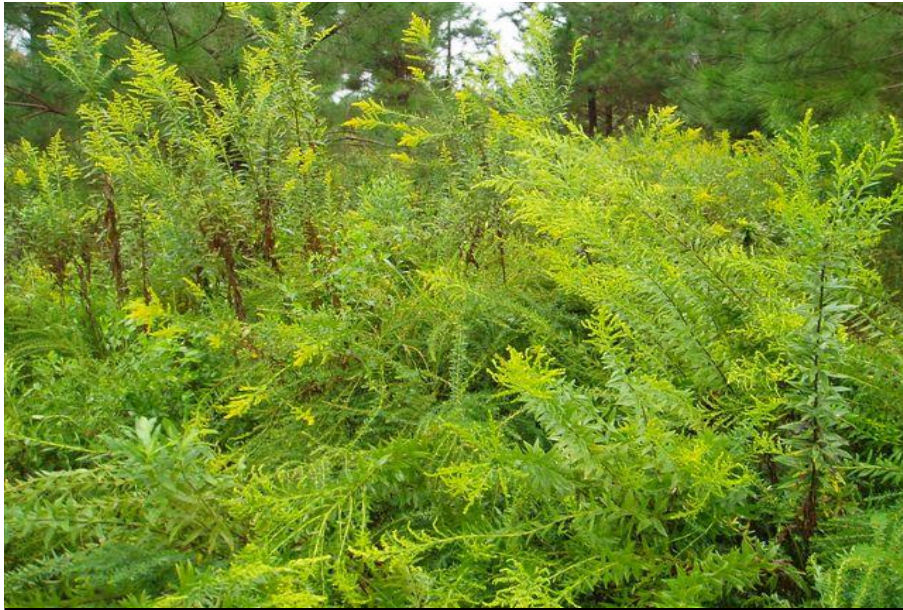
Dense *Lespedeza cuneata* & *Solidago* near CVS plot 9

Scattered patches of invasive *Ligustrum sinense*, *Rosa multiflora*, *Lonicera japonica*, and *Lespedeza cuneata* were noted in many areas, especially near ditch banks and other unmowed areas. Three patches of *Lespedeza*, each 0.2 to 0.3 acre, are mapped on the eastern portion of the site. Other smaller patches will be re-evaluated in MY2 and mapped if they appear to be spreading and/or impeding growth of tree seedlings.

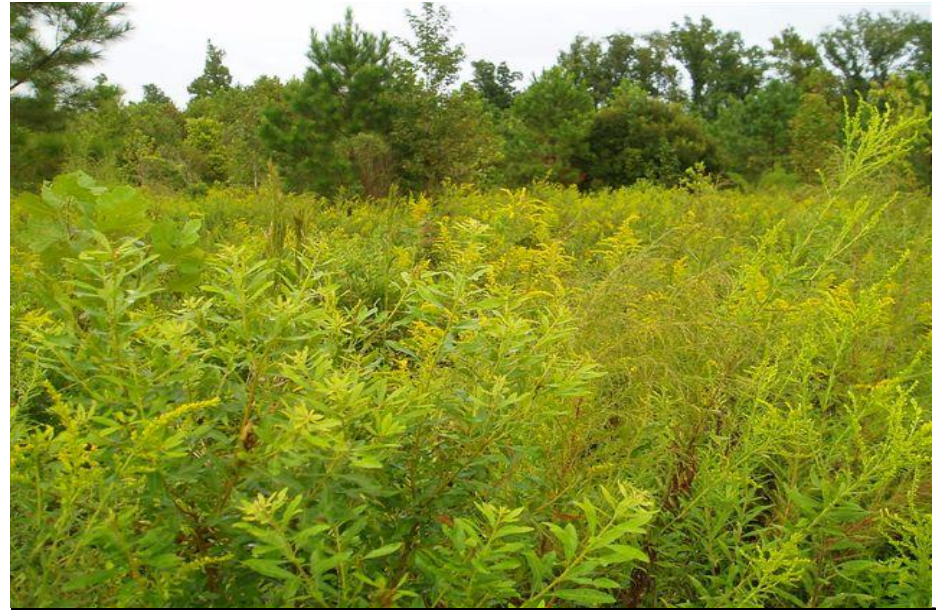
Typical herb-dominated temp warranty plot (temp plot #10)

The 25 temporary warranty plots (10 m x 10 m) yielded lower stem counts, as trees in these plots were not flagged in March soon after mowing and planting as those in the CVS plots were. Only two warranty plots had more than 5 planted stems found. As stated above, it is likely that many planted stems were overlooked due to their small size and sparse leaves among dense shrubs and herbs. MY-2 sampling may yield higher counts if the planted stems put on more growth during 2015. Supplemental planting was conducted in February 2015 by the planting contractor; planting data will be included in the MY-2 (2015) reports.

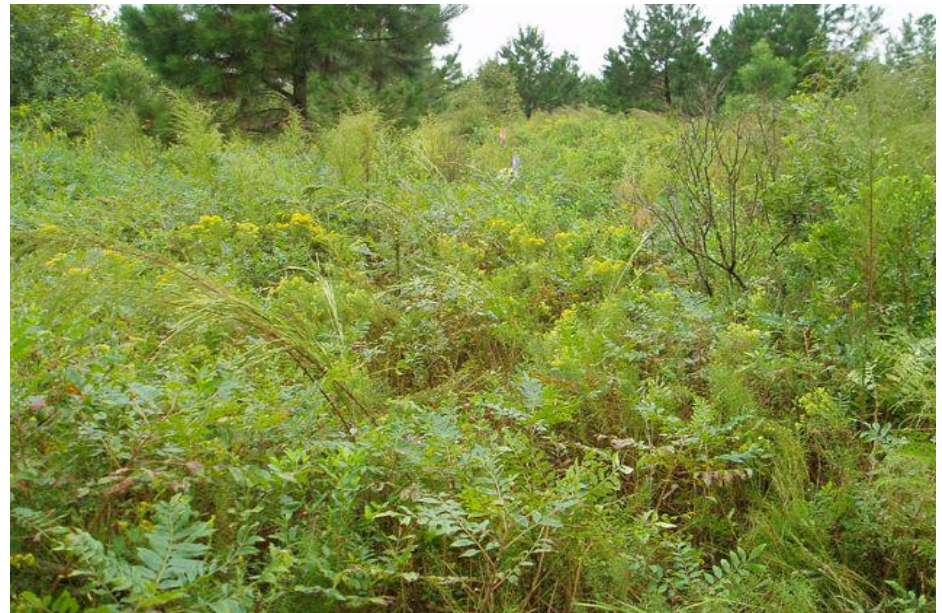
Typical shrub-dominated temp warranty plot (temp plot #8)
