STALLINGS BUFFER RESTORATION SITE -- DMS #357
Jones County NC -- Neuse River HUC# 03020204-010050

MY-3 (2016) ANNUAL MONITORING REPORT (Draft)

North Carolina Department of Environmental Quality
Division of Mitigation Services (DEQ-DMS) -- Contract # 5765

Data Collected: November 2016

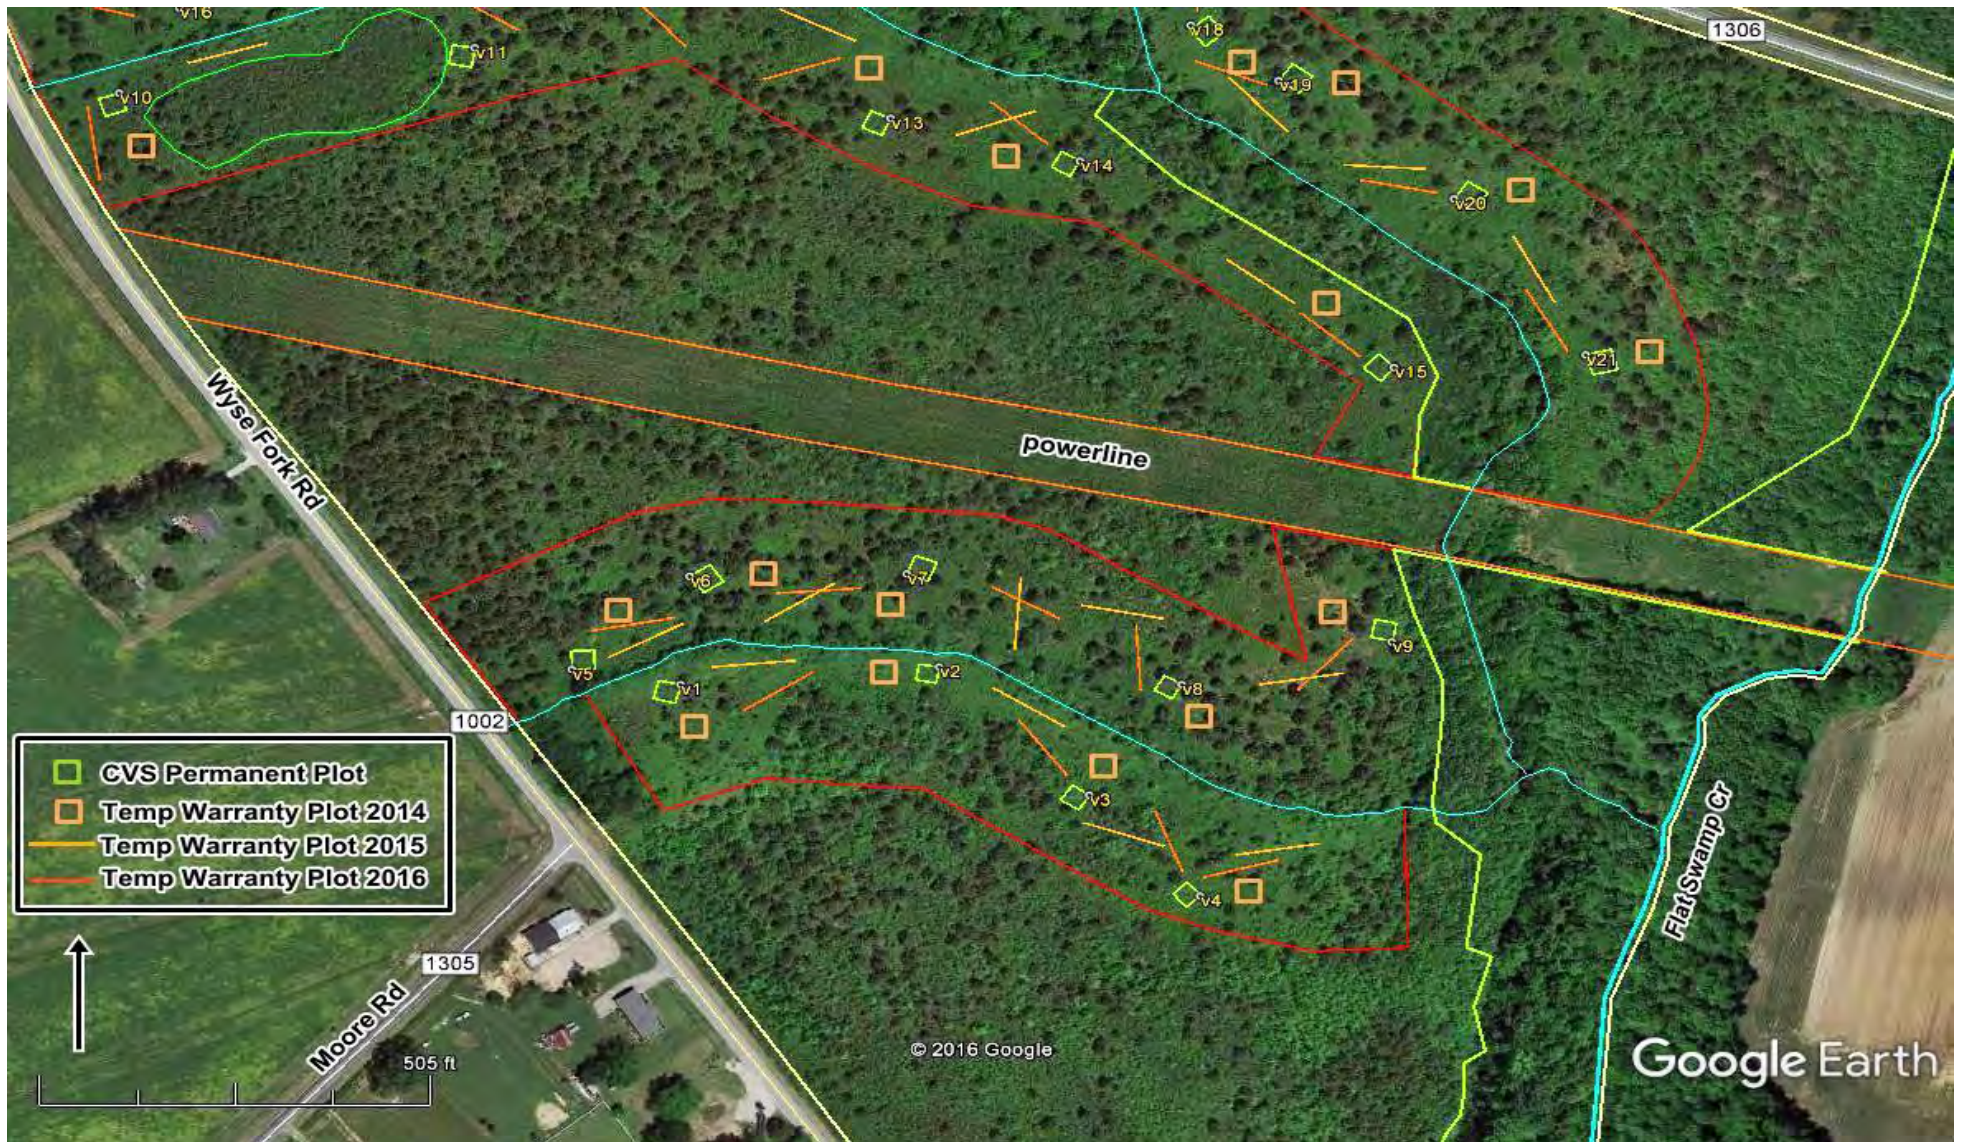
Stallings Site #357: Southern Half, CVS Vegetation Plots 1 through 9. Warranty Plot numbers correspond to their adjacent CVS Plot.

The 25 temporary warranty plots (107.6 x 10 ft = 100 m²) yielded a range of 1 to 10 trees (planted species) and average of 4.3 trees per plot in 2016, or 175 trees per acre (Table 8). Only two warranty plots exceeded 320 planted trees per acre. It remains difficult, as noted in the 2014 and 2015 reports, to locate un-flagged planted trees especially small-leaved species, among the dense tangle of shrubs, vines, and herbs.
