**STALLINGS BUFFER RESTORATION SITE -- DMS #357
Jones County NC -- Neuse River HUC# 03020204-010050**

MY-5 (2018) ANNUAL MONITORING REPORT

**North Carolina Department of Environmental Quality
Division of Mitigation Services (DEQ-DMS) -- Contract # 5765
NC Division of Water Resources Project # 2006-0413**

Data Collected: October 2018

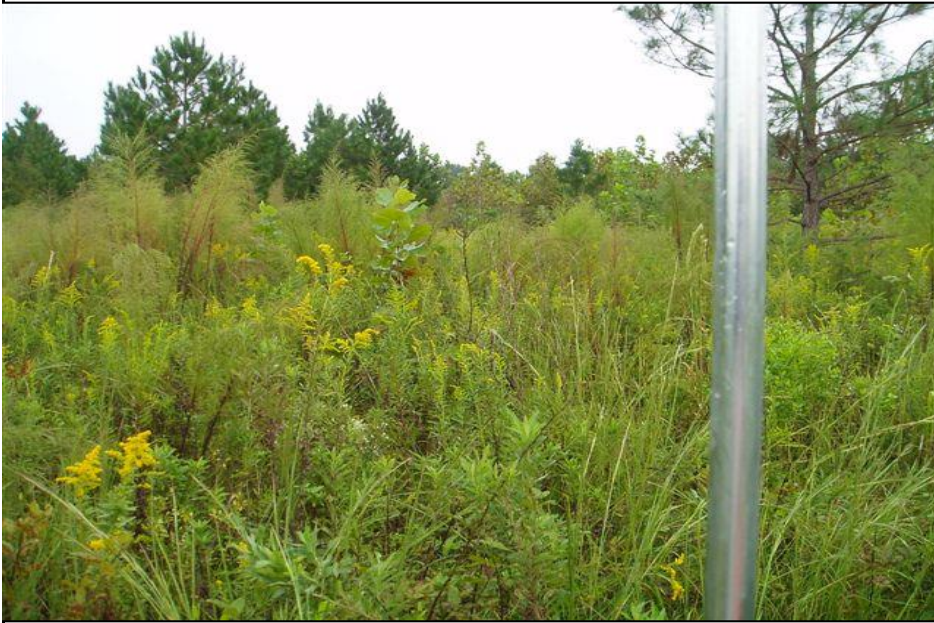
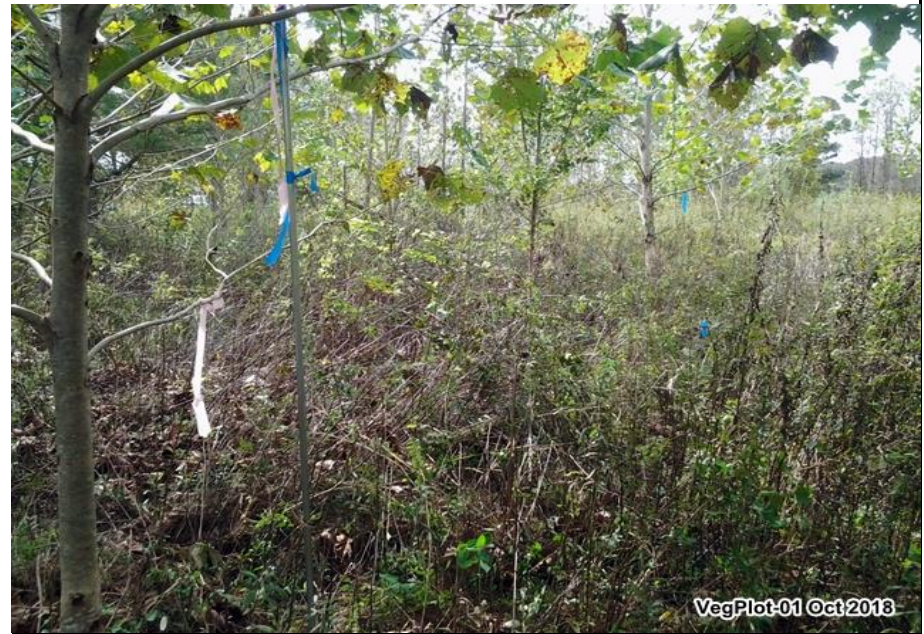
CVS VegPlot-1: MY-1 Sep 23-25, 2014

CVS VegPlot-1: MY-5 Oct 23-25, 2018

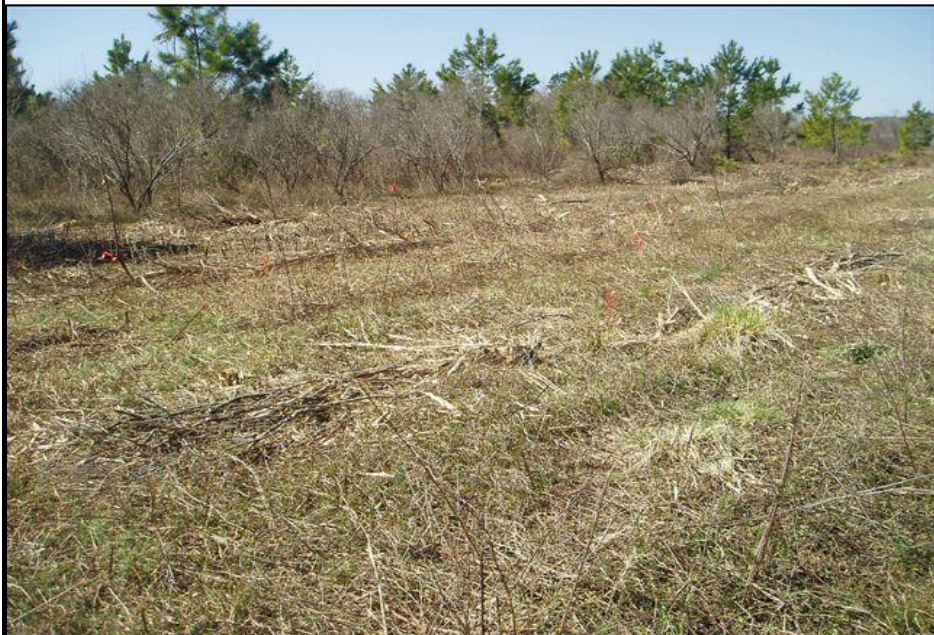
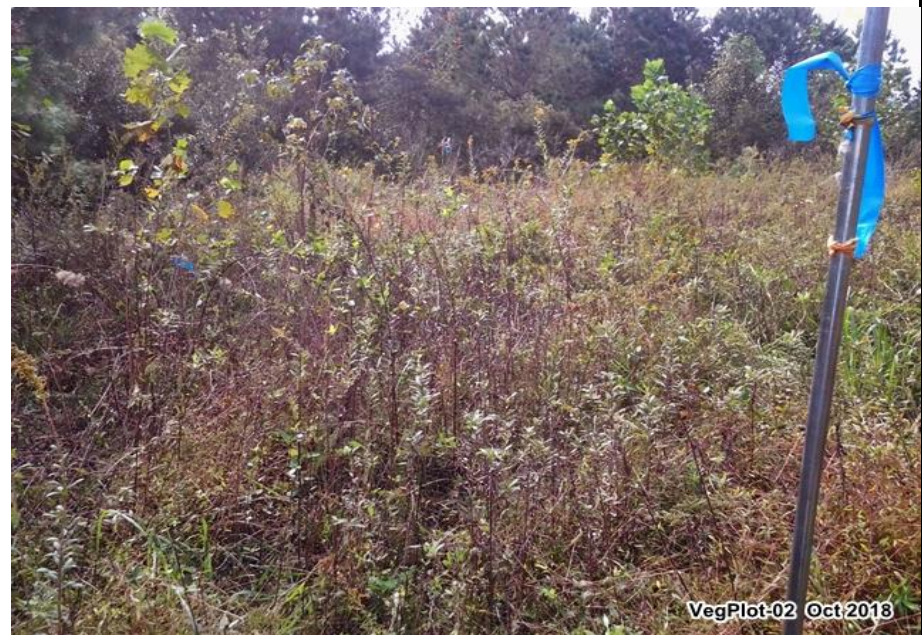
CVS VegPlot-2: MY-0 Mar 11-12, 2014

CVS VegPlot-2: MY-5 Oct 23-25, 2018

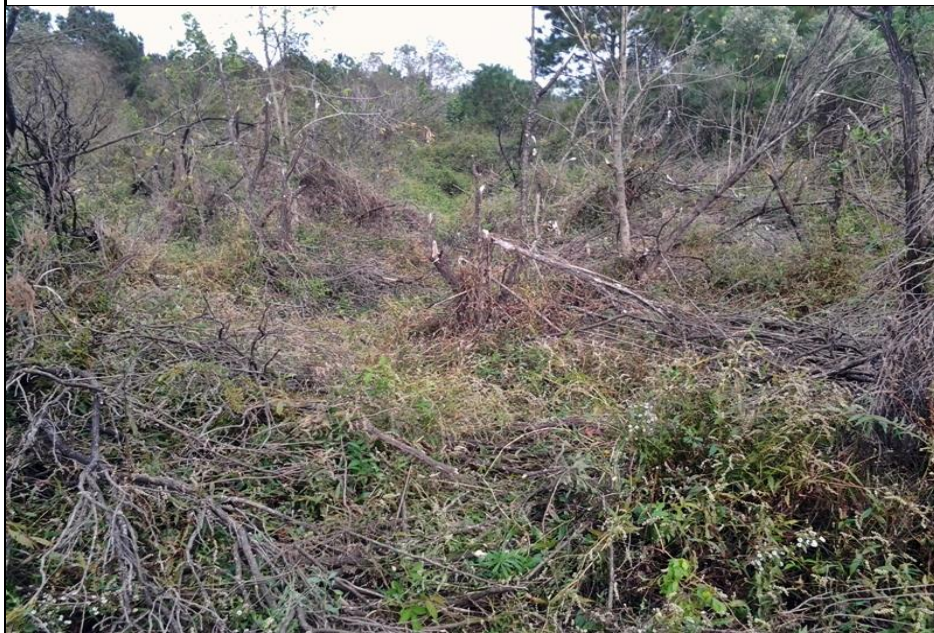
Baccharis thicket W of VP-11 after hurricane. MY-5 Oct 25, 2018

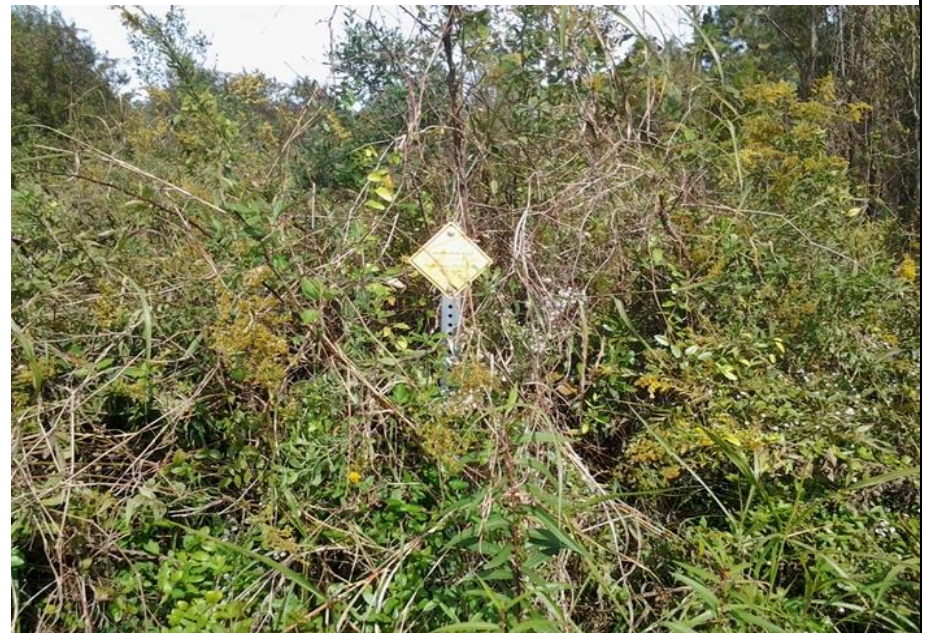
Conservation signpost along Webb Farm Rd. MY-5 Oct 25, 2018

No recent encroachment or damage from vehicles, livestock, or people was observed, other than the paths cut by Carolina Silvics for supplemental planting in fall 2017. “Conservation Area” signs posted along roadsides are intact, although some are obscured from view by shrubs and vine growth. There is no fencing around the Stallings project site.

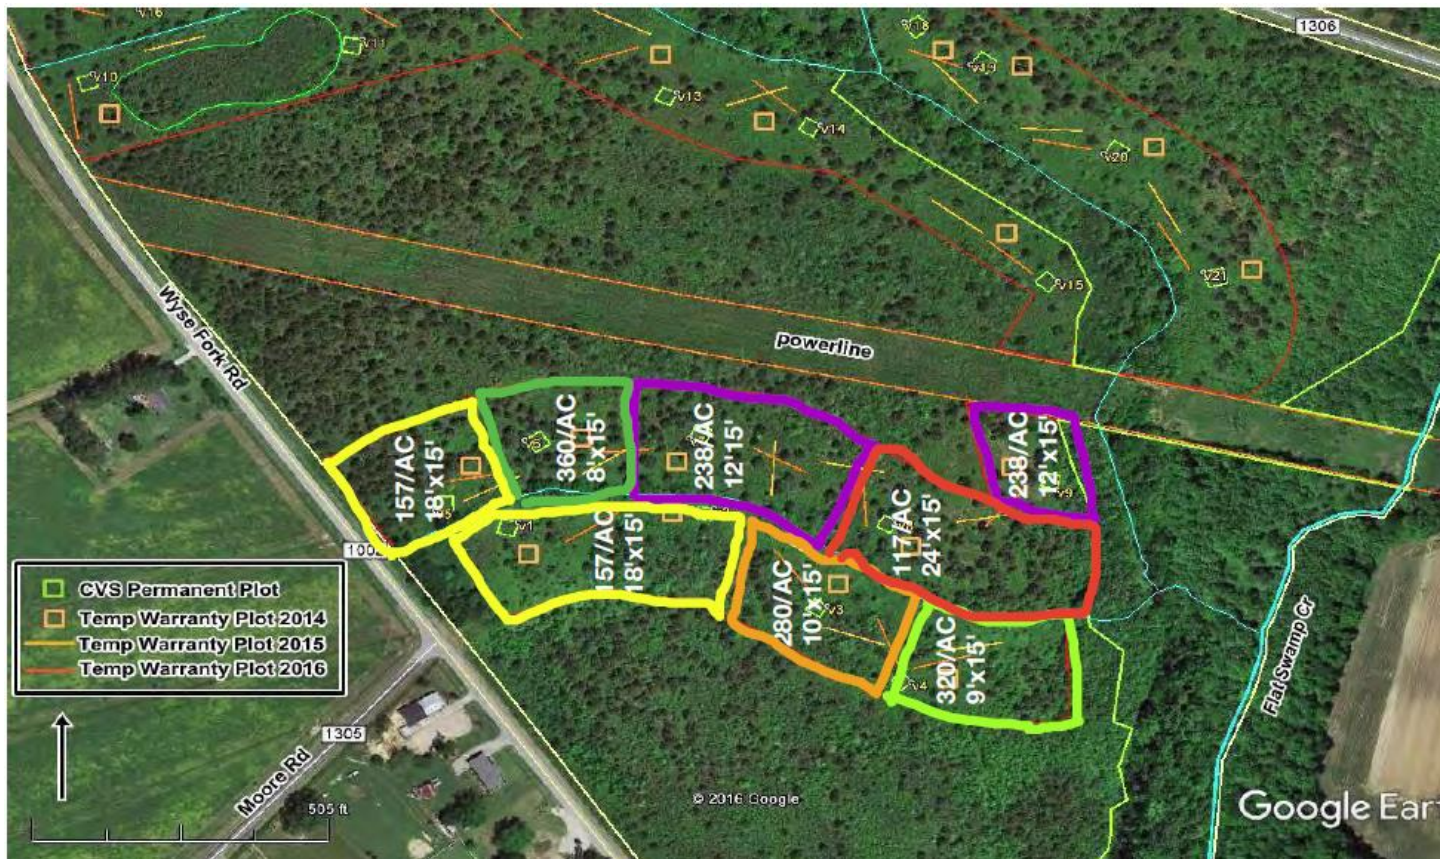
Supplemental Planting Maps from Carolina Silvics -- February 2018 -- Stallings Site #357 -- Southern Half

The yellow lines depict the orientation of the transects to the stream. These are not accurately spaced apart on the map; they just show the general direction.

Areas with low planted tree density reported in 2014 received supplemental planting in February 2015 by Carolina Silvics, the original planting contractor. Approximately 3,800 bare-root seedlings of *Liriodendron*, *Platanus*, *Nyssa*, *Quercus*, and *Fraxinus* were planted on 20 acres, at densities of 109 to 242 trees per acre based on the 2014 CVS plot and warranty plot data (Appendix C, Figure 5). A second supplemental planting (6,000 new stems) was done in February 2018, also by Carolina Silvics. Planting transects were cut with gas-powered brush-cutters in October 2017 (during MY4 data collection) and some of the monitored trees in CVS plots were cut or crushed under the debris. These losses were offset in 2018 by the new planted trees and by increased light exposure for some of the previously planted seedlings that had remained small, shaded under the dense shrub cover.
