Baseline Monitoring Report FINAL

Stanley's Slough Stream and Wetland Restoration Site

Stanley's II Wetland Restoration Site

Northampton County, North Carolina

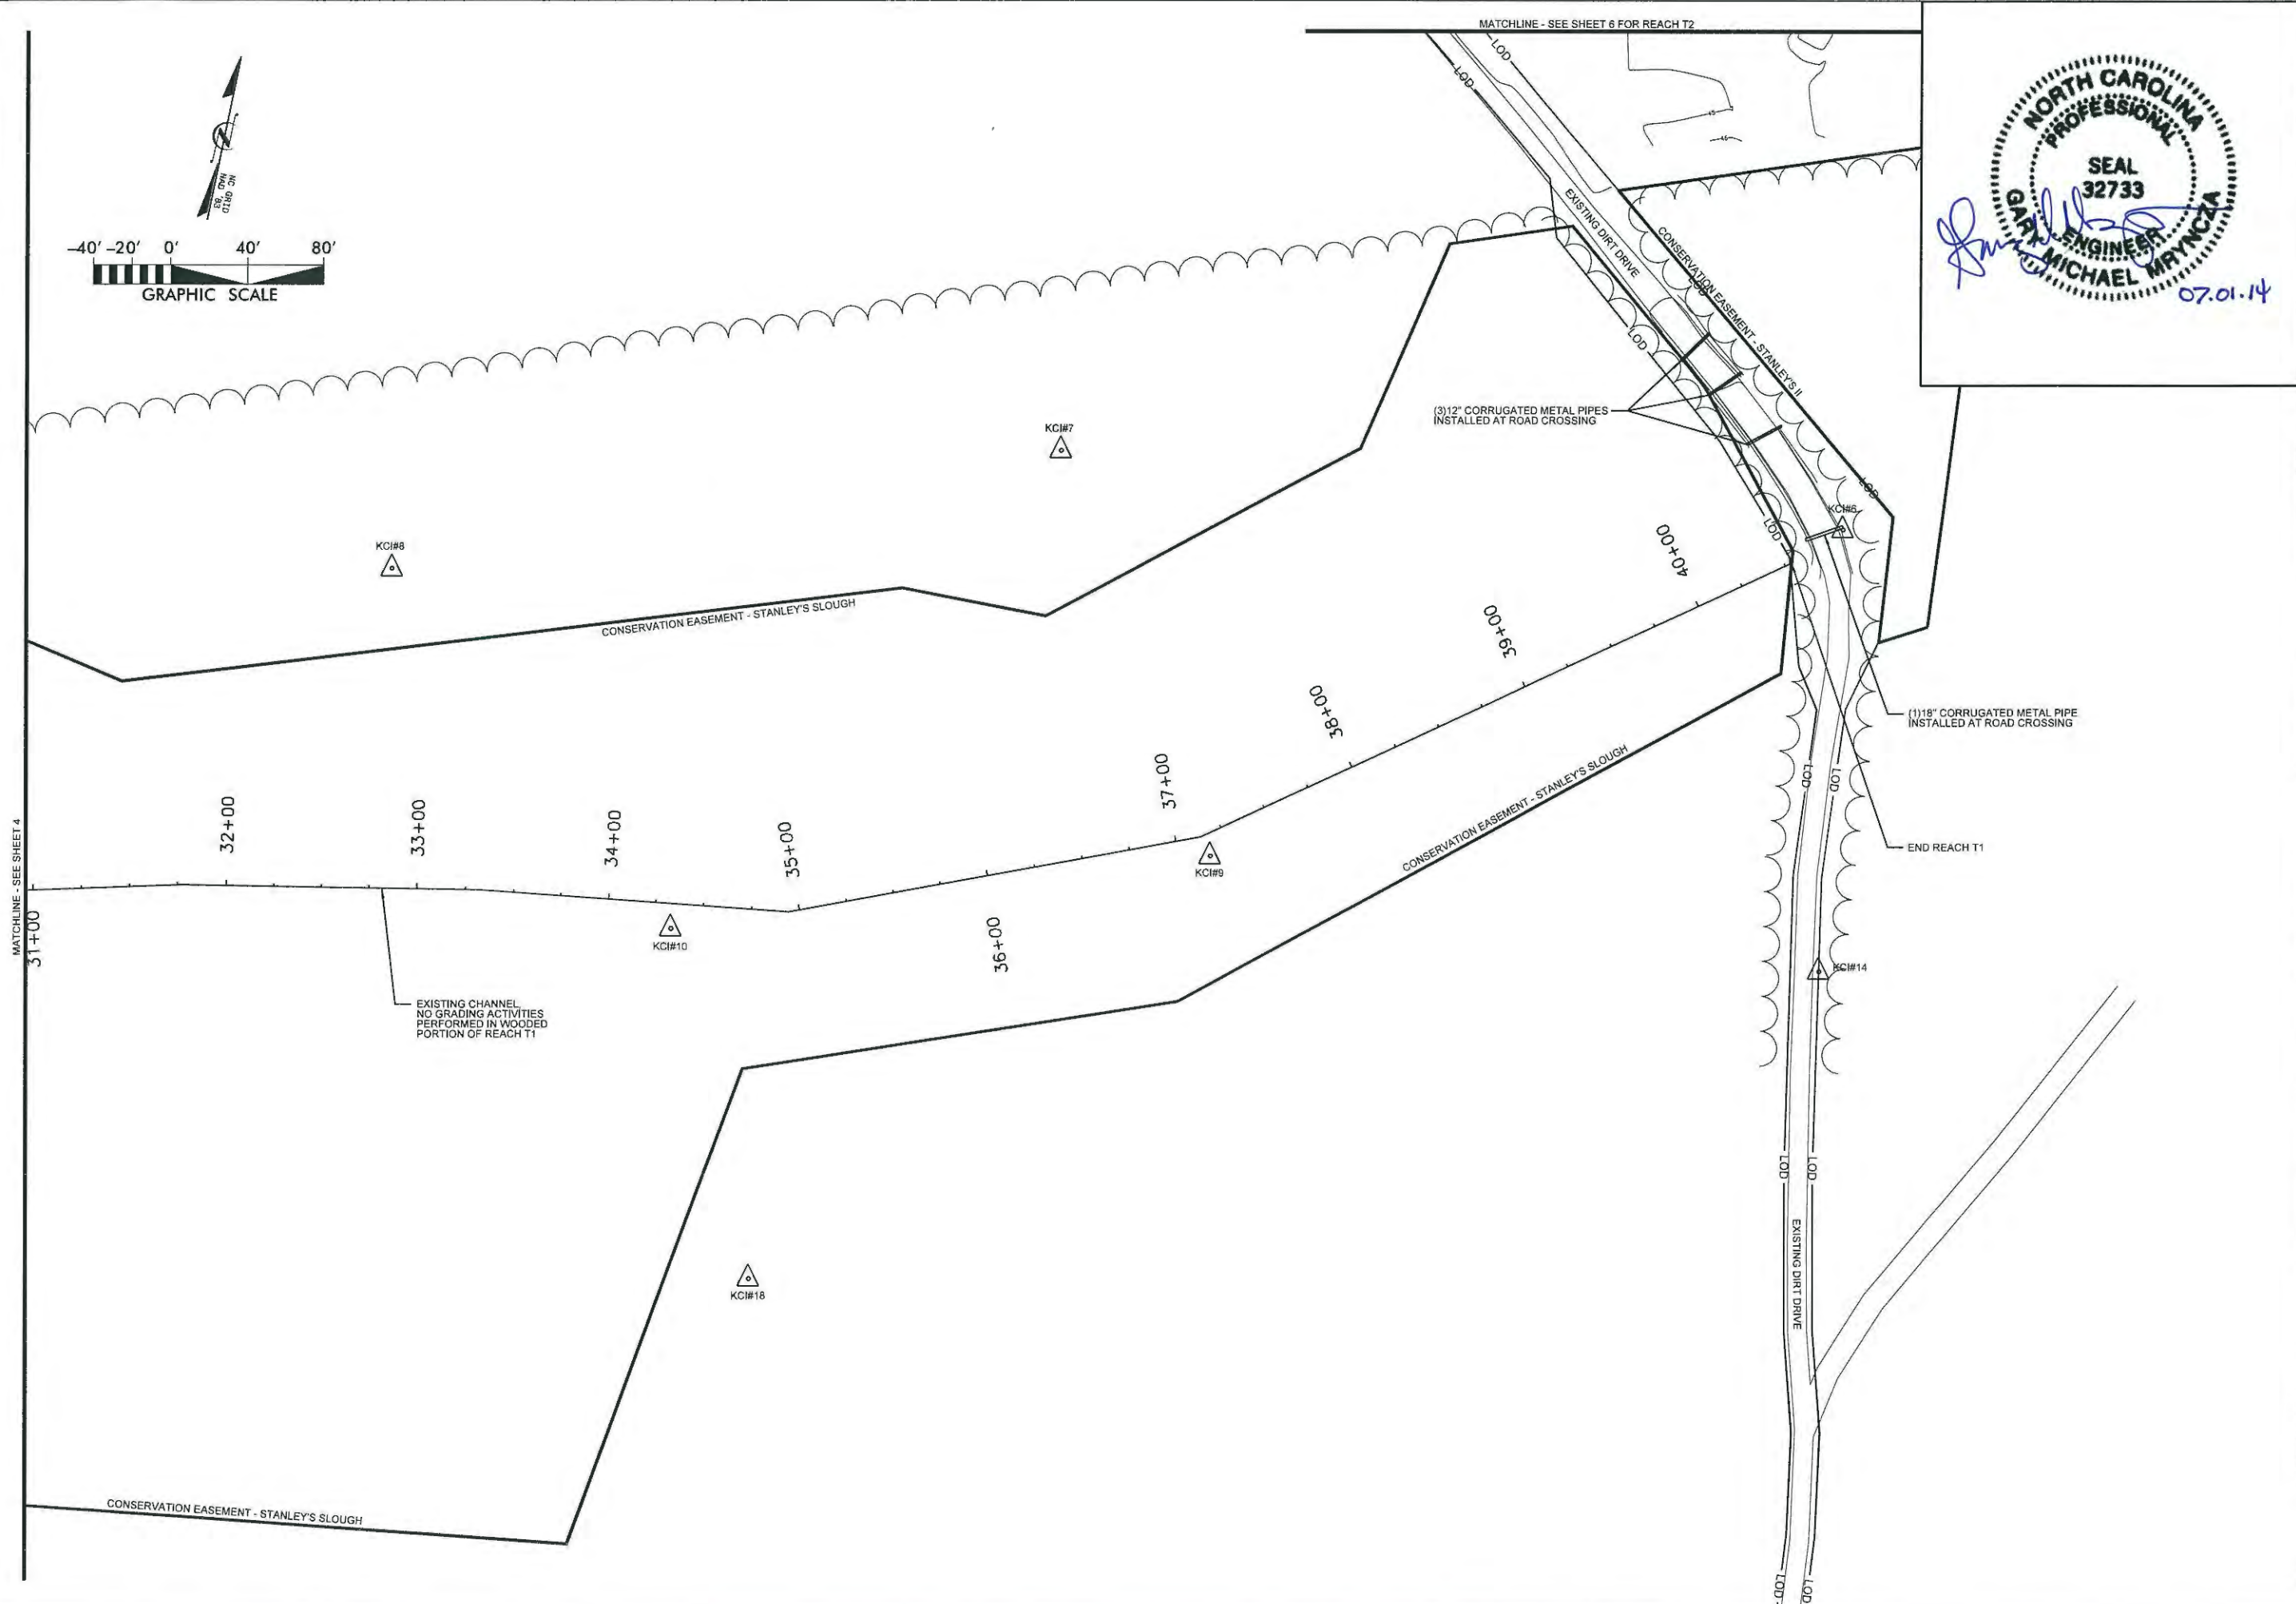
DATE: JULY 2014
SCALE: GRAPHIC
AS-BUILT
SITE PLAN
SHEET 5 OF 7

STANLEY'S SLOUGH / STANLEY'S II
RESTORATION SITES
NORTHAMPTON COUNTY, NORTH CAROLINA
REACH T1

Baseline monitoring data were collected in April/May 2014. Any changes made to the design during construction are shown on the As-Built Site Plan in Appendix D. Both SSS and SII were constructed as designed with only two modifications made to the design plan during construction. A shallow swale was installed on T1 near Station 15+25, and T1 was extended approximately 50 linear feet to connect to the relic forested headwater stream/wetland complex near Station 28+30.
