Monitoring Report

Stanley's Slough Stream and Wetland Restoration Site

Stanley's II Wetland Restoration Site

Monitoring Year 04

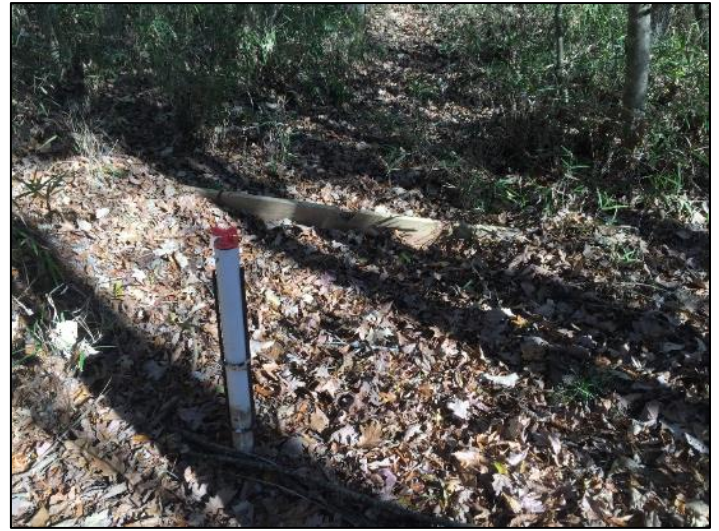
In the headwater stream, six automatic recording gauges were installed to document the presence of surface water within the restored channel. Weirs were constructed just downstream of three (Gauges 2, 3 and Gauge 18) of these gauges to provide a known elevation at which the stream could be considered flowing. Using these elevations as the basis for flow, all three gauges achieved at least 30 consecutive

days of flow. Gauges 2 and 3 (on T1) averaged 122 consecutive days of flow between them and Gauge 18 (on T2) achieved 39 consecutive days of flow. See Appendix D, Photo 2 for an example of these weirs.

Photo 2. Weir at Gauge 3

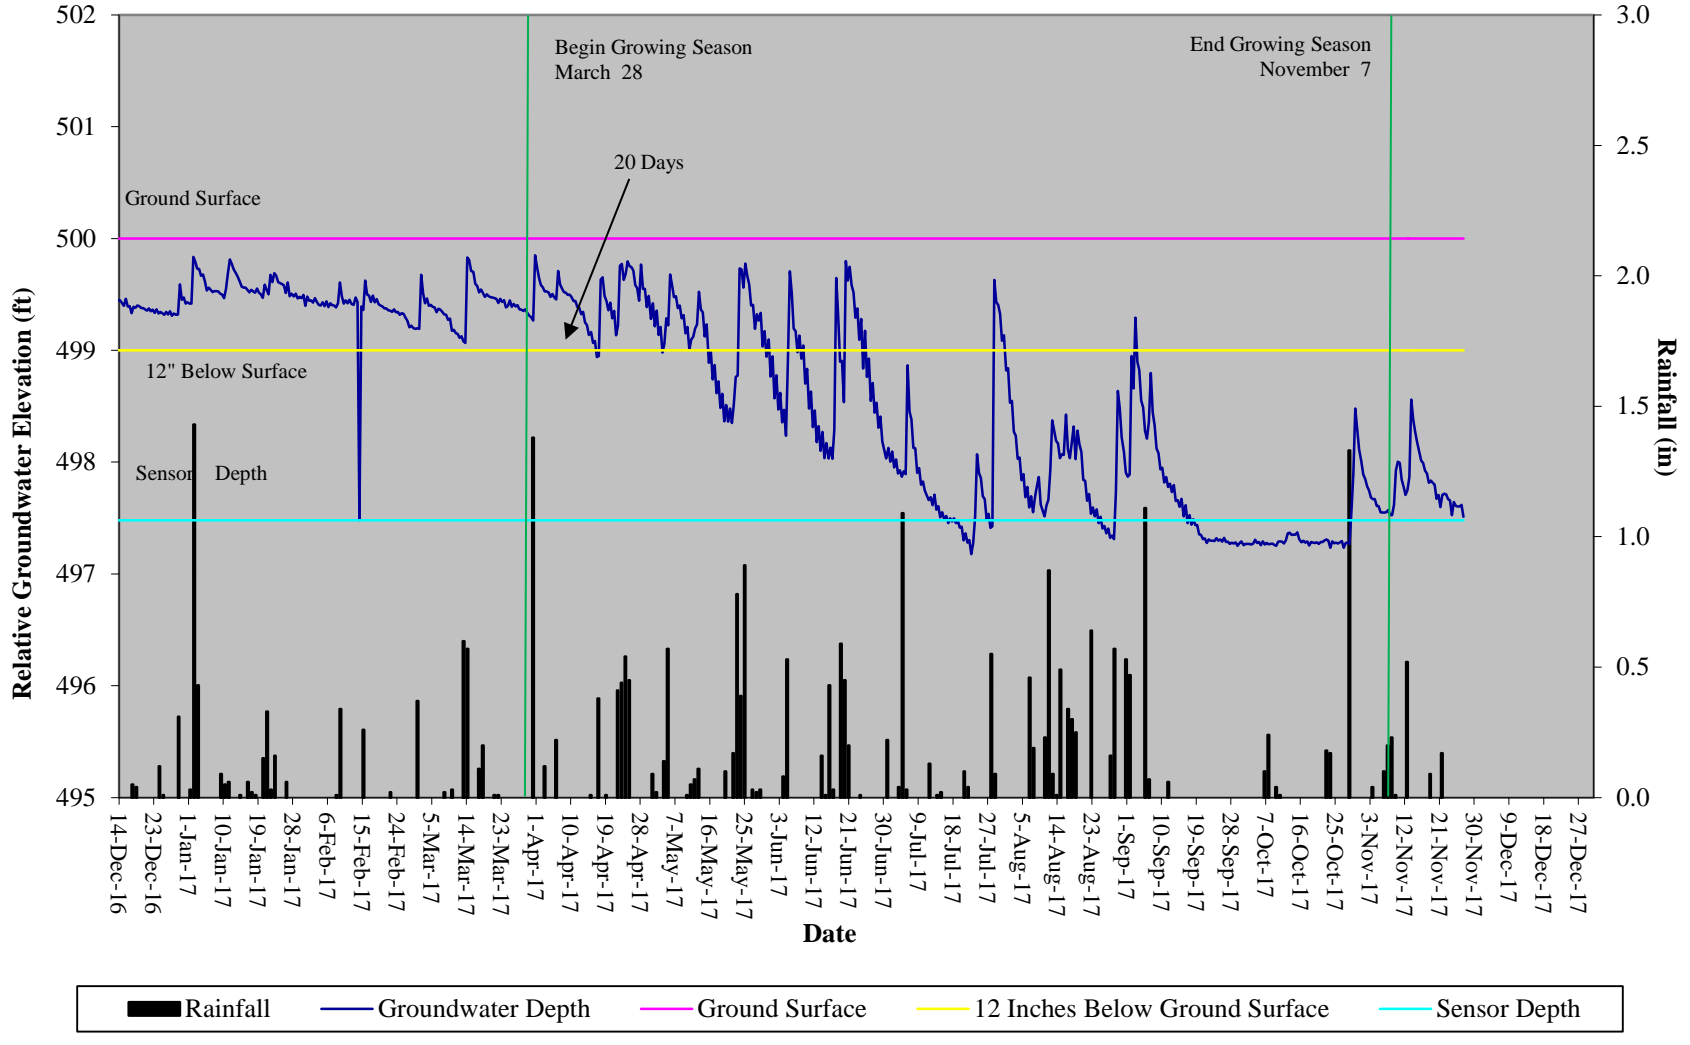
Stanley's Restoration Site Hydrograph Reference Wetland Gauge

- *The reference gauge hydrograph has been added to the report and Table 10 has been updated to include the reference data for all years. This data shows the reference gauge meeting in the previous two years (when data was collected) and not meeting in the current year.*

During the site's fourth growing season, five of the twelve gauges met the success criterion. Gauges 6, 7, 10, 11, 12, 14, and 17 did not meet the success criterion. Collectively the wetland gauges averaged 14.2% (31 days) continuous saturation. The reference gauge, located approximately 900 feet north of T2 also did not achieve the success criteria this year. The low rate of achievement of success criteria across the site is likely due to the very low amount of rain that the site received this year and is not seen as indicative of a problem with the site.
