Monitoring Report

Stanley's Slough Stream and Wetland Restoration Site

Stanley's II Wetland Restoration Site

Monitoring Year 05

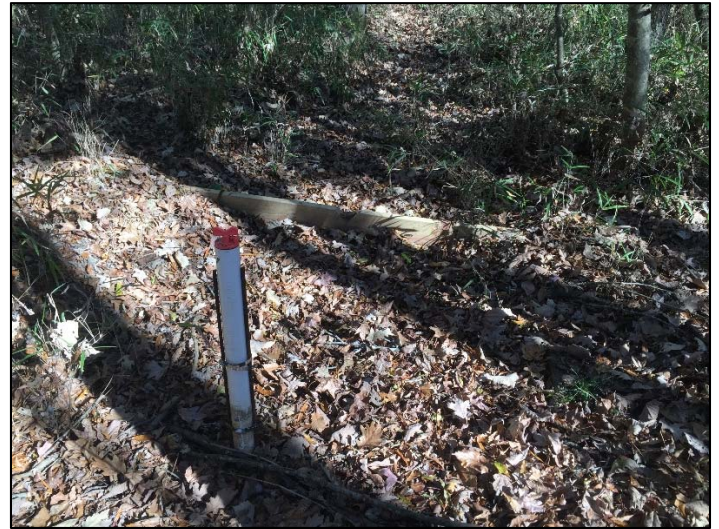
Photo 2. Weir at Gauge 3

In the headwater stream, six automatic recording gauges were installed to document the presence of surface water within the restored channel. Weirs were constructed just downstream of three (Gauges 2, 3 and Gauge 18) of these gauges to provide a known elevation at which the stream could be considered flowing. Using these elevations as the basis for flow, all three gauges achieved at least 30 consecutive days of flow. Gauges 2 and 3 (on T1) averaged 112 consecutive days of flow between them and Gauge 18 (on T2) achieved 41 consecutive days of flow. See Appendix D, Photo 2 for an example of these weirs.

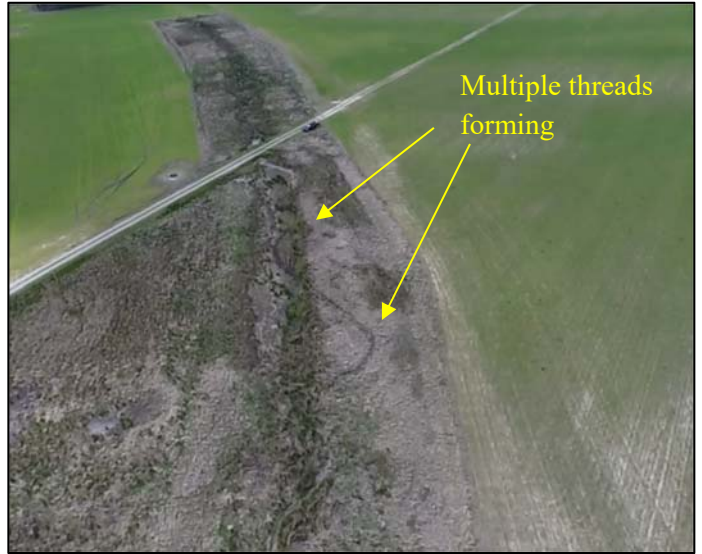
Photo 5. Development of multi thread channel system on T2
