FINAL
Stream and Wetland Mitigation Plan
St. Clair Creek Restoration Project
Beaufort County, North Carolina

EEP Project ID No. 95015

Tar-Pamlico River Basin: 03020104-040040

September 2013

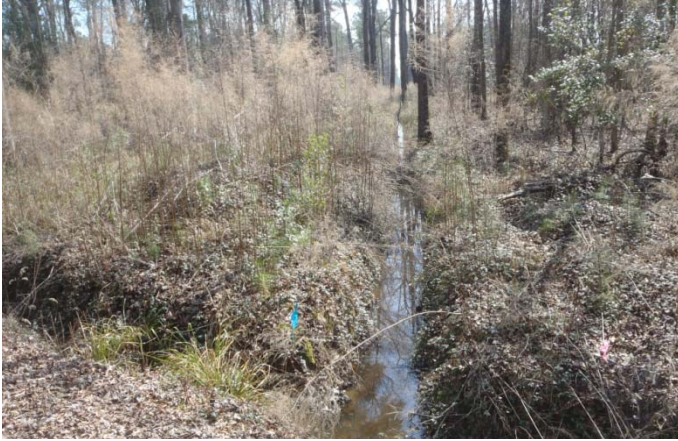
View looking downstream from the proposed beginning of UT3

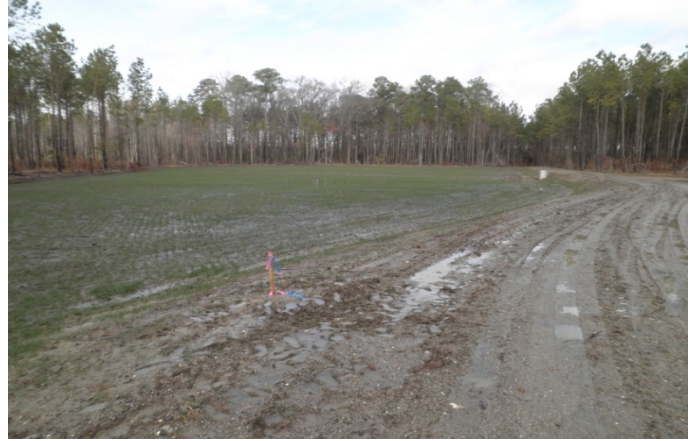
View looking up valley along the existing farm road on UT3 and proposed wetland restoration area along UT3

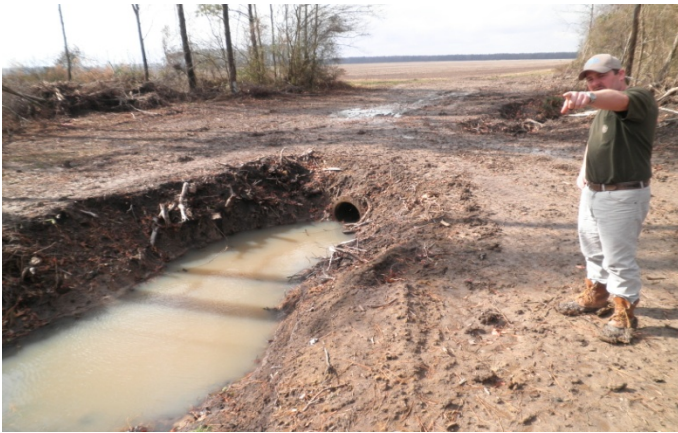
View looking upstream at the proposed beginning of UT2

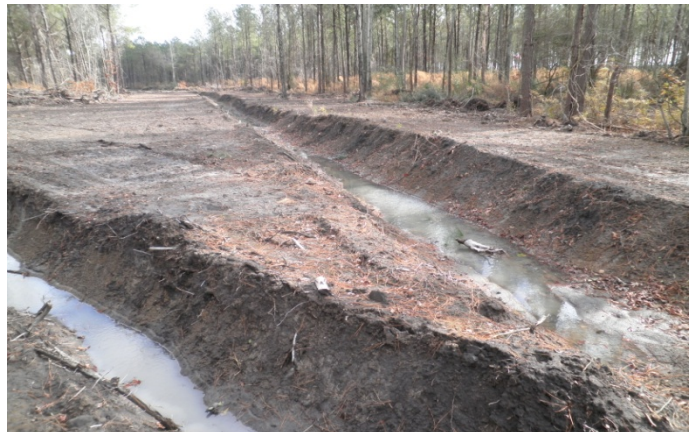
View looking downstream along existing ditches at the proposed beginning of UT2

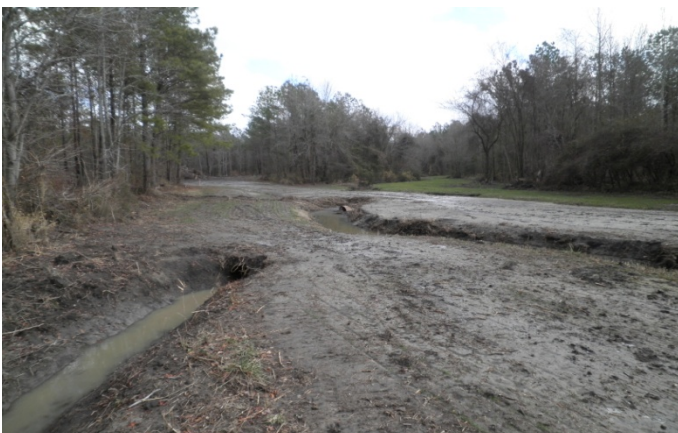
View looking downstream at the existing culverts at the proposed end of UT2

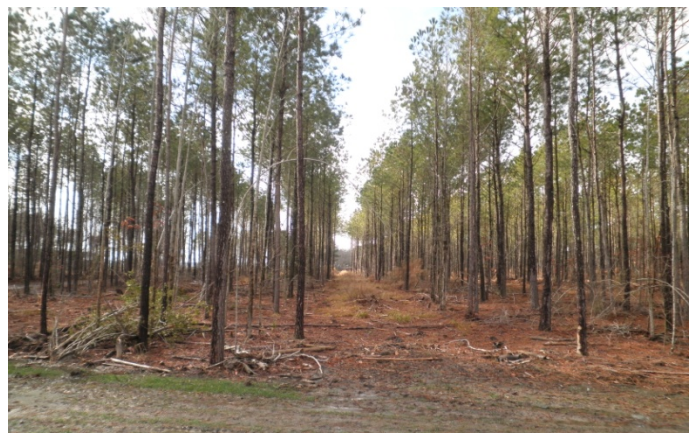
Existing planted pine timber throughout project site

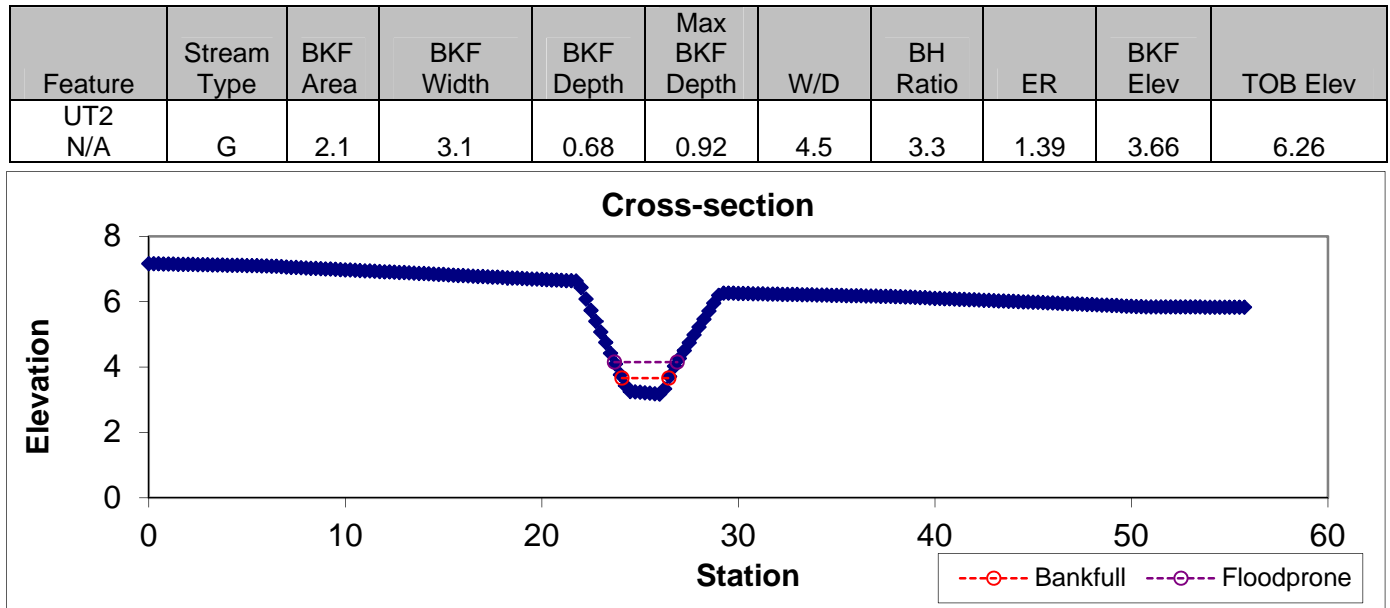
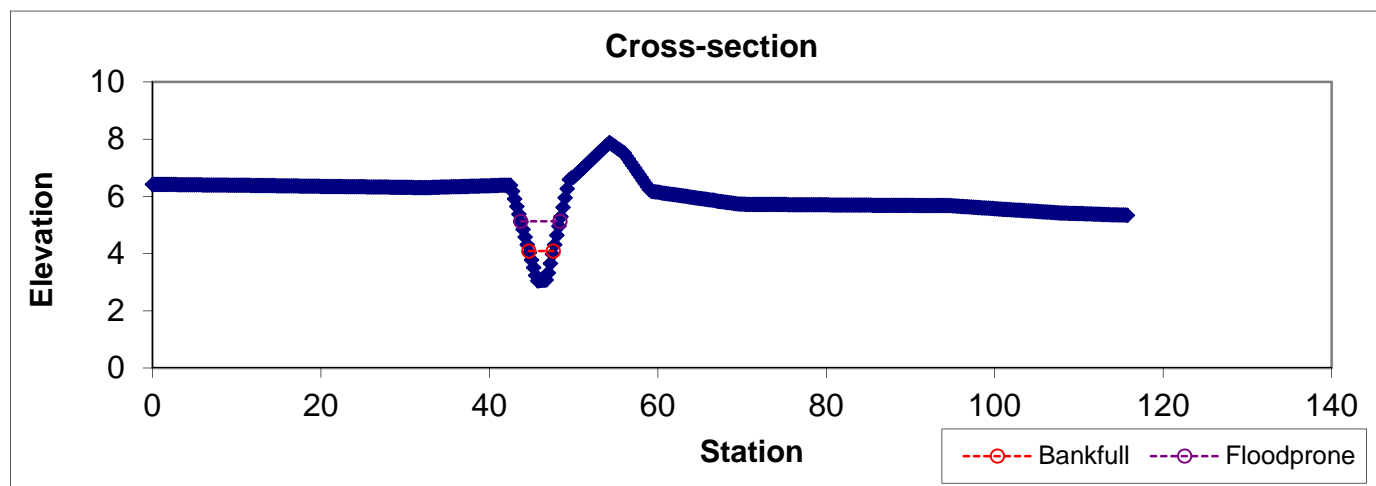
Figure 17.1 Existing Ditch Cross-Sections for Reach UT2 and UT3

Feature	Stream Type	BKF Area	BKF Width	BKF Depth	Max BKF Depth	W/D	BH Ratio	ER	BKF Elev	TOB Elev
UT3 N/A	G	1.0	2.1	0.45	0.61	4.8	5.3	1.4	4.09	6.39

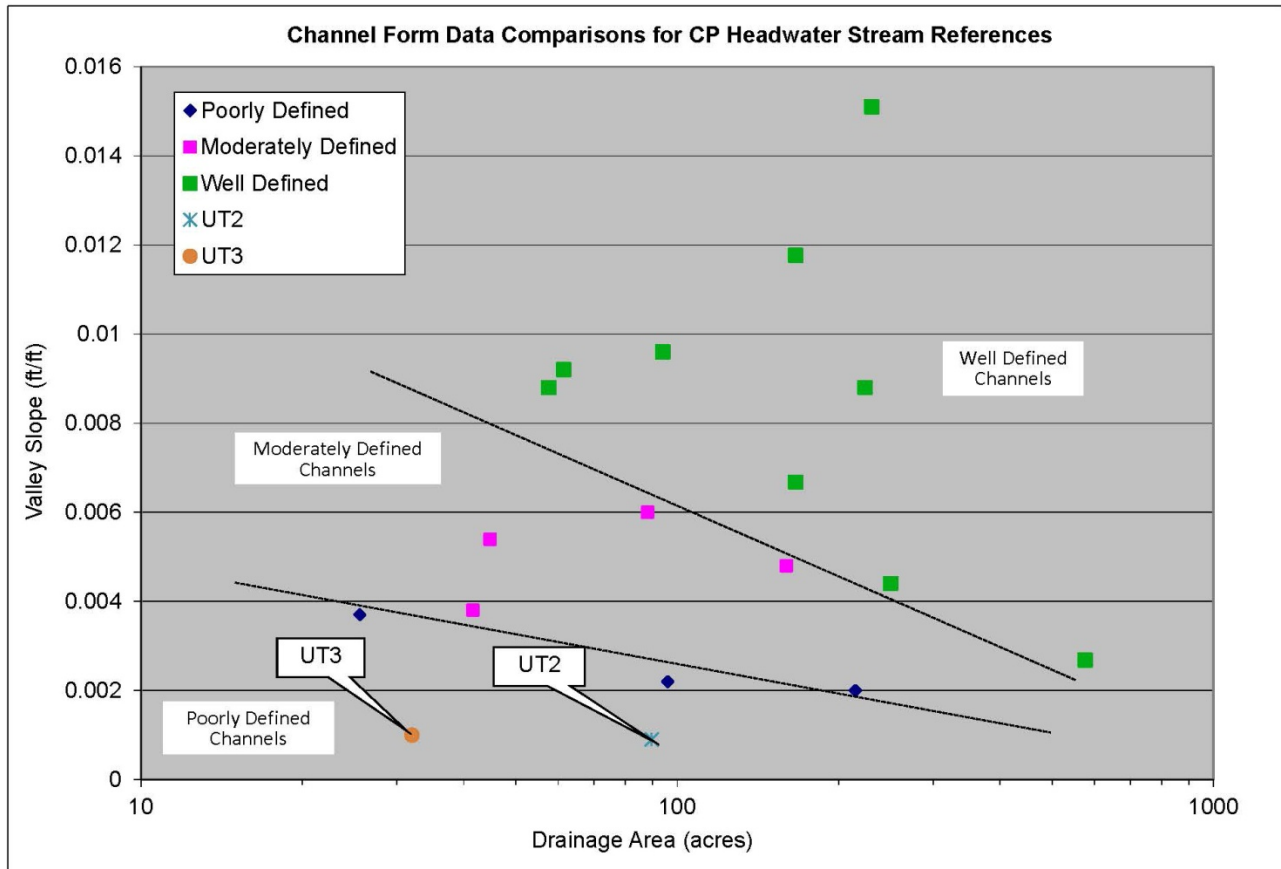
Figure 17.3 Channel Form Data Comparisons for Coastal Plain Headwater Stream References

Reference reach surveys are valuable tools for comparison. The morphologic data obtained such as dimension, pattern, and profile can be used as a template for design of a stable stream in a similar valley type with similar bed material. In order to extract the morphological relationships observed in a stable system, dimensionless ratios are developed from the surveyed reference reach. These ratios can be applied to a stream design to allow the designer to ‘mimic’ the natural, stable form of the target channel type.

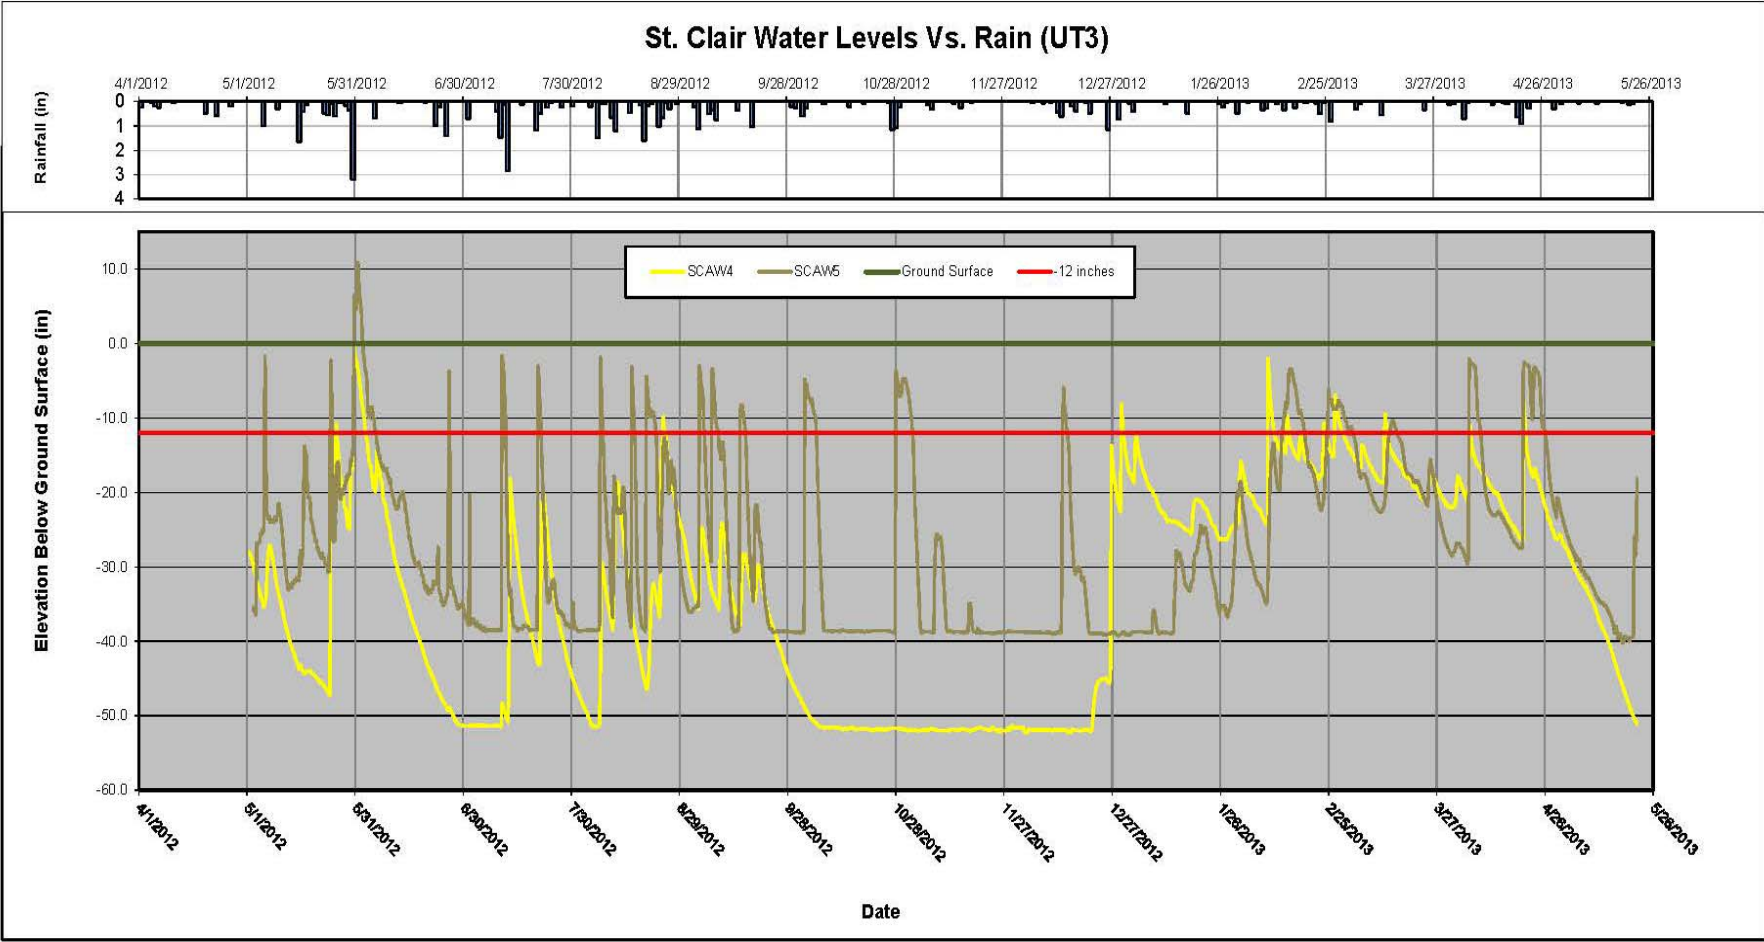
Figure 17.7 Hydrographs of the Groundwater Monitoring Wells 4-5 Compared to Local Rainfall (April 2012 through January 2013)

Automated groundwater well data collected from April 2012 through March 2013 indicate that the site currently exhibits hydrologic conditions drier than jurisdictional wetland conditions. The data were collected during both dormant and growing season, and jurisdictional wetland hydrology was not observed across the project site. The ditches and channelized streams on the site transport surface and shallow, subsurface drainage from the farms fields, lowering the water table and keeping soil conditions favorable for agricultural production. Examination of the available hydrology and hydric soil data indicate that there is good potential for the restoration of a productive wetland and stream ecosystem.

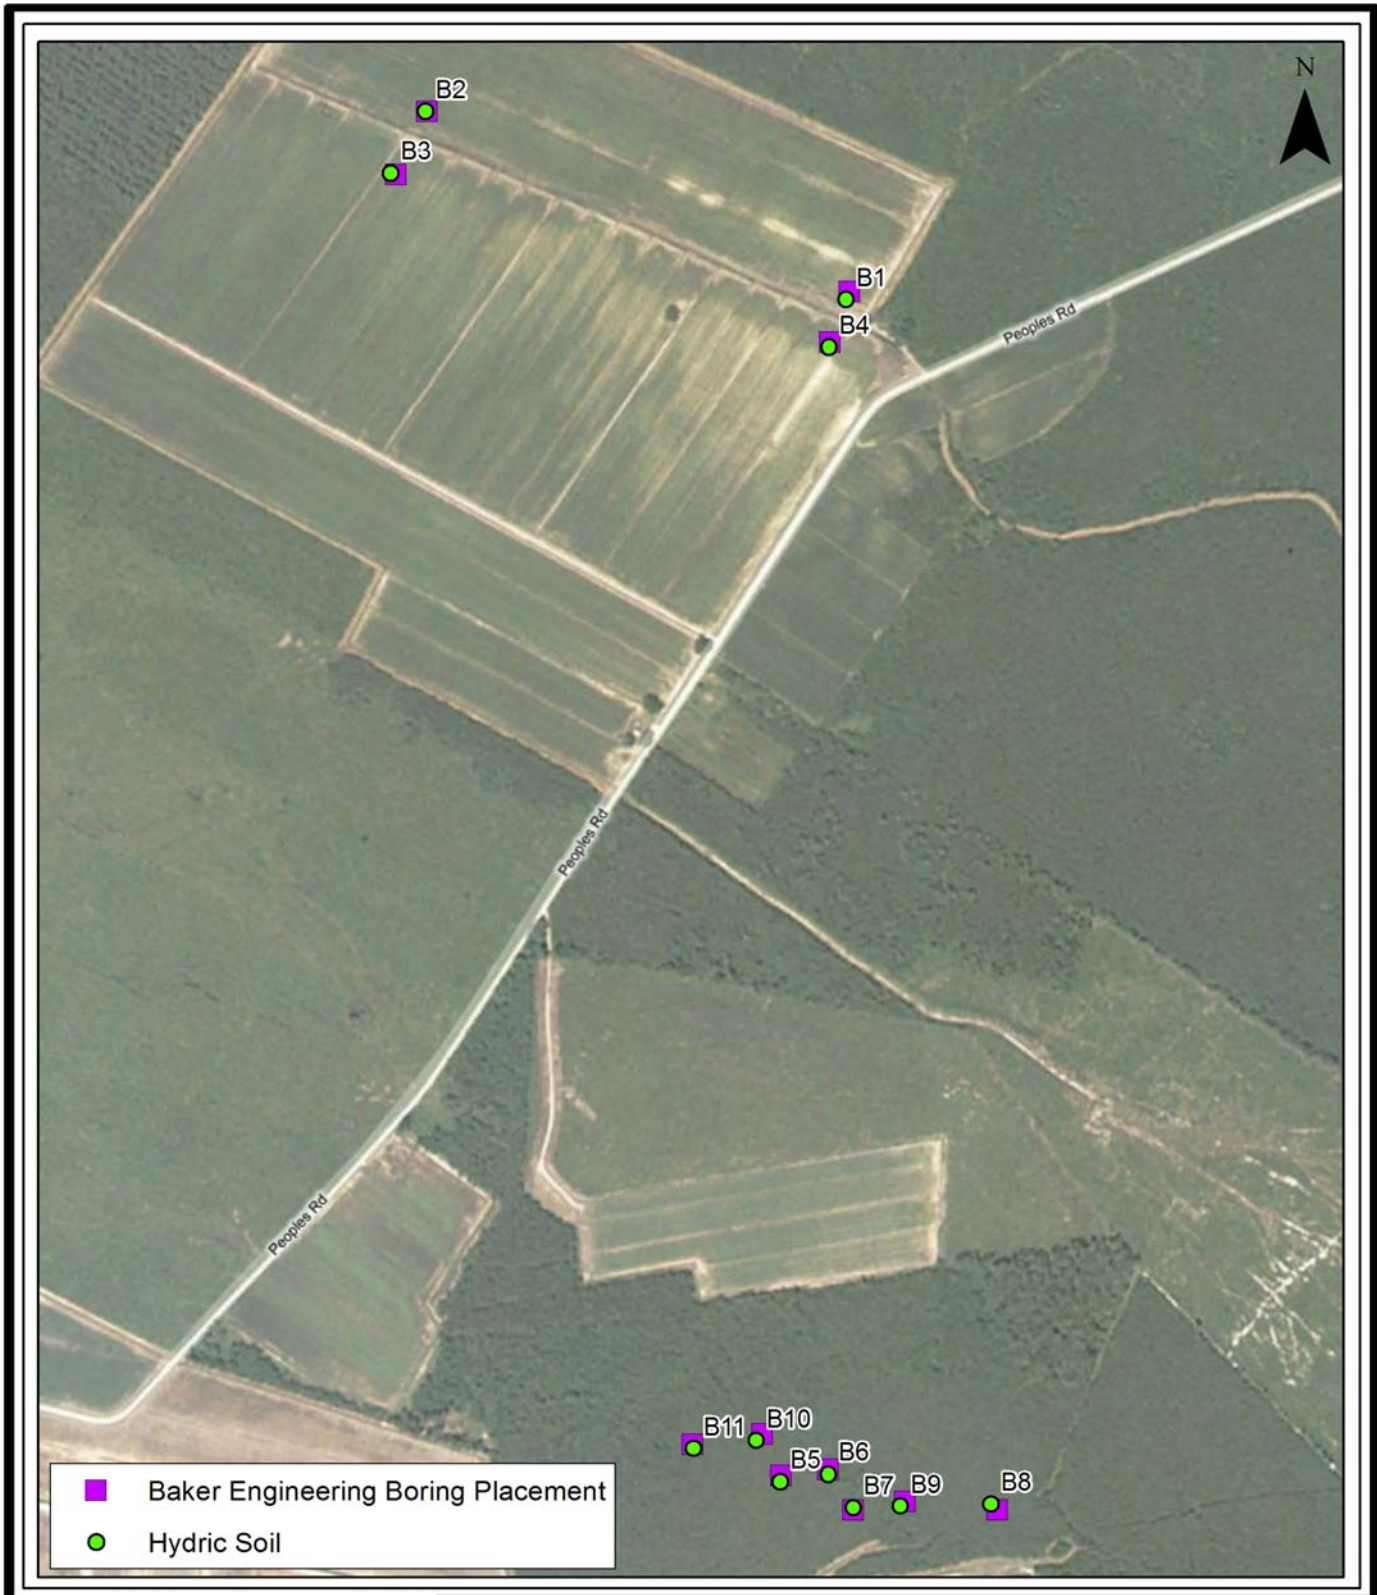
Poole Mitigation Site
 Site and Soil Investigation
 Beaufort County, North Carolina

All soils were identified as hydric by showing at least one hydric soil indicator. The findings presented herein represent TCG's professional opinion based on our Soil and Site Evaluation and knowledge of the current regulations regarding wetland mitigation in North Carolina and national criteria for determining hydric soil. This investigation was done on a broad scale to generally identify the major soil units with regard to hydric status and mitigation potential. If the project is to proceed, additional soil borings are recommended in order to better delineate the soil units.
