St. Clair Creek Restoration Project Year 1 Final Monitoring Report

Beaufort County, North Carolina

EEP Project ID No. 95015

Project Info: Monitoring Year: 1 of 7
 Year of Data Collection: 2014
 Year of Completed Construction: 2014
 Submission Date: January 2015

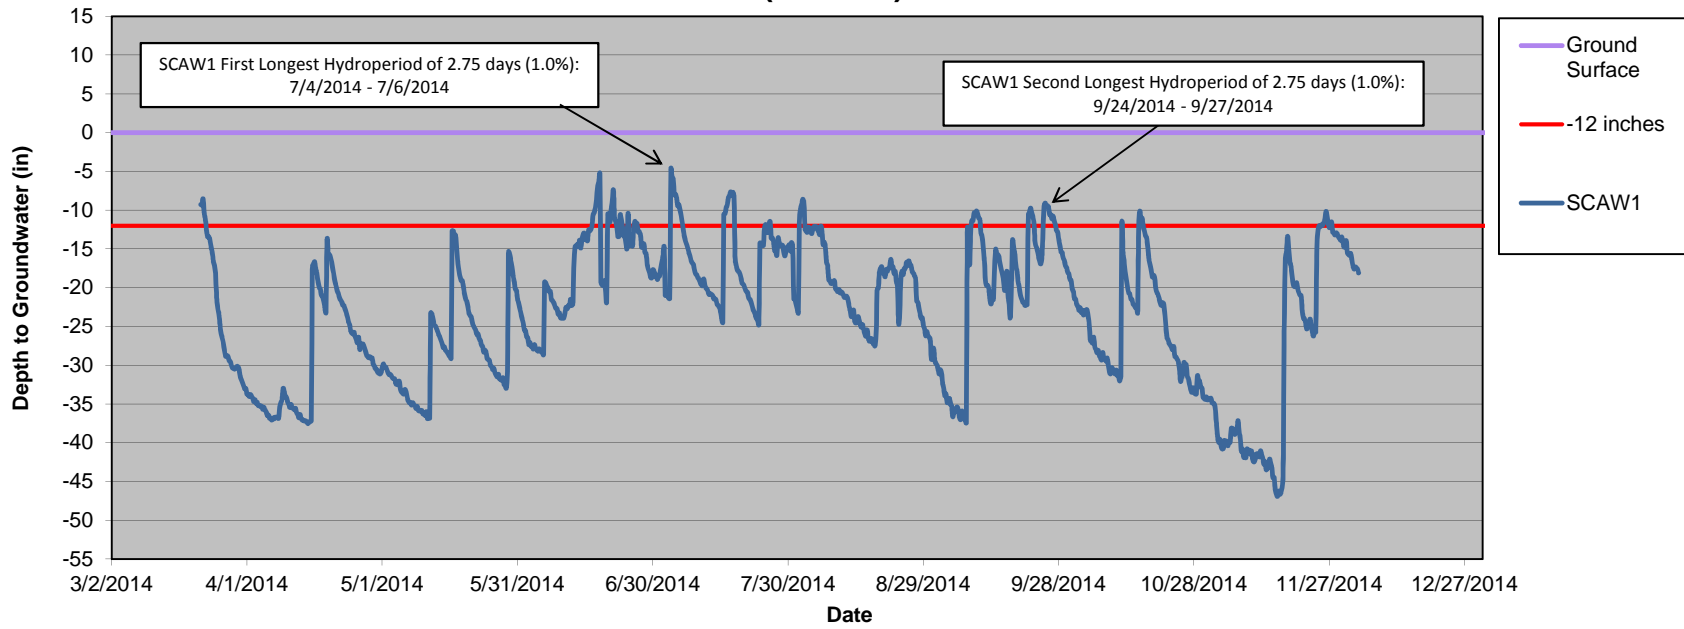
St. Clair Creek UT2 Well (SCAW1)

Year 1 wetland groundwater monitoring demonstrated that 0 of 4 groundwater monitoring wells located along UT2 and UT3 exhibited water levels within 12 inches of the ground surface that was greater than 12 percent of the growing season. The four on-site wetland monitoring wells demonstrated consecutive hydroperiods which ranged from 1.0 to 7.8 percent of the growing season. It is also noted that the monitoring wells were not installed until March 21, 2014 immediately following construction of the Site. The growing season for Beaufort County is from February 28 to December 6. Therefore, Year 1 monitoring of the wetland groundwater levels did not record the first 21 days of March in 2014. Also, during Year 1 monitoring, the on-site wetland reference wells demonstrated consecutive hydroperiods which ranged from 24.8 to 27.0 percent of the growing season.

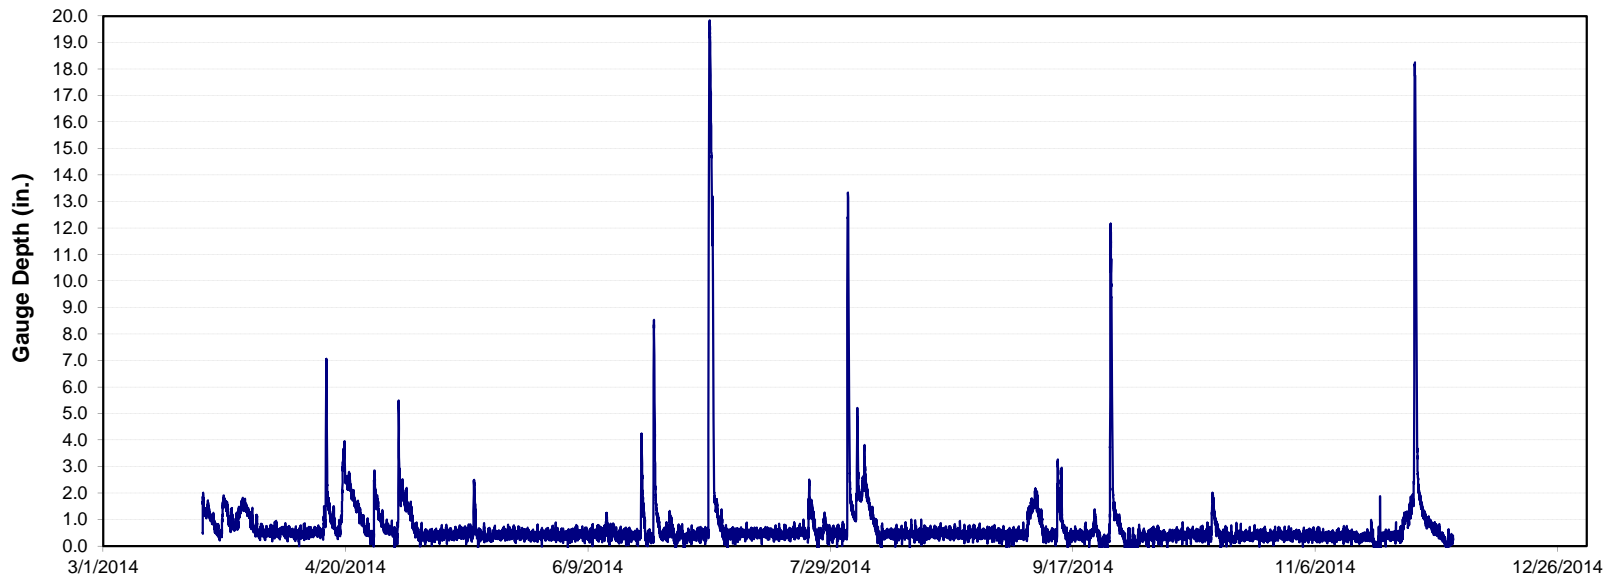
St. Clair Creek Flow Gauge SCFL1 (Downstream UT2)

On-site flow through the restored headwater valleys of UT2 and UT3 was recorded periodically throughout 2014 by the use of pressure transducers. Of the six flow gauges installed on the Site, all gauges recorded flow in 2014. The flow gauges documented flow through the headwater valleys during Year 1 which ranged from 4.6 to 71.0 days in from March 21 to December 4. It is noted that the gauges demonstrated similar patterns relative to rainfall events in the vicinity of the Site.
