STONE MOUNTAIN STATE PARK

Stream Restoration on the East Prong Roaring River

**NC Stream Restoration Institute
and
Stone Mountain Stream Restoration Steering Committee**

April 17, 2000

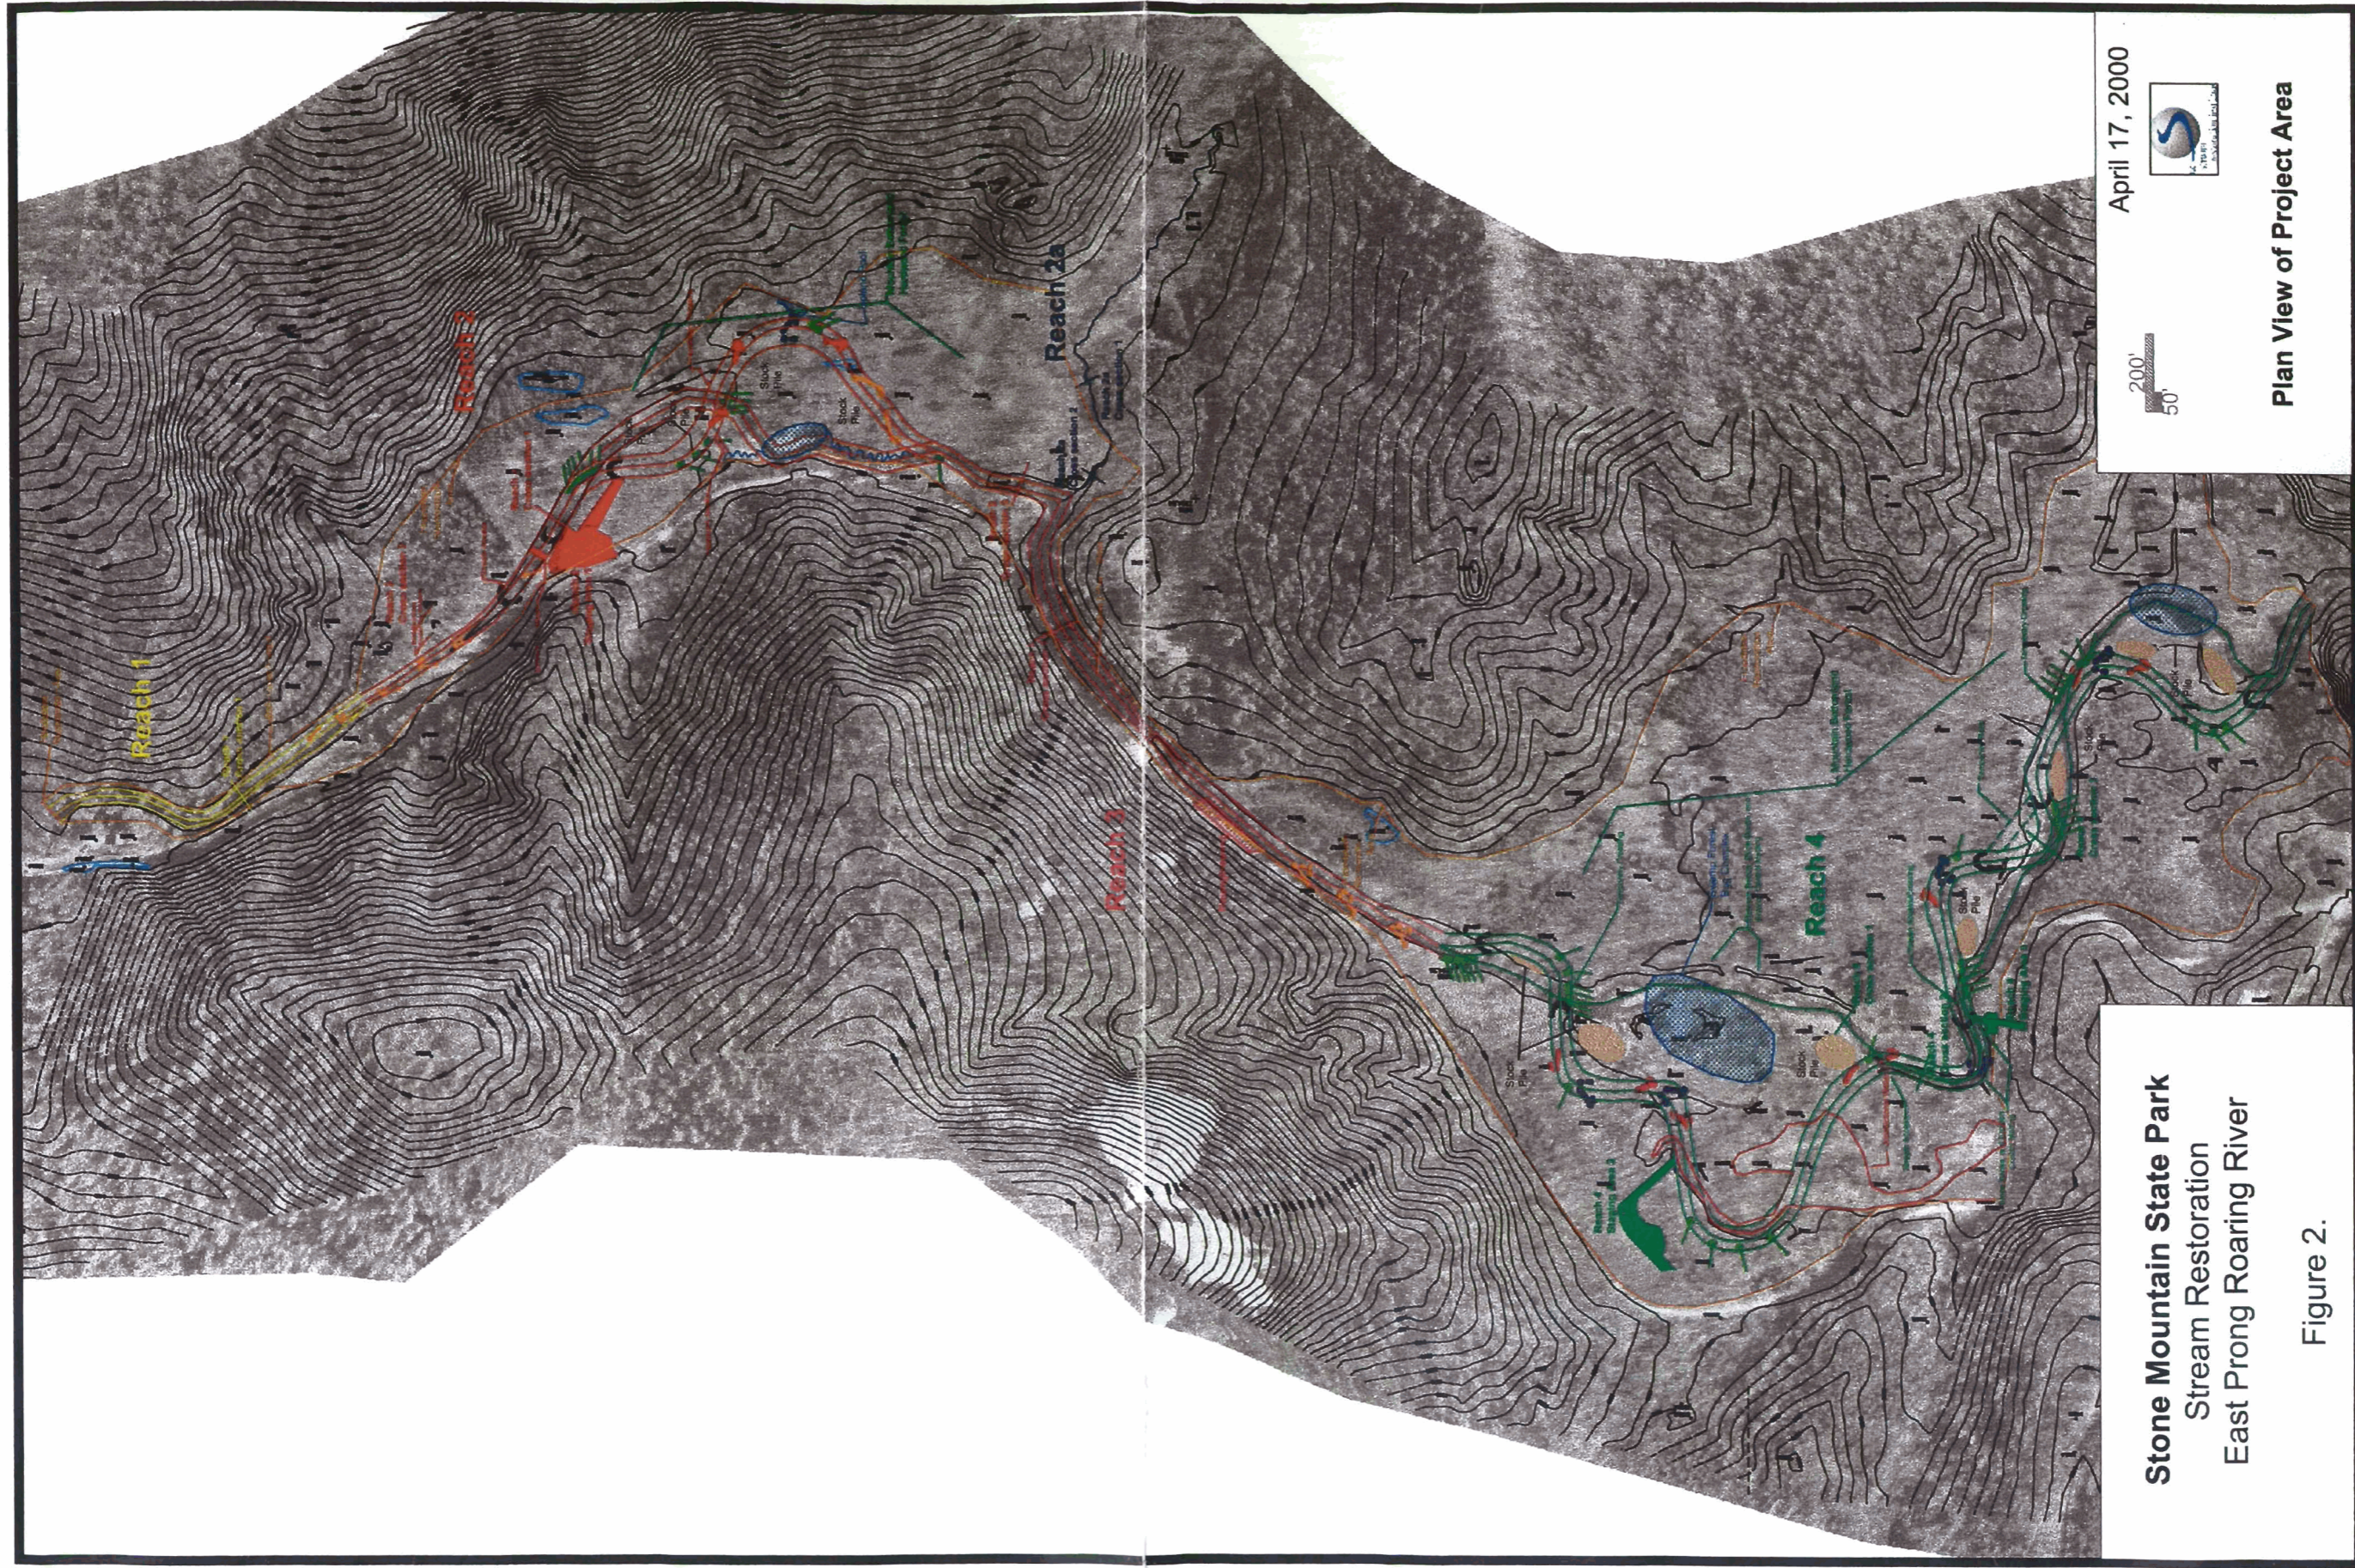
Plan View of Project Area

The project is divided into four reaches as shown on Figure 2. The drainage area for the entire project is 22 mi². The pre and post restoration length of each stream reach is shown below in Table 1. Appendix 5 provides a summary of the existing condition survey.

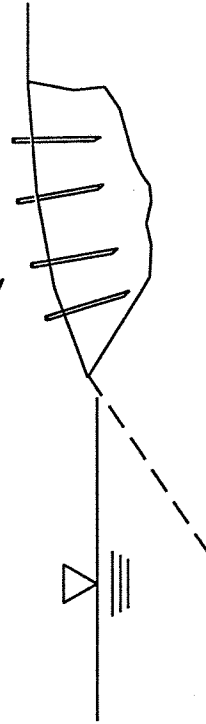
1. ALL LATERAL BRANCHES SHALL BE TRIMMED.
2. A MINIMUM OF TWO BUDS SHALL BE ABOVE THE PLANTING DEPTH.

LIVE STAKES

- A.) PRIOR TO INSTALLATION OF LIVE STAKES, THE STREAM BANK SHOULD BE FERTILIZED, LIMED AND SEEDED.
- B.) LIVE STAKING PLANT MATERIAL SHALL CONSIST OF A RANDOM ASSORTMENT OF MATERIALS SELECTED FROM THE FOLLOWING: SILKY DOGWOOD (CORNUS AMOMUM), BLACK WILLOW (SALIX NIGRA) AND AMERICAN ELDERBERRY (SAMBUCUS CANADENSIS). OTHER SPECIES MAY BE SUBSTITUTED UPON APPROVAL OF NCSU PERSONNEL.
