**EAST PRONG ROARING RIVER  
STREAM RESTORATION,  
Wilkes County, North Carolina**

***ANNUAL MONITORING REPORT  
ADDENDUM***

Prepared by:  
North Carolina State University, Water Quality Group,  
NC Stream Restoration Institute

# 2003 Addendum to the Stone Mountain River Restoration Monitoring Report

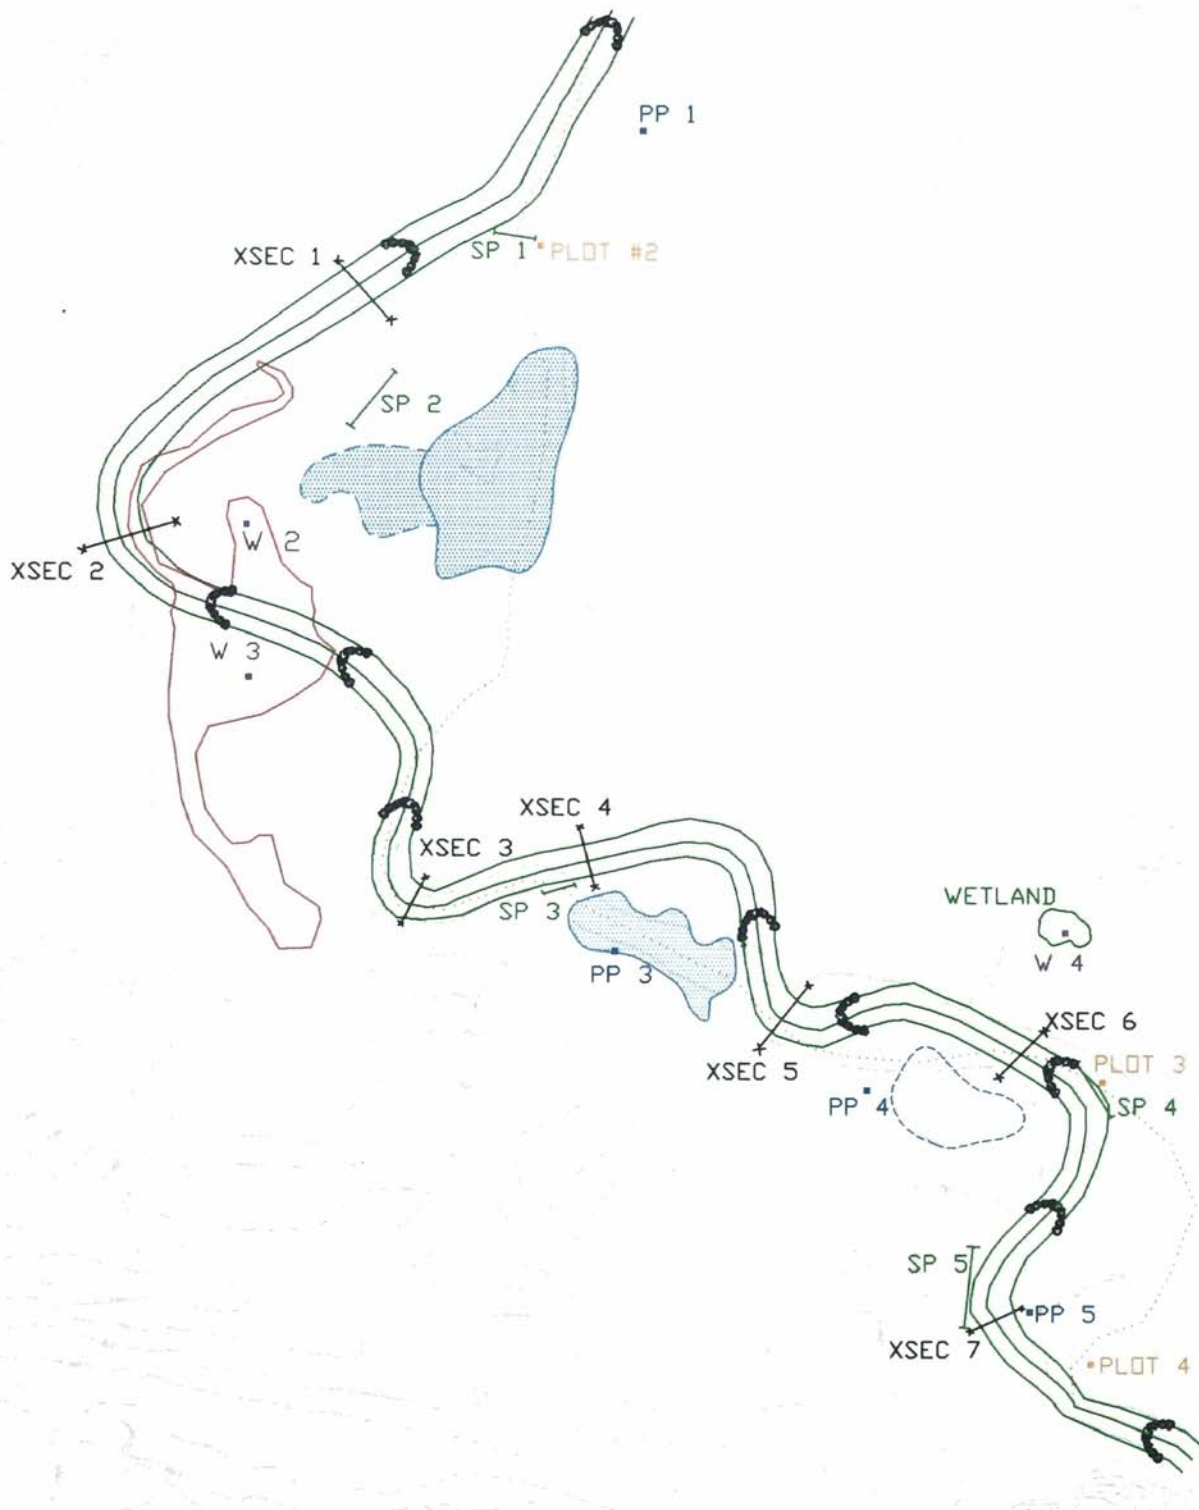
**FIGURE**  
 2 OF  
 2

PROJECT: EAST PRONG ROARING RIVER  
 LOCATION: STONE MOUNTAIN STATE PARK  
 DATE: JANUARY 22, 2003  
 SCALE: 1" = 300'  
 SECTION: REACH 4

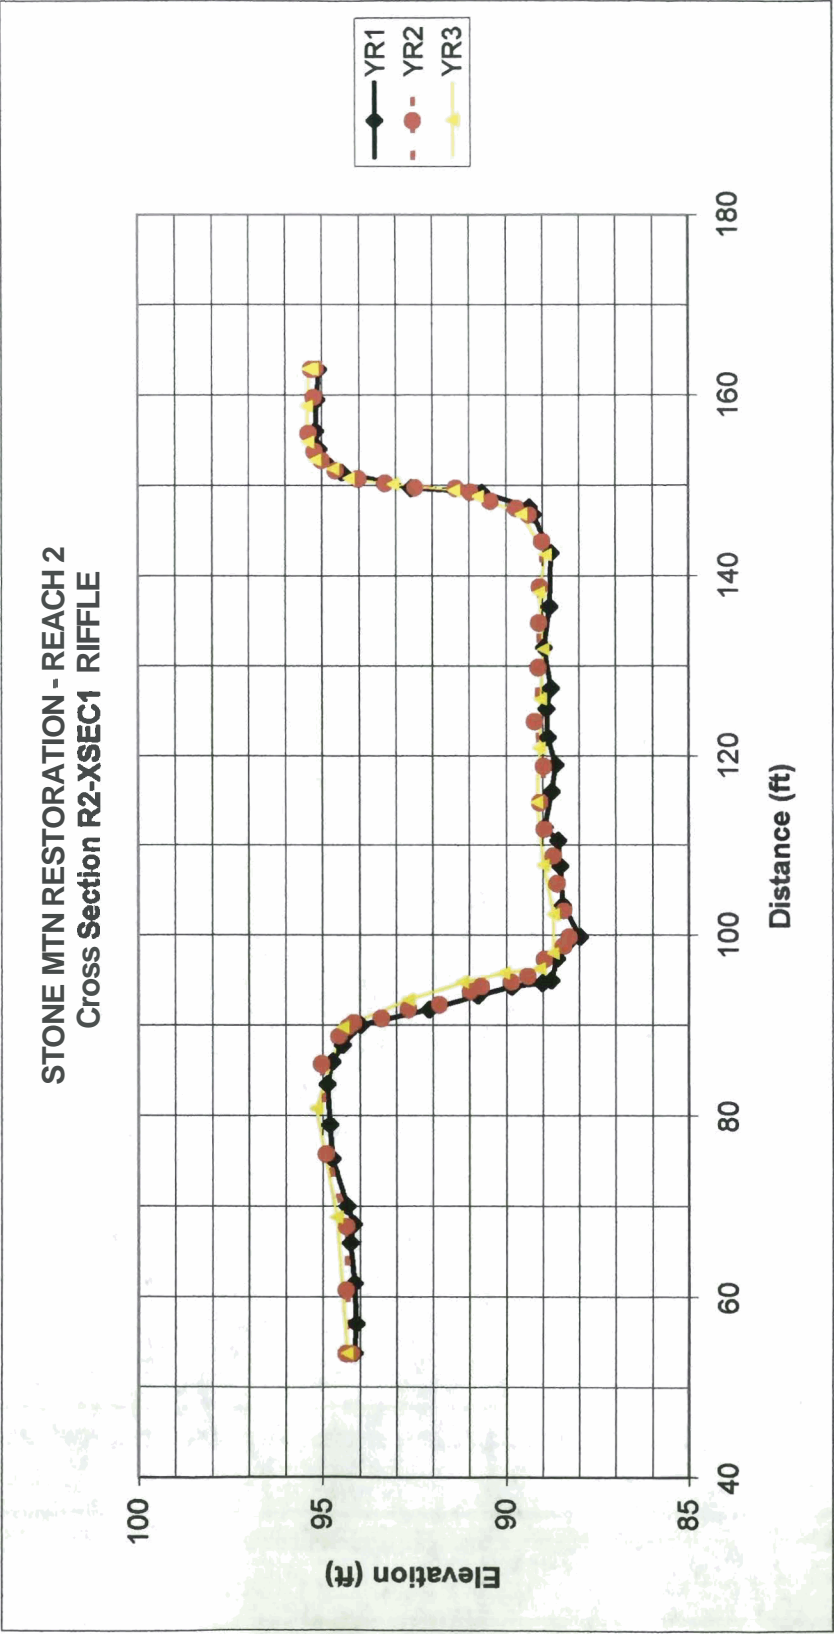
Cross Section R2-XSEC1 RIFFLE

R2-XSEC1	Feature	Type	Wfpa	LBKF	RBKF	ELEV/bkf	Wbkf	Dbkf	W/D	Abkf	Dmax	ER
YR 1	RIFFLE	C4	450	90.0	151.4	93.98	61.4	4.2	14.6	257.9	6.0	7.3
YR 2	RIFFLE	C4	450	90.3	150.8	94.01	60.5	4.0	15.2	241.4	5.7	7.4
YR 3	RIFFLE	C4	450	89.8	150.8	94.27	61.0	3.9	15.6	239.1	5.6	7.4

Field data was collected in 2003 and 2004 on the permanent cross sections throughout Reaches 2 and 4. Overlaying these sections on previous survey data, as shown in Appendices A and B, shows any changes that have taken place in the channel with regards changes in the width/depth ratio, cross-sectional area, and entrenchment ratio. This is useful information over time to determine the stability of the channel. Most of the cross sections surveyed show little to no change from 2000 to 2003. The changes that did occur include deepening of pools (increased habitat), and a slight narrowing of the channel in some areas. These results indicate overall stability within the channel.

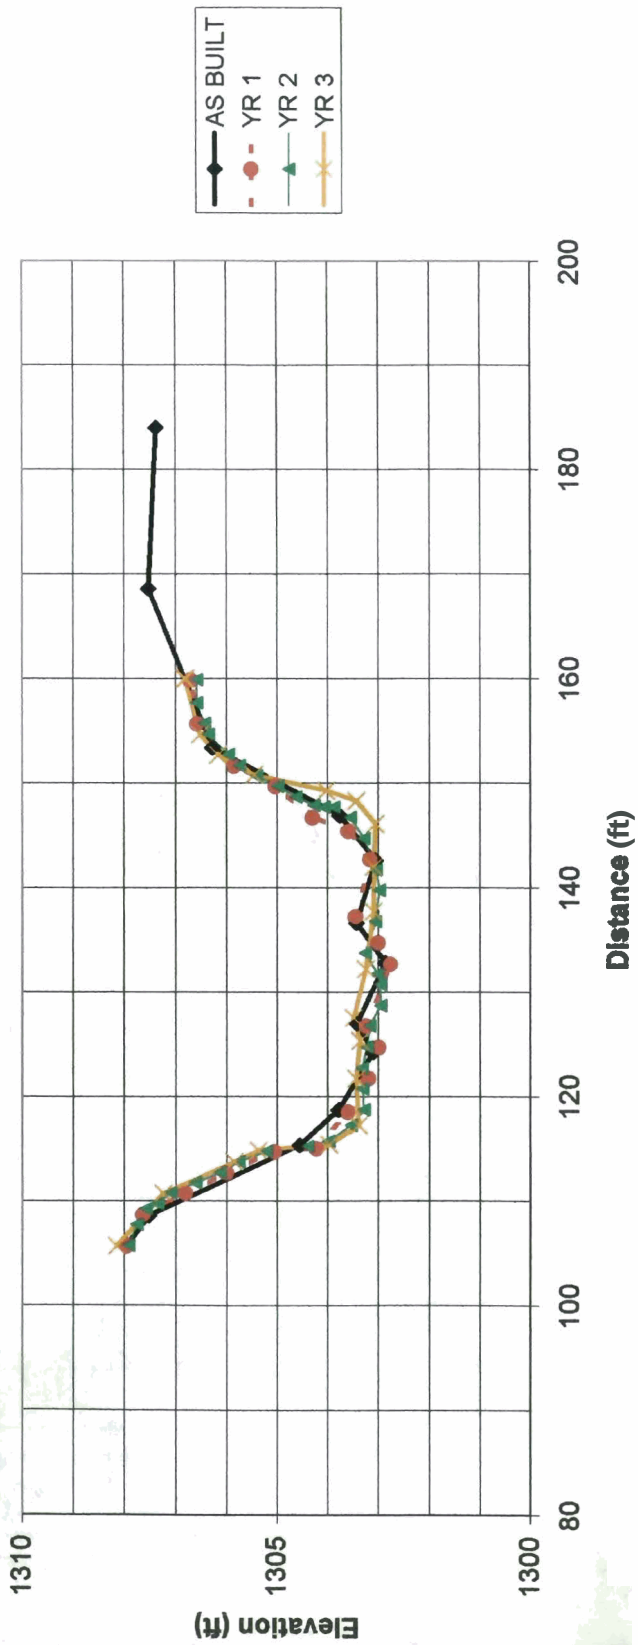
STONE MTN RESTORATION - REACH 2  
Cross Section R2-XSEC3 RIFFLE

R2-XSEC3	Feature	Type	Wfpa	LBKF	RBKF	ELEV/bkf	Wbkf	Dbkf	W/D	Abkf	Dmax	ER
AS BUILT	RIFFLE	C4	300	108.6	168.6	1307.52	60.0	2.8	21.6	166.7	4.7	5.0
YR 1	RIFFLE	C4	300	81.0	132.2	1307.63	51.2	3.3	15.5	169.2	4.9	5.9
YR 2	RIFFLE	C4	300	112.7	154.7	1306.35	42.0	4.0	10.4	169.2	4.9	7.1
YR 3	RIFFLE	C4	300	112.7	154.7	1306.35	42.0	4.0	10.4	170.0	4.9	7.1

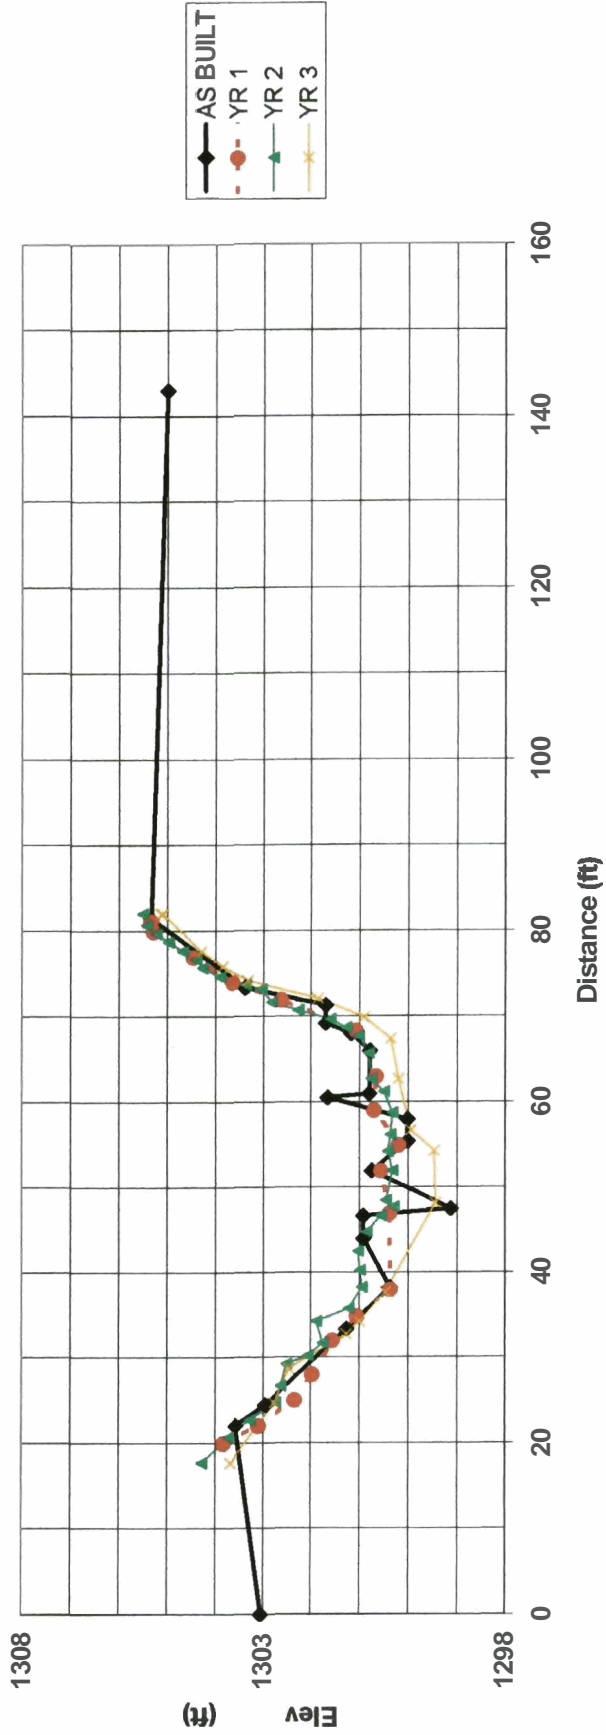
Cross Section R2-XSEC4 RIFFLE

R2-XSEC4	Feature	Type	Wfpa	LBKF	RBKF	ELEVbKF	WbKF	DbKF	W/D	AbKF	Dmax	ER
AS BUILT	RIFFLE	C4	200	22.0	73.4	1303.57	51.4	2.5	20.9	126.2	4.4	3.9
YR 1	RIFFLE	C4	200	20.0	74.0	1303.82	54.0	2.3	23.1	126.2	3.6	3.7
YR 2	RIFFLE	C4	200	22.0	74.7	1303.57	52.7	2.5	21.3	130.4	3.3	3.8
YR 3	RIFFLE	C4	200	17.7	75.9	1303.68	58.2	2.9	19.8	171.1	4.2	3.4

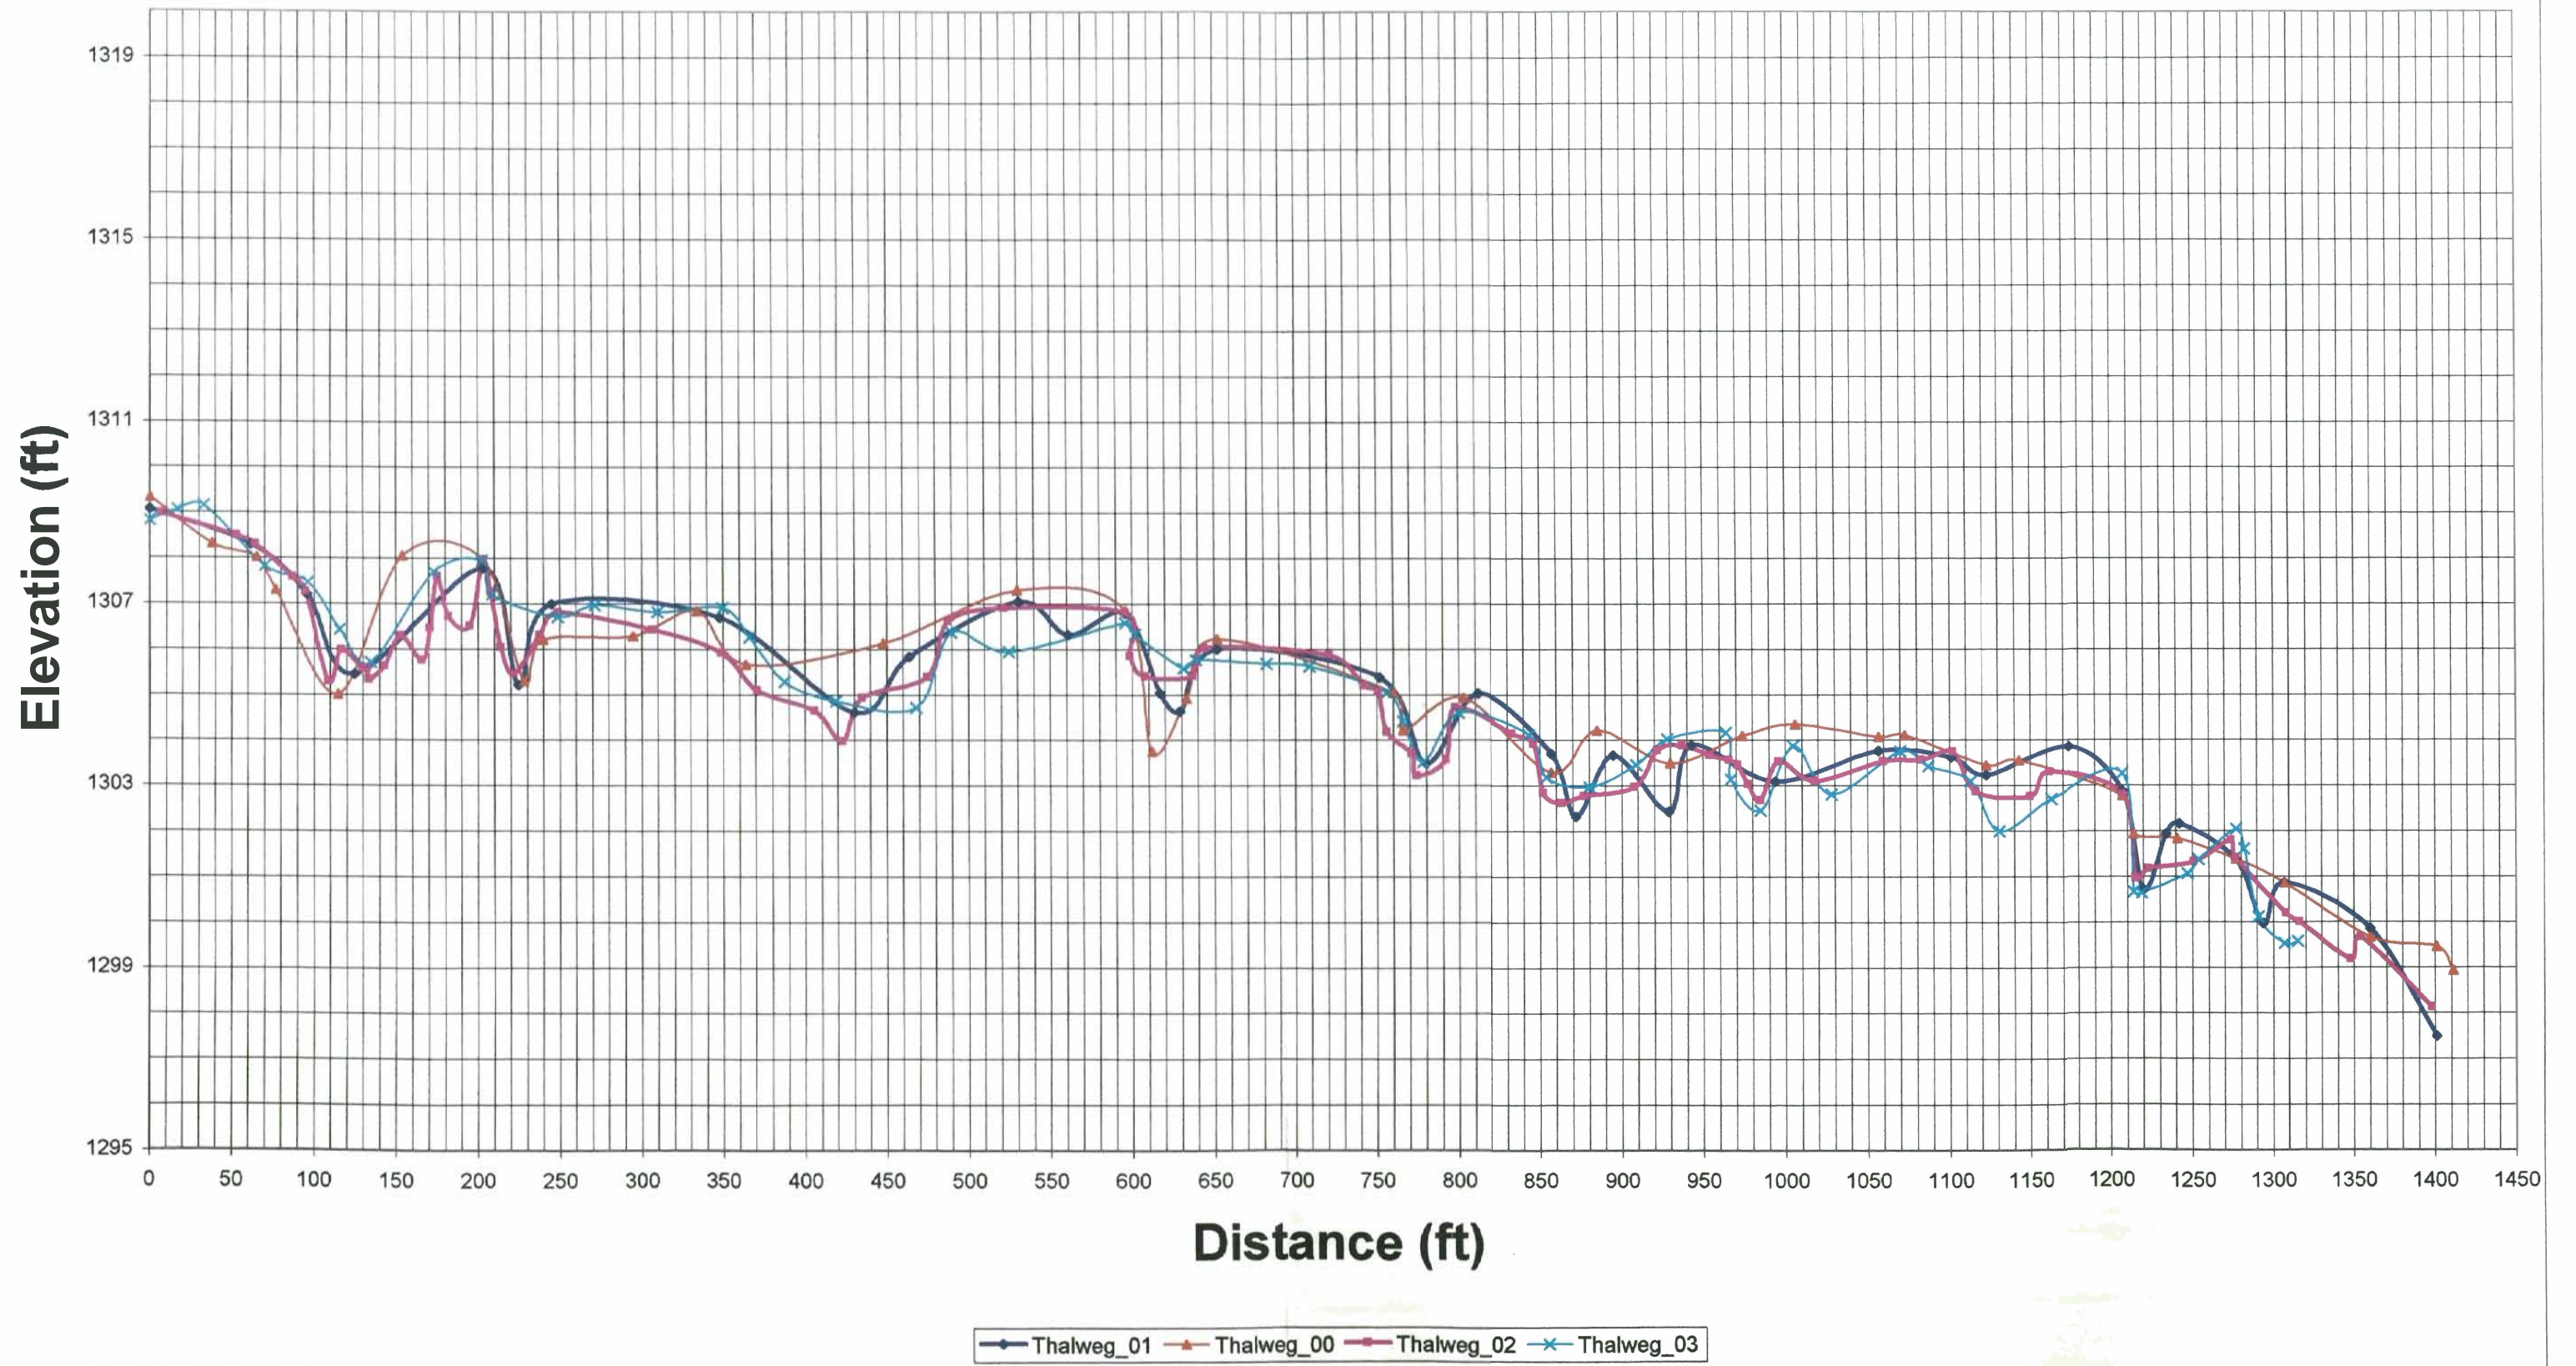
### Longitudinal Profile

Head First Riffle	0	1308.8
Head Last Riffle	1263	1299.6
Valley Length (ft)	950	
Channel Length (ft)	1263	
Elev Change (ft)	9.25

Chan Slope (ft/ft)	0.0073
Valley Slope (ft/ft)	0.0097
Sinuosity, K	1.33

Longitudinal profiles were surveyed in 2003 and 2004. They were each plotted together with previous surveys to show any changes in the bed form over the previous year. Inverts of cross vanes and permanent cross sections were used as control points so that the annual surveys would be accurately compared. The results of the profiles revealed some deepening of the pools, little to no change in riffles, and proper functioning of the grade control structures. The average slope of the channel has also remained stable.

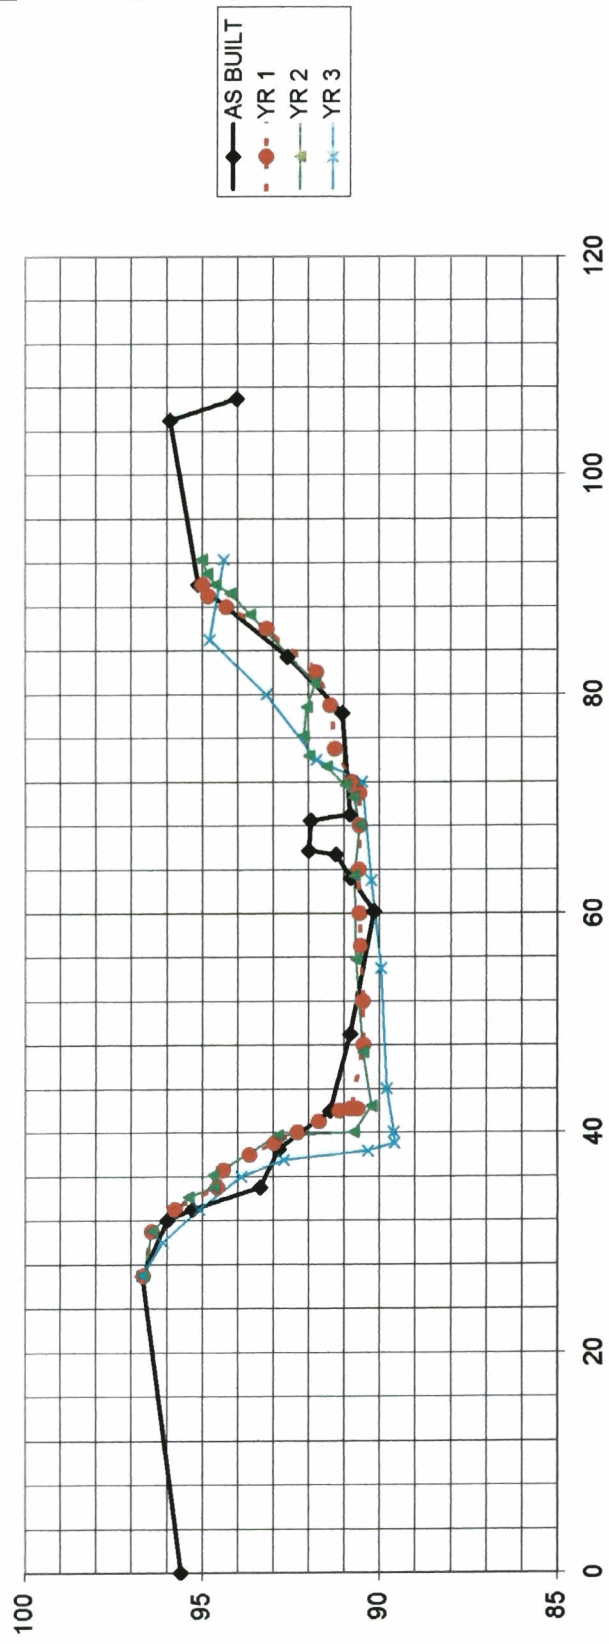
STONE MTN RESTORATION  
Cross Section R4-XSEC1 RIFFLE

R4-XSEC 1	Feature	Type	Wfpa	LBKF	RBKF	ELEVbkf	Wbkf	Dbkf	W/D	Abkf	Dmax	ER
AS BUILT	RIFFLE	C	200	32.0	90.0	95.27	58.0	3.8	15.2	221.9	5.1	3.4
YR 1	RIFFLE	C	200	33.0	90.0	95.77	57.0	3.8	14.9	218.0	5.1	3.5
YR 2	RIFFLE	C	200	34.0	91.0	95.00	57.0	3.5	16.2	200.1	4.7	3.5
YR 3	RIFFLE	C	200	33.0	92.0	94.40	59.0	3.6	16.4	212.4	4.8	3.4

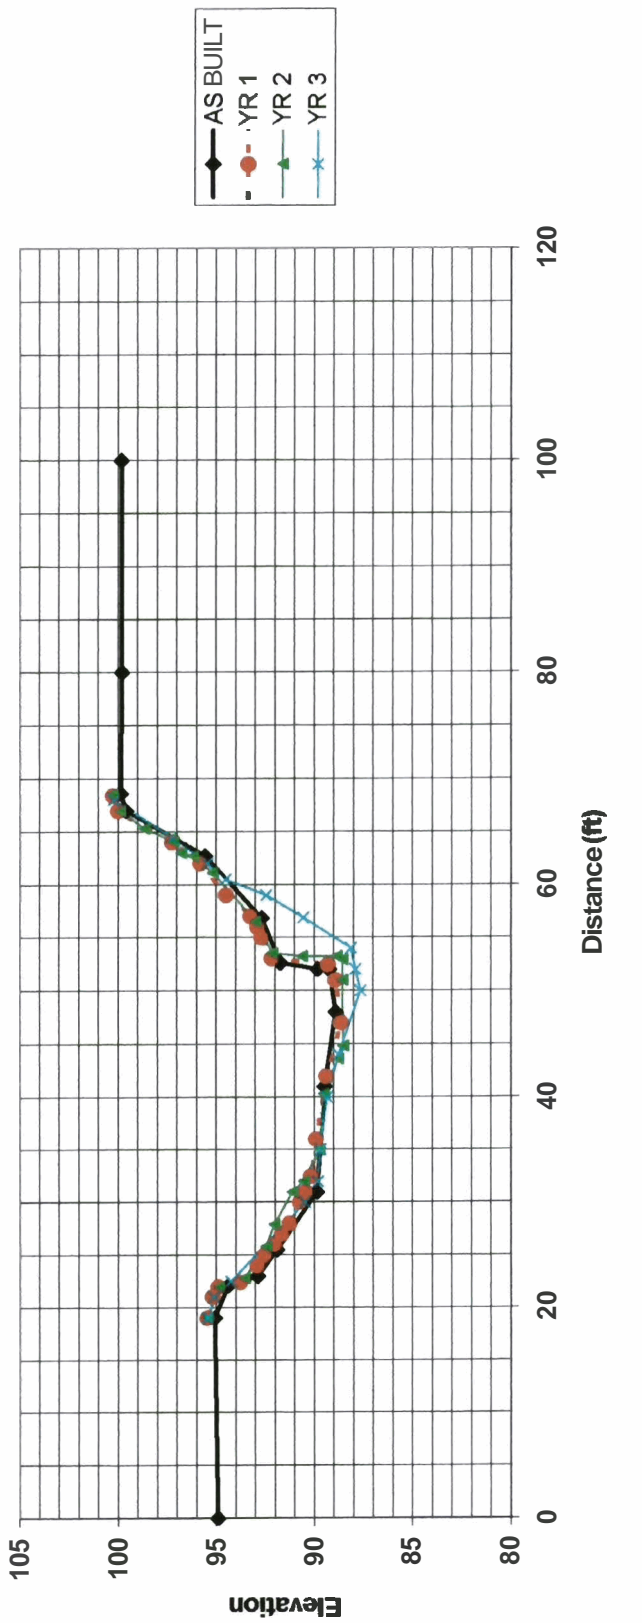
STONE MTN RESTORATION  
Cross Section R4-XSEC2 POOL

R4-XSEC2	Feature	Type	Wfpa	LBKF	RBKF	ELEVbkf	Wbkf	Dbkf	W/D	Abkf	Dmax	ER
AS BUILT	POOL	C	200	19.0	62.7	95.06	43.7	4.3	10.1	189.7	6.2	4.6
YR 1	POOL	C	200	19.0	62.0	95.48	43	4.8	9.0	204.7	6.8	4.7
YR 2	POOL	C	200	19.0	61.1	95.20	42.1	4.6	9.1	194.5	6.6	4.8
YR 3	POOL	C	200	19.0	62.0	95.48	43	5.5	7.9	234.8	7.8	4.7

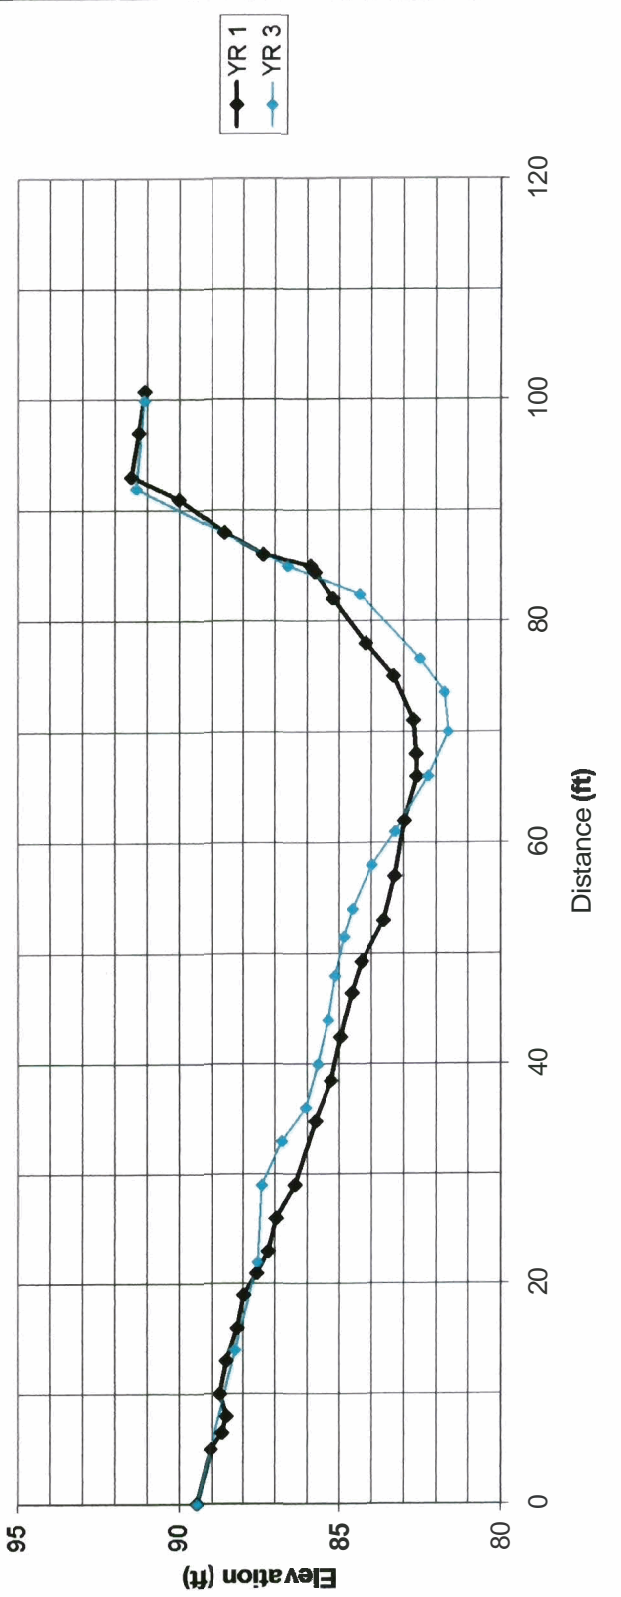
STONE MTN RESTORATION  
Cross Section R4-XSEC5 POOL

R4-XSEC5	Feature	Type	Wfpa	LBKF	RBKF	ELEV/bkf	Wbkf	Dbkf	W/D	Abkf	Dmax	ER
YR 1	POOL	C	200	21.0	86.0	87.57	65.0	3.0	21.7	194.3	5.0	3.1
YR 3	POOL	C	200	22.0	85.0	87.56	63.0	3.5	18.0	223.0	5.9	3.2

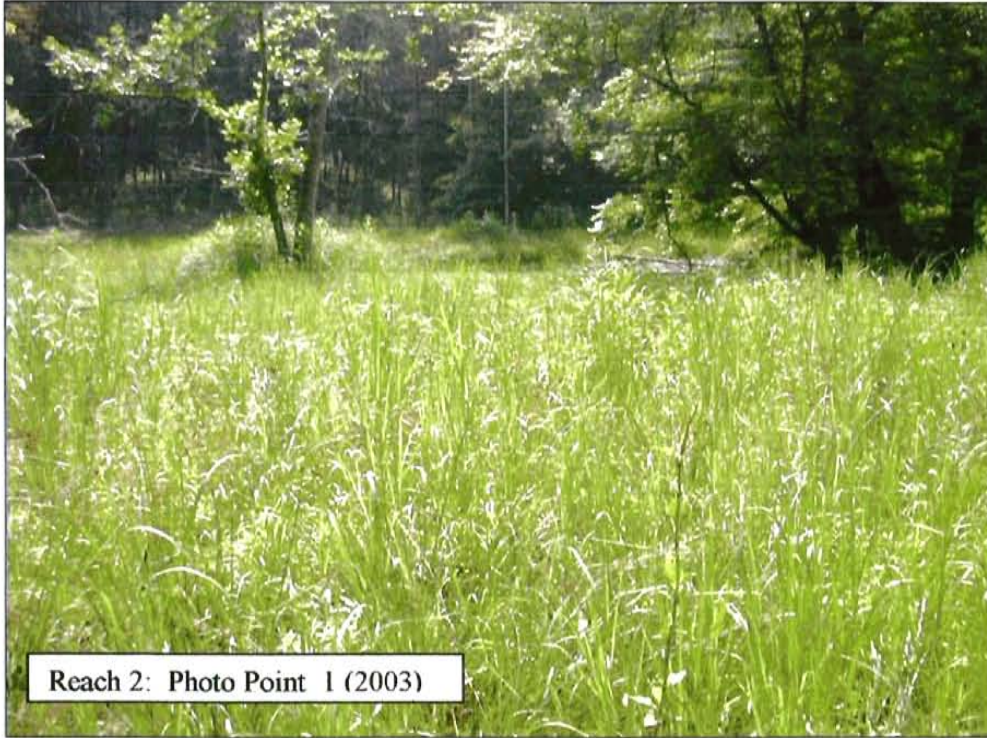
Reach 2: Photo Point 1 (2003)

The photo points taken along the channel and constructed wetlands and ponds in Reaches 2 and 4 show the vegetation that has come up and survived (including transplants). Also, the channel appears stable with no development of unstable depositional features or erosion of the banks in these areas.
