**Wilson Bay (Sturgeon City) Wetland Restoration
Phase II
Jacksonville, Onslow County, North Carolina**

*2005 Annual Monitoring Report
Year 2 of 5*

NCEEP Project Number: .00091
BLWI Project Number: 050039
NCDENR contract: D05056S

17 February 2006

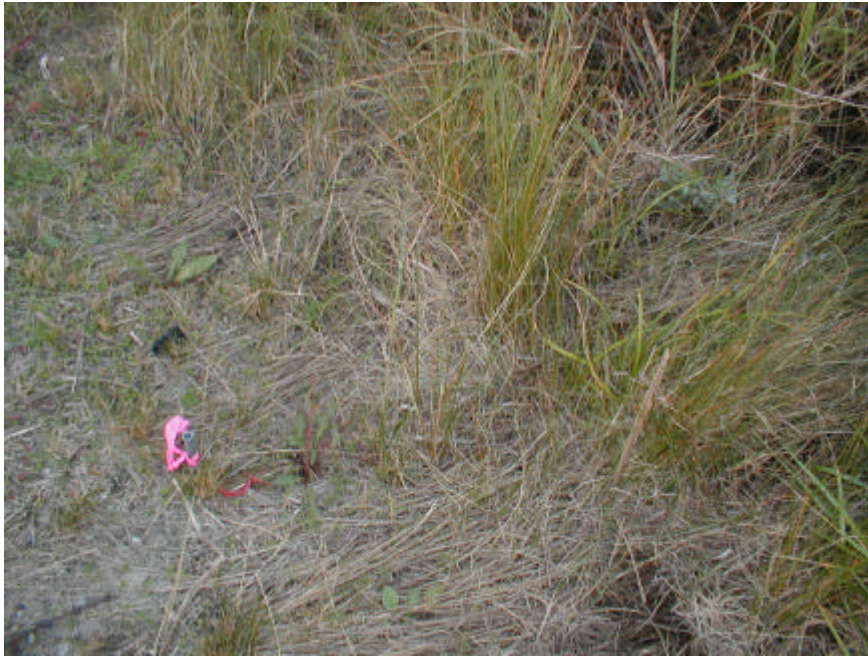
Plot P13

Table VIII. Stem Counts (Marsh Plots)					
Project Number and Name: 050038 Sturgeon City Phase II					
Species	Plot	Count	Height (cm)	% Cover	Notes
<i>Spartina cynosuroides</i>	C1	77	132-285	45	<i>Scirpus</i> present
	C2	47	178-298	50	<i>Scirpus</i> present
	C3	47	137-249	45	<i>Scirpus</i> present
	C4	97	137-297	75	
	C6	58	117-283	50	<i>Scirpus, Aster</i> present
	C7	73	136-277	45	<i>Aster</i> present
	C8	61	258-327	60	<i>Baccharis</i> present
	C9	81	121-260	40	<i>Scirpus</i> present, 6.5" water
	C10	69	135-303	70	<i>Scirpus</i> present
	C11	78	140-259	60	<i>Scirpus, Aster</i> present
	C12	53	261-308	60	<i>Typha</i> present
	<i>Spartina Patens</i>	P5	n/a	130-117	50
P13		n/a	x	x	Impacted by mowing
P14		n/a	120-123	50	Rattlebox present
P15		n/a	45-52	40	<i>Aster</i> present

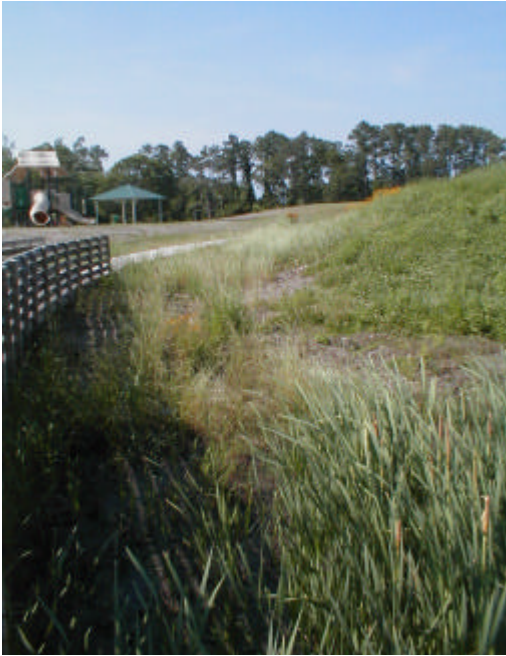
At the most land ward branch of one of the brackish creeks, stormwater runoff from an adjacent road and parking lot has reduced the salinity in the brackish marsh to a point where *Typha latifolia* and *Typha angustifolia* can survive. These invasive species have taken hold in this area to a point where they are beginning to compete with the planted *Spartina cynosuroides*. The City of Jacksonville has completed plans and hired a contractor for the construction of a stormwater wetland to remedy this situation. Construction is scheduled for March 2006. The marsh grass will be replanted by the City of Jacksonville once the site is ready. Plantings should occur by May 2006.

Table VII. Vegetative Problem Areas			
Project Number and Name: 050039 Sturgeon City Phase II			
Feature/Issue	Area	Probable Cause	Photo #
Volunteer Species	7,200 sf	Fresh water runoff in brackish marsh	VPA-1
Vegetation Damage	200 sf	Maintenance staff have mowed <i>S. patens</i>	VPA-2

VPA-1 *Typha* sp. intrusion into brackish marsh

Volunteer native vegetation has been noted at the site. At this time, it does not present a threat to the planted area and is not considered to be an issue. In an area of high stormwater runoff, a zone of *Typha sp.* is competing with the growth and spread of *Spartina cynosuroides*. The City of Jacksonville plans to construct a stormwater wetland to offset these problems. Construction of the stormwater wetland is scheduled to begin in March 2006. The area will be replanted with *Spartina cynosuroides* upon completion.

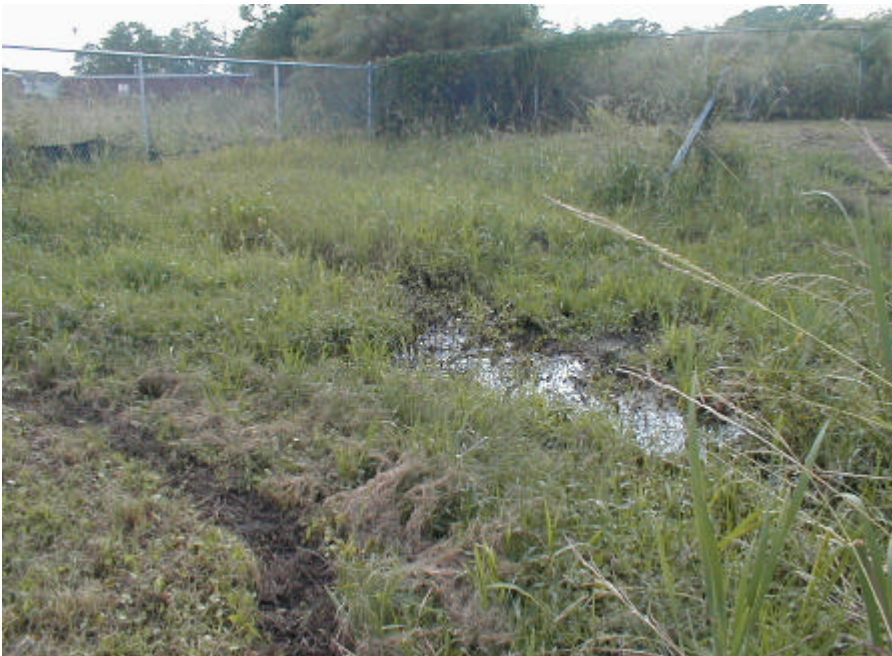
City of Jacksonville staff have consistently mown areas of *Spartina patens*, mainly along the walkways and adjacent to the boardwalks. This problem has been addressed with meetings/discussions with the maintenance staff on the importance of keeping the marsh grass. Survival has not been an issue, only plant growth and spread. The City of Jacksonville is also in the process of placing 'No Mowing' signs in the previously impacted areas.

VPA-2 *Spartina patens* mowed by maintenance staff
