ANNUAL MONITORING REPORT WILSON BAY (STURGEON CITY) PHASE II

WETLAND RESTORATION
ONslow COUNTY, NORTH CAROLINA
(EEP Project Number 367)

Monitoring Year 4 of 5 (2007)

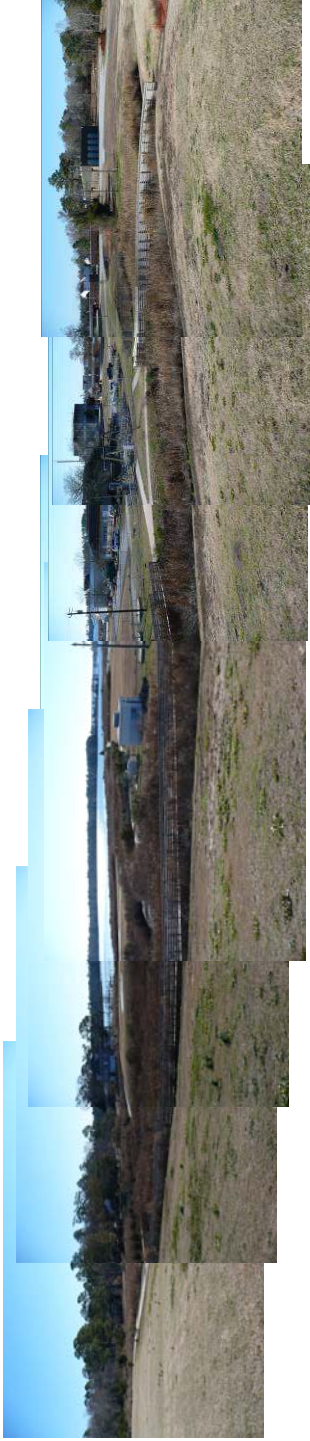
Photographs 1-8: Panoramic from east to south to west looking towards the Site.

Photographs taken in the vegetation monitoring area are included in Appendix A; locations of each are depicted on Figure 2. The photographs show that the marsh grasses are growing well and the Site is functioning as a brackish marsh wetland system.

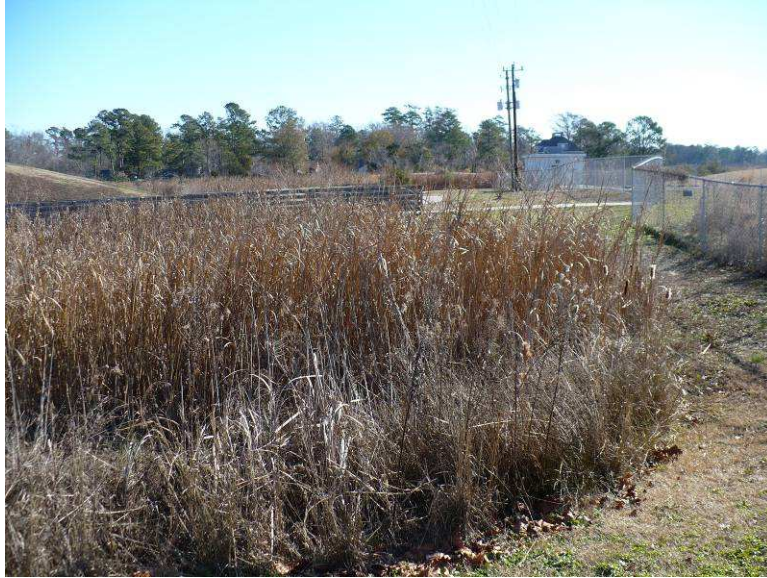
Table 6. Vegetation Problem Areas			
Wilson Bay (Sturgeon City) Wetland Restoration Phase II (EEP Project Number 367)			
Feature/Issue	Location	Probable Cause	Photo
Recovering area of volunteer <i>Typha latifolia</i>	Northwestern portion of the Site	Freshwater runoff from the adjacent parking area	Recovering Problem Area Photos 17 and 18 (Appendix A)

Picture 17: Cattails along edge
of marsh vegetation

Recovering vegetation problem areas within the Site are depicted on Figure 3 and are outlined in Table 6. Last year (year 3) an area along the northernmost and westward trending creek contained a small colony of cattail (*Typha latifolia*) growing within the area of *Spartina cynosuroides*. This may have resulted due to freshwater runoff from the adjacent parking area. However, there are very few cattail remaining, the area is recovering naturally, and is no longer considered a problem area.

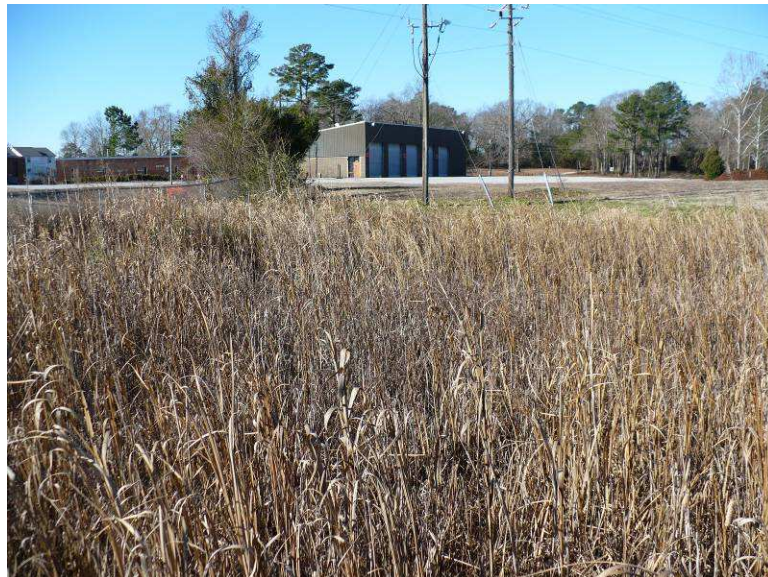
Picture 18: Cattails along edge
of marsh vegetation, taken from
boardwalk
