Wilson Bay Wetland Restoration  
Phase I  
Jacksonville, Onslow County, North Carolina

2003 Annual Monitoring Report

**Wilson Bay Wetland Restoration Site – Phase I  
Fall 2003 Monitoring Summary**

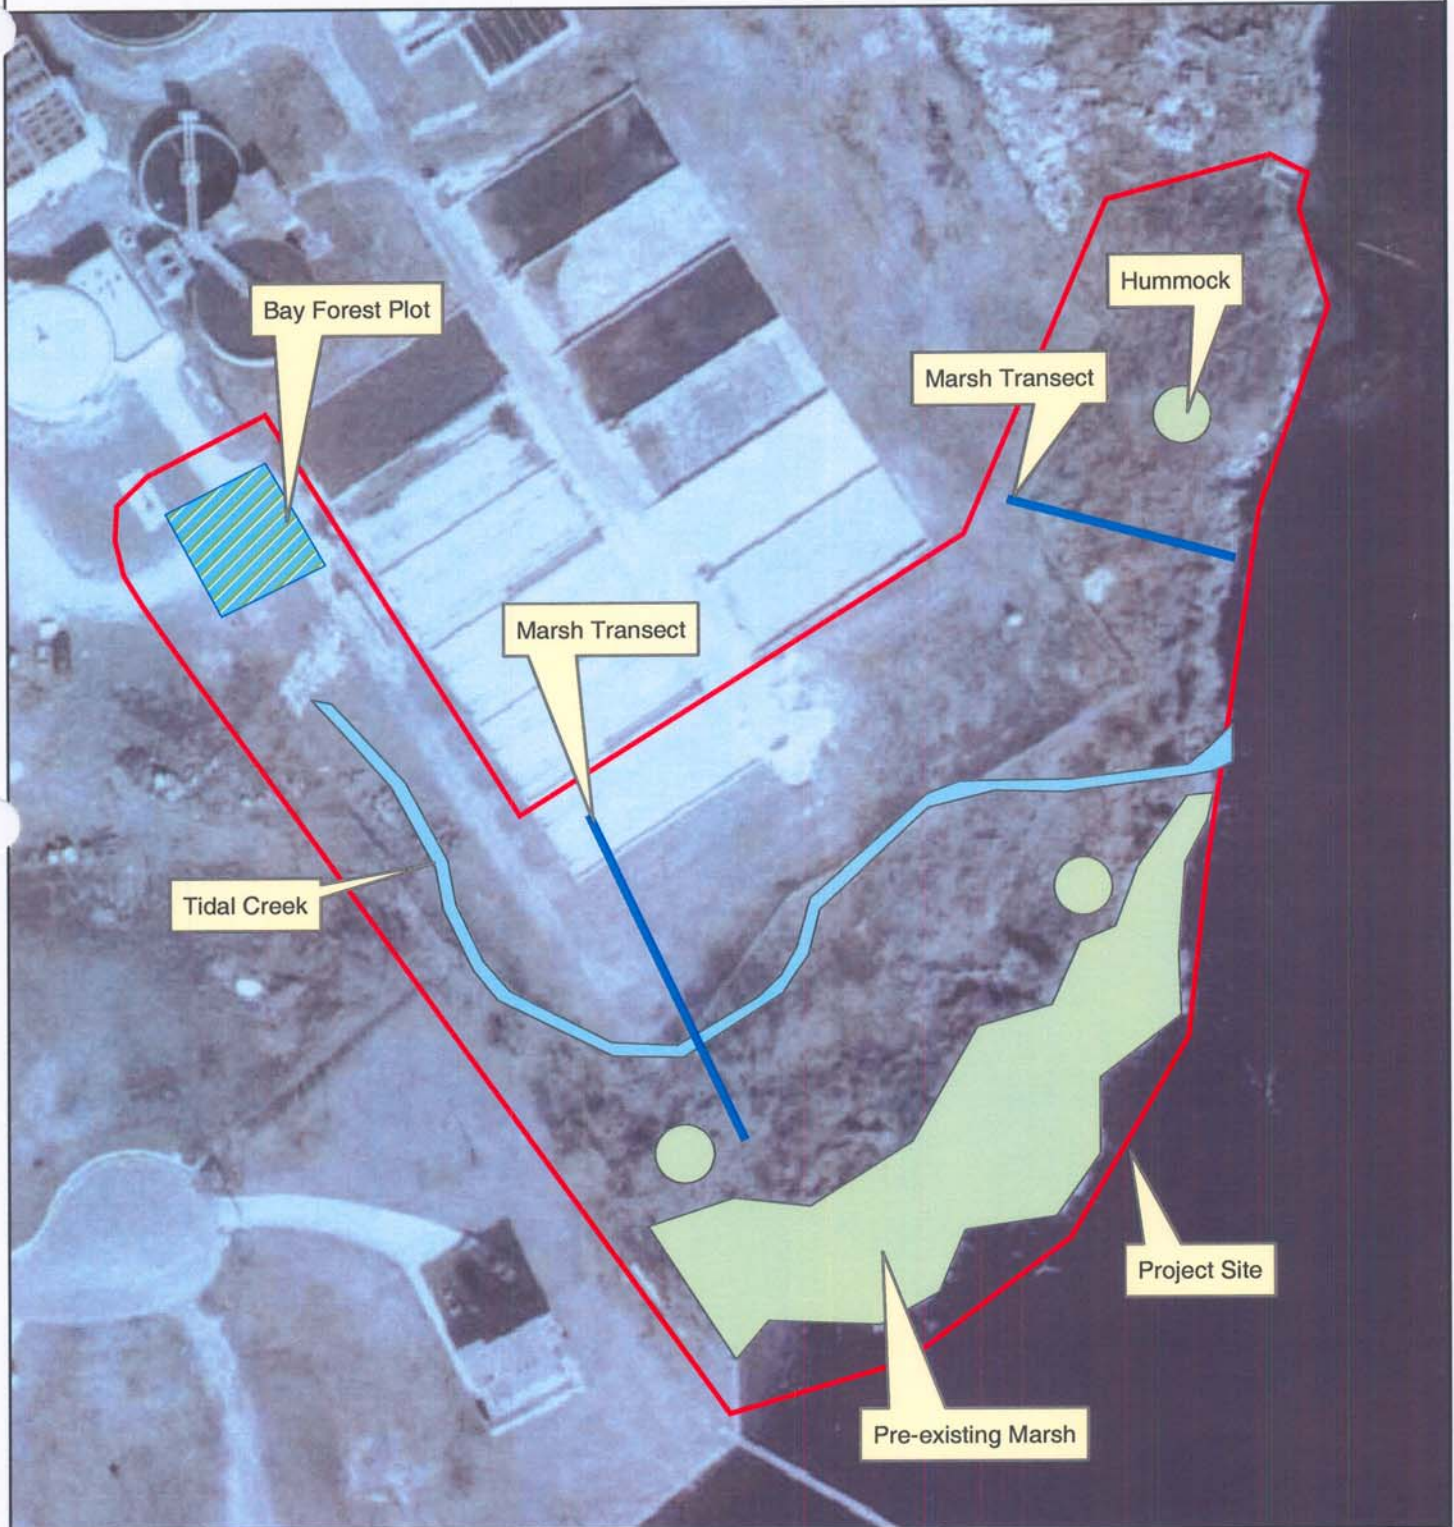
# Monitoring Map

As described in the “Draft Vegetation Monitoring Plan for NCWRP Riparian Buffer and Wetland Restoration Projects” document, belted transects were set up for recording vegetation density and survivability in the marsh areas. A total of two (2) transects were set up that run perpendicular to the shoreline from the water edge to the upper limit of the restored marsh. 1 meter x 1 meter plots were set up at various intervals along the transects. Measurements were made in three (3) plots in the *Spartina cynosuroides* areas and 1 plot in the *Spartina patens* area for each transect. A single 10 meter x 10 meter plot was set up for measuring survivability of trees in the bay forest area. Smaller nested plots were set up within this plot. A 5 meter plot was set up for recording shrubs and a 1 meter plot was set up for herbaceous measurements. Other vegetative communities at the site were found to be too small to justify additional plots. However, our staff visited each area to make observations on the health and development of those communities.

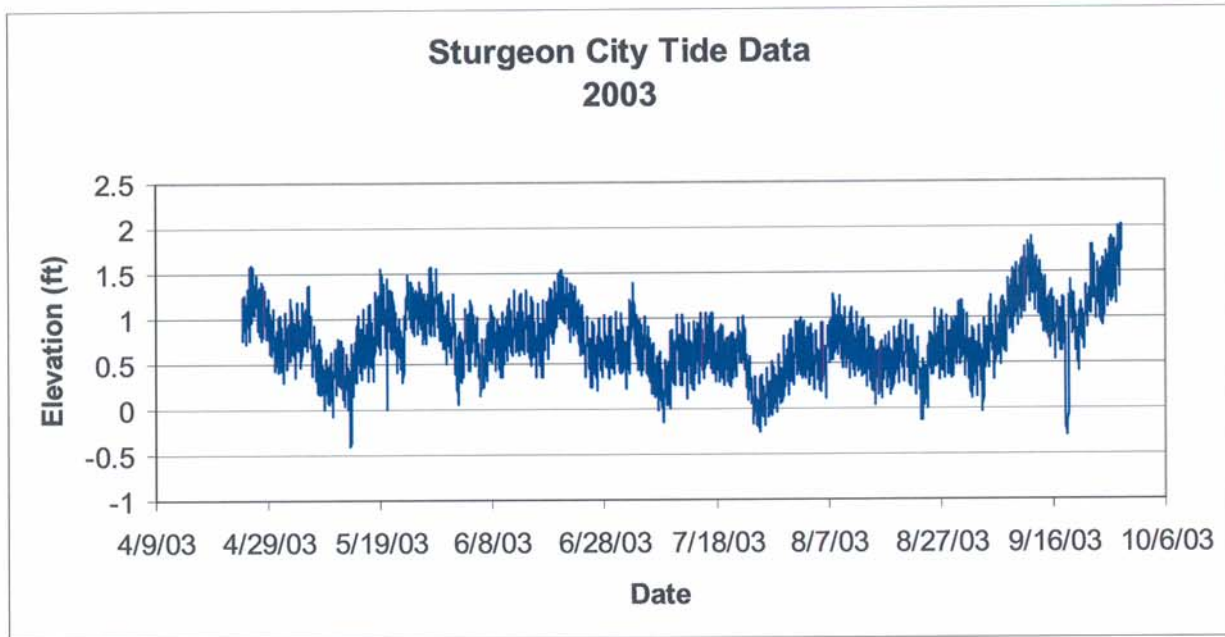
**Figure 3. Sturgeon City Tide Data**

Additional tide level data is also being recorded. This data can be used to verify and support the marsh design and development. The tide data for 2003 is shown below and was provided by the design consultant, BLUE: Land, Water, Infrastructure, PA (BLWI). The data confirms tidal fluctuations are sufficient to initiate regular overflow into the tidal marsh. Regular surface inundation of brackish water and subsequent drainage and flushing are integral to the survival and development of the designated marsh community. This type of information helps confirm hydrologic conditions in the marsh, and will be especially valuable if any problems ever develop.

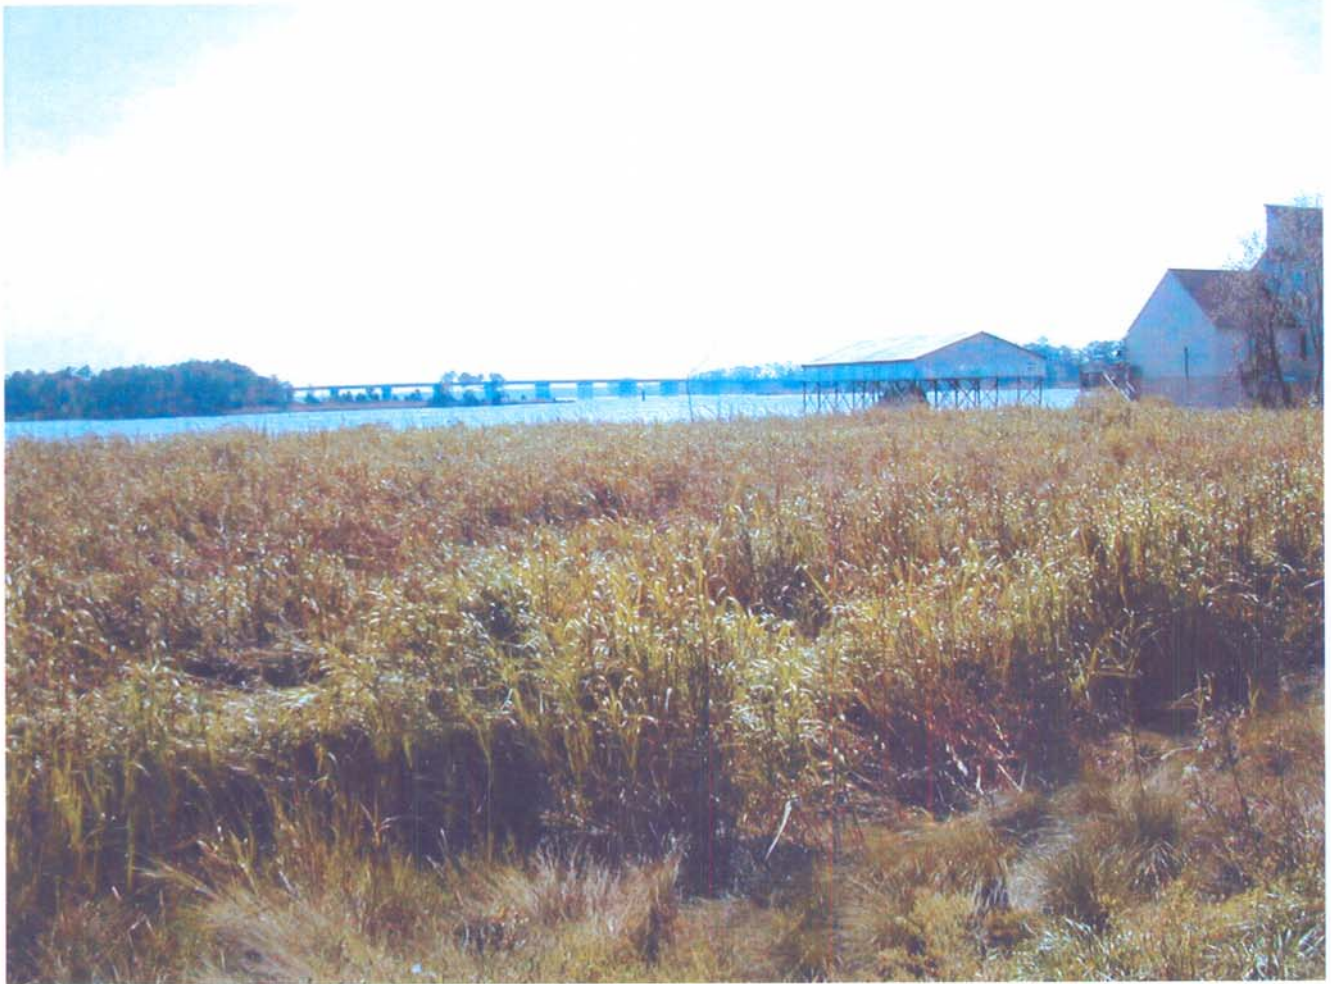
Photo 1. Marsh view from drying beds.

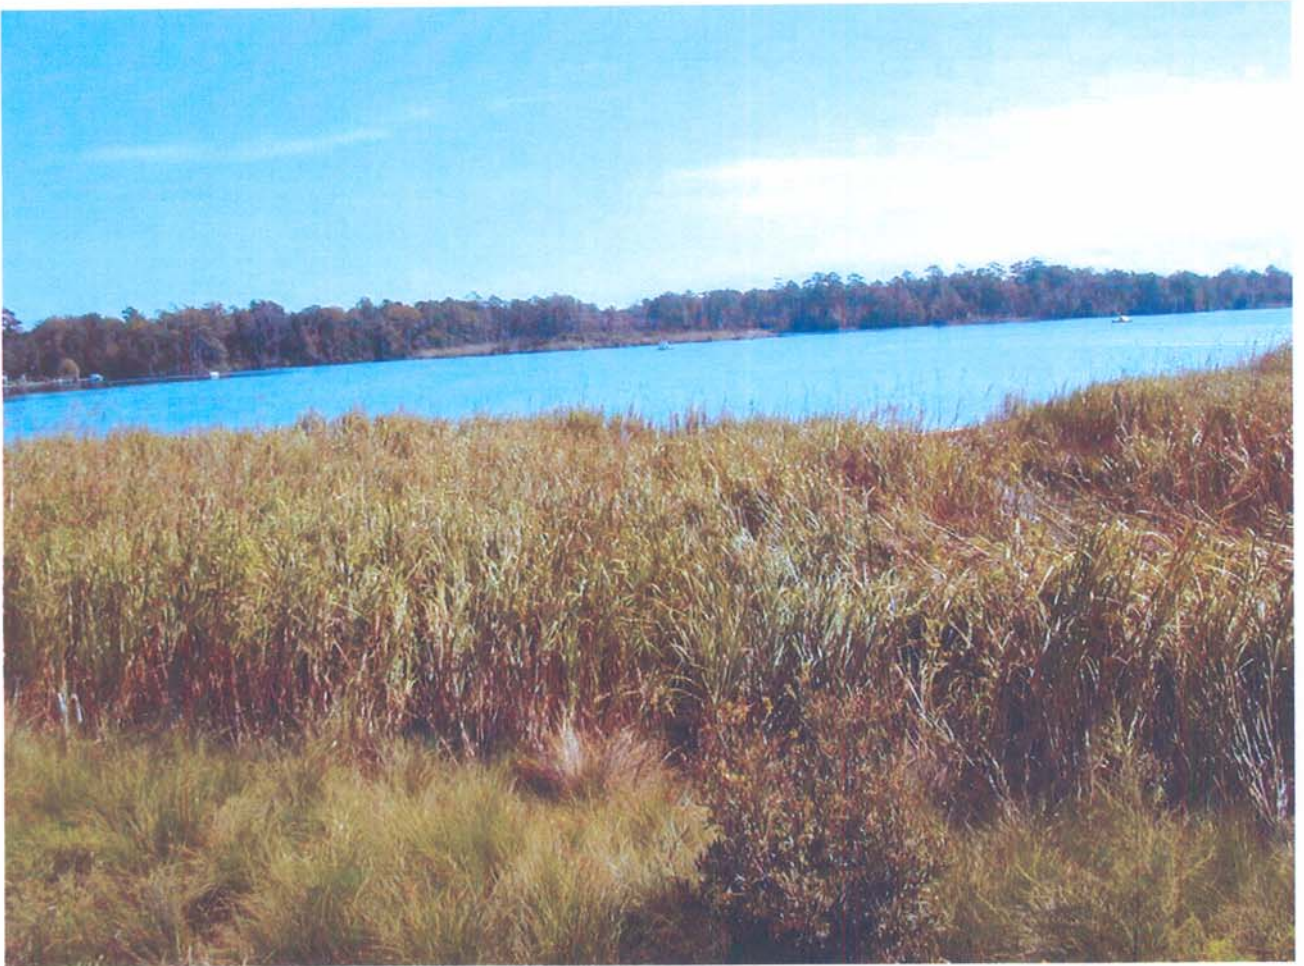
Photo 2. Marsh and Wilson Bay

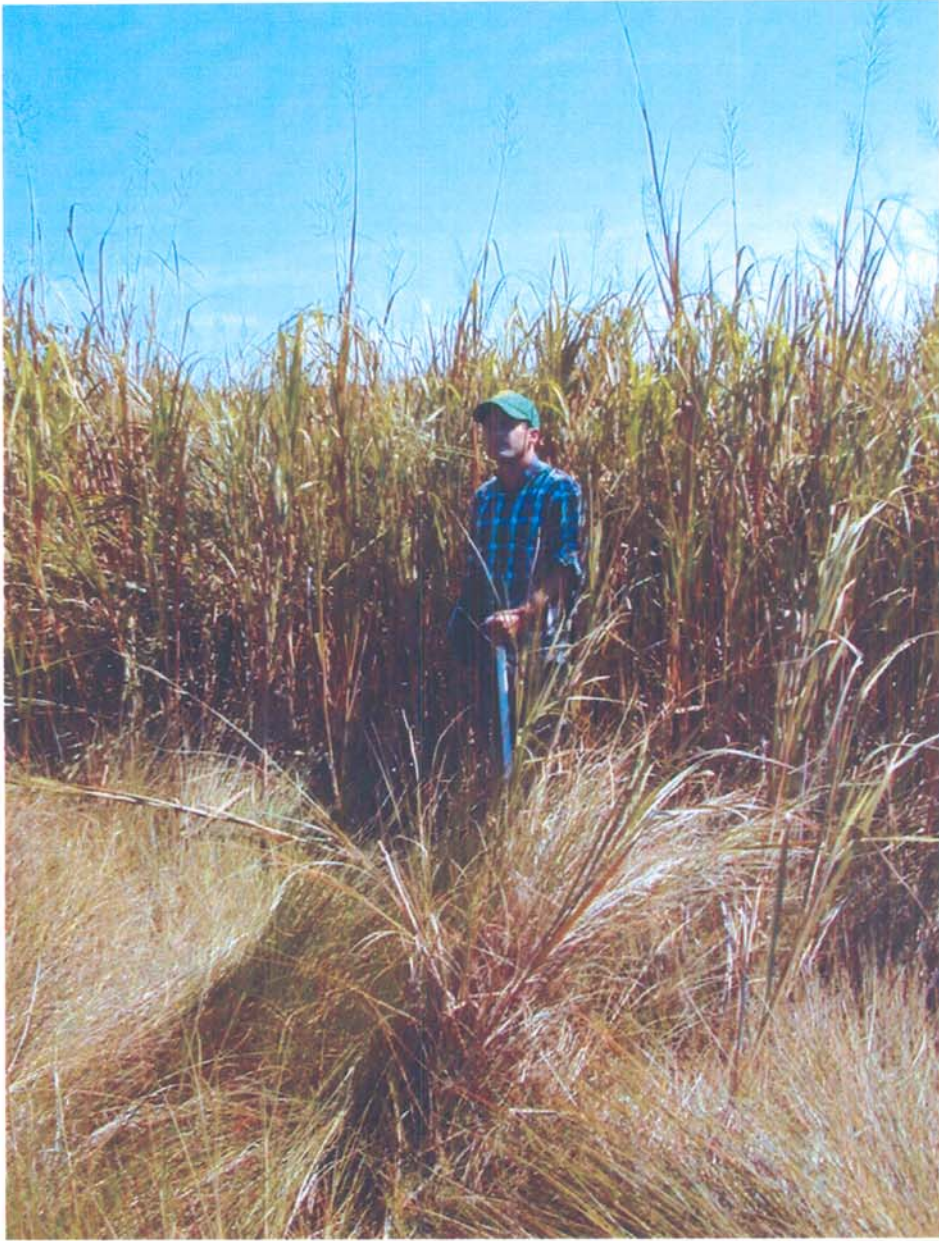
Observations in the restored marsh areas revealed a dense, healthy stand of the primary planted species. The density of *Spartina cynosuroides* made walking difficult and the average plant height was several feet above the researcher’s heads. Plot data in the *S. cynosuroides* areas resulted in a total of 392 stems in 6 plots for an average of 65 stems per plot. With an initial planting density of approximately 10,000 plants/acre (2.5 stems/plot), this indicates excellent development of the lower marsh. *Spartina cynosuroides* ranged between 6 to over 7 feet in height and covered between 35-60% of the plot surface area. Organic material buildup in most of the plots was around 0.5 inches. Old growth organic buildup, percent coverage, and general development in plots nearer the water and in the middle of the marsh was better than in plots on the upper edges.

Development in the upper marsh areas planted with *Spartina patens* was even more substantial than in the main marsh. Populations of *S. patens* were too dense to count every stem in the 1 meter plots. Plots in these areas were composed entirely of the desired species with no encroaching species found. A mat of old growth organic material between 6-8 inches thick covered the ground. New growth 2-2.5 feet in height covered 100% of the plot area.

Photo 3. Close up of Big Cordgrass and Saltmeadow Cordgrass

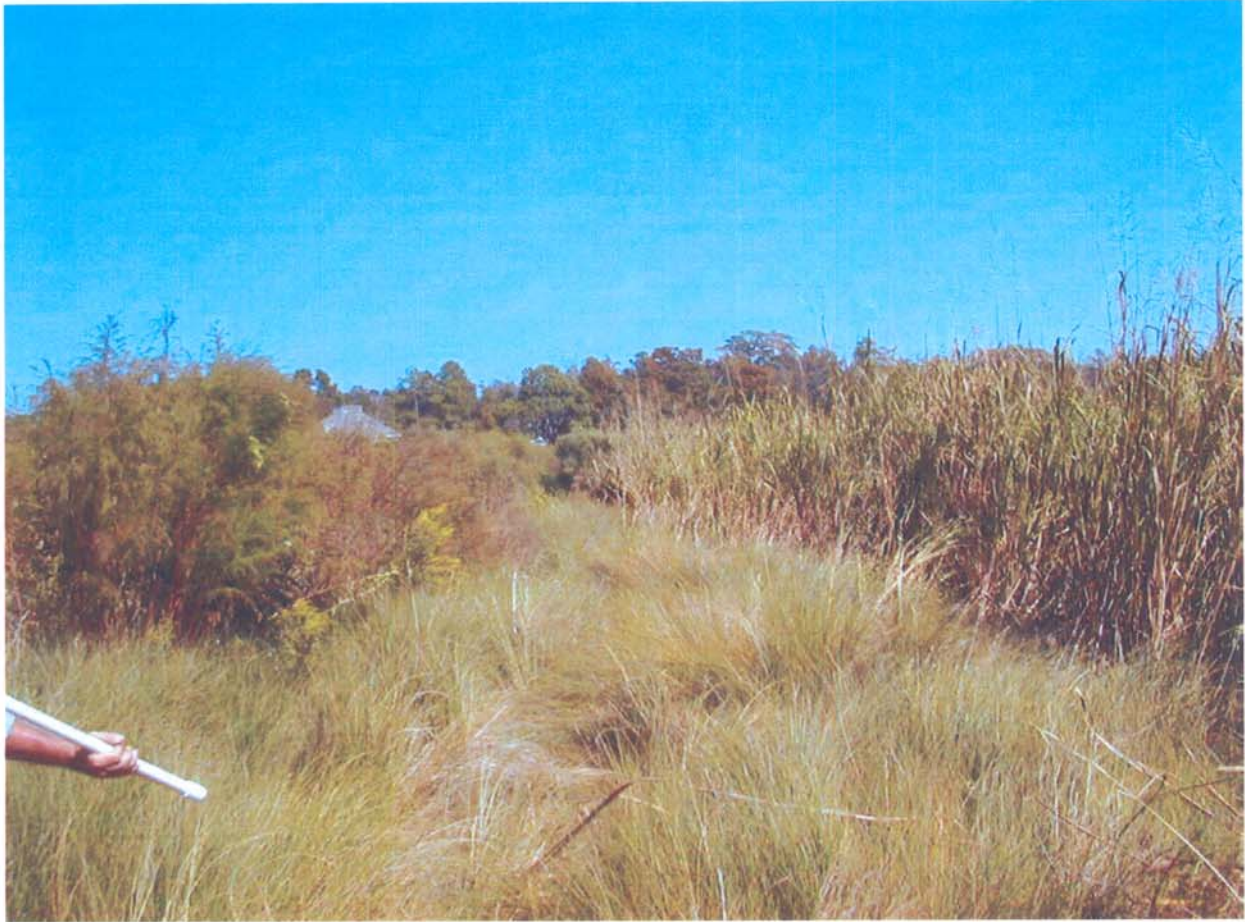
Photo 4. Transition between upper and lower marsh.

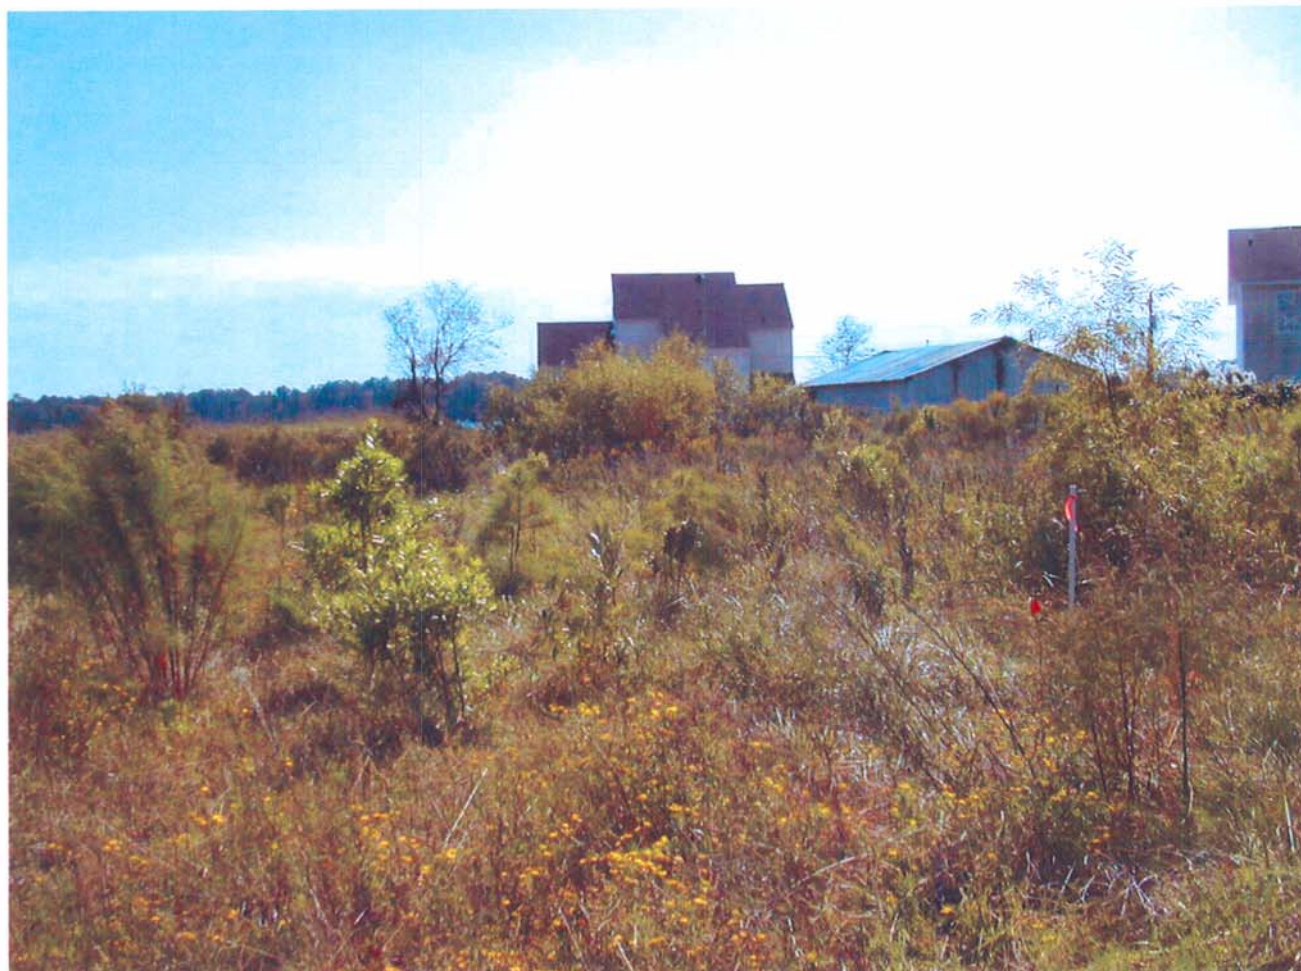
Vegetation throughout the Bay Forest appeared healthy and consisted of a combination of both planted trees and shrubs and volunteer shrubs and herbaceous plants. The wetland appeared to be going through an early successional stage despite the numerous planted shrubs and trees. This was evidenced by an abundance of *Andropogon glomeratus* throughout the area. Additionally, *Ambrosia artemisiifolia* (ragweed), *Aster* spp., and *Panicum* spp. were abundantly present within the plot, signifying early succession. *Magnolia virginiana* (sweetbay) and *Ilex coriacea* (gallberry) were the only shrubs recorded in the plot, although *Ilex glabra* (inkberry) and *Alnus serrulata* (tag alder) was located throughout the bay forest. *I. coriacea* was the dominant shrub and appeared to be thriving in transitional and freshwater wetland areas of the site. Planted trees, including *Pinus serotina* (pond pine) and *P. palustris* (longleaf pine), were the only trees located in the plot vicinity. *P. serotina* was the dominant tree in the plot, with only three stems counted. This translates into a density of 120 stems/acre. Little tree mortality was noted within the plot.

Photo 5. Bay Forest

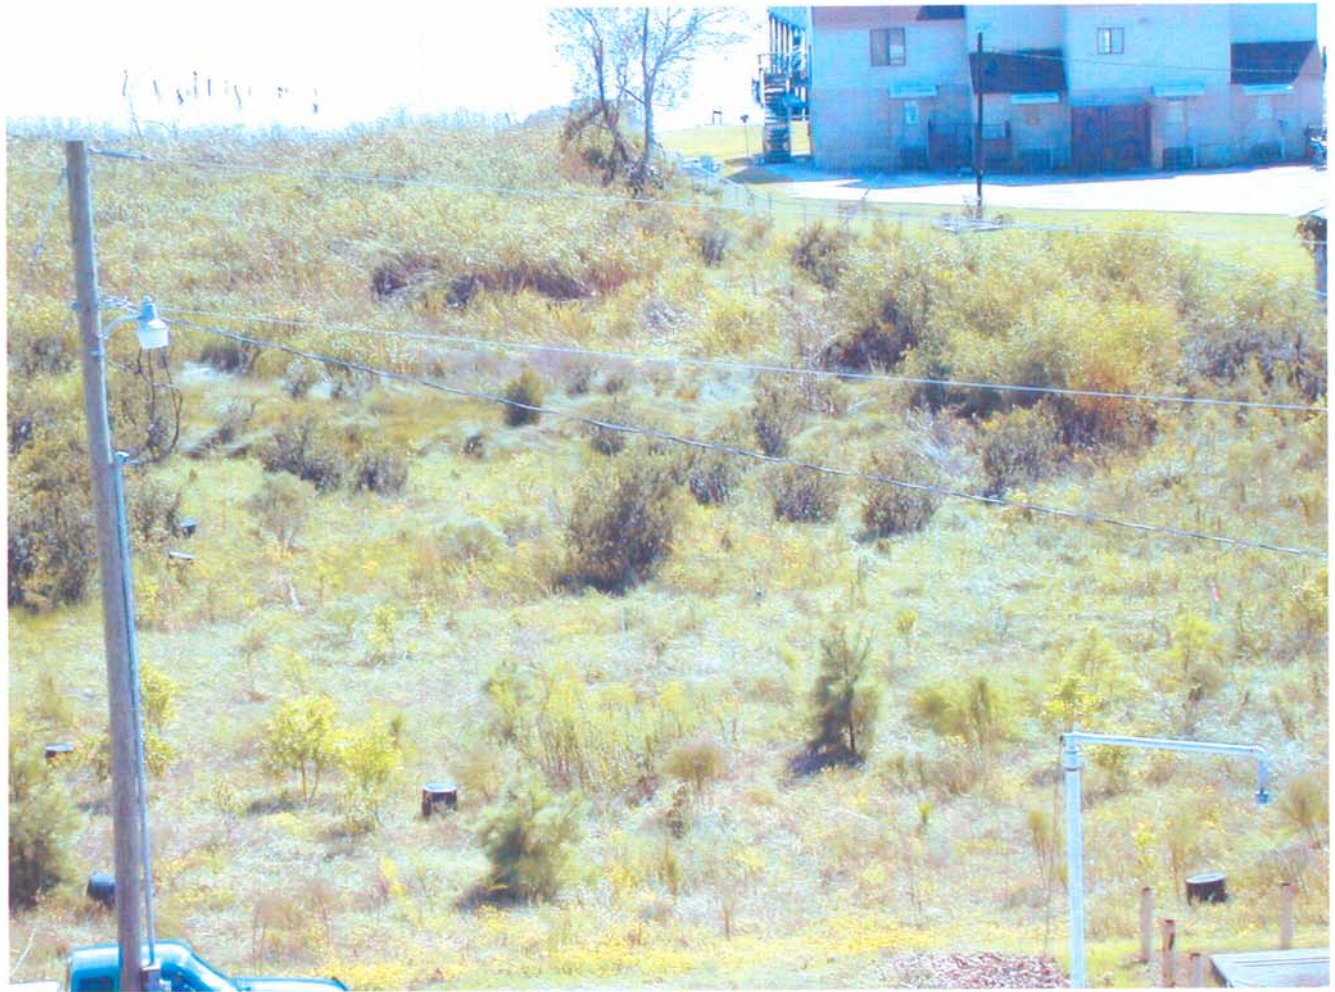
Photo 6. Overview of Bay Forest Area.
