Wilson Bay Wetland Restoration
Phase I
Jacksonville, Onslow County, North Carolina

2004 Annual Monitoring Report

December, 2004

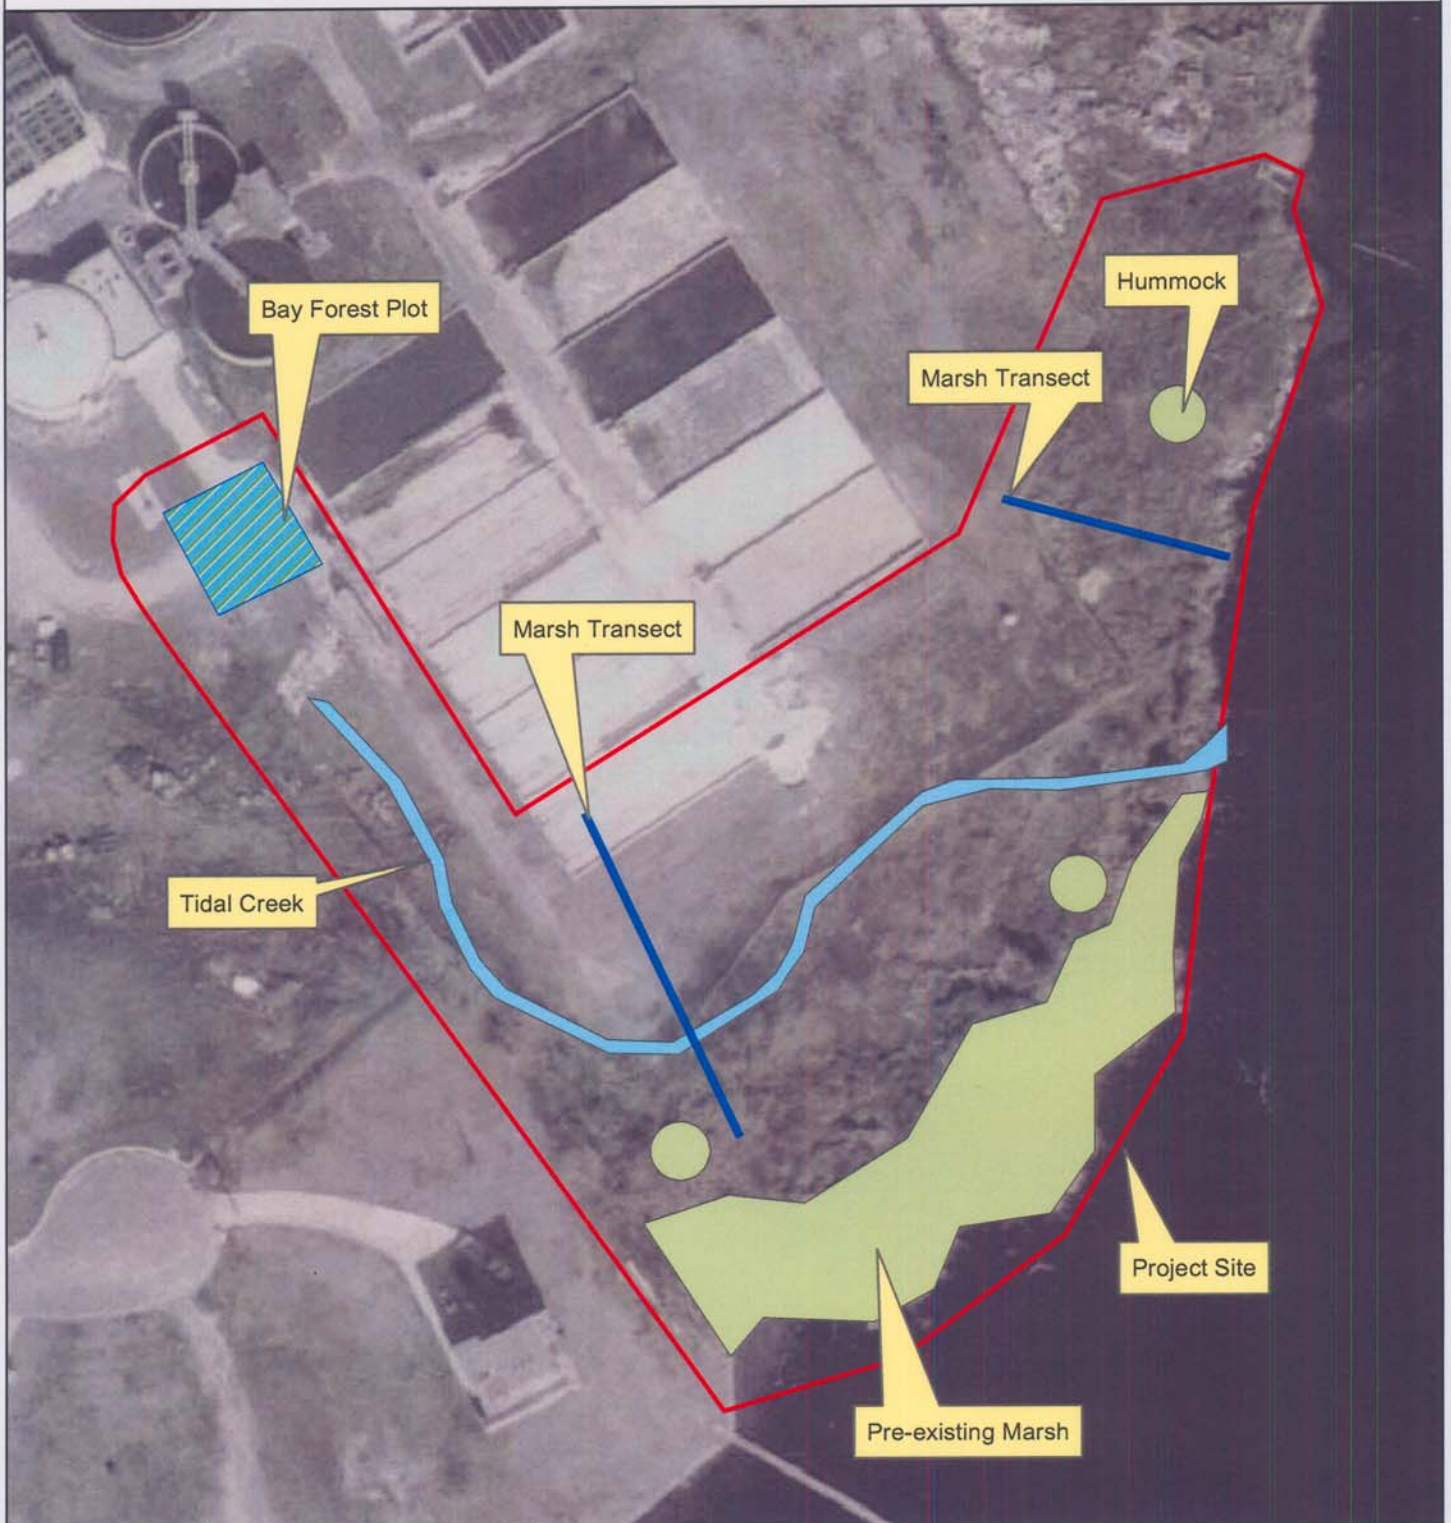
Monitoring Map

As described in the “Draft Vegetation Monitoring Plan for NCWRP Riparian Buffer and Wetland Restoration Projects” document, belted transects were set up for recording vegetation density and survivability in the marsh areas. A total of two (2) transects were set up that run perpendicular to the shoreline from the water edge to the upper limit of the restored marsh. 1 meter x 1 meter plots were set up at various intervals along the transects. Measurements were made in plots in the *Spartina cynosuroides* area and in the *Spartina patens* area for each transect. A single 10 meter x 10 meter plot was set up for measuring survivability of trees in the bay forest area. Smaller nested plots were set up within this plot. A 5 meter plot was set up for recording shrubs and a 1 meter plot was set up for herbaceous measurements. Other vegetative communities at the site were found to be too small to justify additional plots. However, our staff visited each area to make observations on the health and development of those communities.

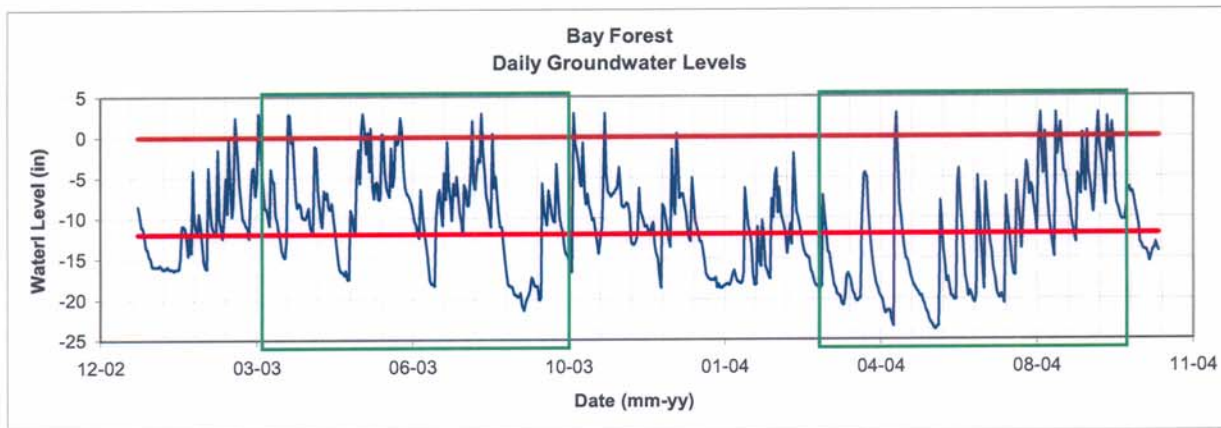
Figure 3. Bay Forest Groundwater Data

Figure 3 depicts water table depths in the Bay Forest area in the 2003 and 2004 growing seasons. The green boxes show the growing seasons, which are marked between March and October. General hydrologic criteria involve resulting groundwater levels within 12 inches of the surface for at least one period lasting 12.5% of the growing season. With the growing season beginning mid to late March and running through October, this would result in a period between 25-30 days. In both years, there were multiple periods during the growing season where the water table depth was within 12 inches of the surface. There were 7 periods ranging from 3-42 days in duration during 2003 and 9 periods ranging from 2-47 days in duration in 2004. Three periods in 2003 and one period in 2004 lasted longer than 25 days. It appears that the hydrology of this site is meeting the needs of the Bay Forest area and the planted woody vegetation.

A groundwater gage was installed in the bay forest area of the site. The gage was installed soon after construction activities were completed at the site. The gage is made by Remote Data Systems (RDS). The gage is set to record the water table depth once each day. Data download during the first monitoring visit was unsuccessful. Data downloads during the spring and fall visits in 2004 were both successful, and the data from 2003 was able to be retrieved.

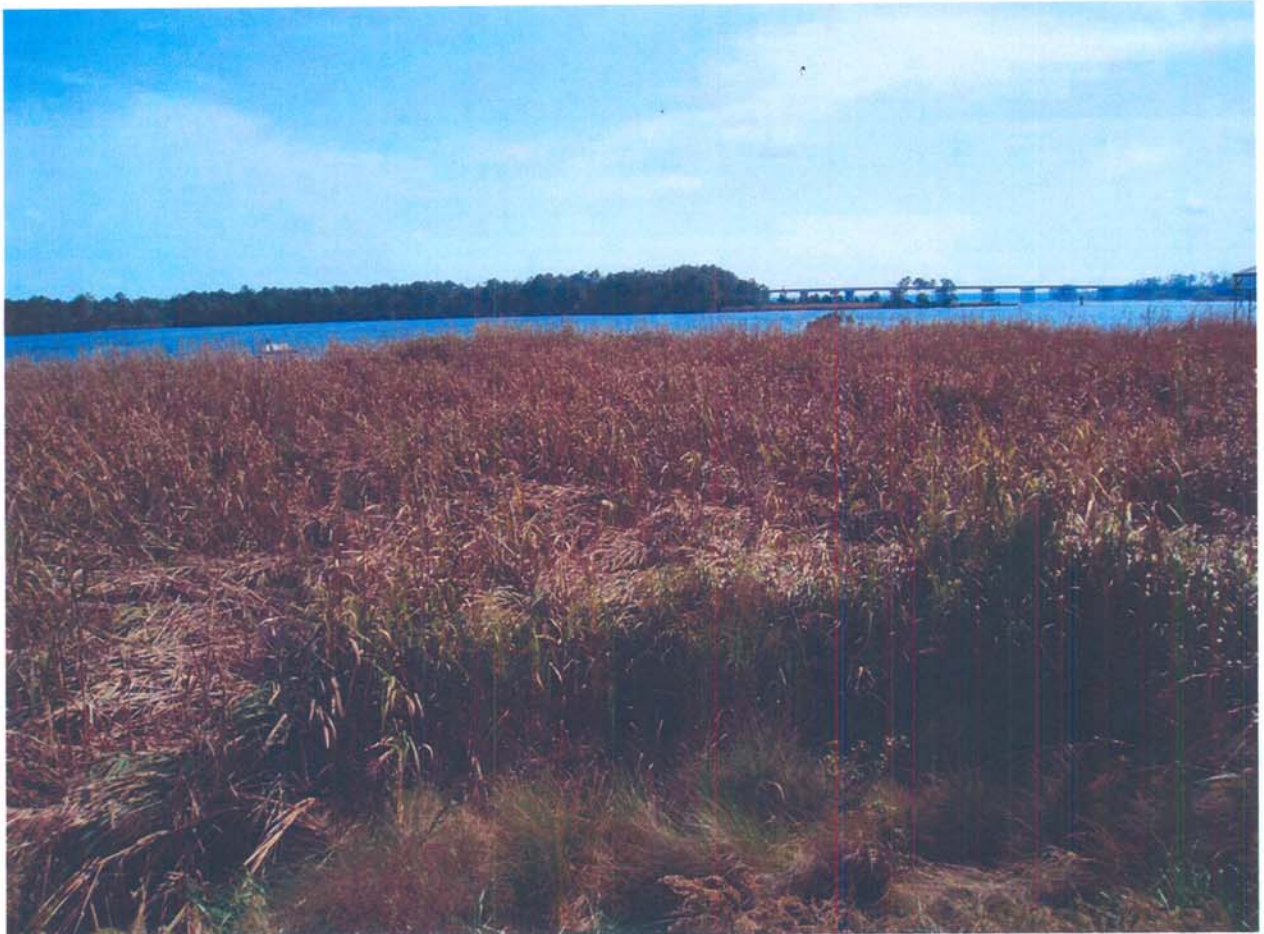
Photo 1. Marsh view from drying beds.

Observations in the restored marsh areas revealed a dense, healthy stand of the primary planted species. The density of *Spartina cynosuroides* made walking difficult and the average plant height was above the researcher’s heads. Plot data in the *S. cynosuroides* areas resulted in a total of 230 stems in 4 plots for an average of 58 stems per plot. Although the overall average is slightly lower than in 2003 (65 stems/plot), the marsh may have already reached a near maximum stem count. *Spartina cynosuroides* ranged between 5.5 to 6.5 feet in height and covered between 35-60% of the plot surface area. Organic material buildup in most of the plots was around 0.5 inches. Marsh communities along the shoreline were more developed this year compared to 2003.

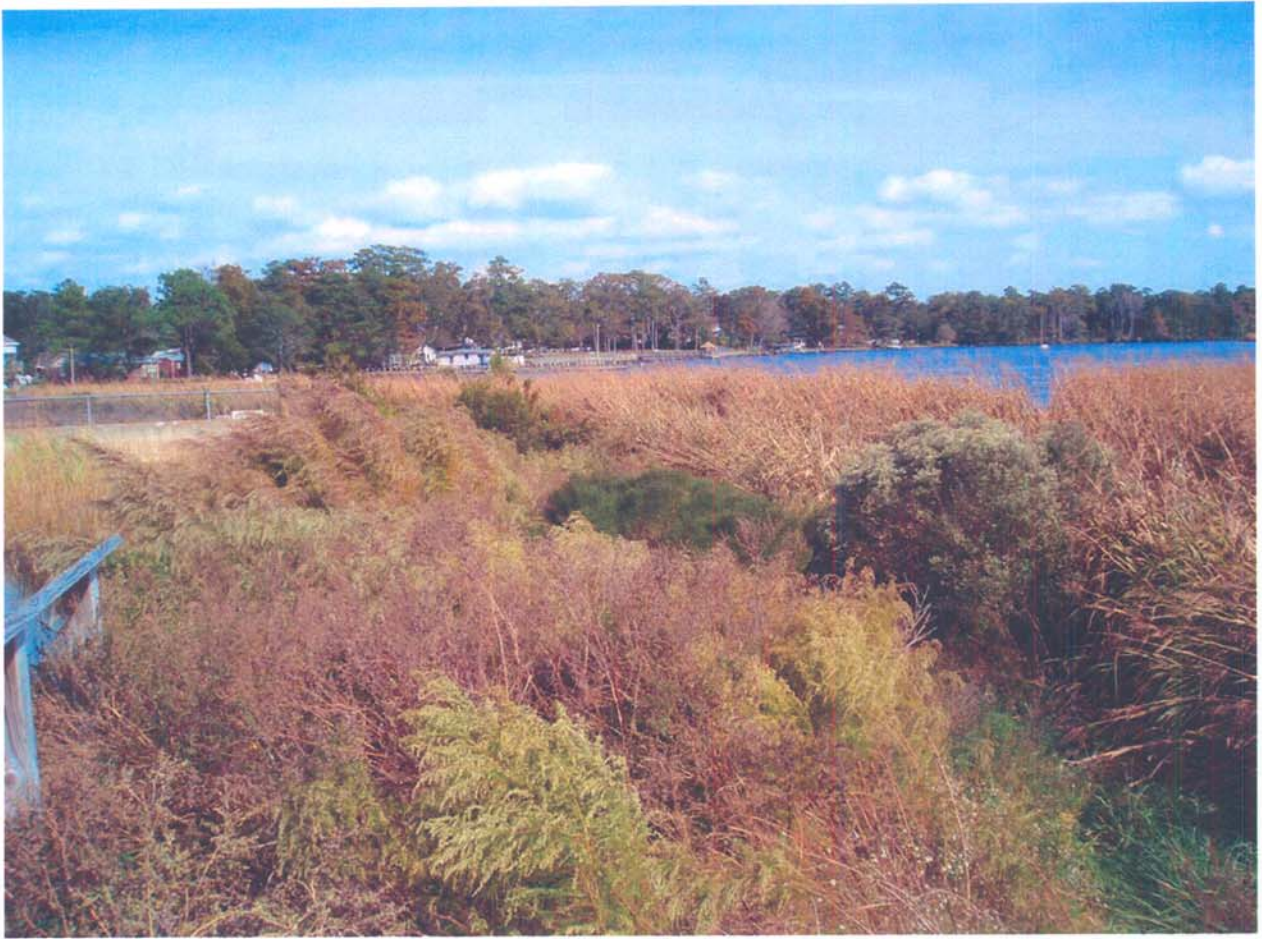
Photo 2. Marsh and Wilson Bay

Marsh areas throughout the site have exceeded survivability requirements as proposed in the monitoring plan for the site. Based on observations, the site is developing similarly to reference marsh area, although no reference measurements were made.

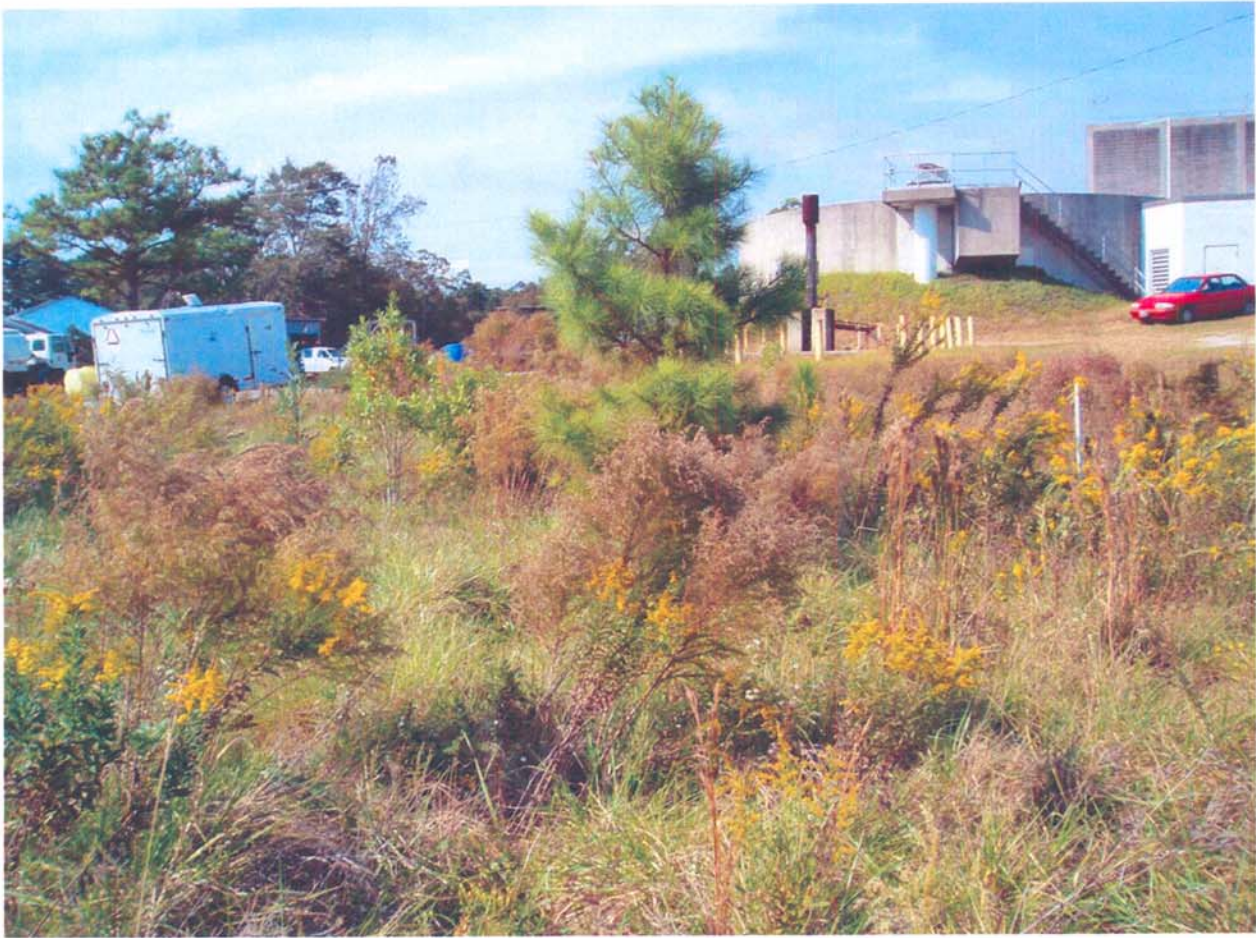
Photo 3. Bay Forest Area.

Vegetation throughout the wetland appeared healthy and consisted of a combination of both planted trees and shrubs and volunteer shrubs and herbaceous plants. The wetland appeared to be going through an early successional stage despite the numerous planted shrubs and trees. This was evidenced by an abundance of *Andropogon glomeratus* throughout the area. Additionally, *Ambrosia artemisiifolia* (ragweed), *Aster* spp., and *Panicum* spp. were abundantly present within the plot, signifying early succession. *Myrica cerifera* (wax myrtle) and *Ilex coriacea* (gallberry) were the only shrubs recorded in the plot, although *Ilex glabra* (inkberry) and *Alnus serrulata* (tag alder) were located throughout. *I. coriacea* was the dominant shrub and appeared to be thriving throughout the entire site. Planted trees, including *Pinus serotina* (pond pine) and *P. palustris* (longleaf pine), were the only trees located in the plot vicinity. *P. serotina* was the dominant tree in the plot, with only three planted stems counted. Three volunteer species of the pine were also noted. Extrapolation gave a value of 120 planted trees per acre. No tree mortality was noted within the plot.
