**Wilson Bay (Sturgeon City) Wetland Restoration  
Phase I  
Jacksonville, Onslow County, North Carolina**

*2005 Annual Monitoring Report  
Year 5 of 5*

NCEEP Project Number: .00090  
BLWI Project Number: 050038  
NCDENR contract: D05056S

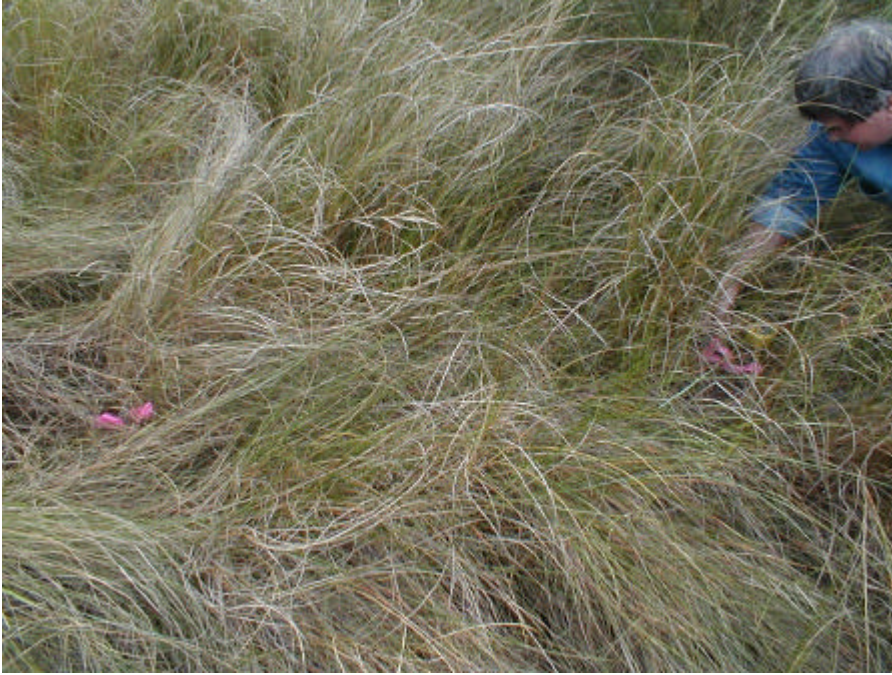
P1

Transact 1 was shifted slightly to a new location for this monitoring report because of boardwalk construction which did not allow the transact to be observed in its original location. Overall, the transects showed good tidal water flow throughout the habitat and the *Spartina cynosuroides* marsh has a very good old growth organic mat substrate being formed. The marsh has matured enough to have very little problem with invasive species. The *Spartina patens* marsh was impacted by construction of the boardwalk, but has recovered well over the last year. Small patches of Goldenrod continue to be a minor problem.

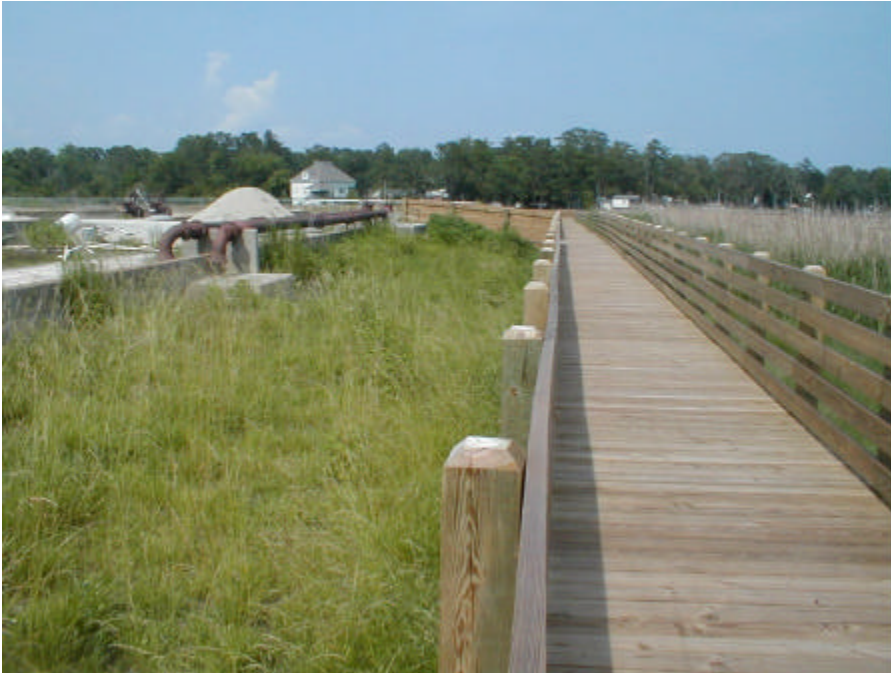
Exhibit Table VII. Vegetative Problem Areas			
Project Number and Name: 050038 Sturgeon City Phase I			
Feature/Issue	Area	Probable Cause	Photo #
Salt shrub, <i>Spartina patens</i> . vegetation removal	1,920 sf	Construction of Boardwalk along drying beds	VPA-1,

VPA-1 Salt shrub removal along drying beds for boardwalk construction 1

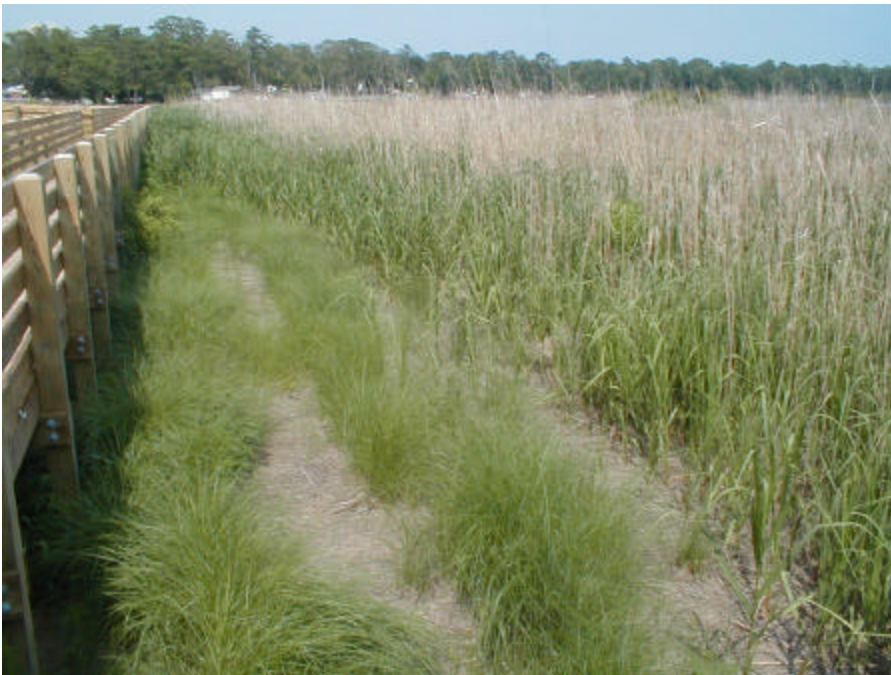
An area of *Spartina patens* was disturbed during boardwalk construction along the drying beds, but the site appears to be reestablishing well.

Table XI. Wetland Problem Areas			
Project Number and Name: 050038 Sturgeon City Phase I			
Feature/Issue	Area	Probable Cause	Photo #
Spartina patens vegetation removal	1,280 sf	Construction of boardwalk along drying beds	WPA-1

WPA-1 *Spartina patens* trying to reestablish after boardwalk construction

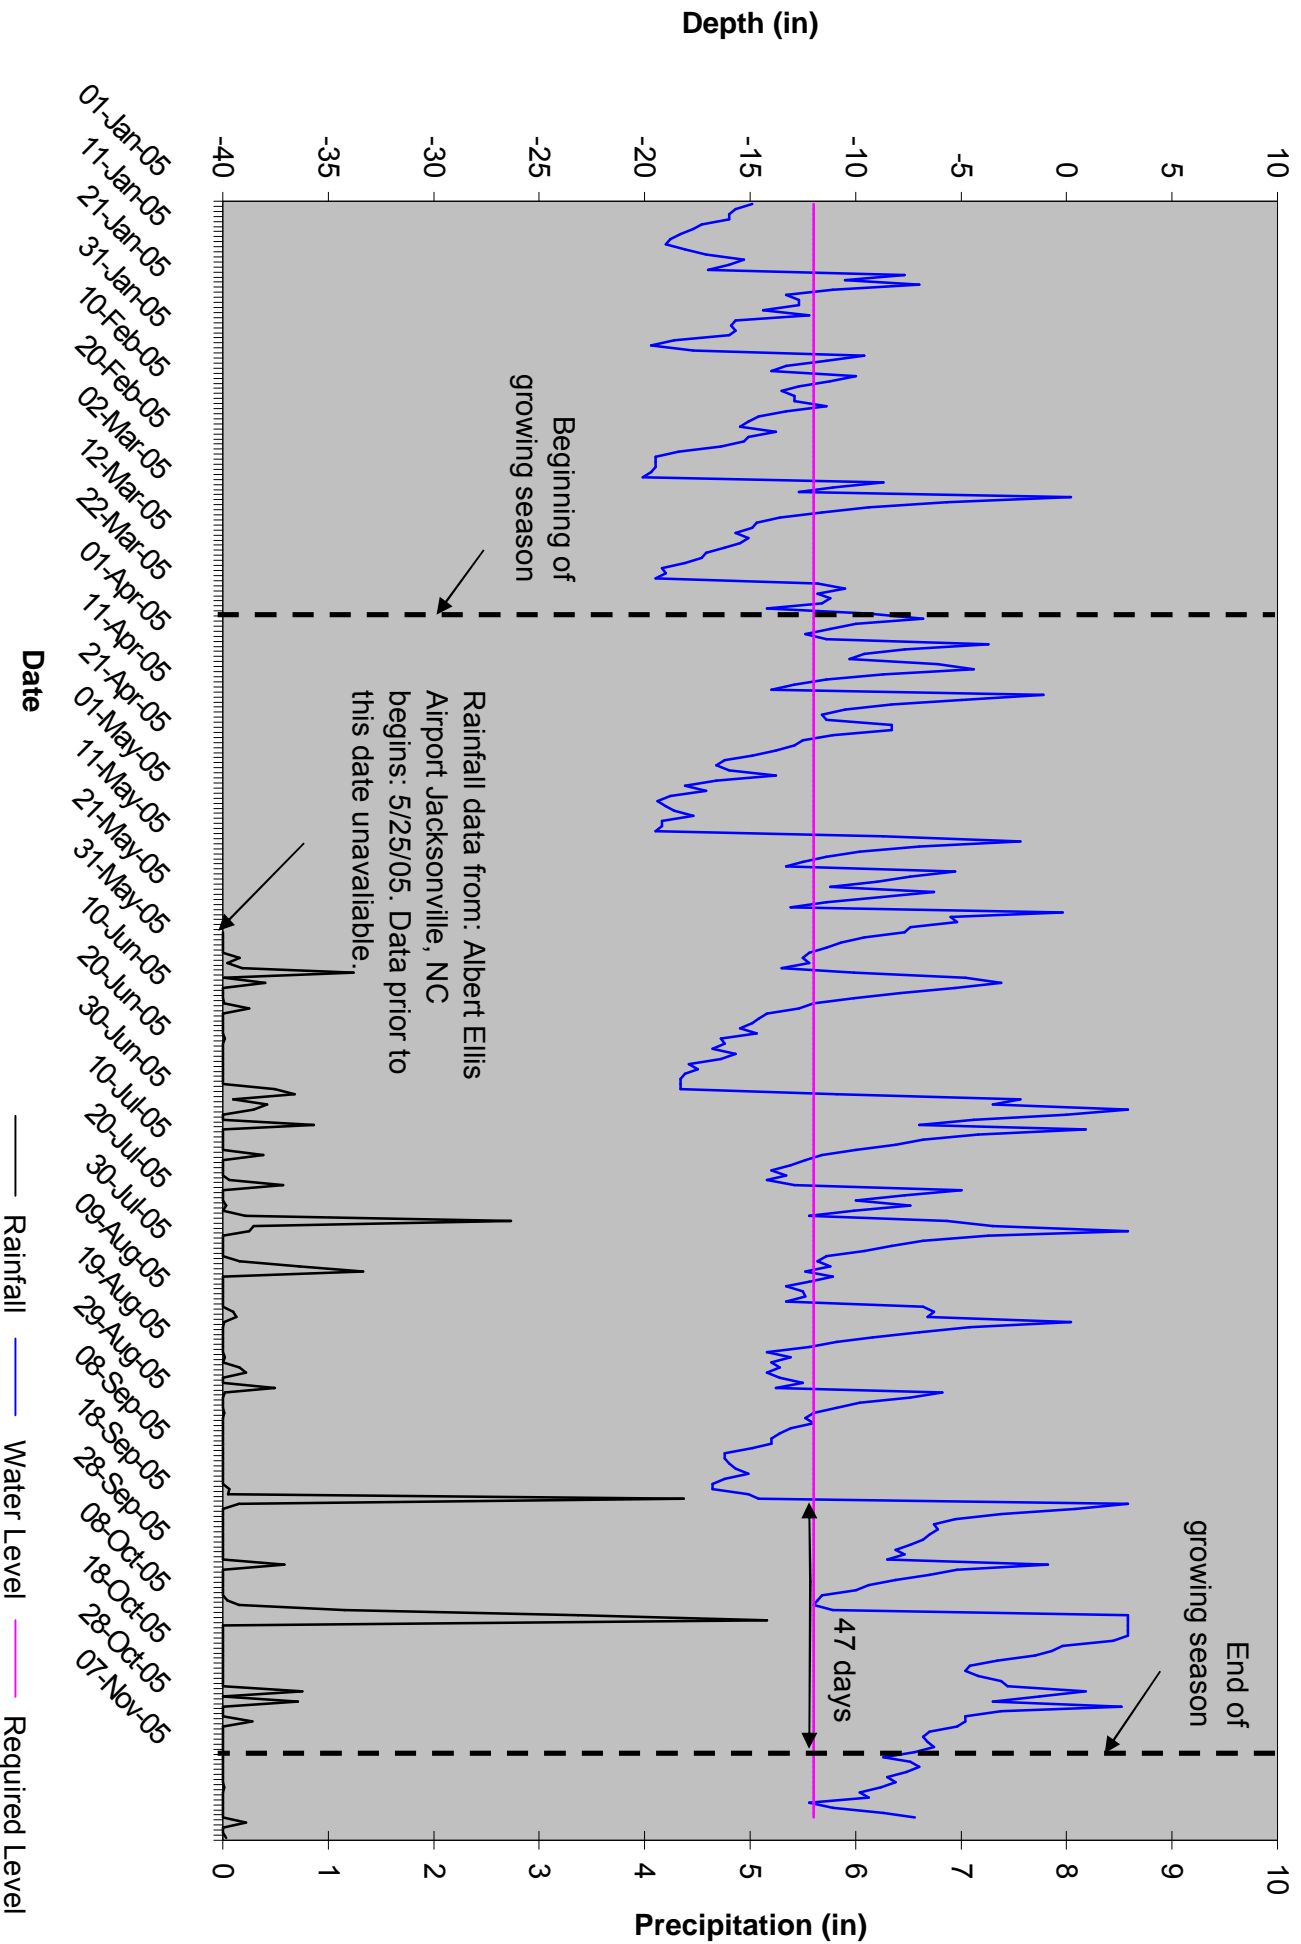
Sturgeon City Phase I  
 S353919  
 (Figure 5)

There is only one ground water well, RDS WL-40, located within the project area. It is the upper portion of the bay forest. The site (visual observation) indicates the marsh area seems to exhibit appropriate hydrology (tidal) to support the targeted marsh habitat (see Figure 5). From the beginning of January 2005 through the end of November 2005 ground water levels which support wetland status were maintained. During this year higher than normal rainfall during the months of September and October were the result of hurricane Ophelia and a tropical storm.

For the upcoming closeout year, the water level/tide data collected by the City of Jacksonville staff should be verified and used to support hydrologic conditions. This data would show monthly trends in water level fluctuations in the creek, marsh and fringed wetlands; areas where data is unavailable.
