ANNUAL MONITORING REPORT WILSON BAY (STURGEON CITY) PHASE I

WETLAND RESTORATION
ONslow COUNTY, NORTH CAROLINA
(EEP Project Number .00090)

Monitoring Year 6 (2006)

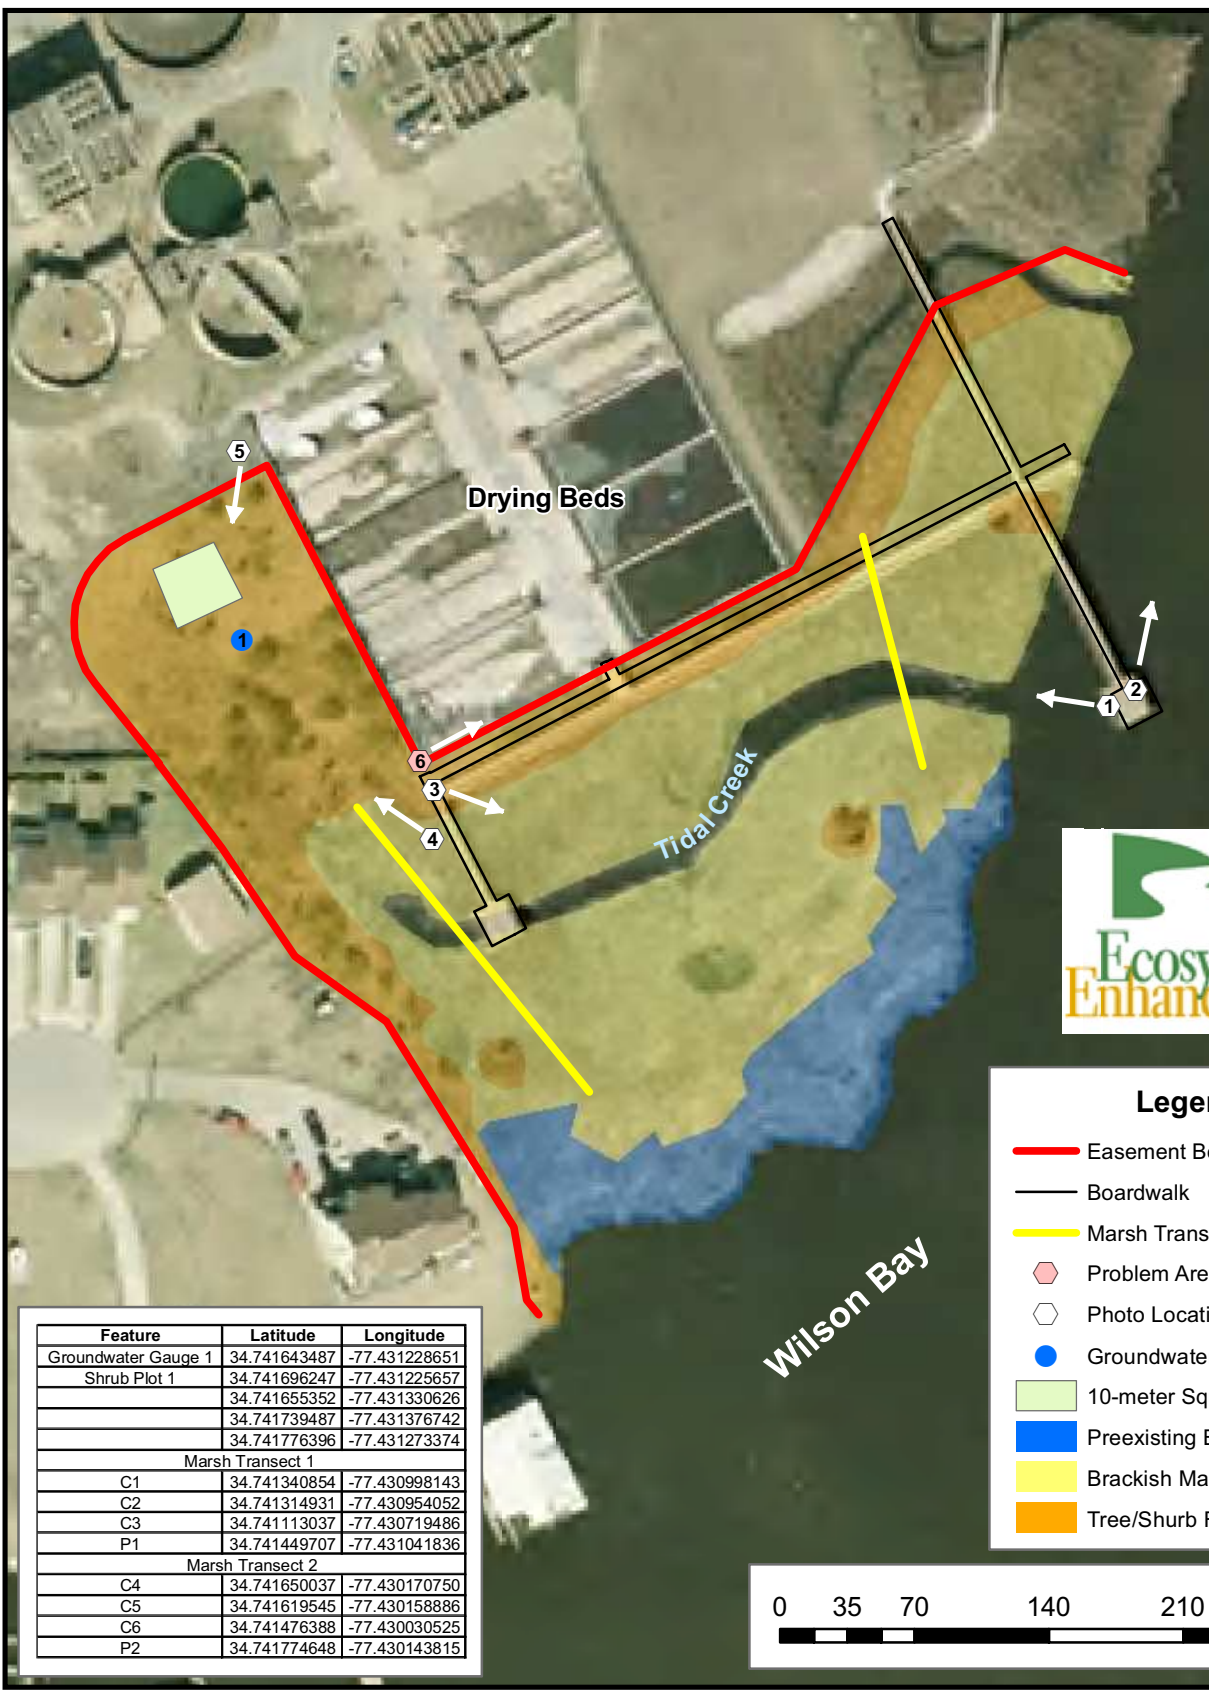
FIGURE
2

Monitoring activities for the Site, including relevant structures and utilities, project features, specific project structures, and monitoring features are detailed in Figure 2.

Site features have been monitored with one 10-meter square shrub/bay forest vegetation plot, eight 1-meter square marsh grass vegetation plots along two transects, one continuous recording groundwater gauge, and photographic documentation.

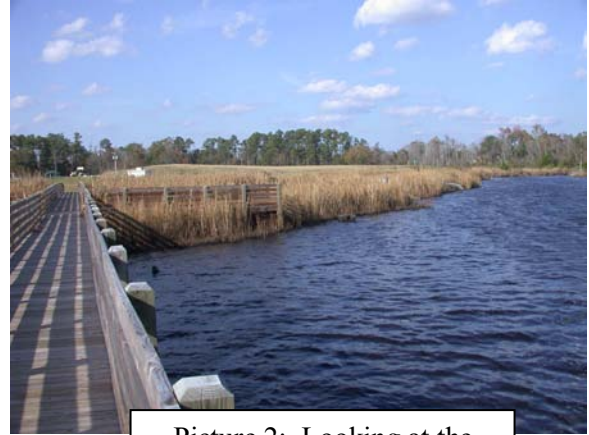
Picture 2: Looking at the edge of the marsh from dock

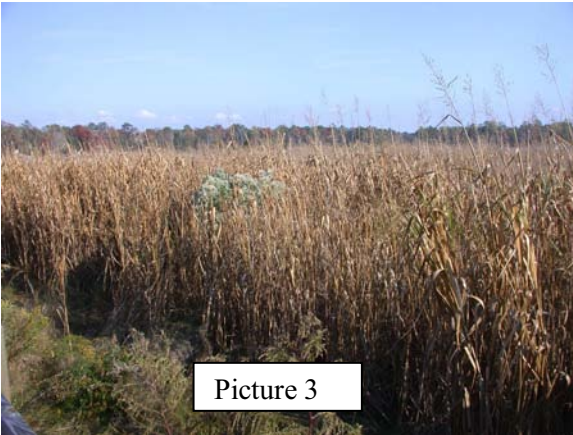
Picture 3

Photographs taken in the vegetation monitoring area are included in Appendix A; locations of each are depicted on Figure 2. The photographs show that the marsh grasses are growing well and the shrub/bay forest area continues to mature with a diversity of woody and herbaceous species.

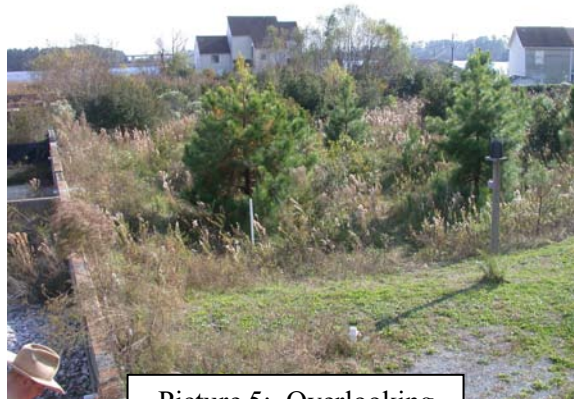
Picture 5: Overlooking the shrub area

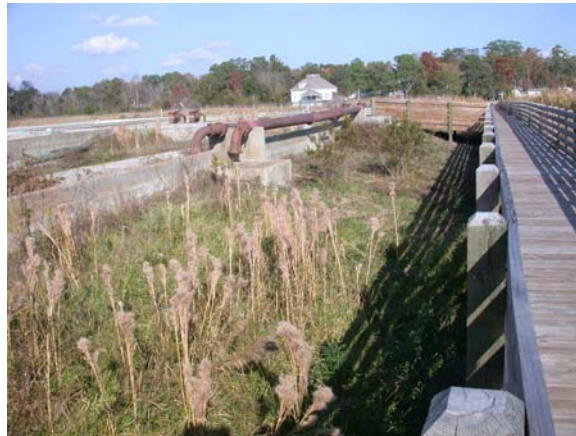
Table 6. Vegetation Problem Areas			
Wilson Bay (Sturgeon City) Wetland Restoration Phase I (EEP Project Number .00090)			
Feature/Issue	Location	Probable Cause	Photo
Vegetation removal	Between the drying beds and the boardwalk	Vegetation removal associated with boardwalk construction	Problem Area Photo 6 (Appendix A)

Picture 6: This area had been mowed and shrubs were removed between the boardwalk and the drying basins. However, the area is started to recover and is expected to recover naturally.

Vegetation problem areas within the Site are depicted on Figure 3 and are outlined in Table 6. Vegetation problem areas include an area between the drying beds and the boardwalk along the edge of the Site where vegetation had been removed prior to year 6 (2006) monitoring. However, this area is beginning to recover and is expected to recover naturally as long as vegetation removal activities are not resumed.

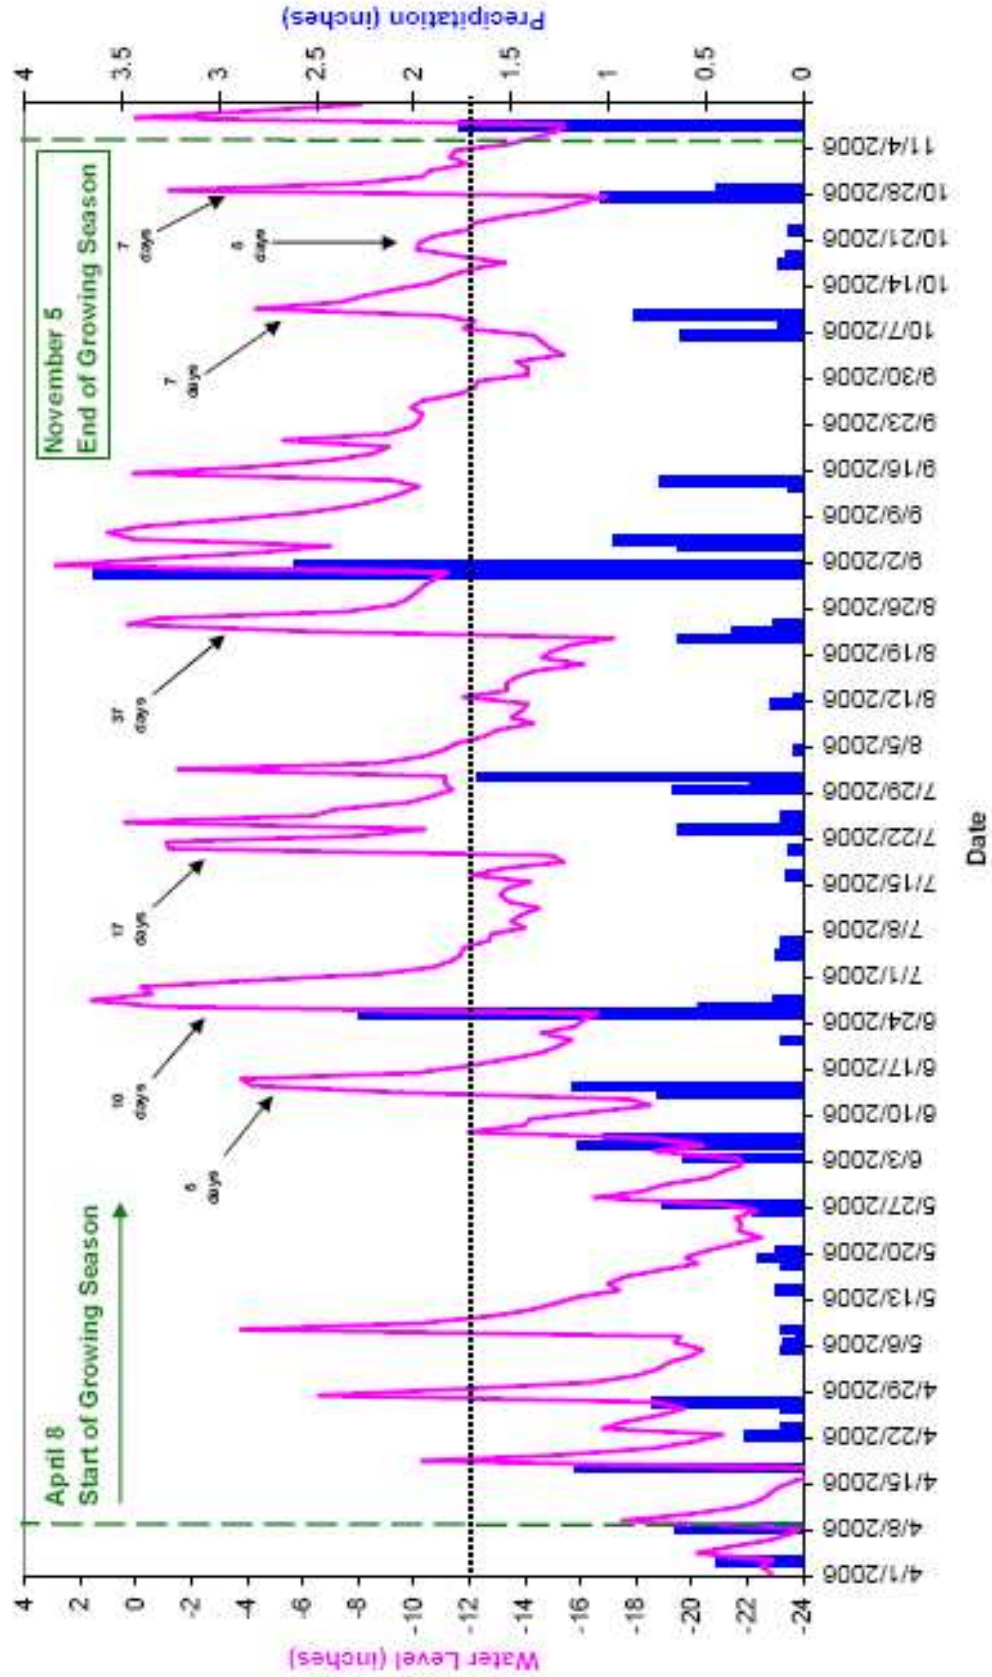
Sturgeon City (Wilson Bay) Phase I
Year 6 (2006 Gauge Data)

Groundwater hydrology within 12 inches of the soil surface occurred for greater than 12.5 percent of the growing season for the year 6 (2006) growing season with 37 days (17.5 percent) of consecutive saturation or inundation. The gauge has met success criteria each year since its installation.

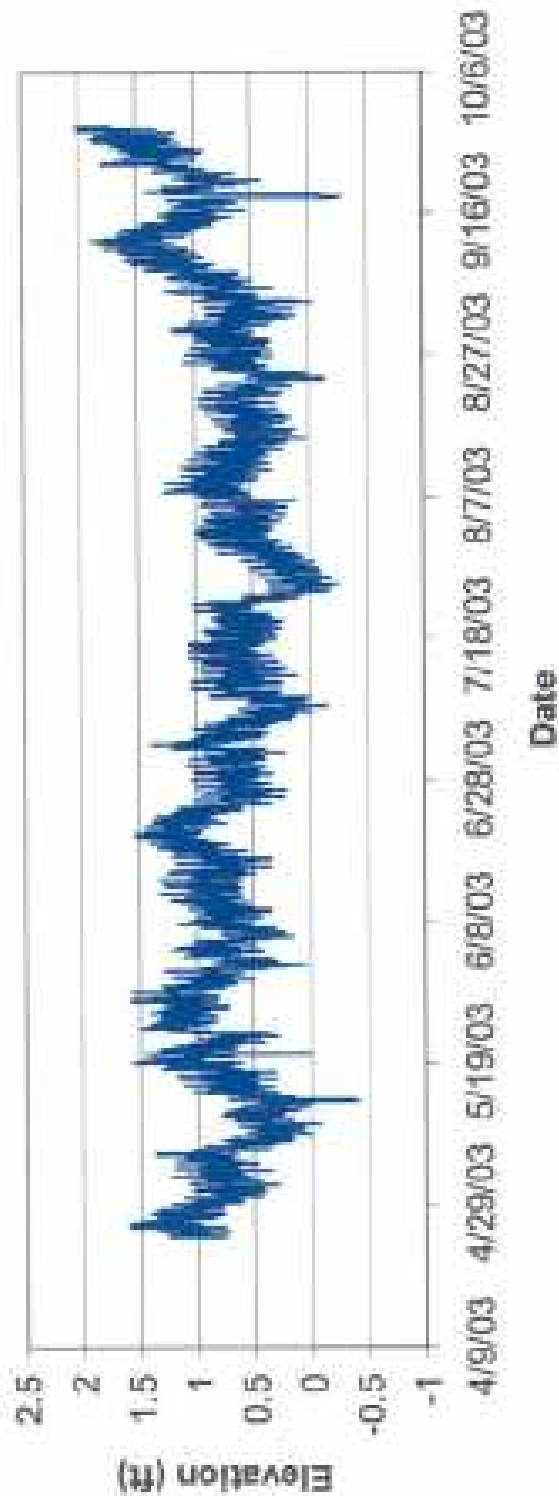
**Sturgeon City Tide Data
2003**

APPENDIX E
YEAR 3 (2003) GROUNDWATER GAUGE GRAPH
