Executive Summary of Design

Suck Creek Stream Restoration Project Moore County, North Carolina

Prepared for:
NCDENR-Wetlands Restoration Program
Raleigh, North Carolina

May 2002

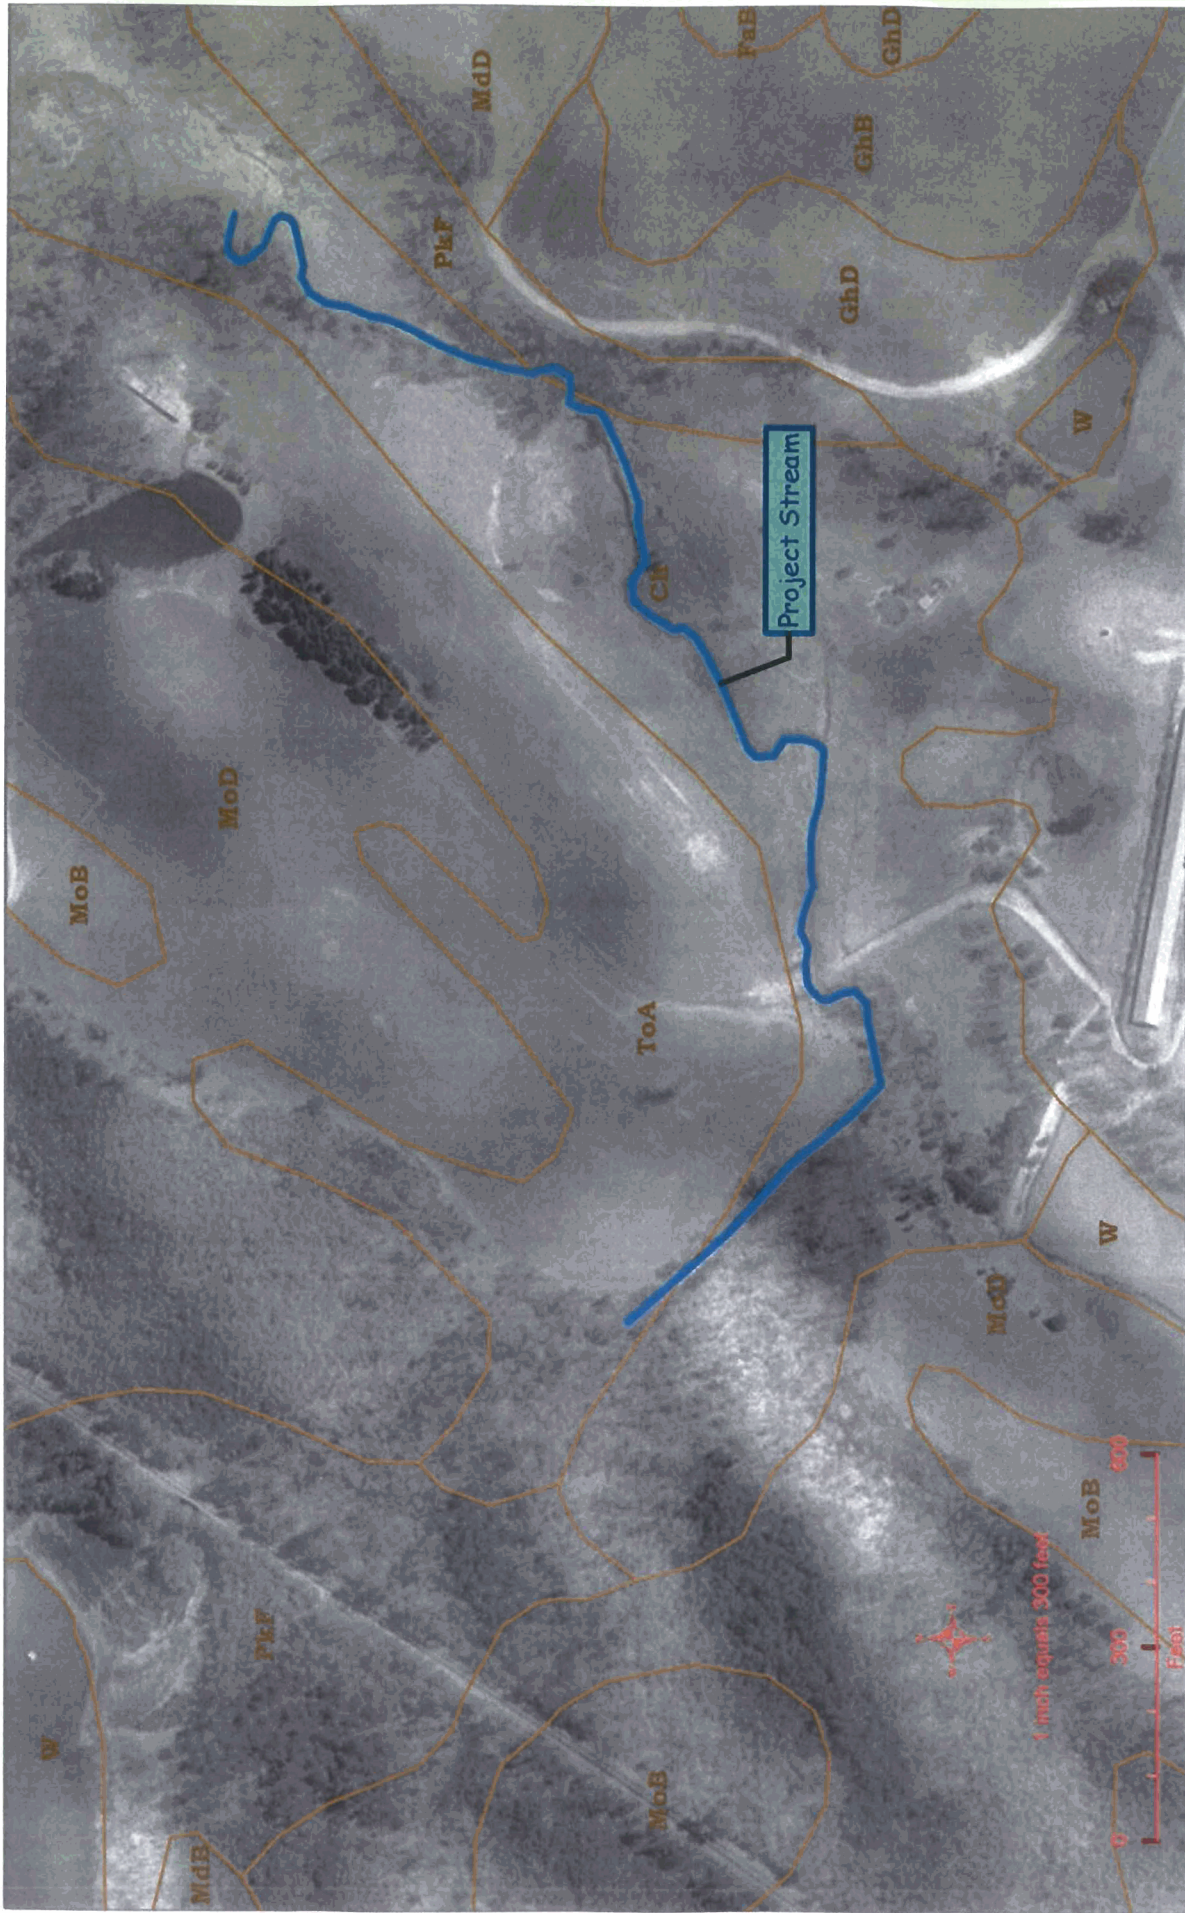
Figure: 3

Title: Suck Creek Soils (NRCS)

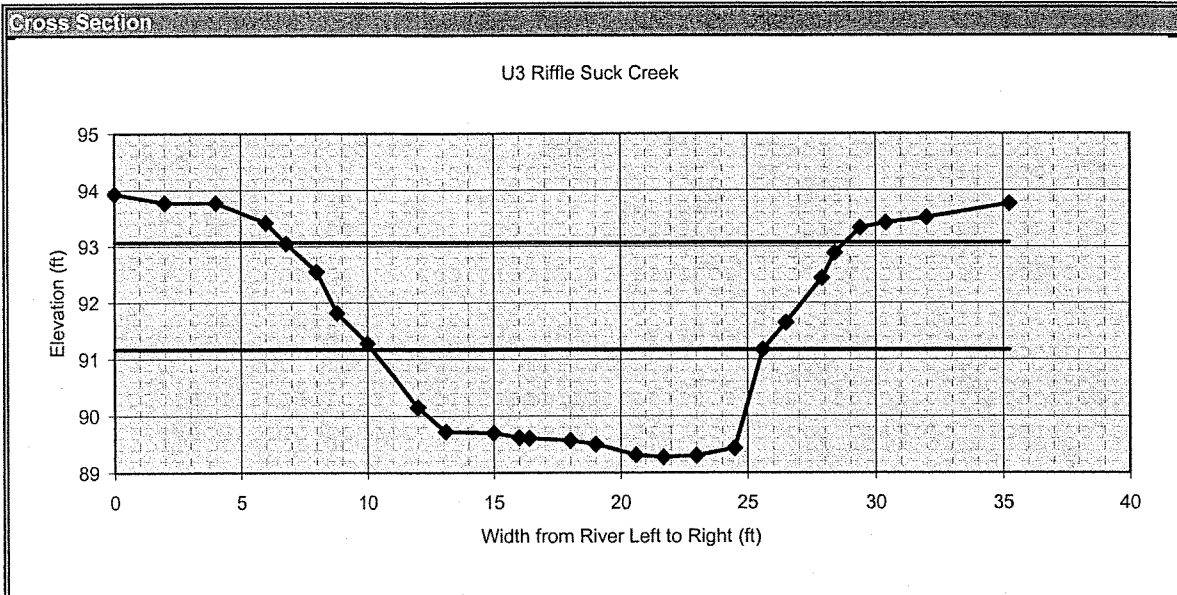
section: **U3**

Riffle
Suck Creek

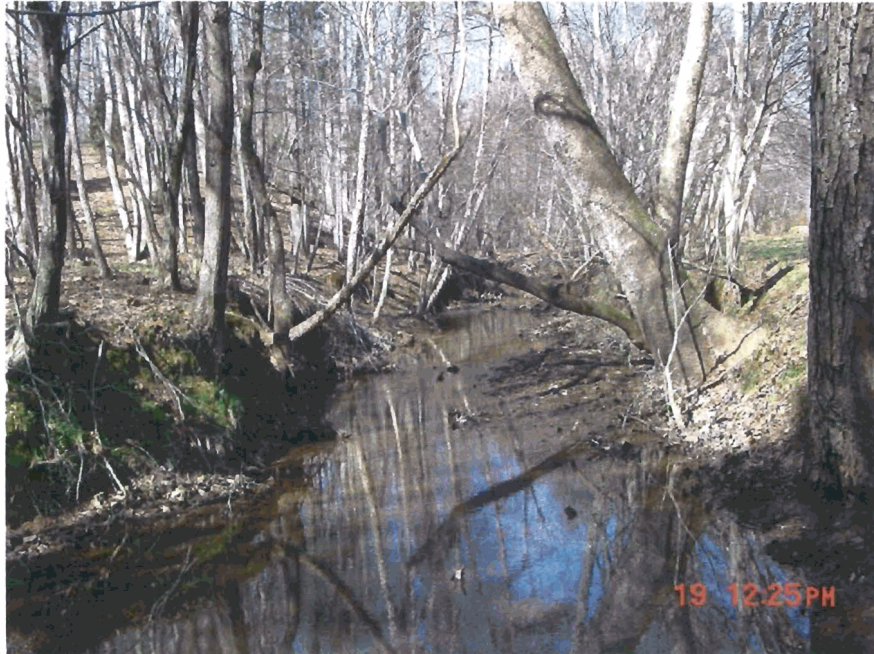
Photo 1a: *View of the first 800 feet of the project reach near the first ford crossing, looking upstream.*

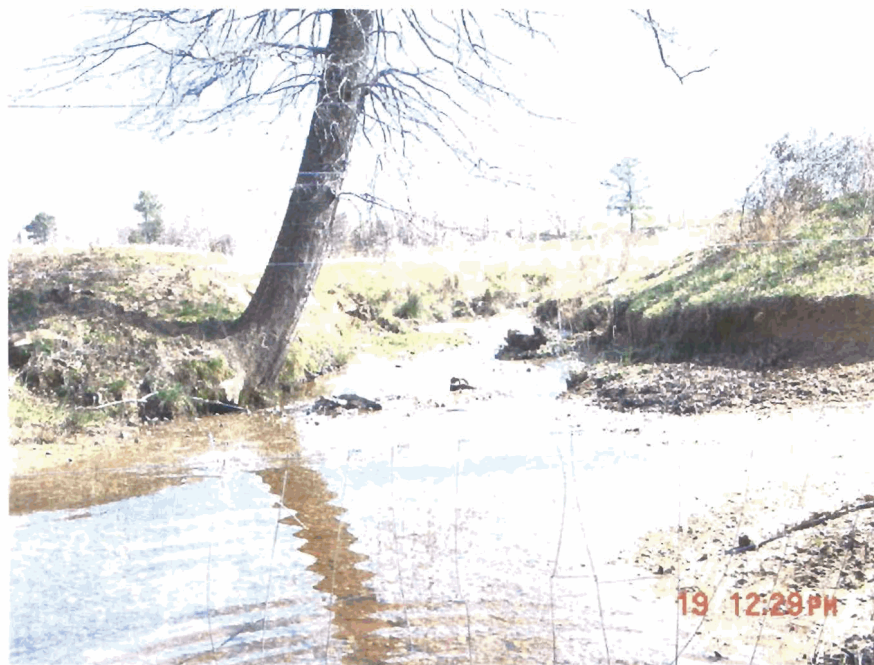
Photo 1b: *View of the first 800 feet of the project reach near first ford crossing, looking downstream.*

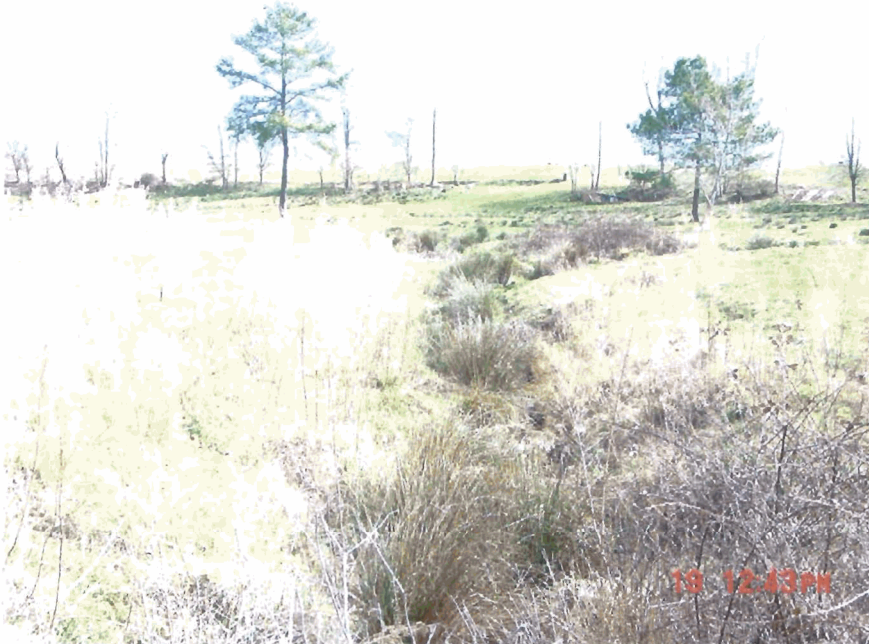
Photo 2: Looking downstream from the project stream's upper section; woody vegetation is not present on stream.

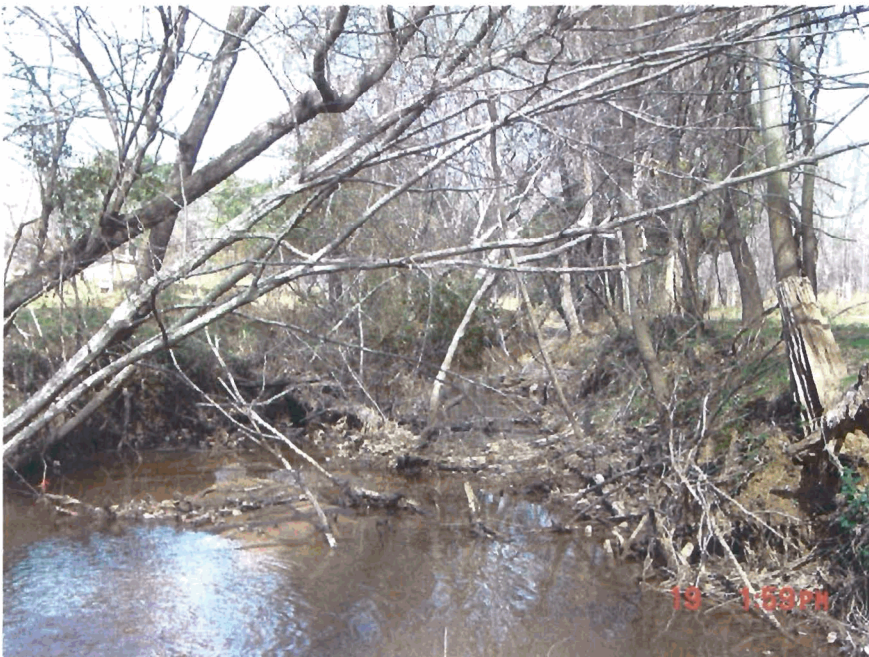
Photo 3: Looking downstream from the project stream's lower section; woody vegetation is present on stream banks, but is falling in due to erosion.

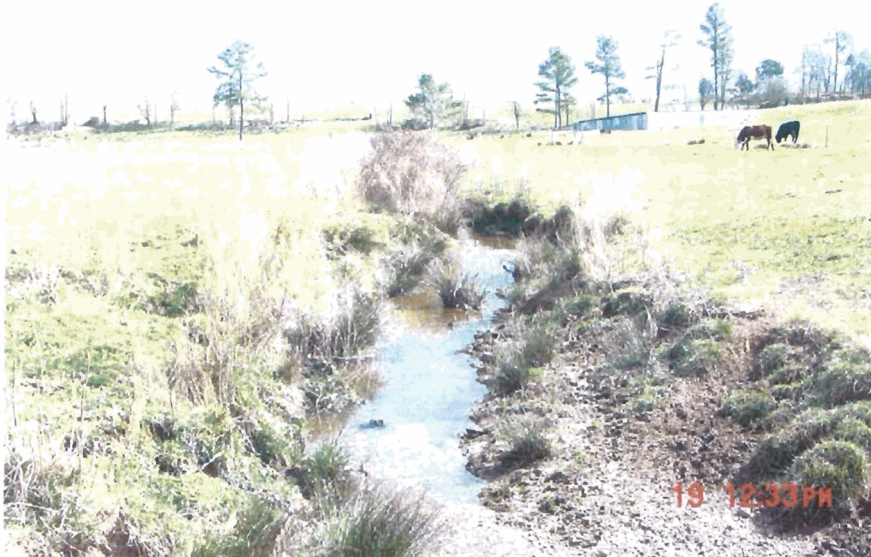
Photo 4: Looking downstream of upper section of project stream; the stream channel is unstable due to denuded banks and hoof shear.

Large portions of the stream appear to have been straightened and relocated to one side of the valley, most likely to maximize the amount of pasture. The channel has become incised to entrenched, exhibiting a bank height ratio (low bank-height to max bankfull-depth) ranging from 1.1 to 2.3 (1.8 mean). A channel that is not incised will exhibit a bank height ratio of 1.0. The stream is exhibiting entrenchment ratios of between 1.3 and 1.4 (i.e., slightly entrenched). It appears that the combination of cattle accessing the stream and channel straightening has caused the channel to become incised-to-entrenched and thus unstable (Photo 4).

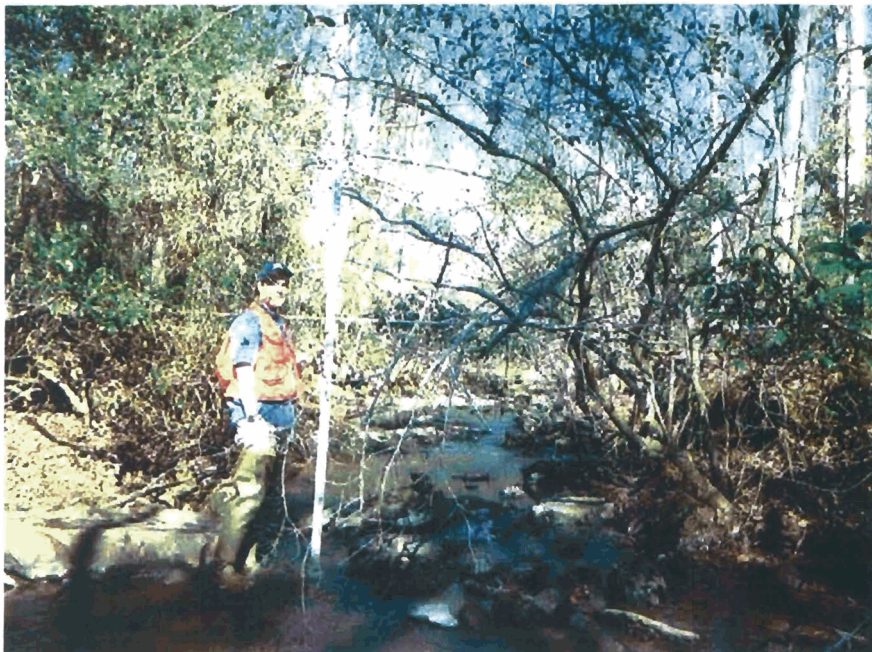
Photo 5: Looking upstream at the cross-section of the reference reach on Suck Creek upstream of the project, near the fence line of Robertson property. The Rosgen stream type is B4.

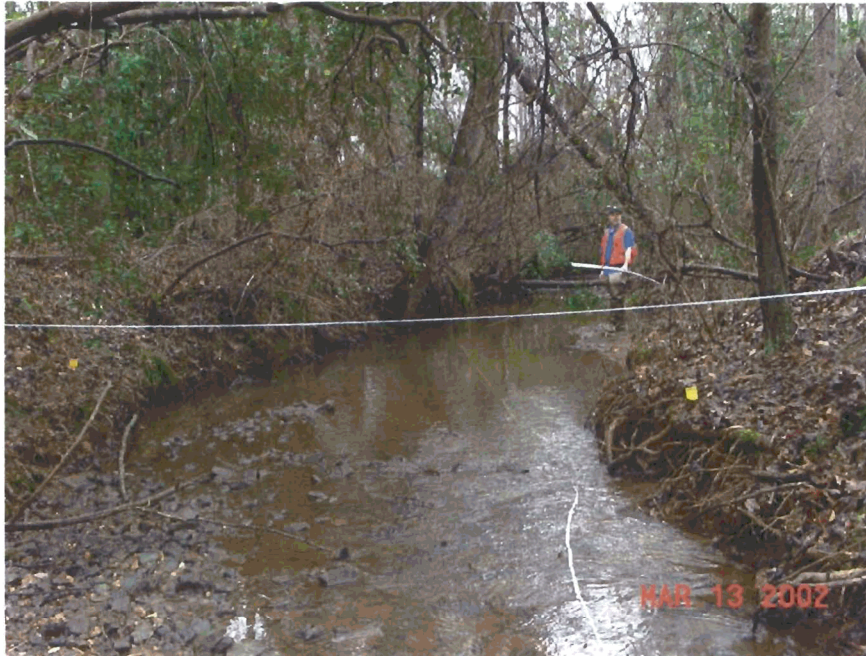
Photo 6: Looking downstream from the cross-section of the reference reach on Suck Creek approximately 300 feet downstream of Beulah Hill Church Road. The Rosgen stream type is B4.

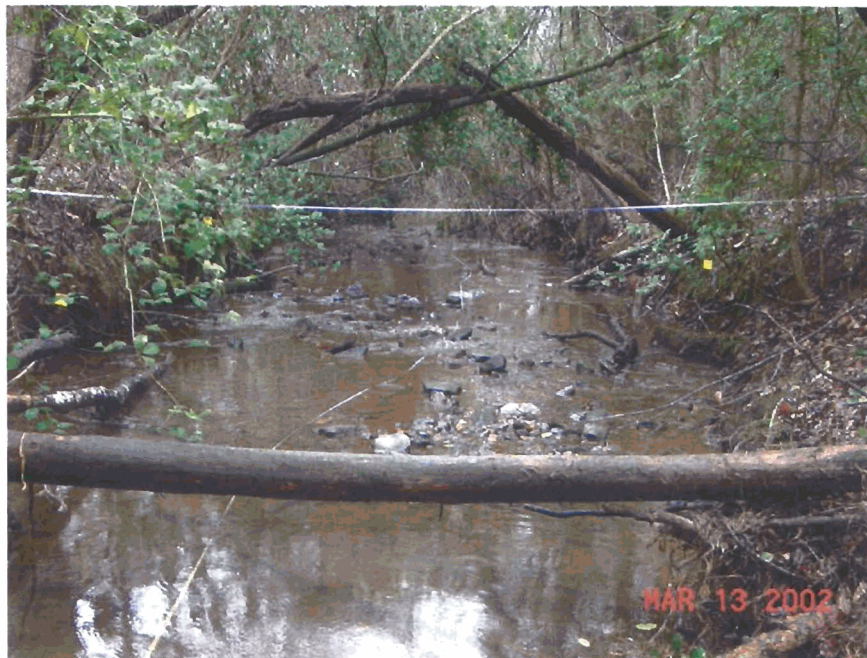
Photo 7: Looking downstream from cross section of B4 type reference reach located on Suck Creek upstream of project and located 325 feet downstream of Beulah Hill Church Road.

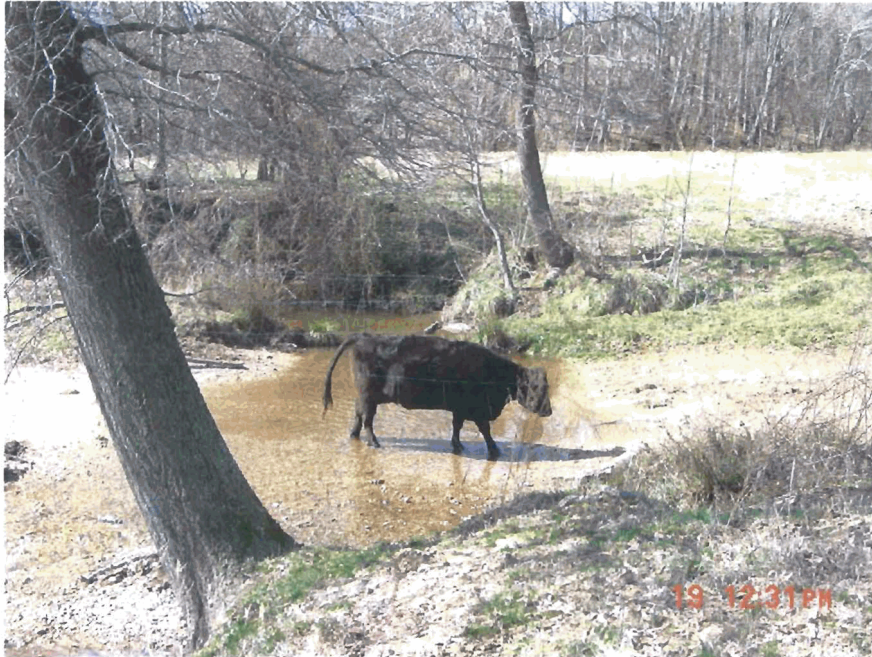
Photo 8: Looking upstream at the existing upstream ford crossing.
