# **ANNUAL WETLAND MONITORING REPORT** **YEAR 1 (2011)**

## **SUMMIT SEEP NON-RIPARIAN WETLAND MITIGATION SITE**

**Davidson County, North Carolina**

**November 2011**

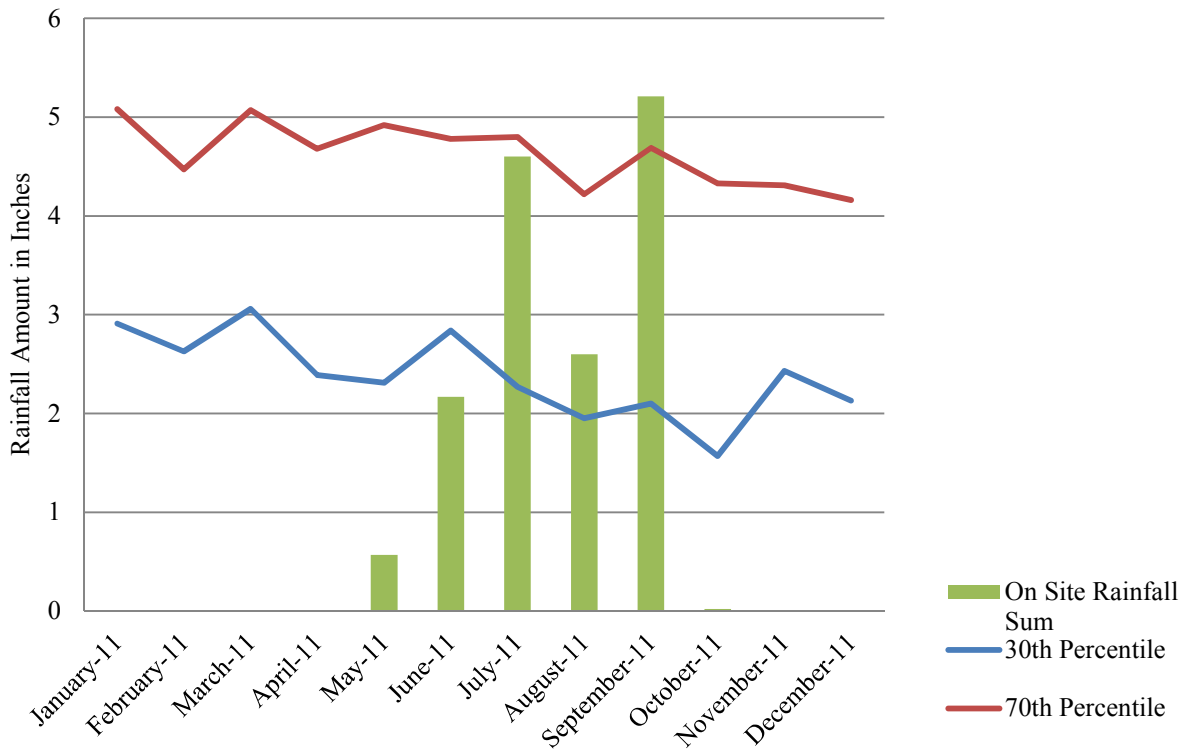
**Figure 4: Summit Seep 30-70 Percentile Graph for Rainfall in 2011**

Data from WETS Station : LEXINGTON, NC4970

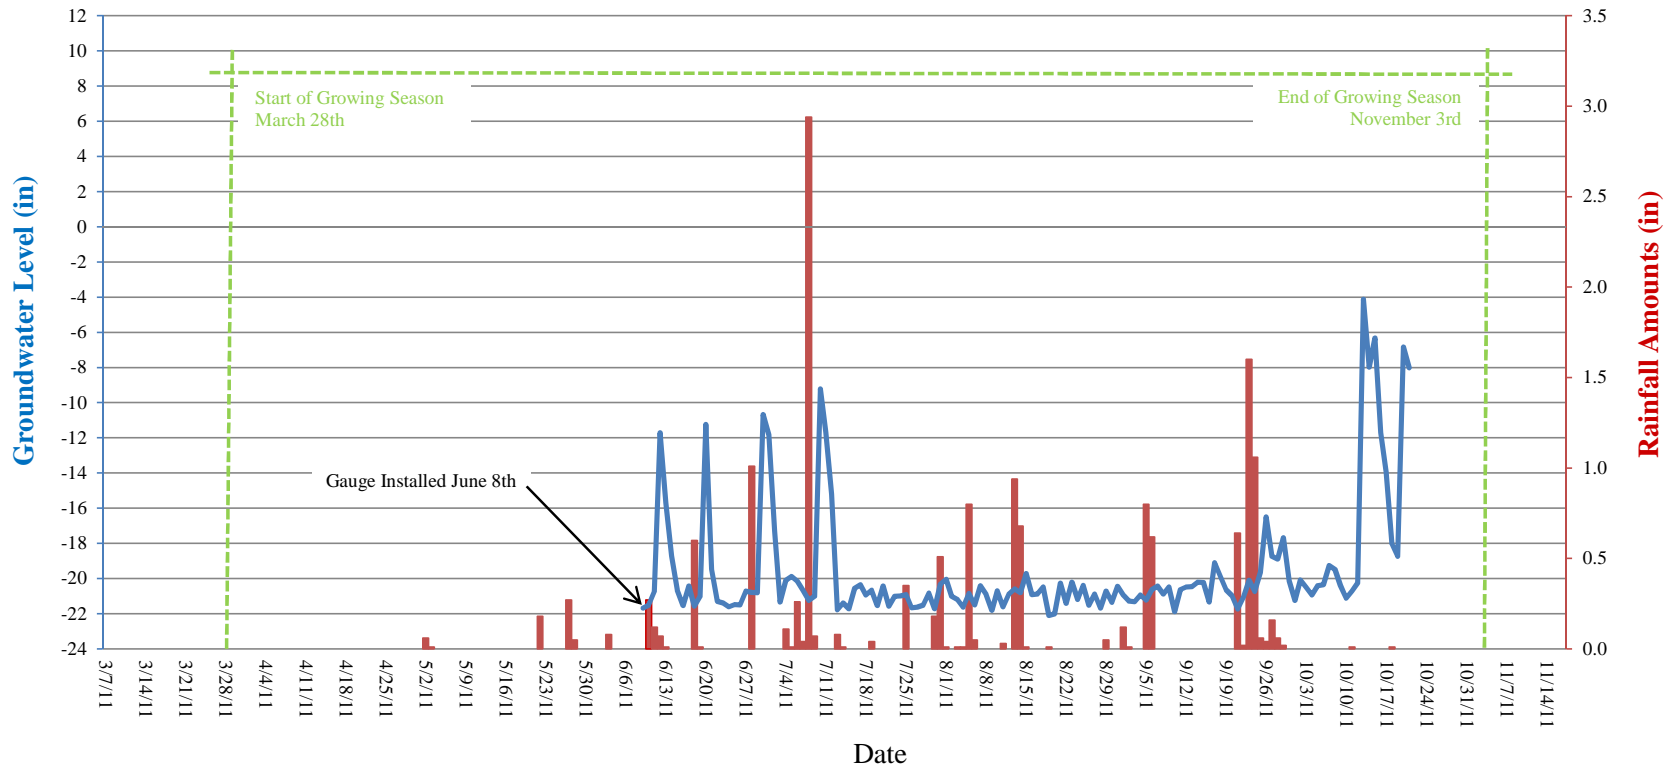
## Summit Seep Groundwater Gauge 5 Year 1 (2011 Data)

\* This gauge was installed in early June 2011; therefore, data from the beginning of the growing season is not available. Based on the data from other gauges, it is likely that this gauge would have met criteria.
