YEAR 2 (2012)
ANNUAL WETLAND MONITORING REPORT

SUMMIT SEEP NON-RIPARIAN WETLAND MITIGATION SITE

RFP # 16-002835 Contract # 003244
NC EEP Project ID # 94646
Davidson County, North Carolina
Data Collected March 3, 2012 – October 24, 2012

December 2012

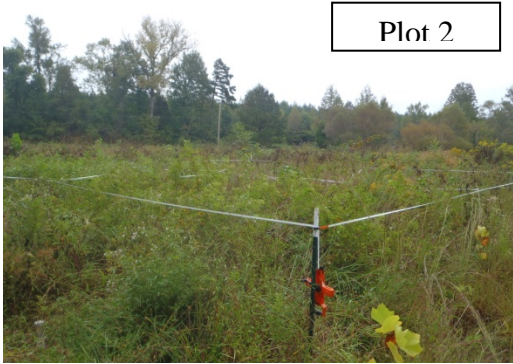
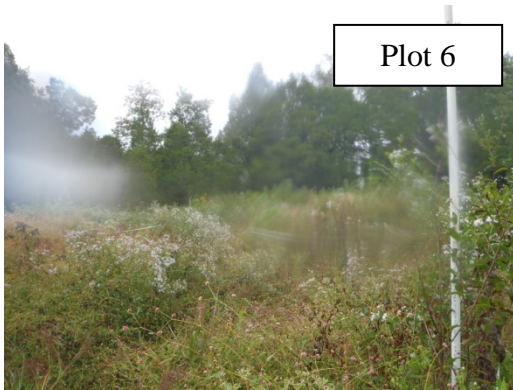
**Summit Seep
2012 (Year 2) Vegetation Monitoring Photographs
Taken October 2012**

Vegetation sampling across the Site was above the required average density with 600 planted stems per acre surviving. In addition, each individual plot was above success criteria.
