YEAR 4 (2014)
ANNUAL WETLAND MONITORING REPORT

SUMMIT SEEP NON-RIPARIAN WETLAND MITIGATION SITE

EEP Project # 94646 RFP # 16-002835 Contract # 003244
Davidson County, North Carolina
Data Collected February 2014 – November 2014

December 2014

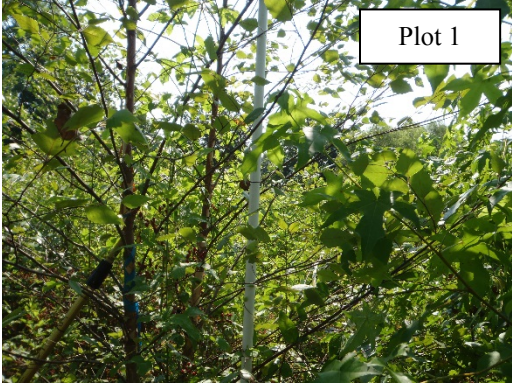
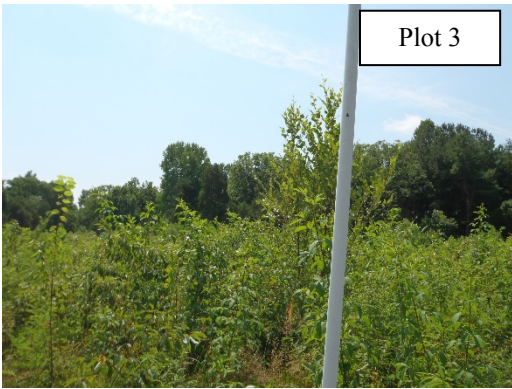
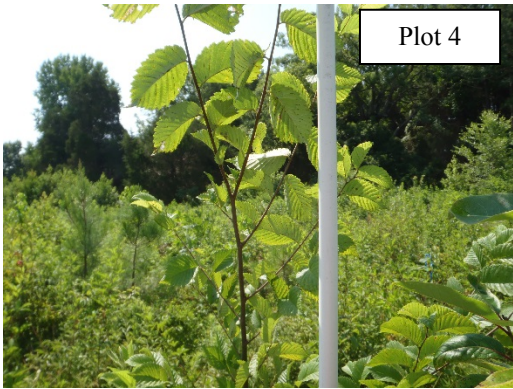
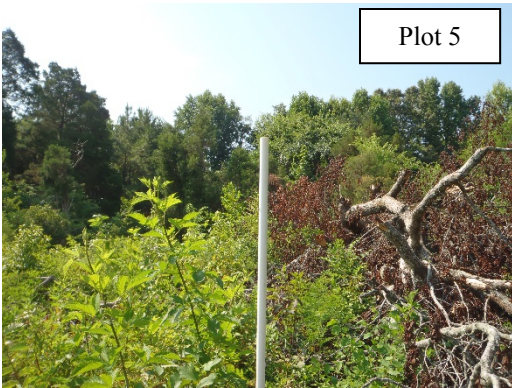
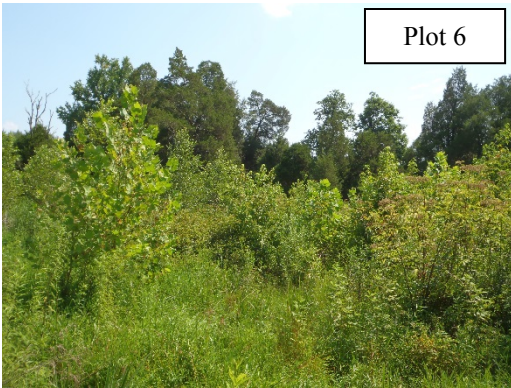
**Summit Seep
2014 (Year 4) Vegetation Monitoring Photographs
Taken July 2014**

Appendix C. Year 4 (2014) stem count measurements indicate an average of 519 planted stems per acre across the Site. In addition, each individual plot met success criteria.

During the spring of 2014, a mature sweetgum (*Liquidambar styraciflua*) fell in the southwest portion of the easement, partially covering vegetation plot 5. Though several stems were killed, the tree does not appear to be a threat to site success. Additionally, one area was observed to have poor growth during year 4 (2014) monitoring; much of the wetland enhancement area on the south edge of the Site is characterized by reduced stem density and less vigorous trees than the remainder of the site. The lack of growth is likely due to poor soils in the ditch-fill area. This area will continue to be watched closely during year 5 (2015) monitoring.
