MITIGATION PLAN

SWAMP GRAPE STREAM AND WETLAND MITIGATION SITE

Robeson County, North Carolina

DMS Project ID No. 100115

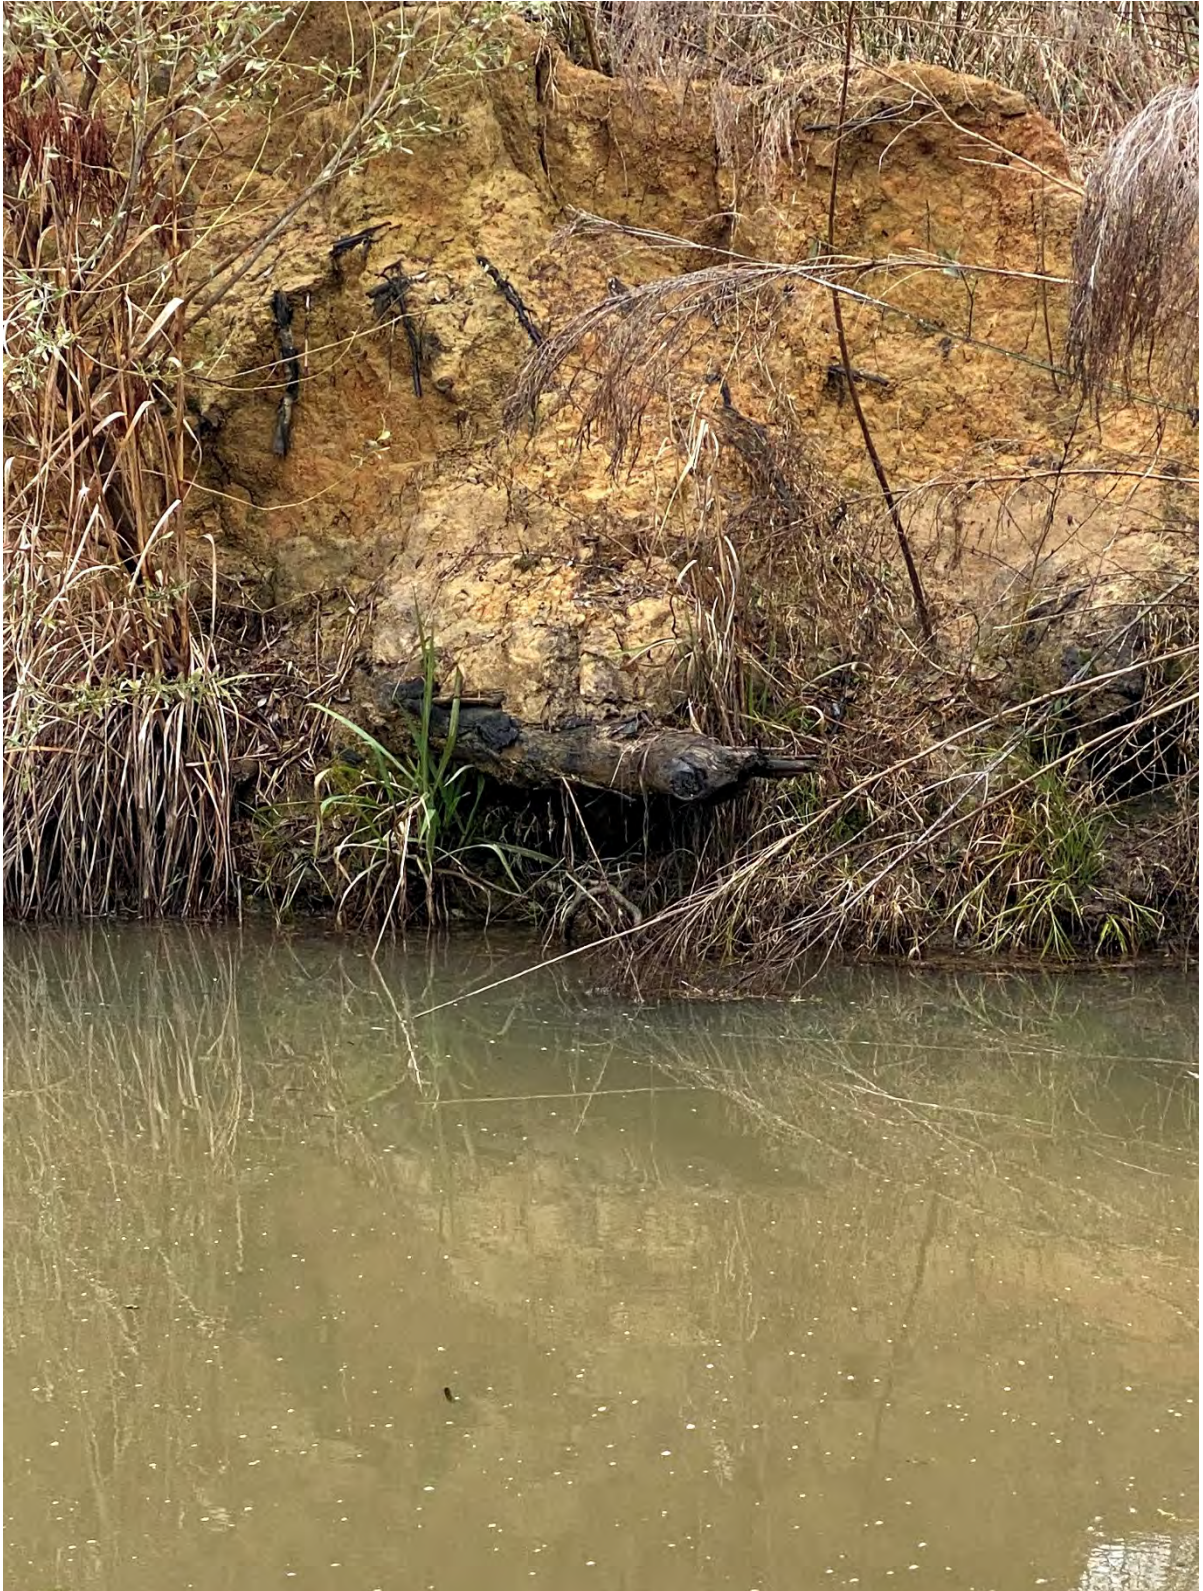
Photo 1.) UT-2 Failed Crossing – Historic floodplain elevation with historic tree roots visible at break between historic floodplain and fill material

Regarding the road crossing over UT-2, we conducted four soil profiles, two within the dam's footprint, one immediately below, and one within the eroded bank where the road failed. None of our profiles indicated the road was keyed-in below the natural grade. All exhibited strong evidence that construction of the road resulted from fill material being placed directly on top of the historic wetland. We observed historic tree material (cut stumps and large roots) along the crossing at the historic soil surface, with fill material immediately above. Alex prepared four soil profile descriptions, which I have attached with a context map and additional images showing the historic tree material observed.

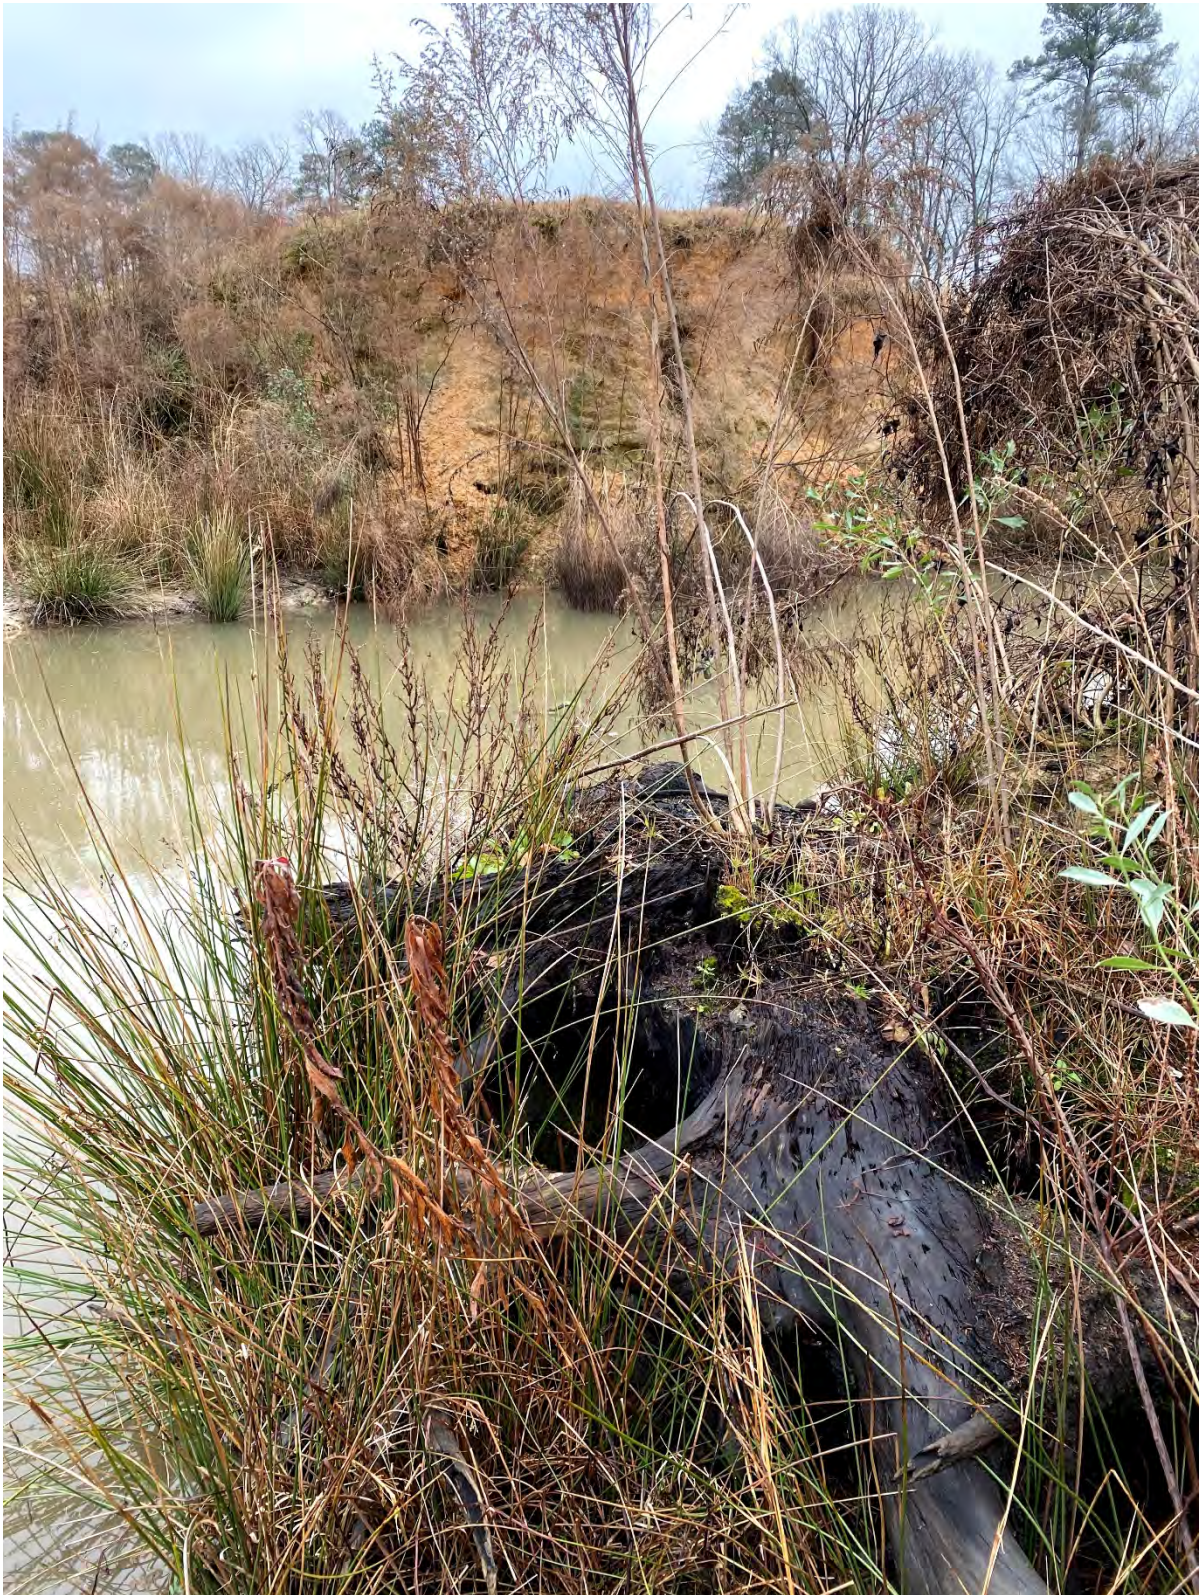
Photo 2.) UT-2 Failed Crossing – Historic floodplain elevation with historic tree roots visible at break between historic floodplain and fill material

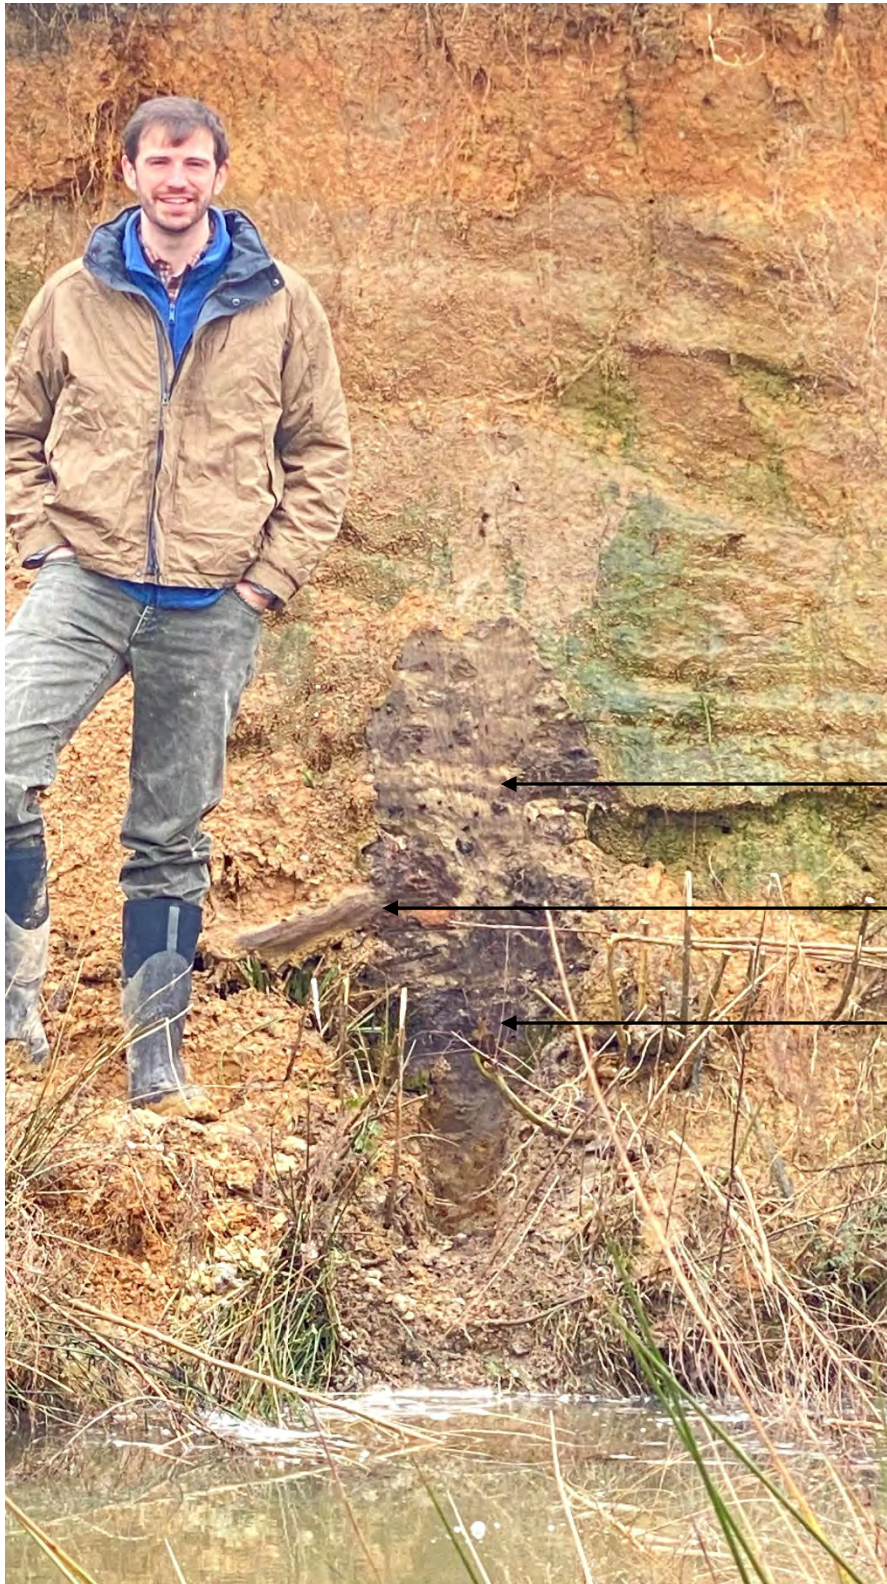
Fill material from crossing

Observed native tree material

Photo 3.) UT-2 Failed Crossing – Historic floodplain elevation with historic tree roots visible at break between historic floodplain and fill material

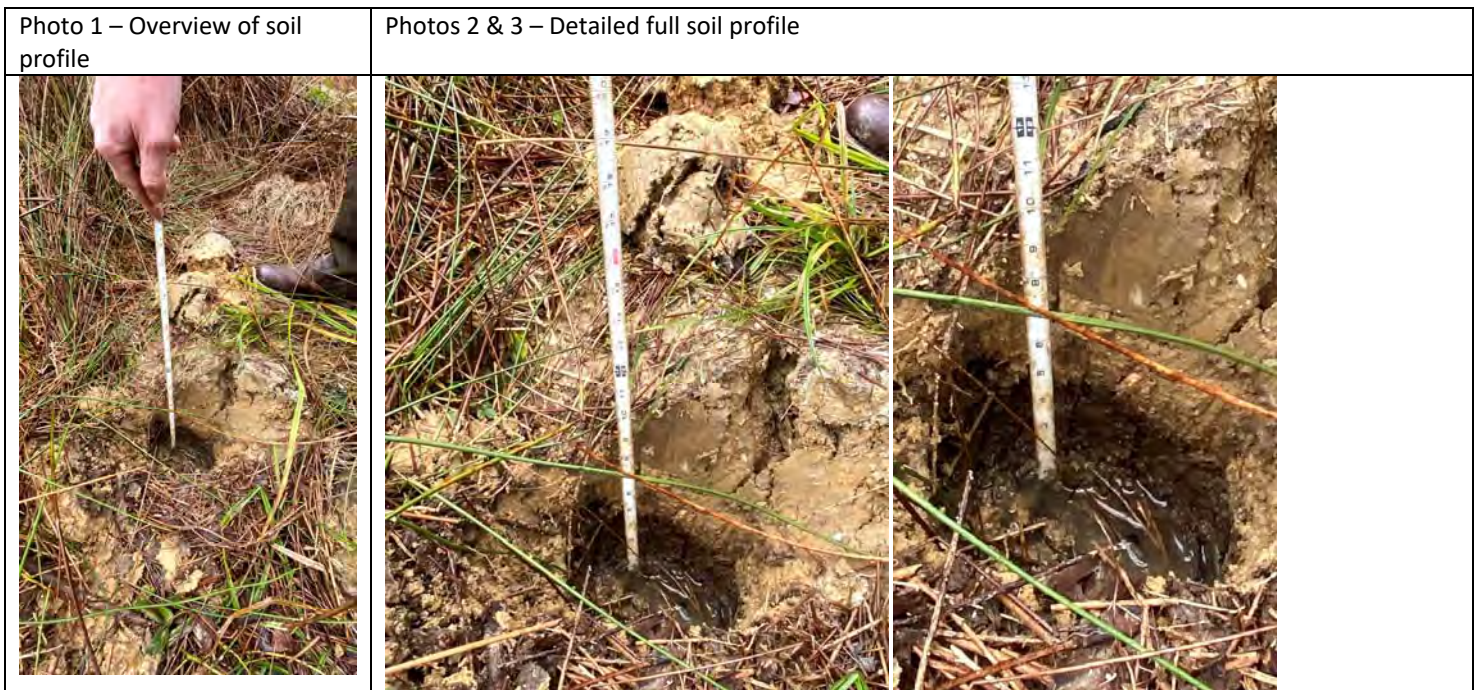
PROFILE ID: SPD #3

SOIL PROFILE DESCRIPTION FORM

DEPTH (inches)	MATRIX		REDOXIMORHPIC FEATURES			TEXTURE	NOTES
	COLOR	%	TYPE ¹ /LOCATION ²	COLOR	%		
0-12	10YR 2/1	85	OM/M	10YR 2/1	15	SL	Tree material observed at the historic soil surface
			MS/M	10YR 2/1	80		
12-18	10YR 4/1	90	RC/M	7.5YR 3/4	10	L-SL	
18-27+	10YR 6/2	70	RC/M	7.5YR 4/6	20	SL	
			RC/M	7.5YR 3/4	10

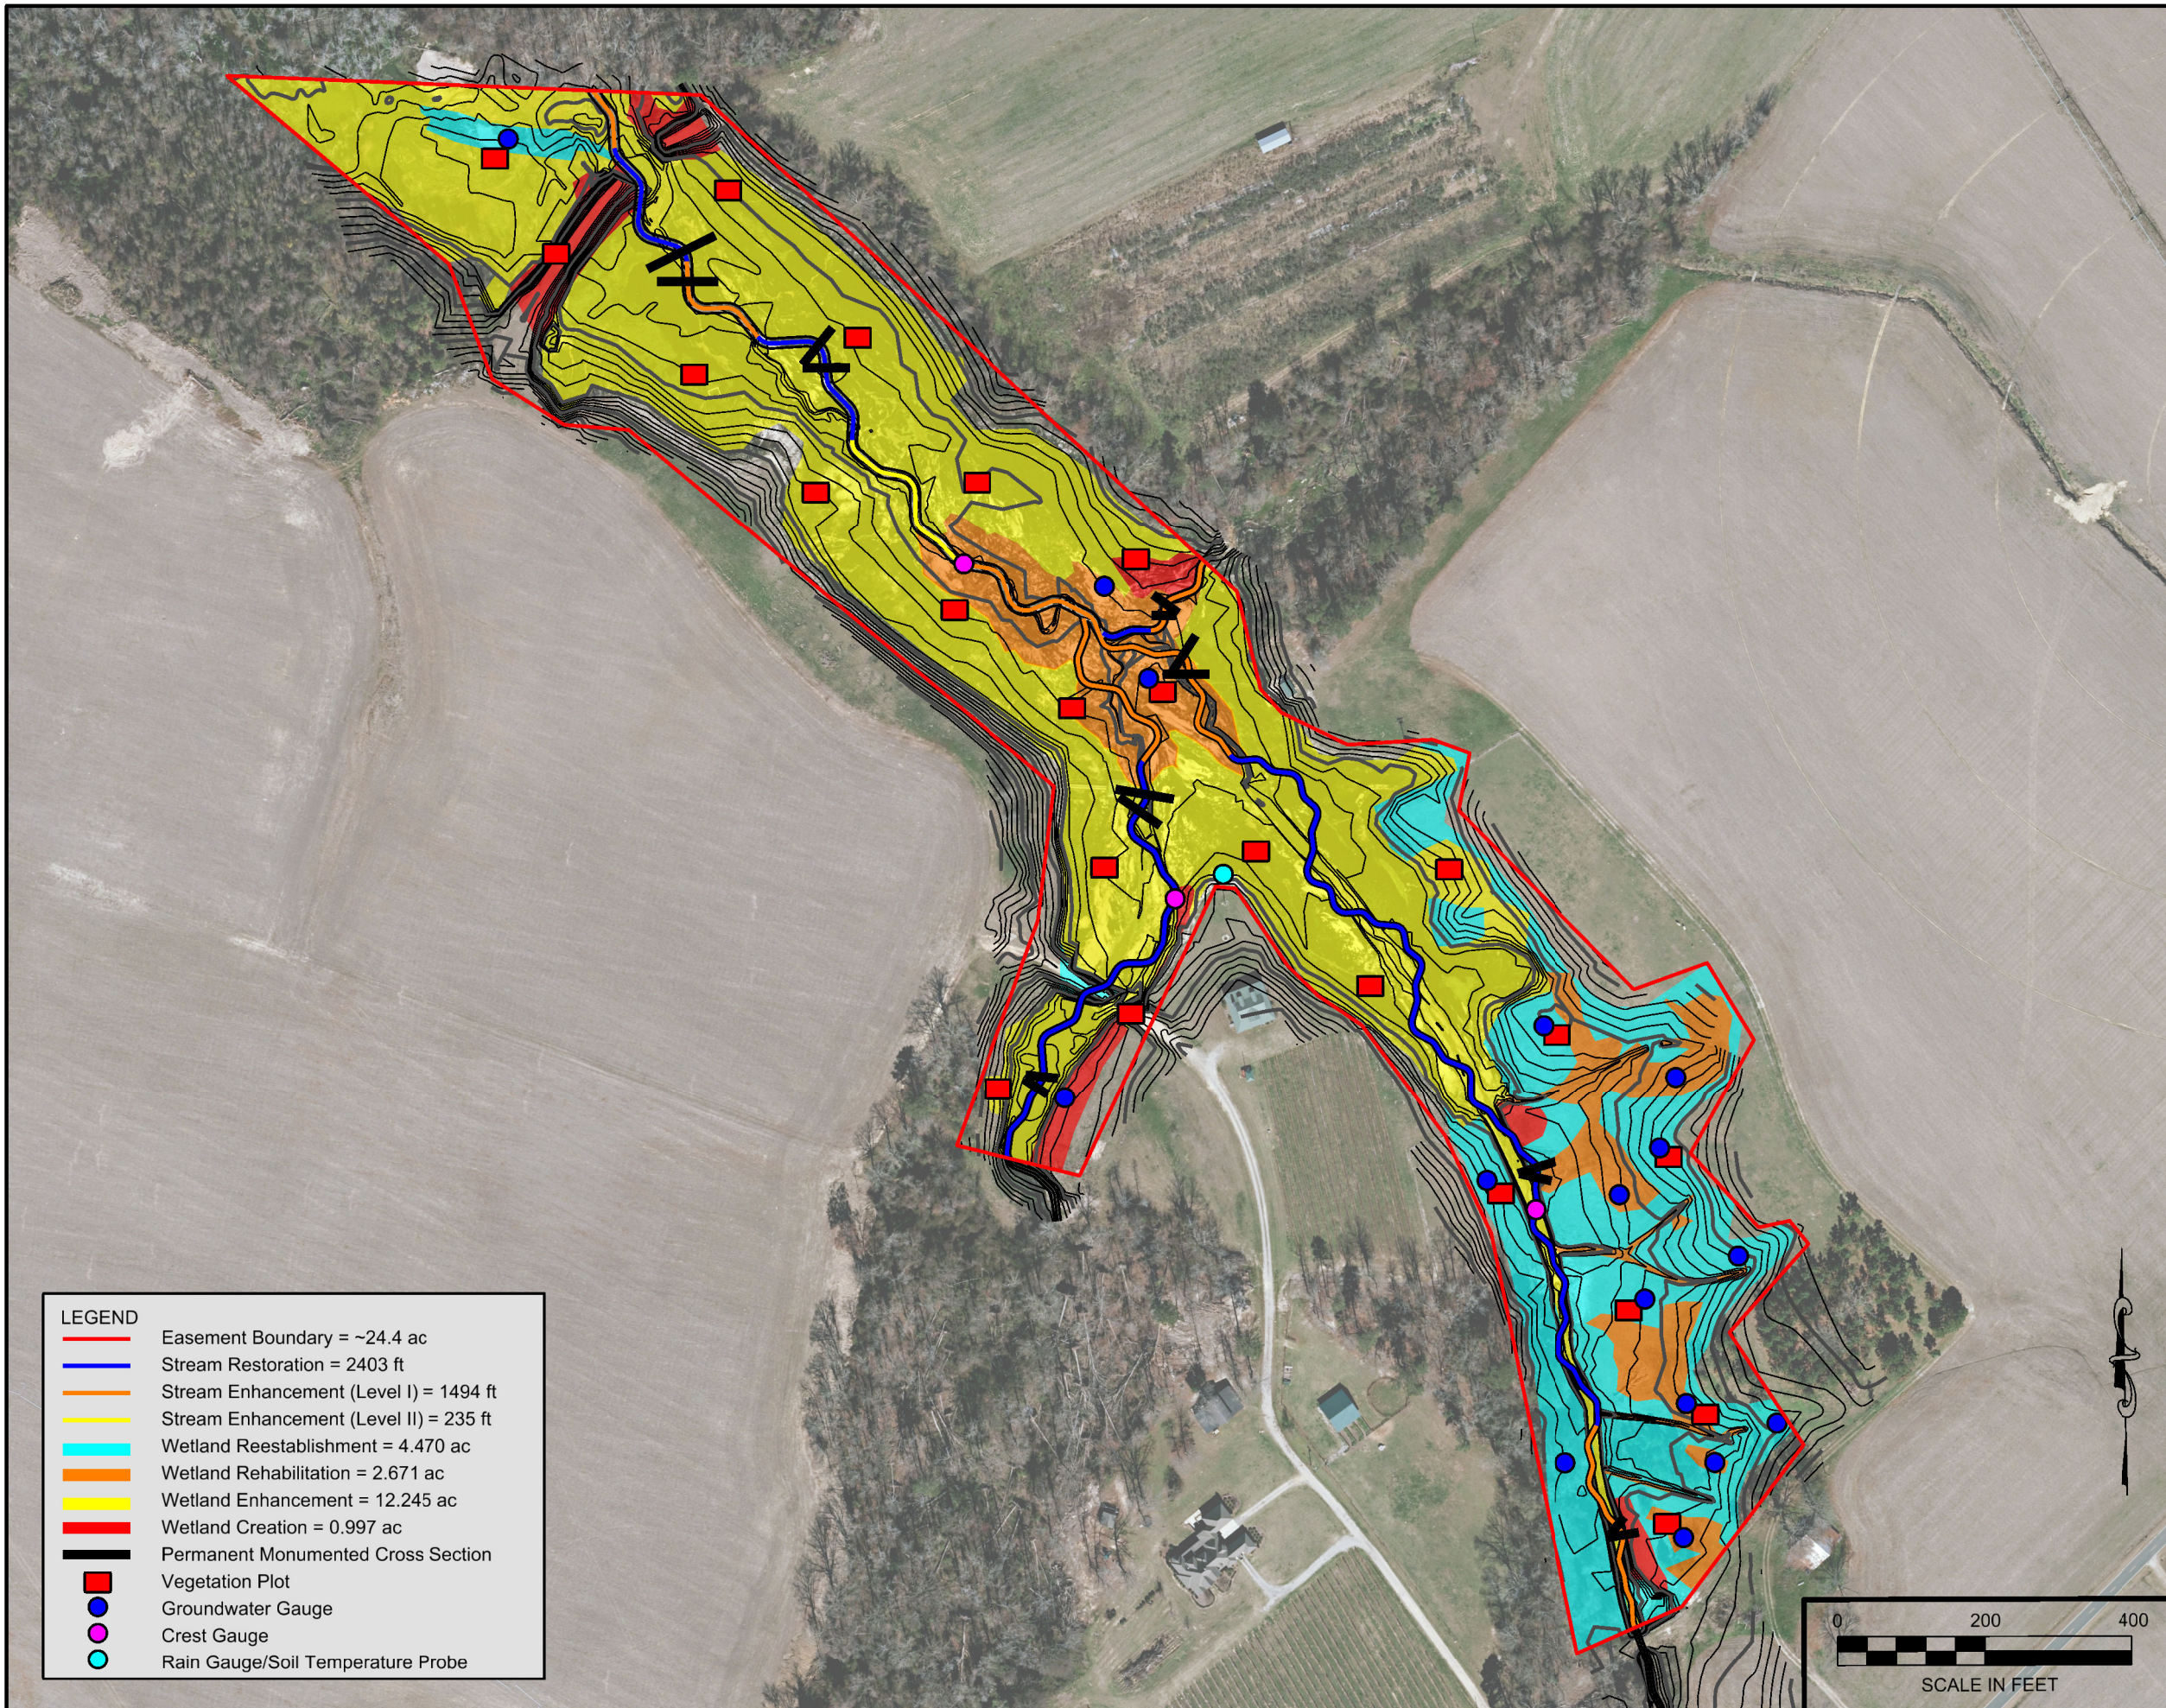
Scale: AS SHOWN	FIGURE NO. 10
Date: Mar 2020	
Project No.: 20-003

Easement Boundary = ~24.4 ac
	Stream Restoration = 2403 ft
	Stream Enhancement (Level I) = 1494 ft
	Stream Enhancement (Level II) = 235 ft
	Wetland Reestablishment = 4.470 ac
	Wetland Rehabilitation = 2.671 ac
	Wetland Enhancement = 12.245 ac
	Wetland Creation = 0.997 ac
	Permanent Monumented Cross Section
	Vegetation Plot
	Groundwater Gauge
	Crest Gauge
	Rain Gauge/Soil Temperature Probe

- a. Recommend adding the vegetation monitoring plots to the planting zone map to ensure each zone is monitored. The inclusion of the veg plots in Figure 10 is good to ensure the all wetland mitigation approaches/treatments are monitored.

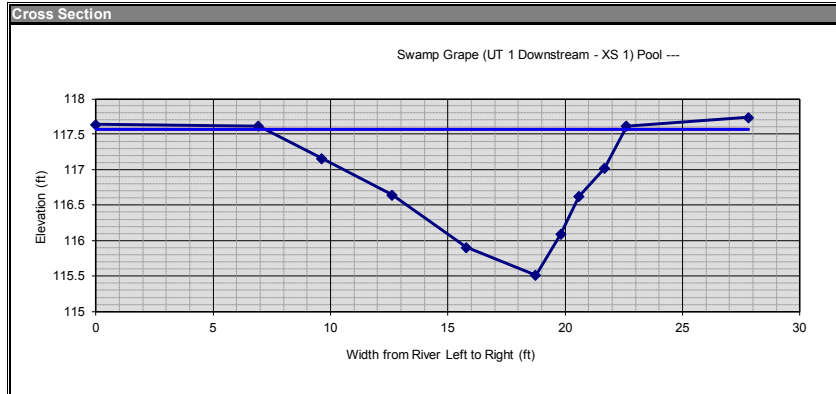
section: Swamp Grape (UT 1 Downstream - XS 1)
Pool

description: Swamp Grape (UT 1 Downstream - XS 1)
height of instrument (ft): 200.00

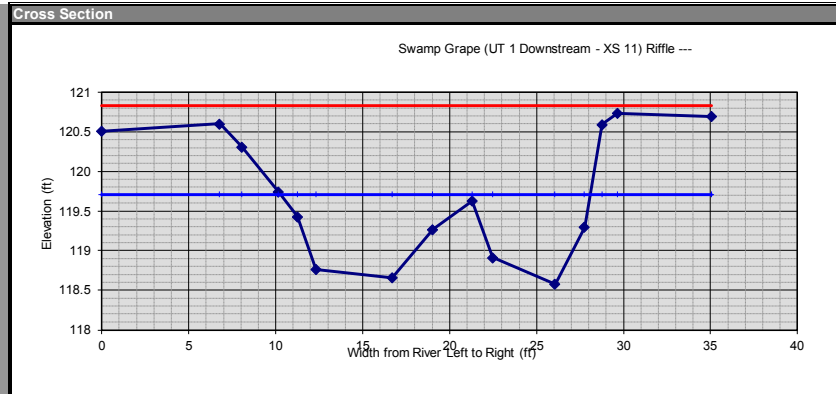
section: Swamp Grape (UT 1 Downstream - XS 11)
 Riffle

description: Swamp Grape (UT 1 Downstream - XS 11)
 height of instrument (ft): 200.00

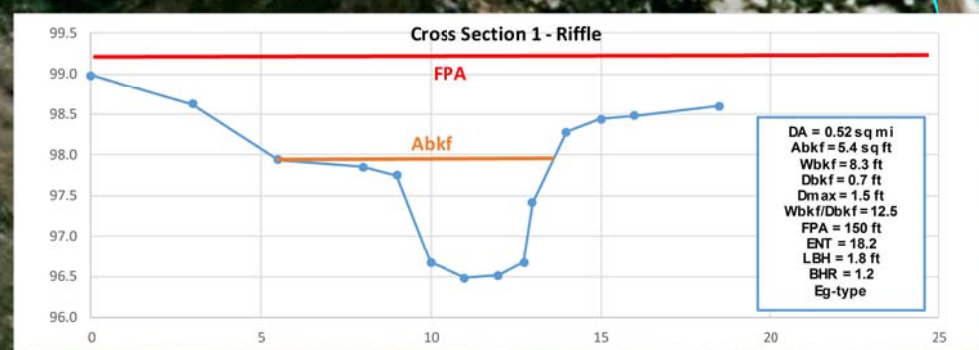
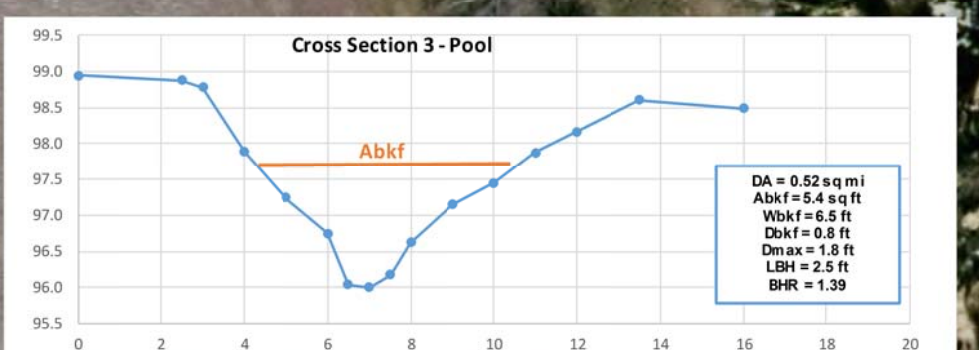
Existing Channel
Sinuosity = 1.14
Width = 7.6 ft
Radius = 7.8 to 13.9 ft

Proposed Channel
Sinuosity = 1.09
Width = 9.8 ft
Radius = 20 to 30 ft

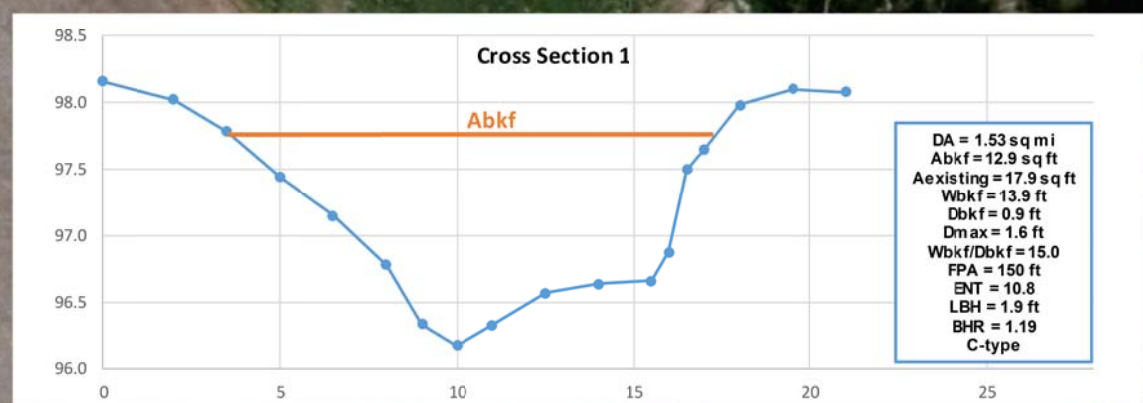
XS 1

Existing Channel
