Stream and Wetland Restoration Plan **Tarlton Site**

Cumberland County, North Carolina
Project ID No. 012857003

February 2006

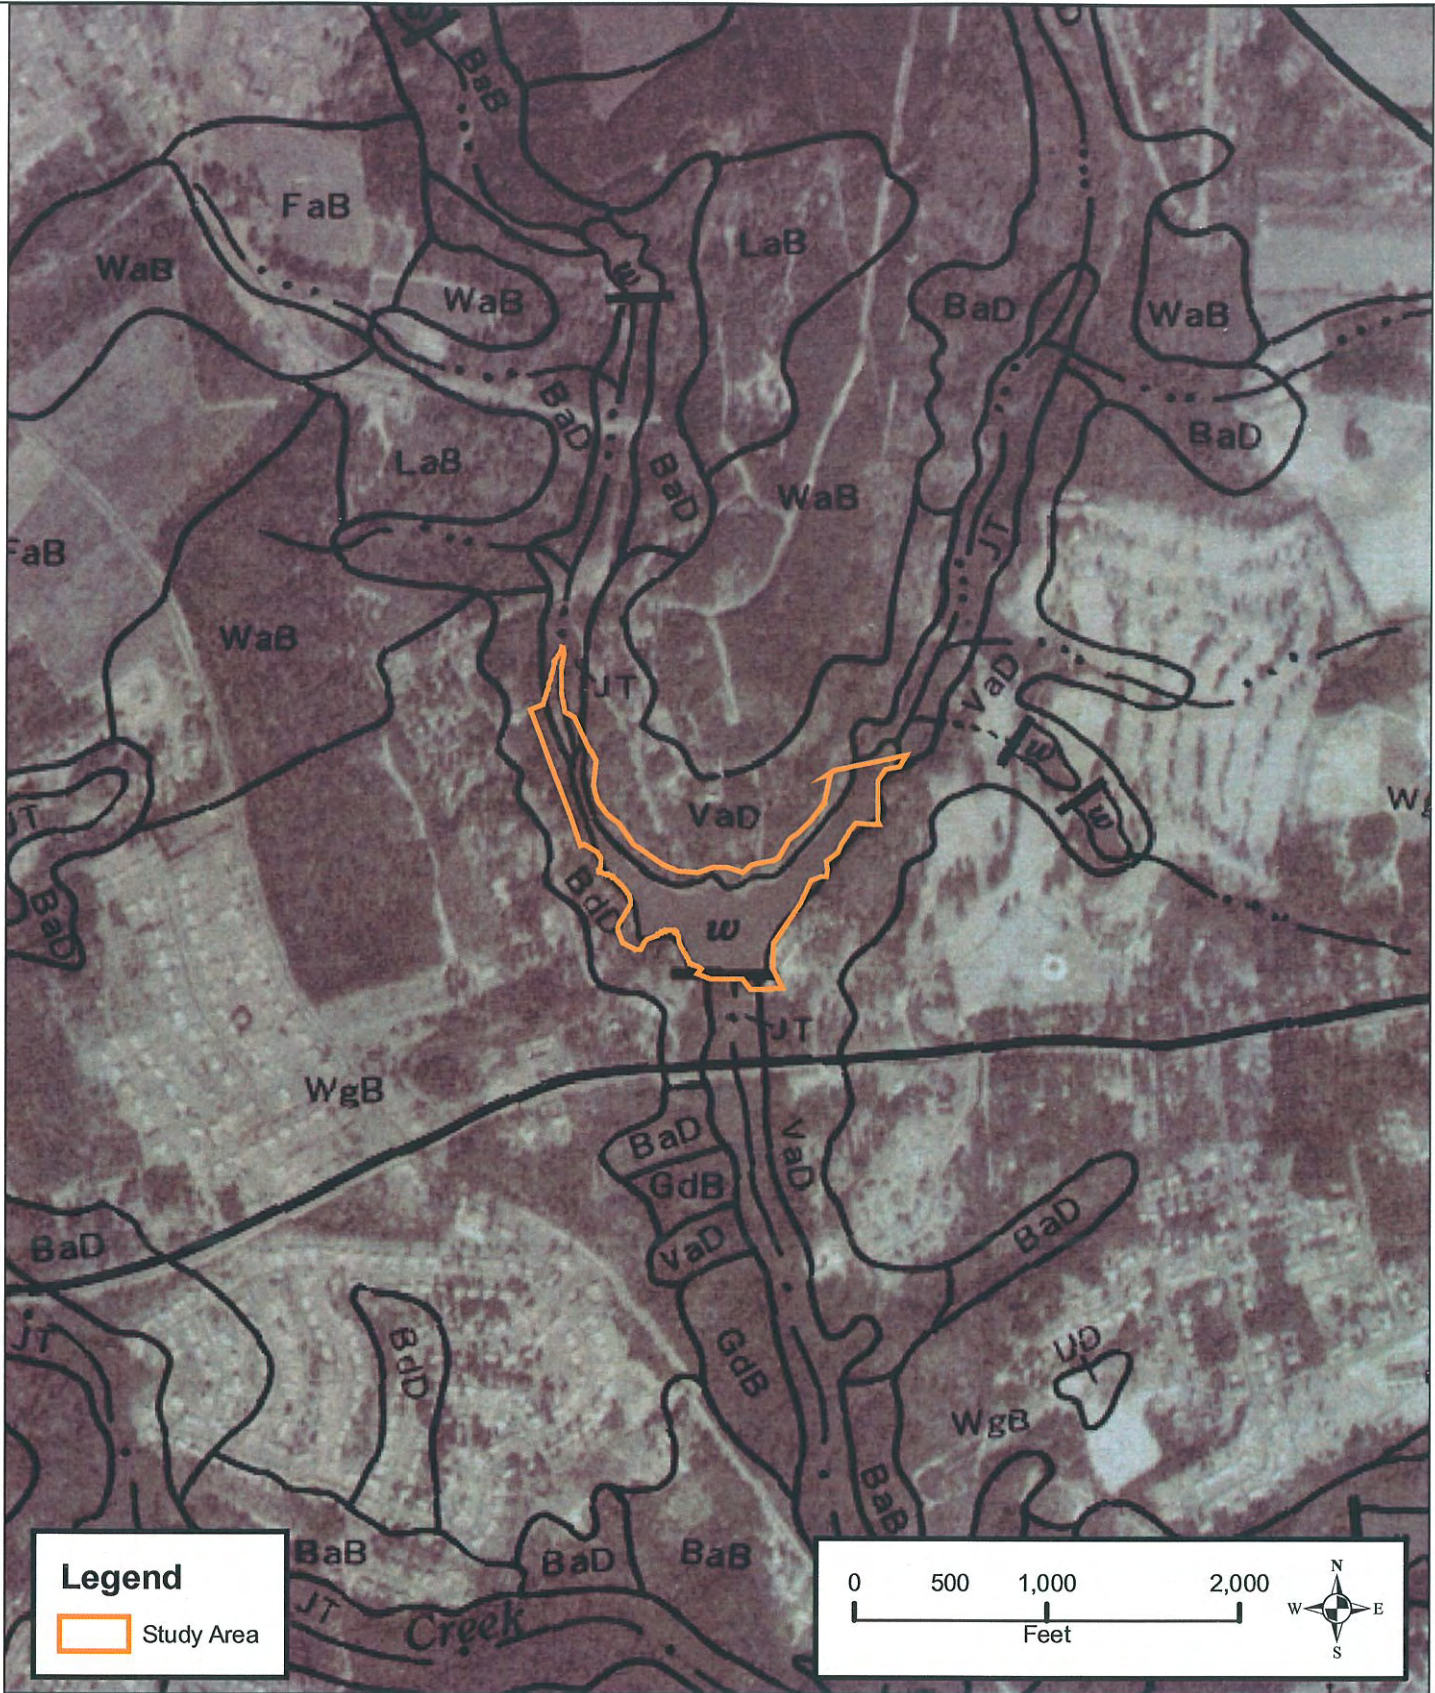
Title		Project Site NRCS Soil Survey Map		
Prepared For: Mid-Atlantic Mitigation, LLC	Project	Tarlton Stream and Wetland Restoration Cumberland County, North Carolina		
	Date	2/24/06	Project Number	012857003
			Figure	3

volcanic slate. Cumberland County Soil Survey soil mapping of the project area is shown in **Figure 3**.

The NRCS Cumberland County Soil Survey mapping shows the historical extent of Country Club Lake mapped as open water, and the headwater areas are mapped as Johnston mucky loam (Jt) (Figure 3). Johnston mucky loam taxonomic classification is: *Coarse-loamy, siliceous, active, acid, thermic Cumulic Humaquepts*.

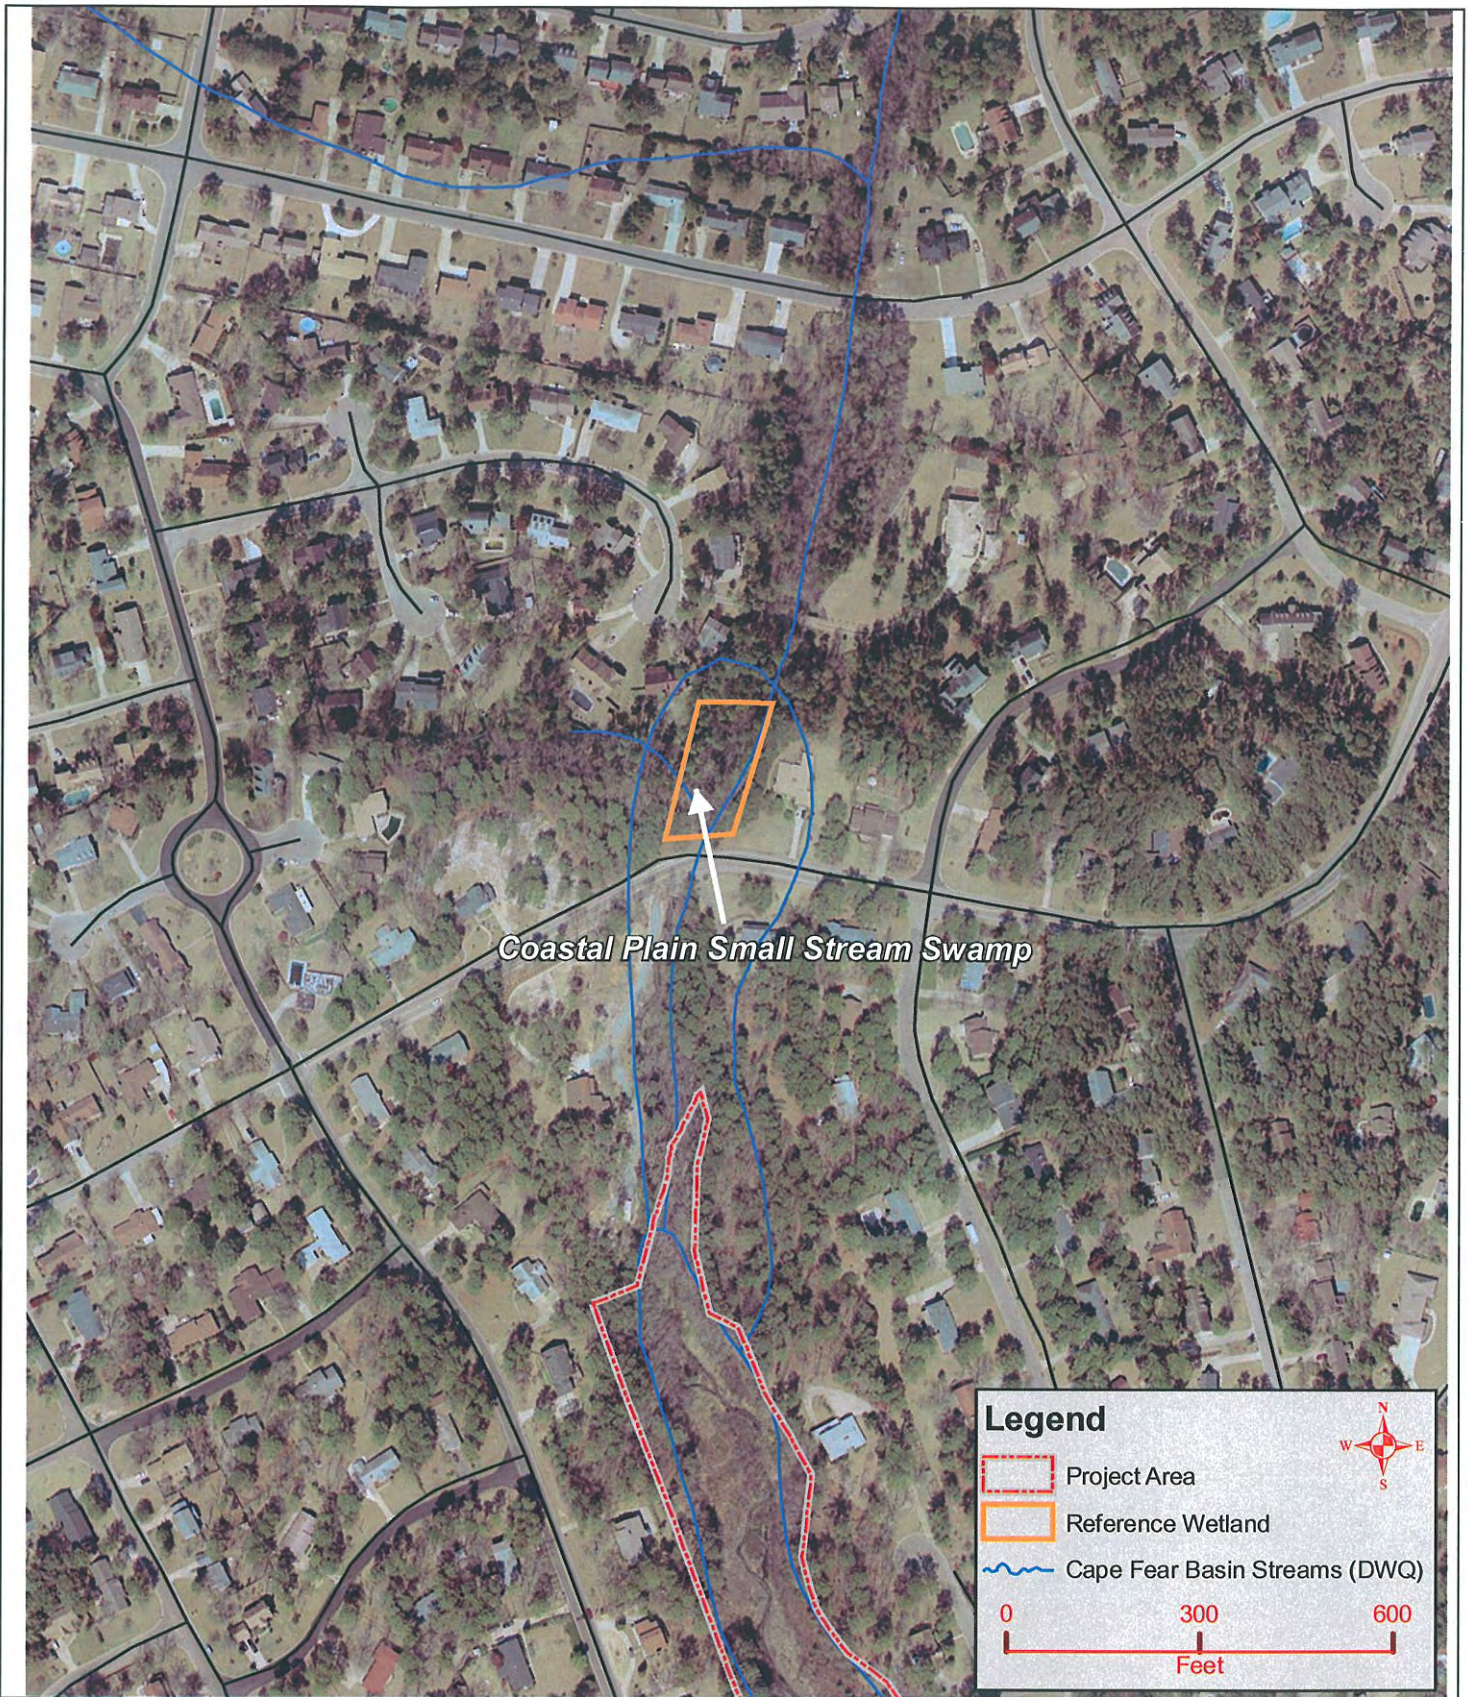
Title		Reference Site Vegetative Communities Map		
Prepared For: Mid-Atlantic Mitigation, LLC	Project	Tarlton Stream and Wetland Restoration Cumberland County, North Carolina		
	Date	2/24/06	Project Number	012857003
			Figure	10

The reference wetland is typical of the Coastal Plain Small Stream Swamp community as described in *Classification of the natural Communities of North Carolina, 3rd Approximation* (Shafale and Weakley, 1990). The site contains a diverse riparian wetland community including, but not limited to, Black Gum, Red Maple, Loblolly Bay, Privet, Sweet Pepperbush, Elderberry, Pokeberry, Smartweed, Sensitive Fern, Northern Chain Fern, Lizard's Tail, Microstegium, Grape Vine, Greenbriar, Blackberry, and False Nettle.

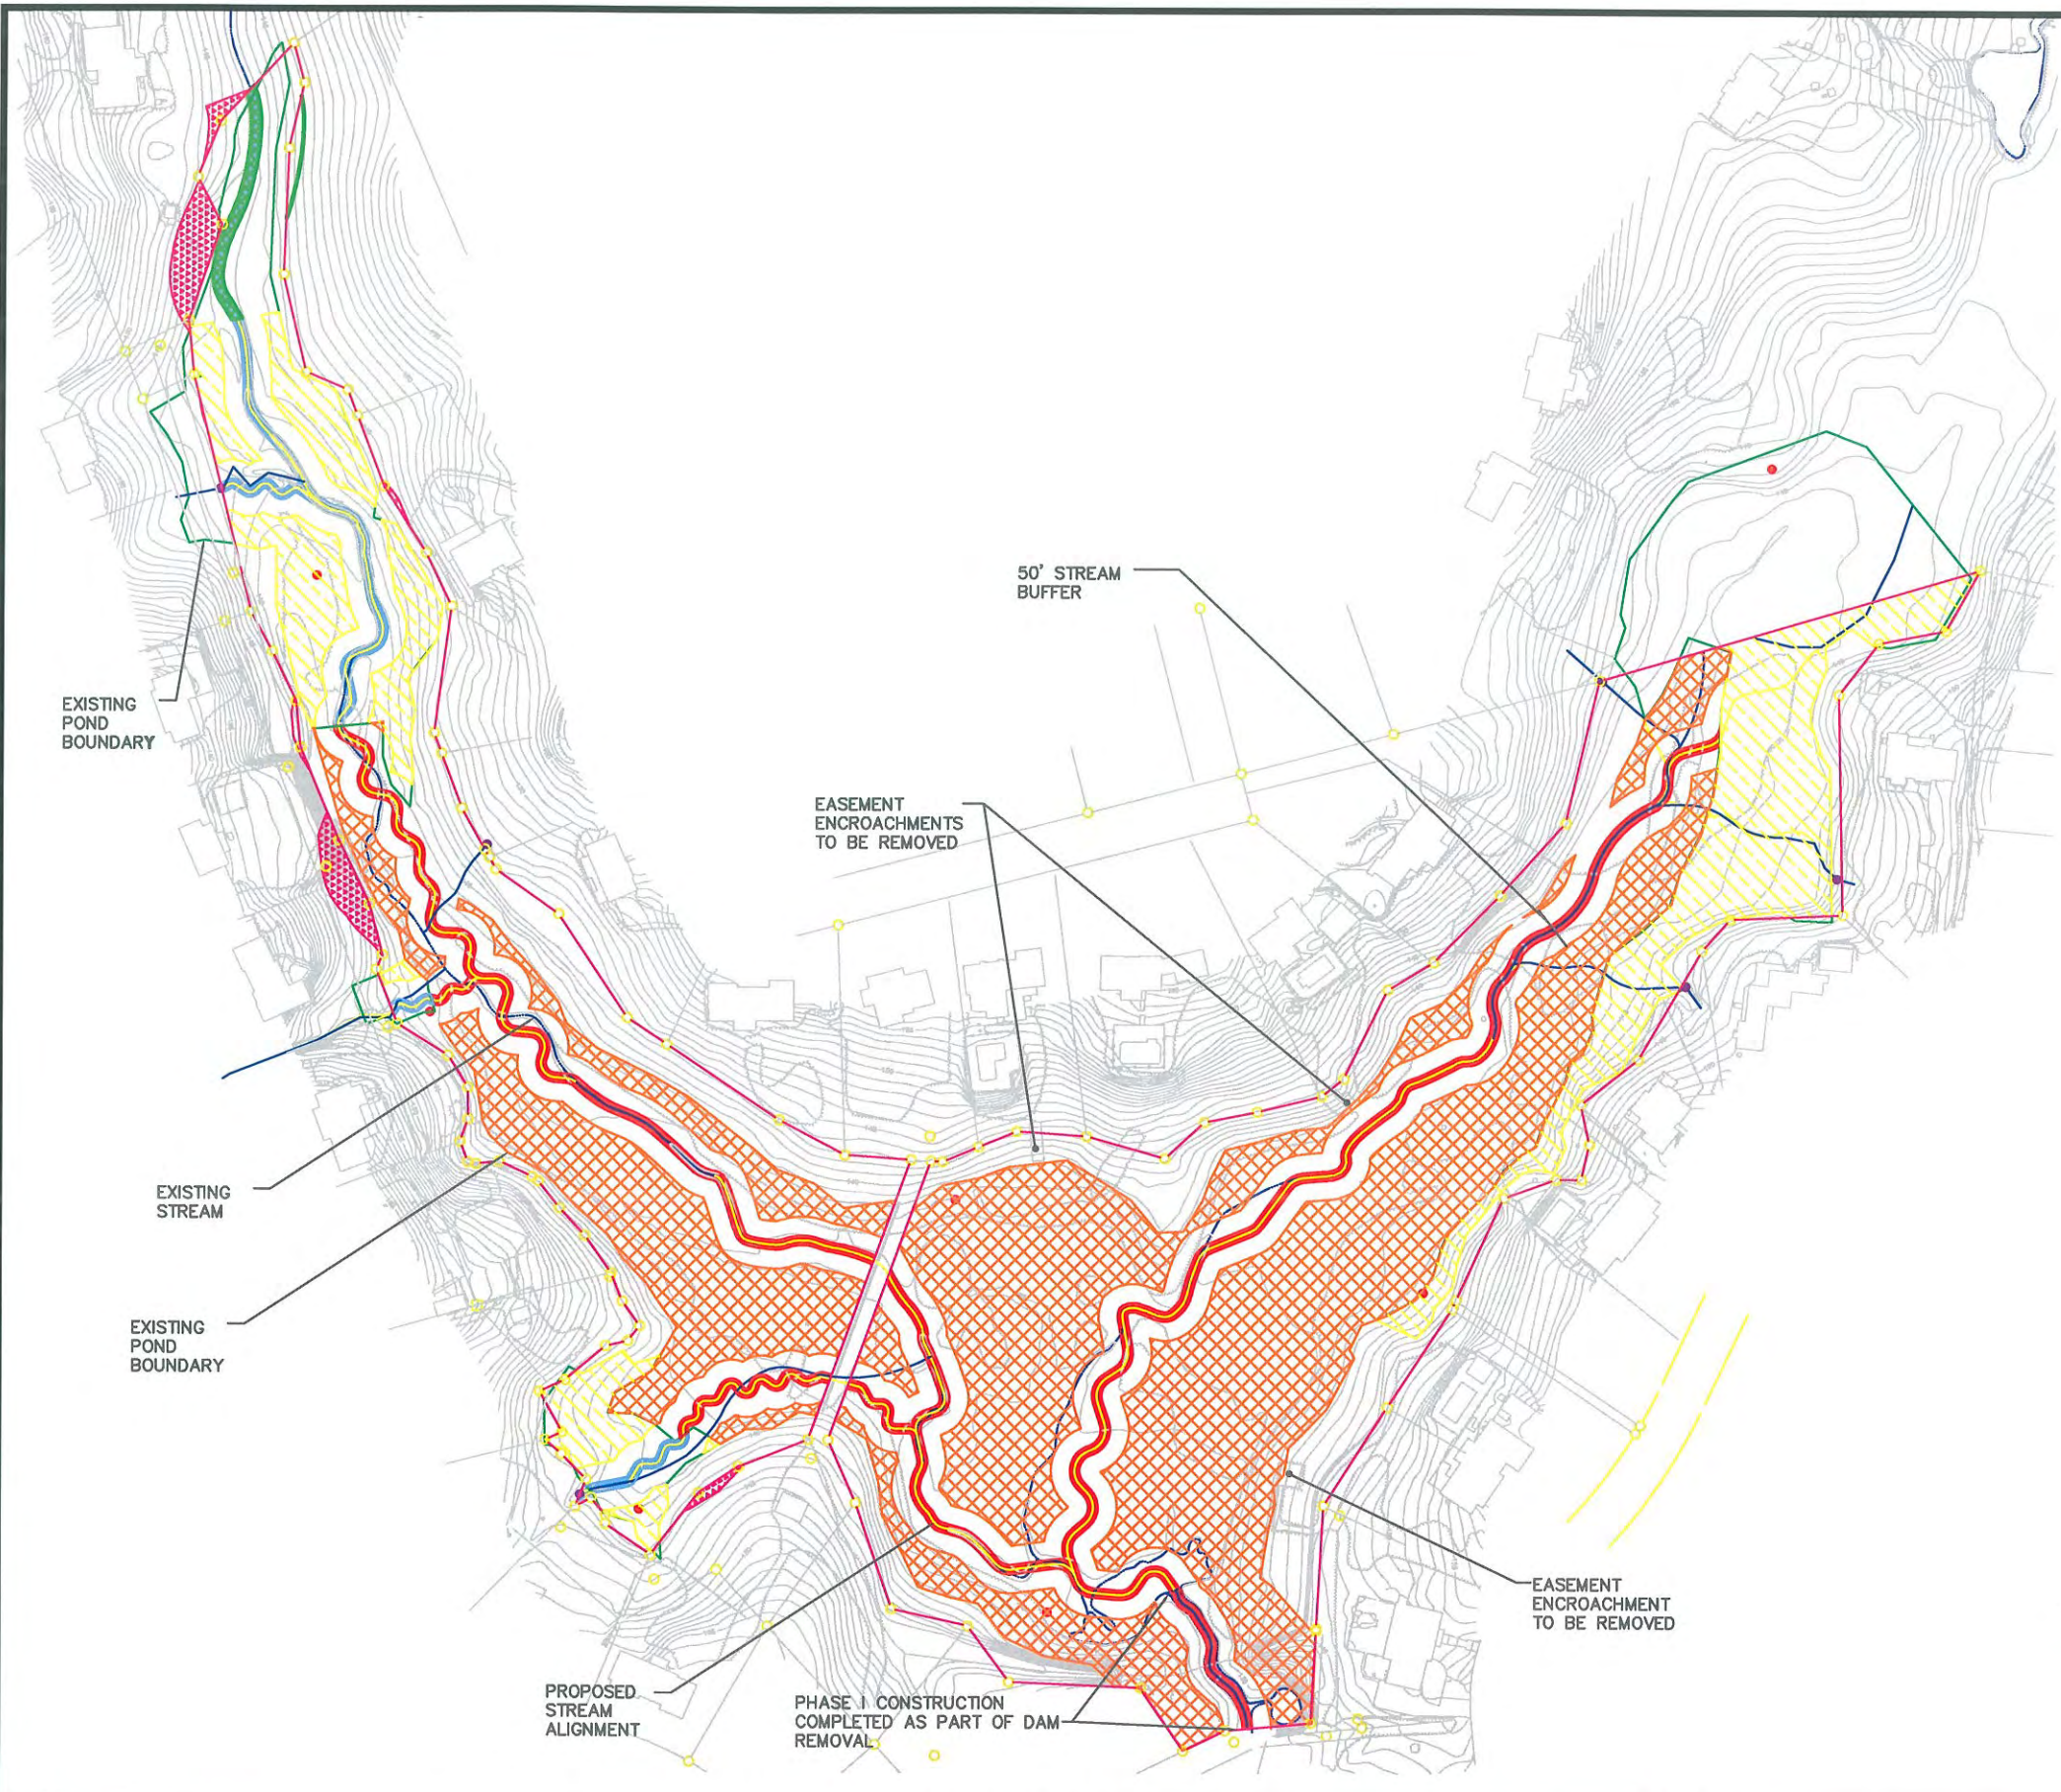
ATTACHED REFERENCE FILES: JOB NUMBER: 012857003 FIGURE NUMBER: 11

MITIGATION SUMMARY						
MITIGATION TYPE		RESTORATION	ENHANCEMENT	PRESERVATION	TOTAL MUs	% RESTORATION
STREAM	LENGTH (FEET)	3,221	826	255	3,823	84%
	MITIGATION UNITS	3,221	551	51		
RIVERINE WETLAND	AREA (ACRES)	6.8	2.4	-	8.0	85%
	MITIGATION	6.8	1.2	-

NOTE: WETLAND MITIGATION AREAS DO NOT INCLUDE THE ADJACENT 50' STREAM BUFFER AREA THAT SURROUNDS PROPOSED STREAM MITIGATION AREAS.

The conservation easement that consists of the entire parcel owned by Greg Tarlton (Tarlton Site) has been secured by Mid-Atlantic Mitigation. The conservation easement boundary is shown on the Existing Conditions map (**Figure 11**) and the Restoration Plan (**Figure 12**).

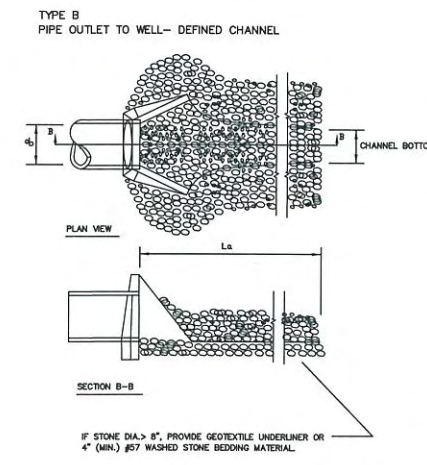
NOTES:
(1) $d = 1.5$ TIMES THE MAXIMUM STONE DIAMETER BUT NOT LESS THAN 6 INCHES.
(2) $d = 1'$ ABOVE MAXIMUM TAILWATER OR TOP OF CHANNEL BANK (WHICHEVER IS LESS).
(3) L_a = LENGTH OF RIPRAP APRON.

OUTLET PROTECTION
NTS

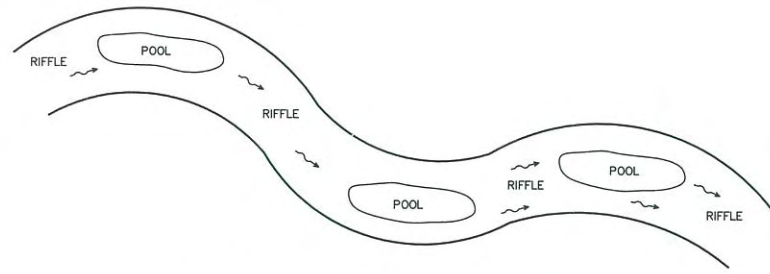
TYPICAL PLAN VIEW SCHEMATIC

NOTES:
TYPICAL SECTIONS ARE PROVIDED TO GIVE THE GENERAL DIMENSIONS OF THE CHANNEL. FINAL GRADING WILL GIVE THE CHANNEL A MORE "NATURAL" APPEARANCE AND ALLOW A SMOOTH TRANSITION FROM EXISTING CHANNEL TO NEW CHANNEL.

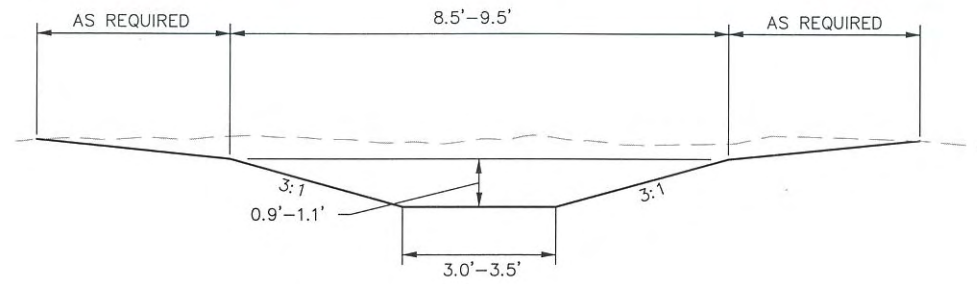
TYPICAL RIFFLE
[RESTORATION GOALS EASTERN PRONG]
NTS

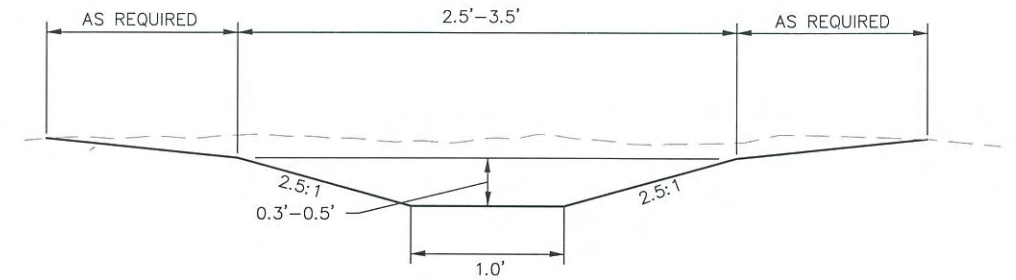
TYPICAL RIFFLE
[RESTORATION GOALS UT TO WESTERN PRONG]
NTS

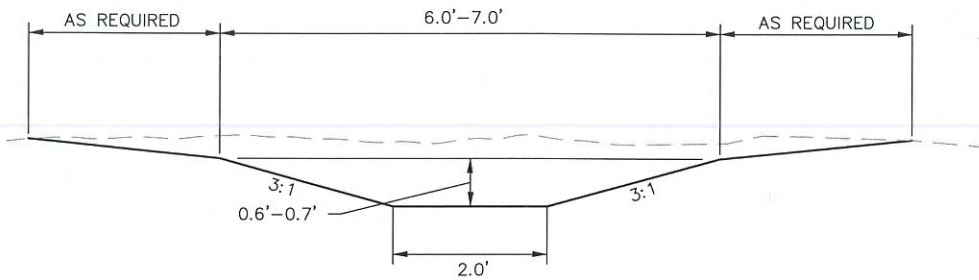
TYPICAL RIFFLE
[RESTORATION GOALS WESTERN PRONG]
NTS

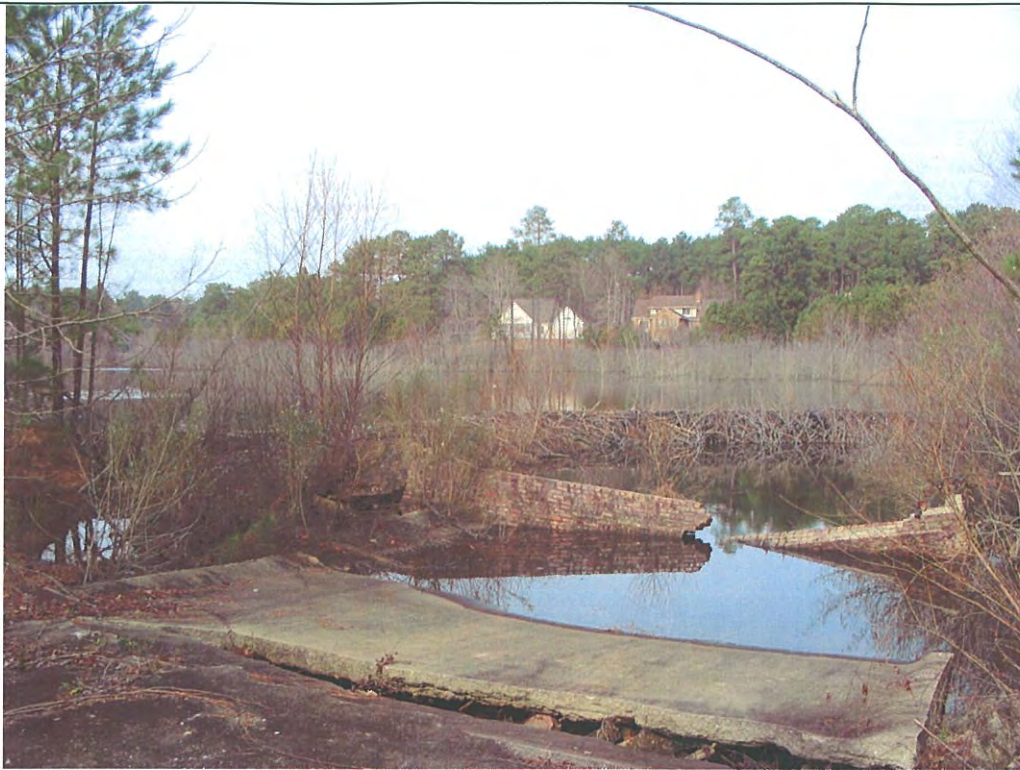
Photograph 1. Existing Conditions: Beaver Dam. Photo taken 1/12/2005.

The Tarlton Site was impounded by a man-made dam until it ultimately failed in 1994. Since then beavers have been active in maintaining the impoundment. The footprint of the open water area of the lake, and the extent functioning stream channel, has been fluctuating with the level of beaver dam development, periodic dam removal/maintenance, and storm events blowing out the structure. Therefore, the streams within the project area have been in constant adjustment (pattern and profile) and sediment transport capacity, i.e. alternating periods of deposition and incision. As of October 2005, the site consisted of approximately 1,420 linear feet of stream, 5.1 acres of wetland, and 10.3 acres of open water (impounded area from the beaver dams). The jurisdictional determination of wetland and streams within the project area was reviewed in the field and approved by the USACE on October 12, 2005. The delineation map provided to the USACE at the field review and is included in **Appendix 8**.

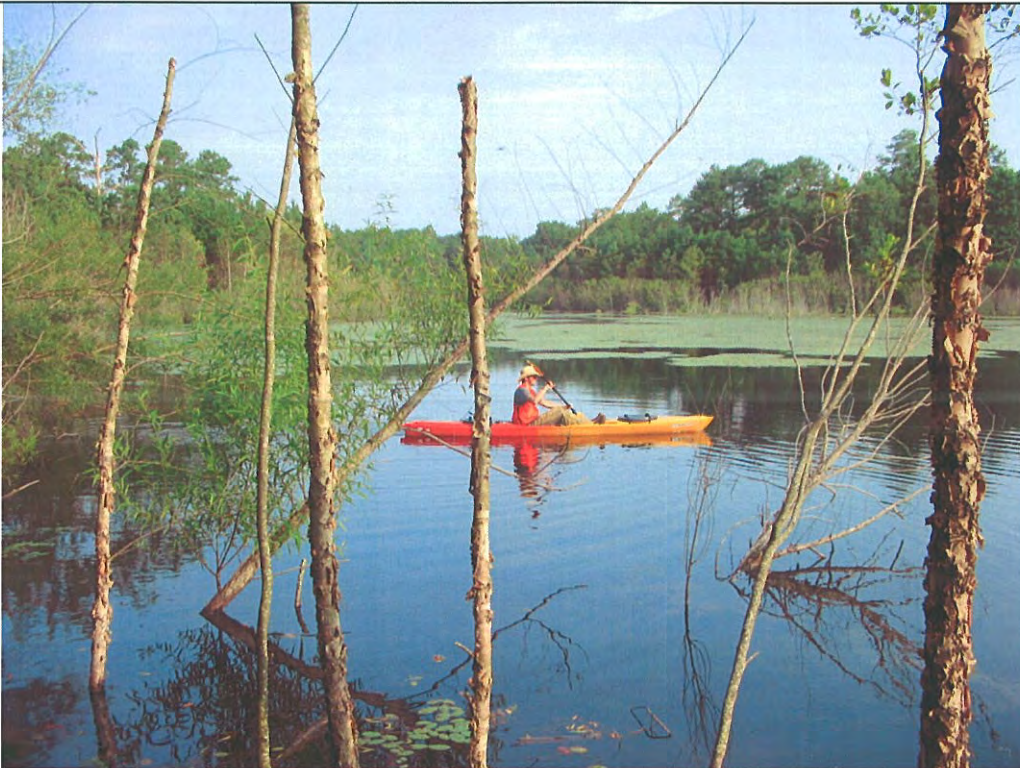
Photograph 2. Existing Conditions: Open Water. Photo taken 7/28/2005.

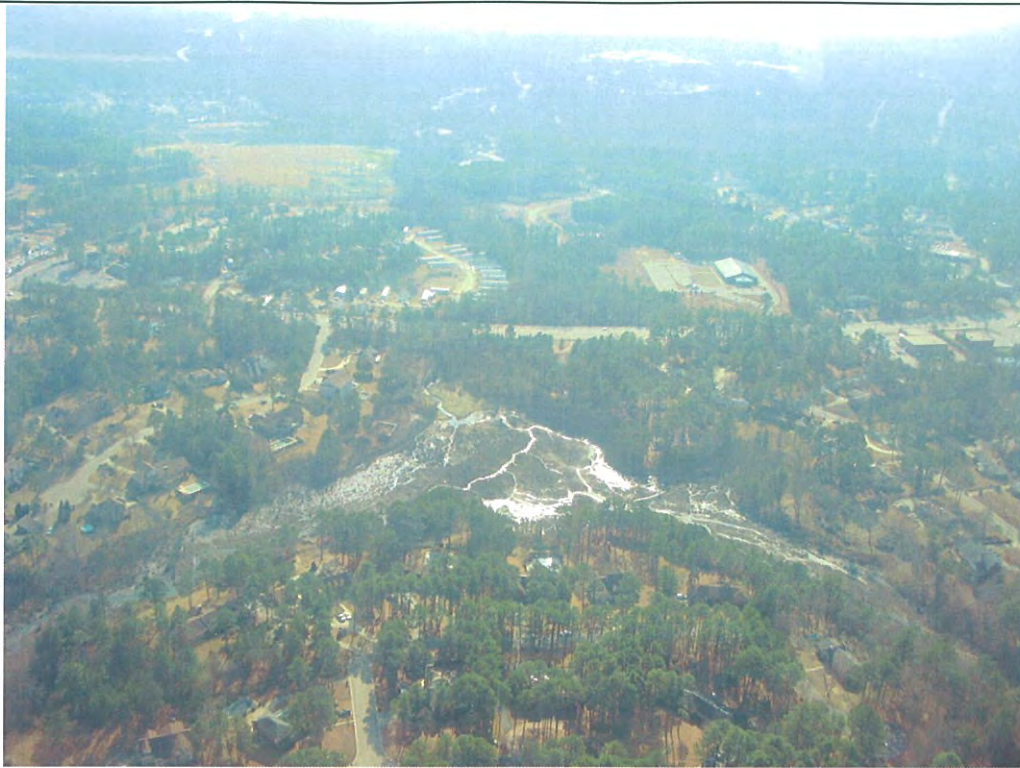
Photograph 3. Existing Conditions: Aerial photograph of project site. Photo taken 1/12/2006.

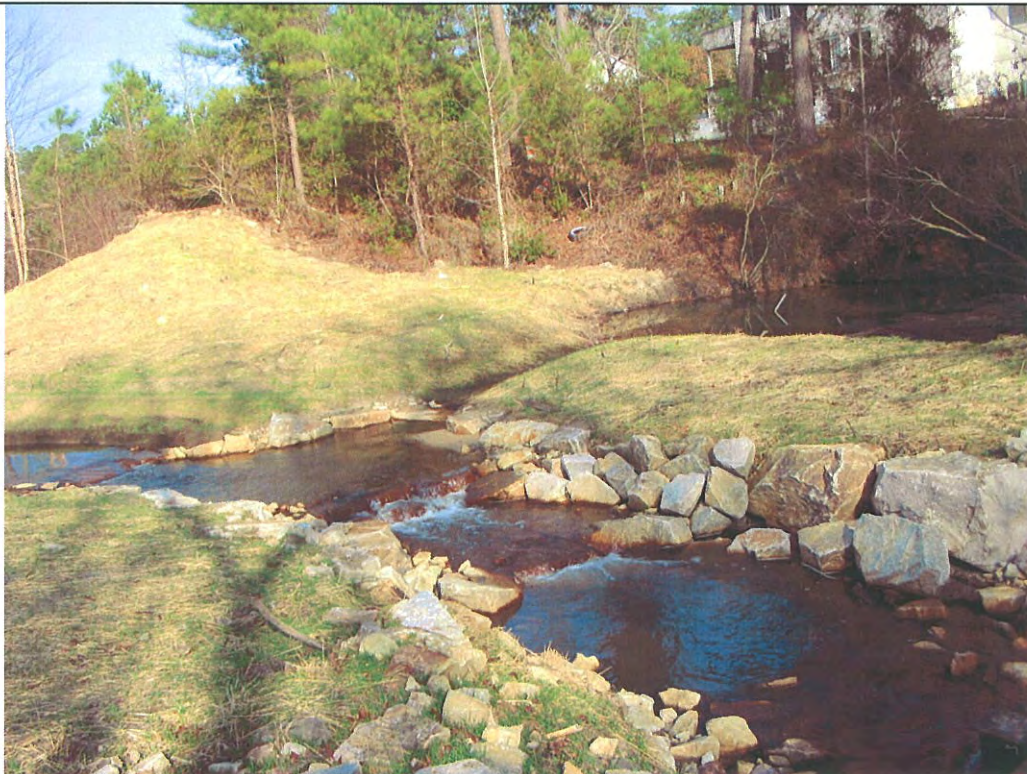
Photograph 4. Phase I Completed: Restored section of stream. Photo taken 1/12/2006.

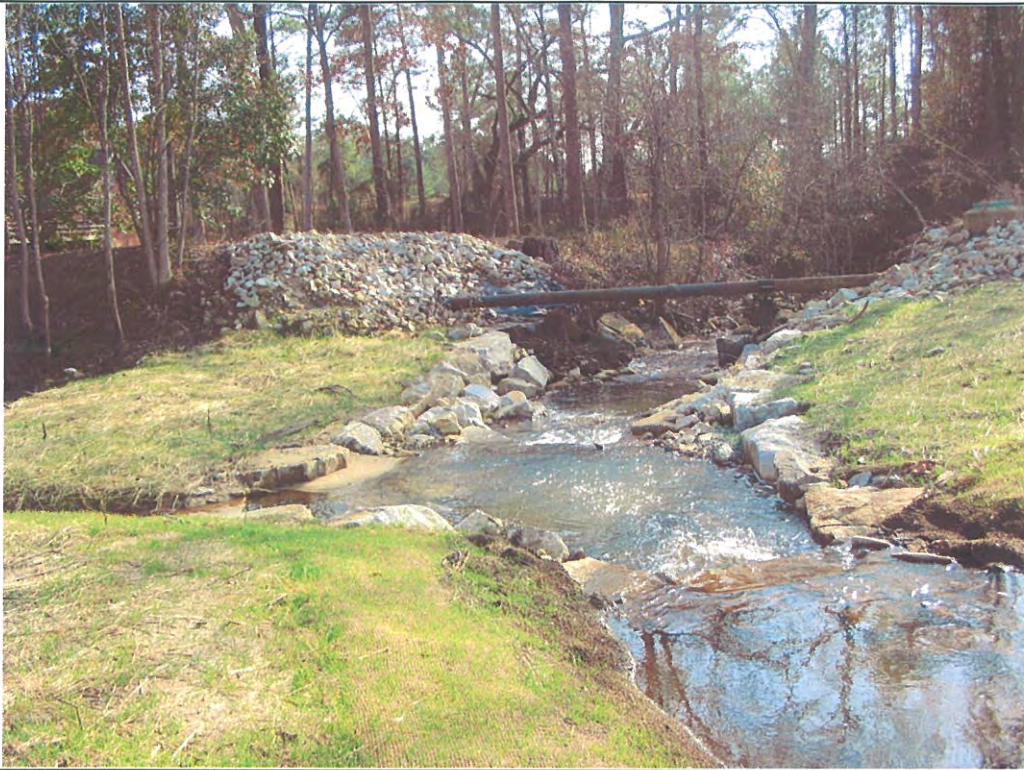
Photograph 5. Phase I Completed: Southeast view of restored stream at utility crossing. Photo taken 1/12/2006.

An elevated Fayetteville gravity sanitary sewer line and utility easement crosses the eastern prong approximately 600 feet upstream from the confluence of the eastern and western prongs. This utility easement was removed from the conservation easement. PWC plans to replace the aerial crossing with a pipe crossing inside the easement. Since the pipe is a gravity line the new pipe will also be an aerial crossing and will not influence the hydrologic connection of the project. All future construction and maintenance of this sanitary sewer line will be outside the conservation easement.

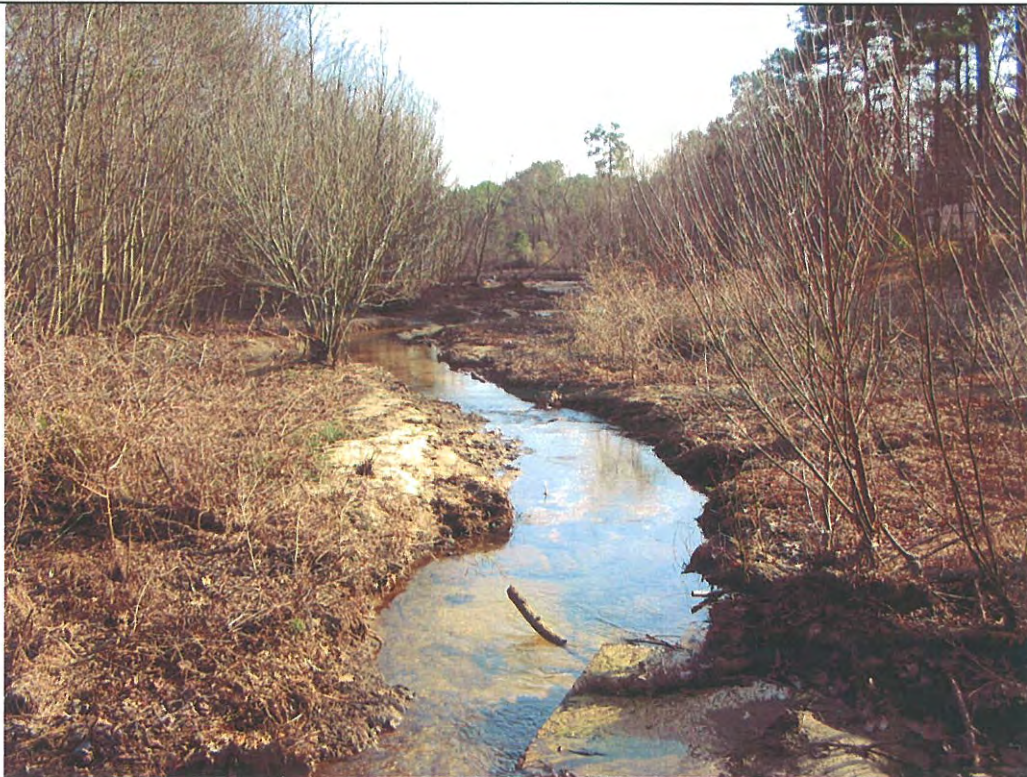
Photograph 6. Existing Conditions: Eastern prong of project site. Photo taken 1/12/2006.

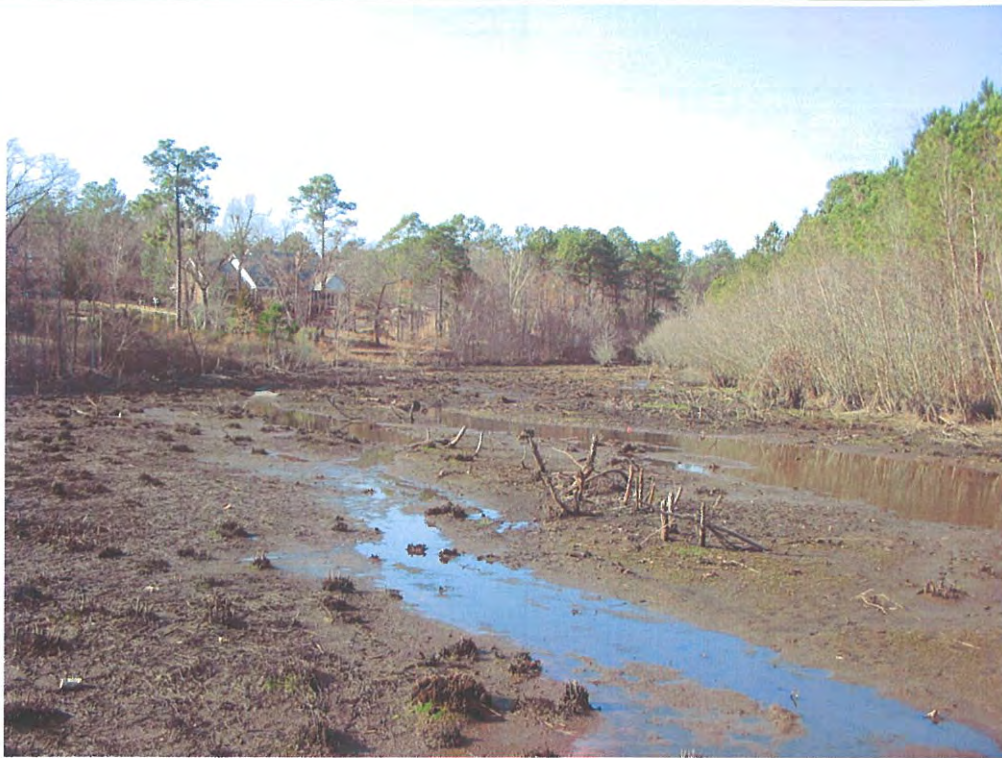
Photograph 7. Existing Conditions: Drained Country Club Lake. Photo taken 1/12/2006.

The project site was historically impounded by a dam built in the 1970s, creating Country Club Lake by impounding about 4,500 feet of two perennial prongs of the stream. The impoundment was breached by a storm on September 15, 1989, rebuilt in June of 1990, and breached again on March 5, 1994 completely draining the lake. After the second failure in 1994 the dam was never rebuilt nor was the failed dam and spillway ever completely removed. Since 1994, the site has been hydrologically influenced by beaver activity with a fluctuating lake level. There are areas of fringe wetlands and open waters within the project area, however, due to the instability of the lake level, these areas are unstable and under a constant change in hydrology. This is apparent by various vegetation communities.

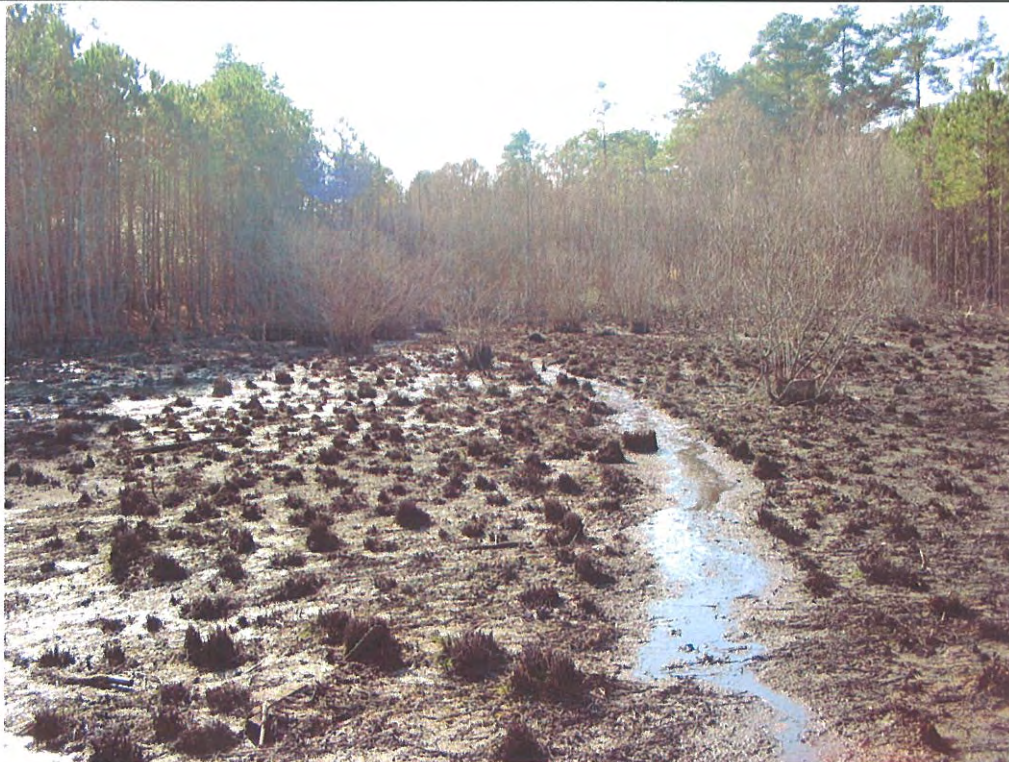
Photograph 8. Existing Conditions: West view of drained Country Club Lake. Photo taken 1/12/2006.

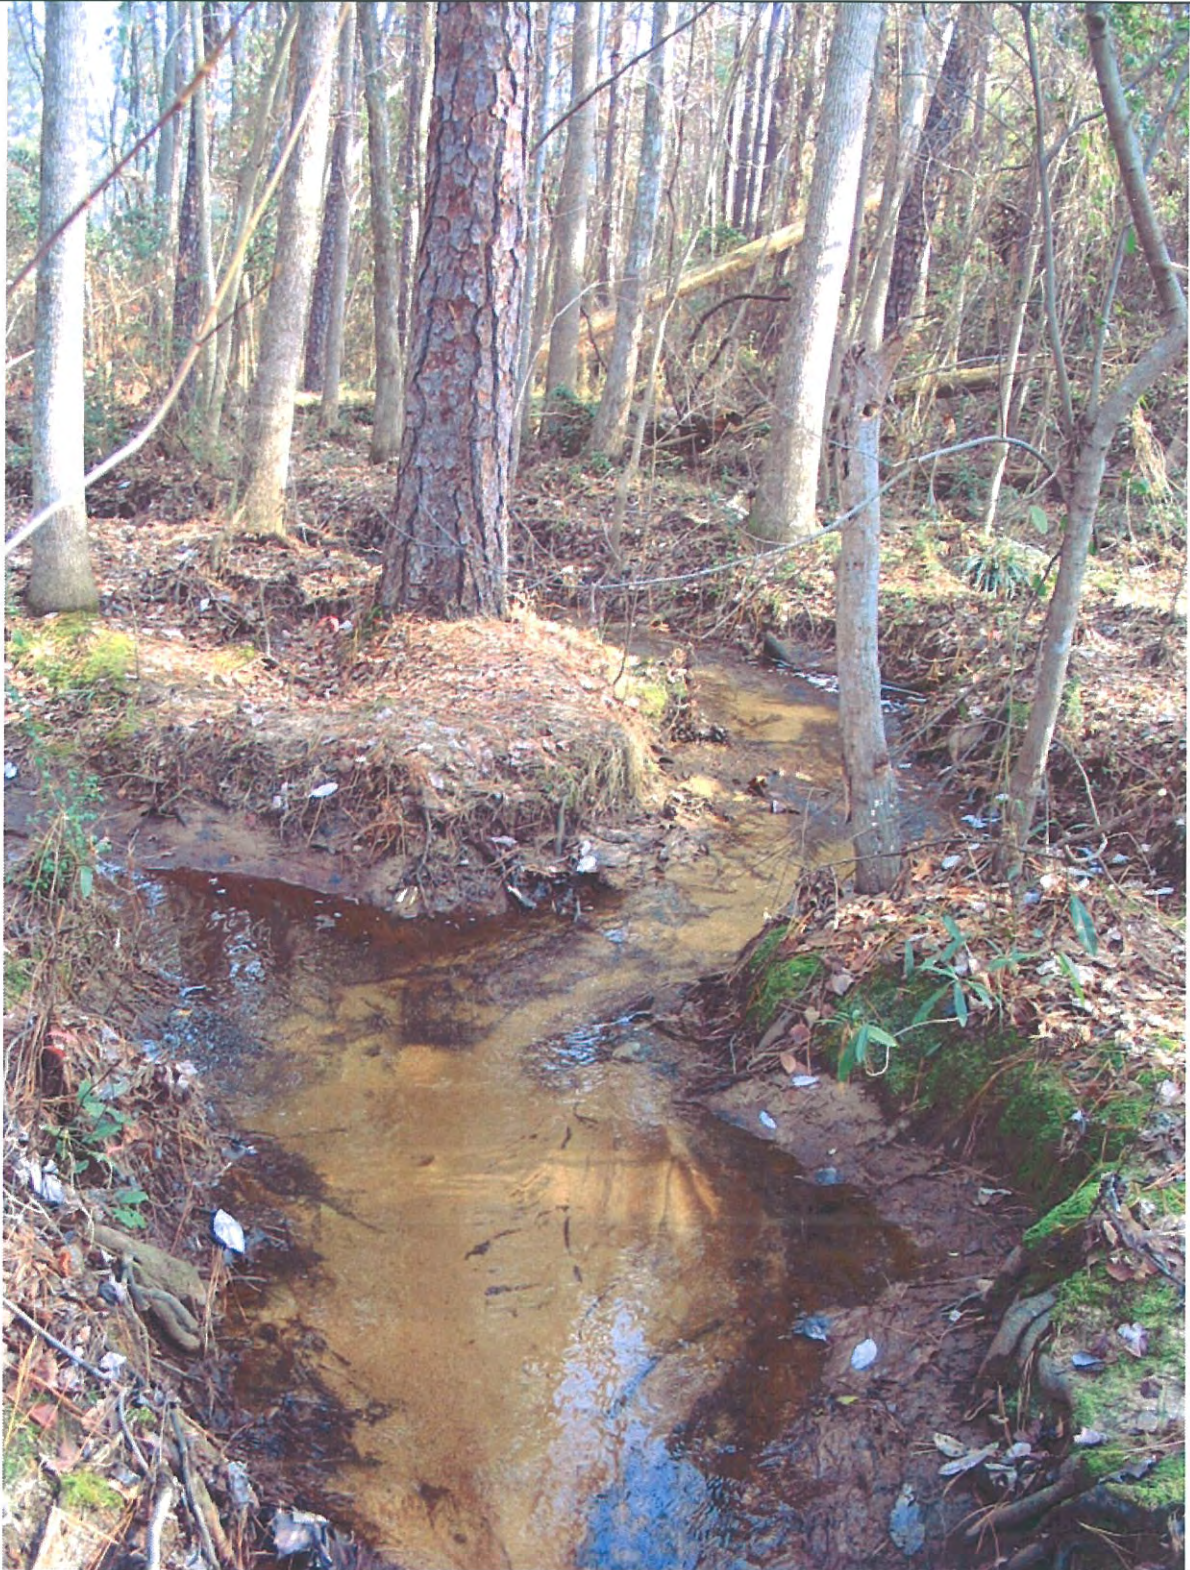
Photograph 1. Reference reach upstream of Hillard Drive. Photo taken 1/12/2005.

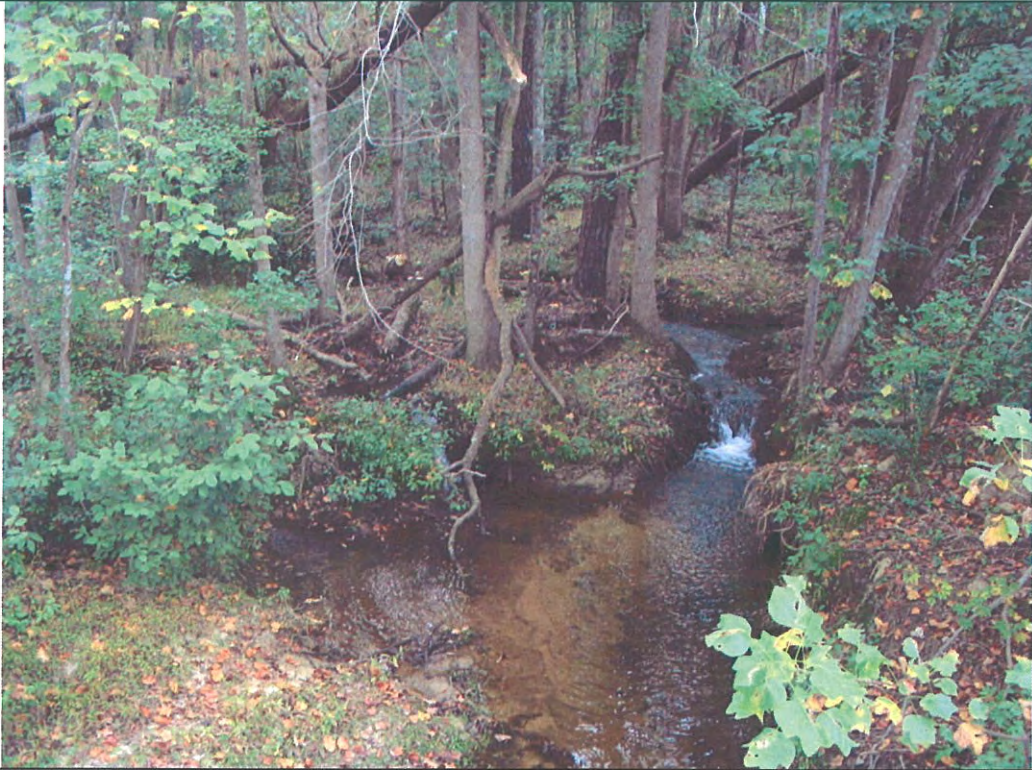
Photograph 2. Reference reach upstream of Hillard Drive. Vegetation is representative of that at the project site. Photo taken 10/27/2004.

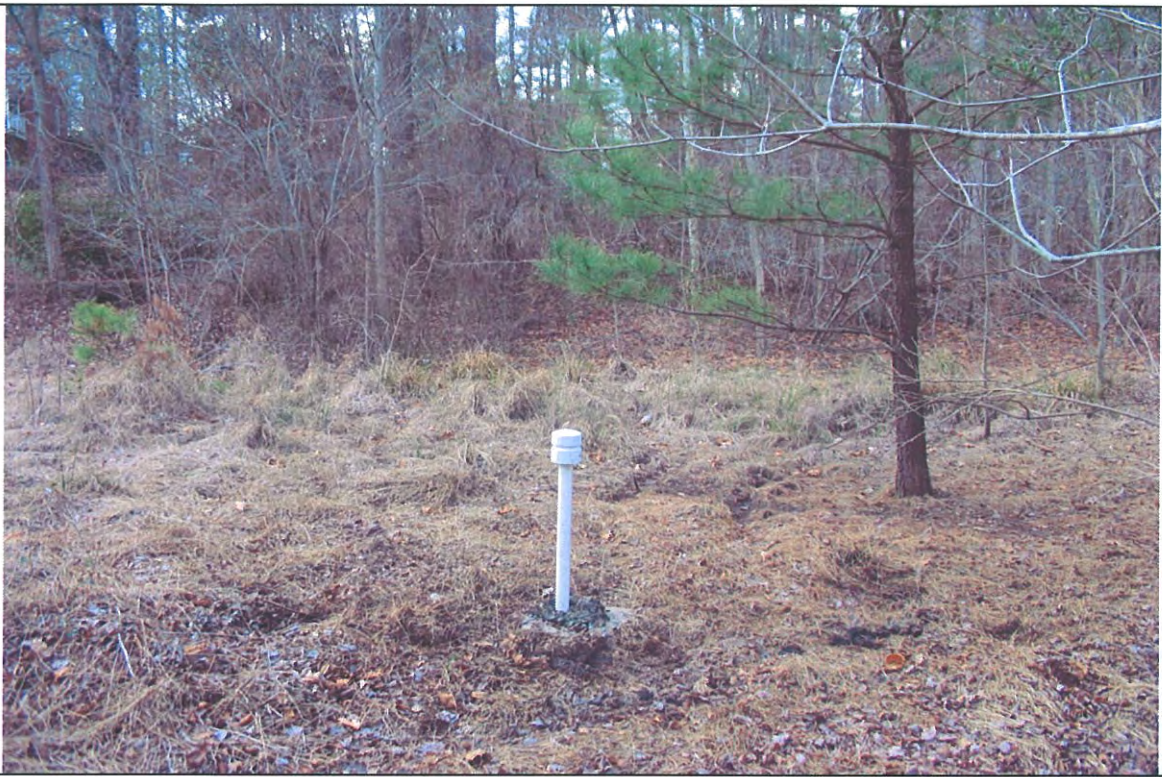
Photograph 1. Gage Location 1: Located in the upper portion of site. West view, towards the gage and easement boundary along the toe-of-slope. Photo taken 1/17/2006.

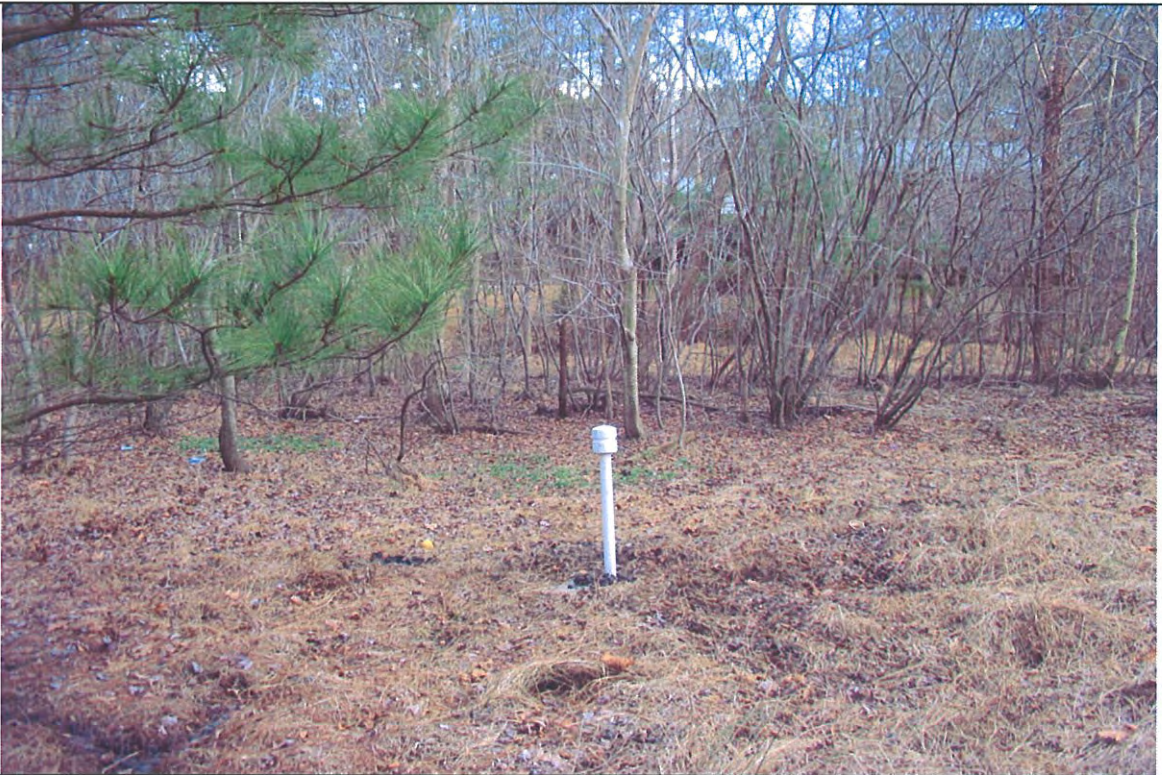
Photograph 2. Gage Location 1: East view towards the stream channel, taken from the floodplain toe-of-slope. Photo taken 1/17/2006.
