Stream and Wetland Restoration Plan **Tarlton Site**

Cumberland County, North Carolina
Project ID No. 012857003

February 2006

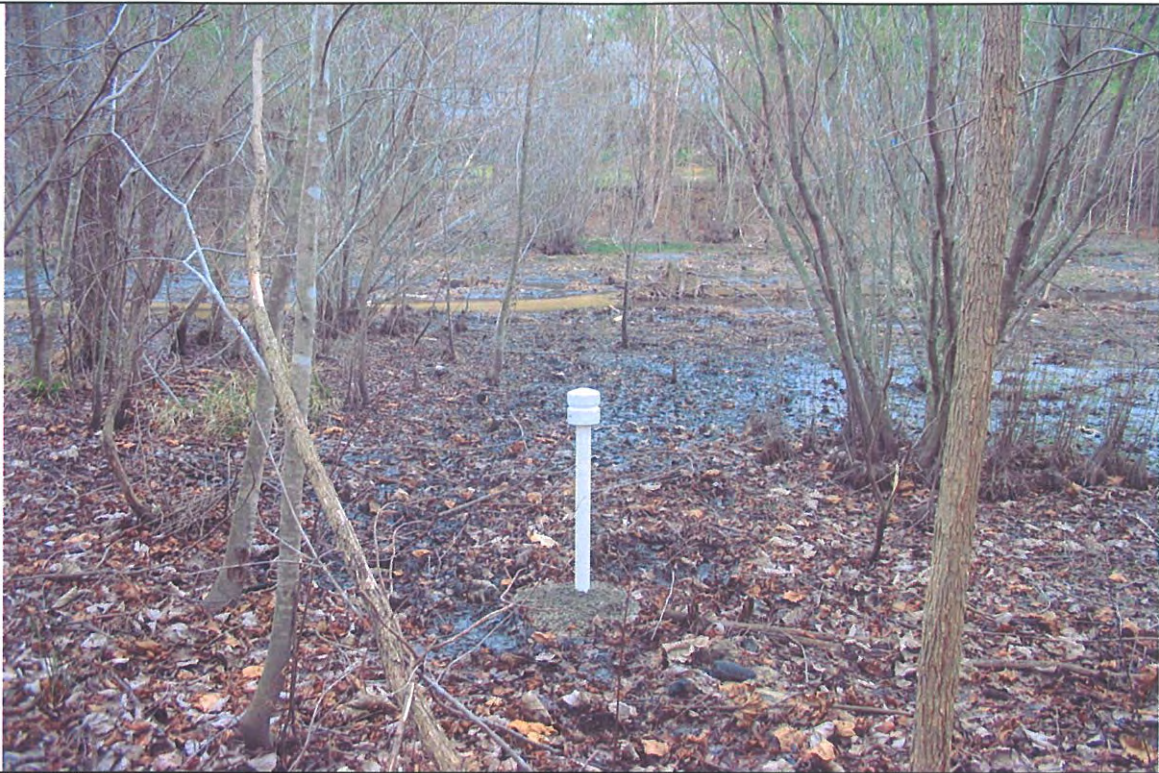
Photograph 3. Gage Location 2: East view, taken from near the easement boundary. Photo taken 1/17/2006.

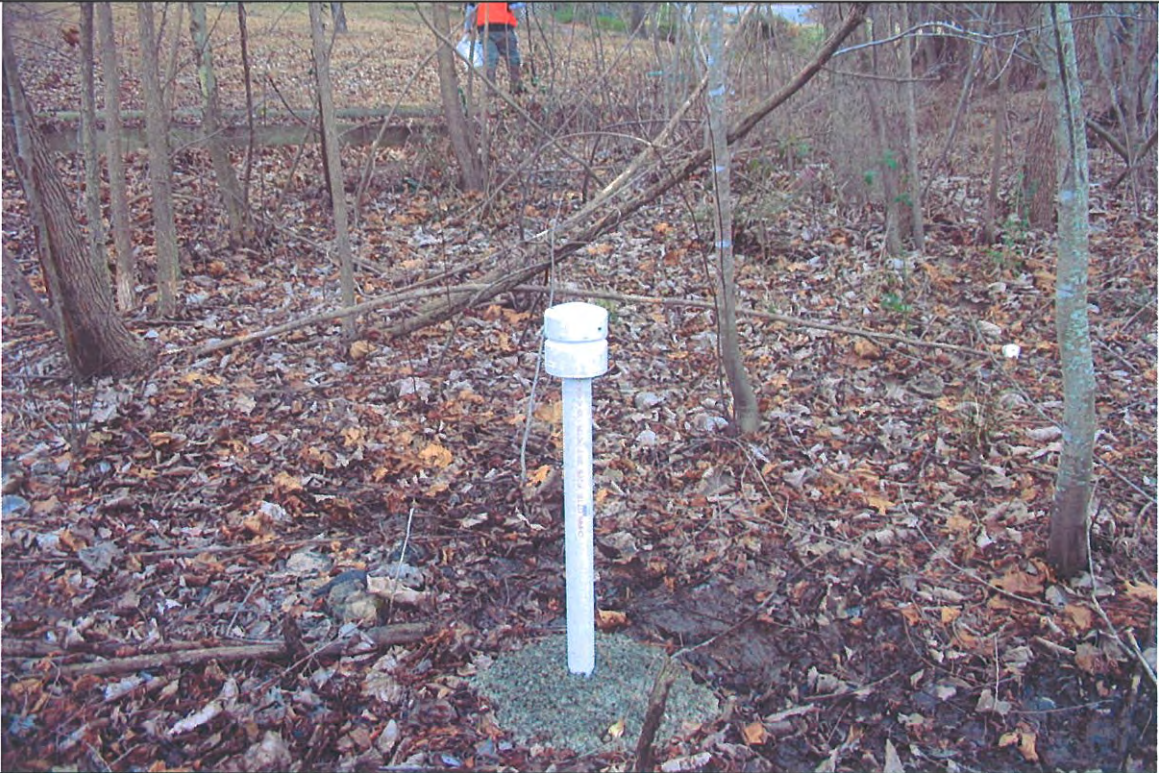
Photograph 4. Gage Location 2: West view of gage location 2. Note concrete bulkhead at easement boundary, delineating historical limits of Country Club Lake. Photo taken 1/17/2006.

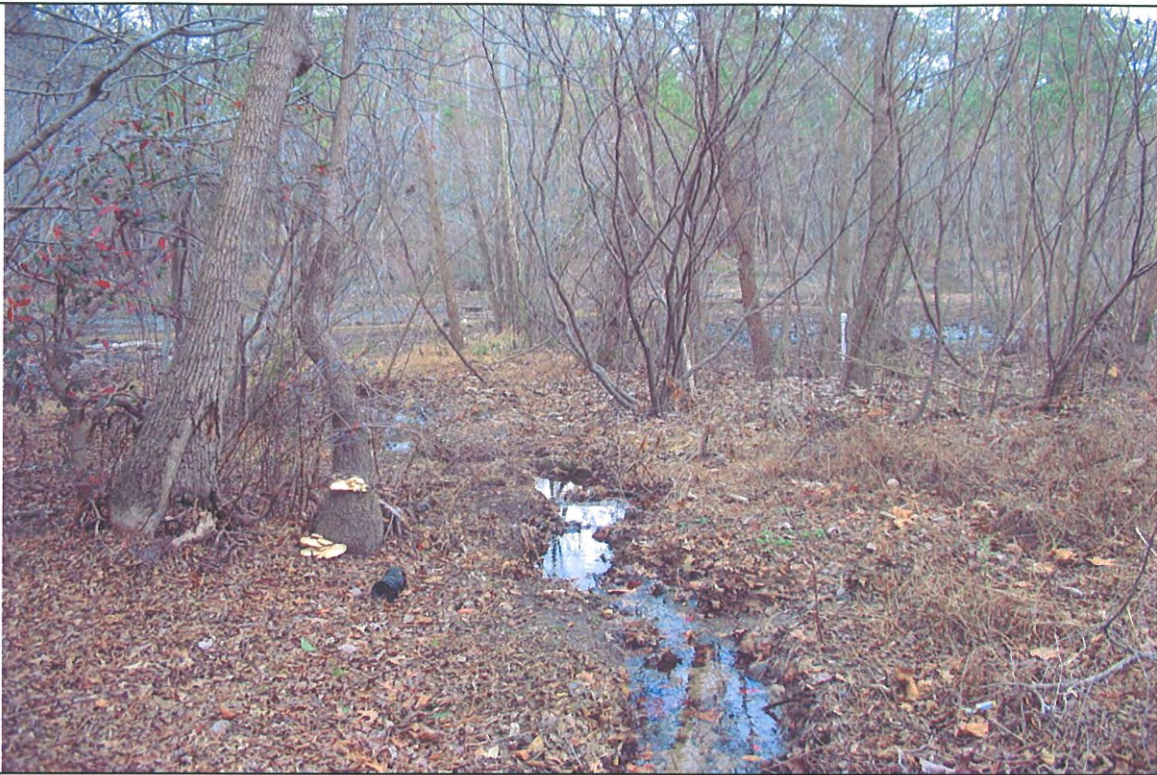
Photograph 5. Gage Location 2: East view of gage, showing small tributary. Photo taken 1/17/2006.

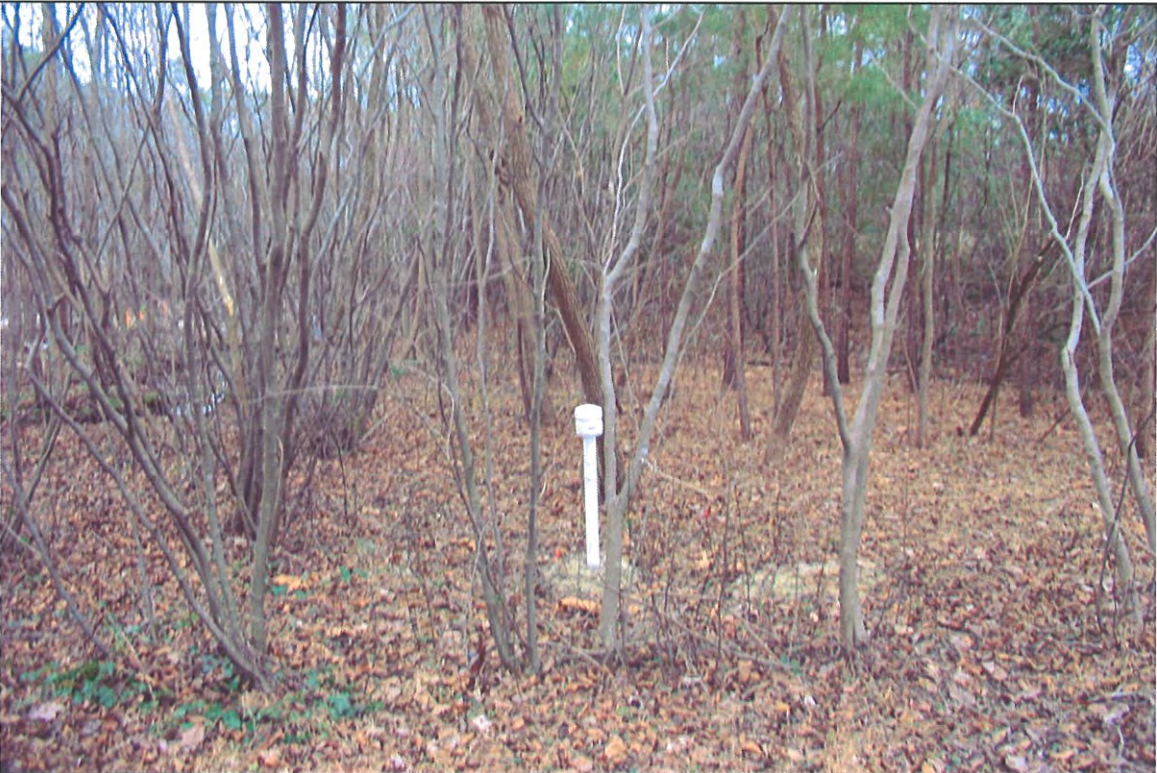
Photograph 6. Gage Location 3: Northeast view of gage location. Small tributary occurs along the left edge of photo. Photo taken 1/17/2006.

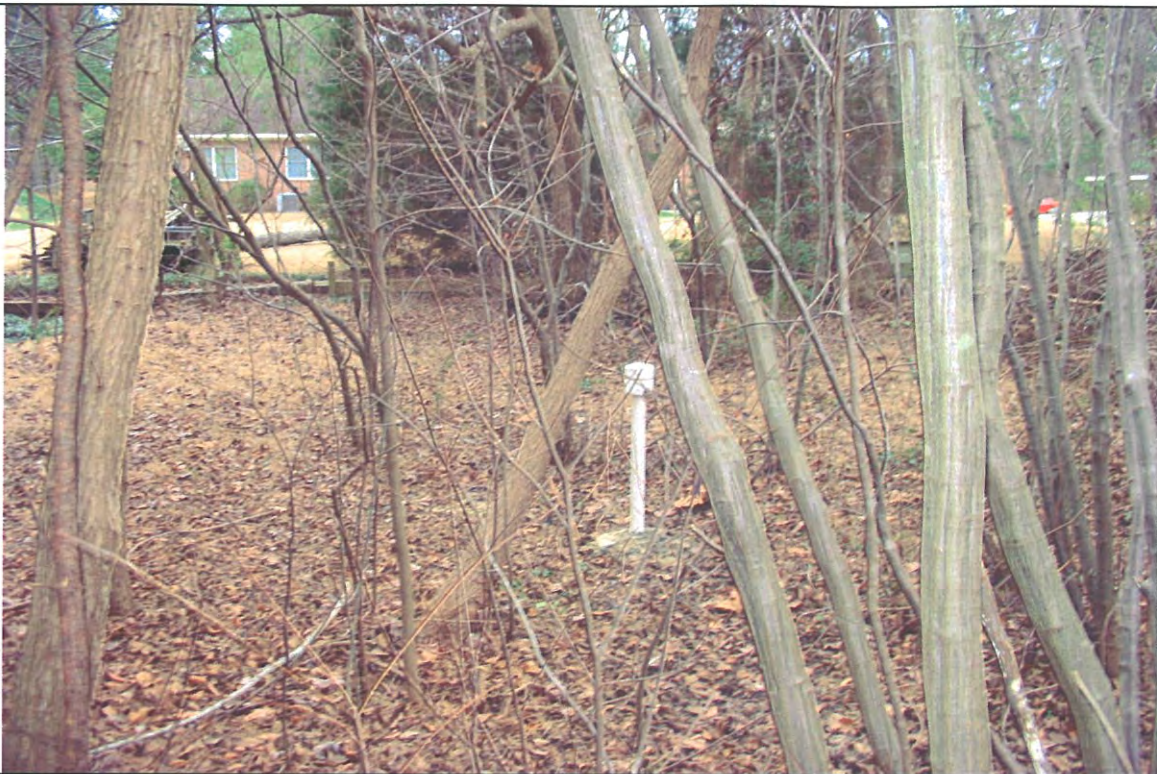
Photograph 7. Gage Location 3: Southwest view of gage location 3. Note culvert outlet on right side of photo. Photo taken 1/17/2006.

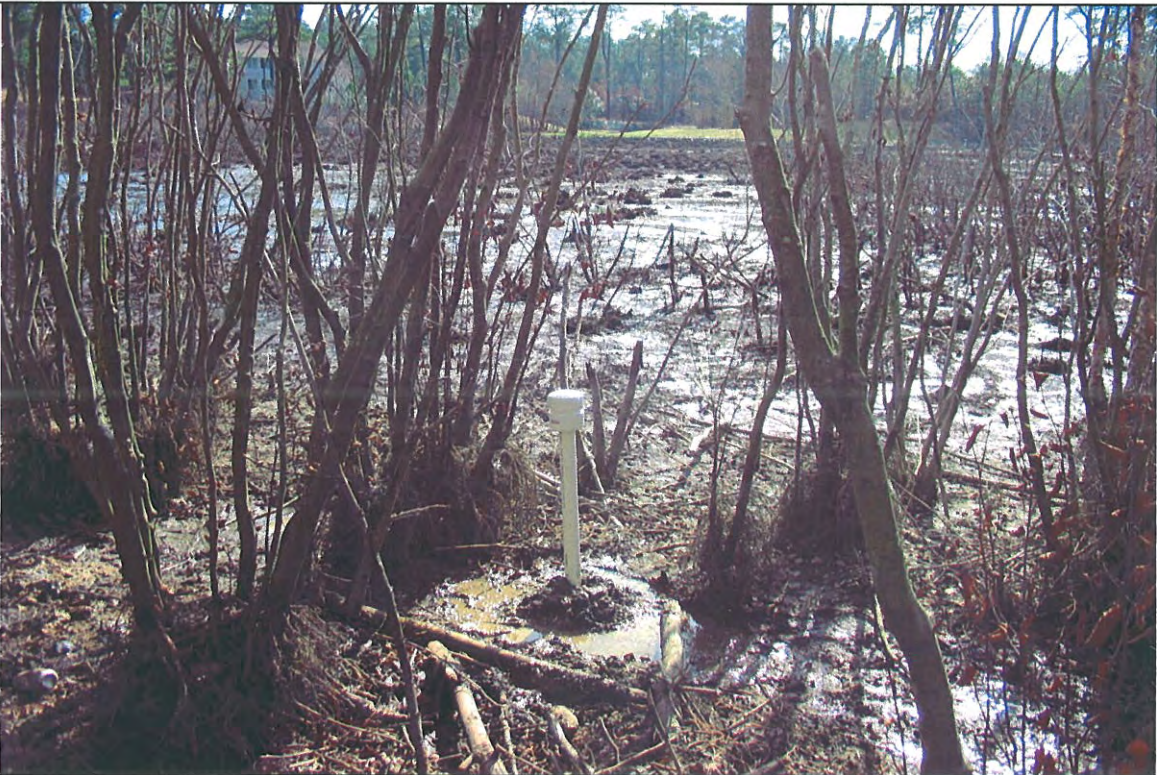
Photograph 8. Gage Location 4: South view of gage location 4. Note grade control and restoration seen in the distance (across the drained portion of the lake site). Photo taken 1/17/2006.

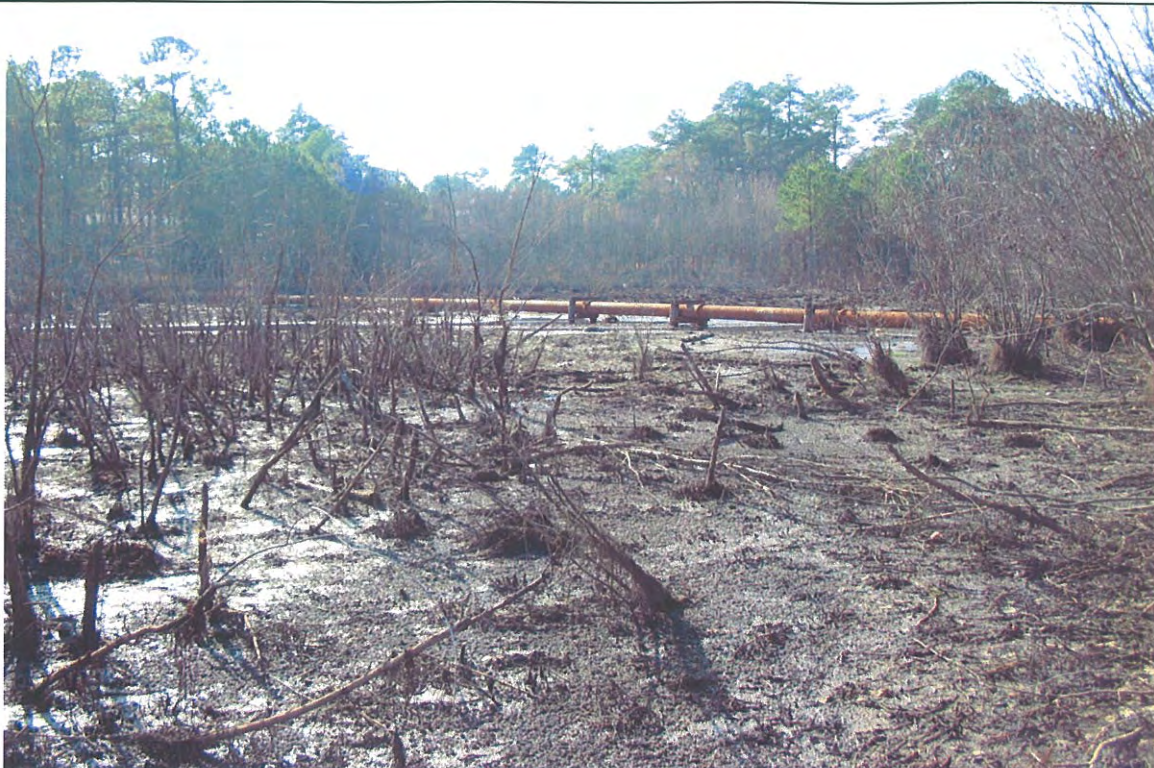
Photograph 9. Gage Location 4: West view of restoration site taken from gage location 4. Note sewer easement crossing across western prong. Photo taken 1/12/2006

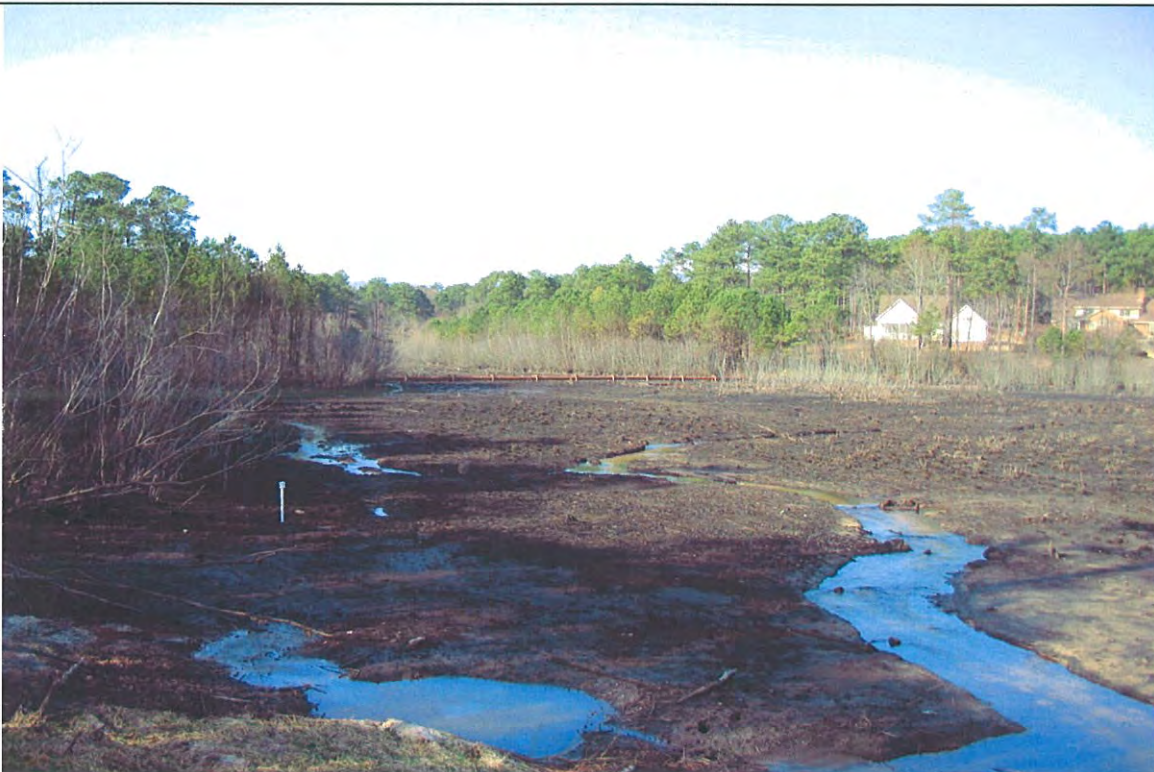
Photograph 10. Gage Location 5: Northwestern view of gage location 5. Gage is approximately ~30 feet from remnants of Country Club Lake dam in recently drained portion of the site. Photo taken 1/12/2006.

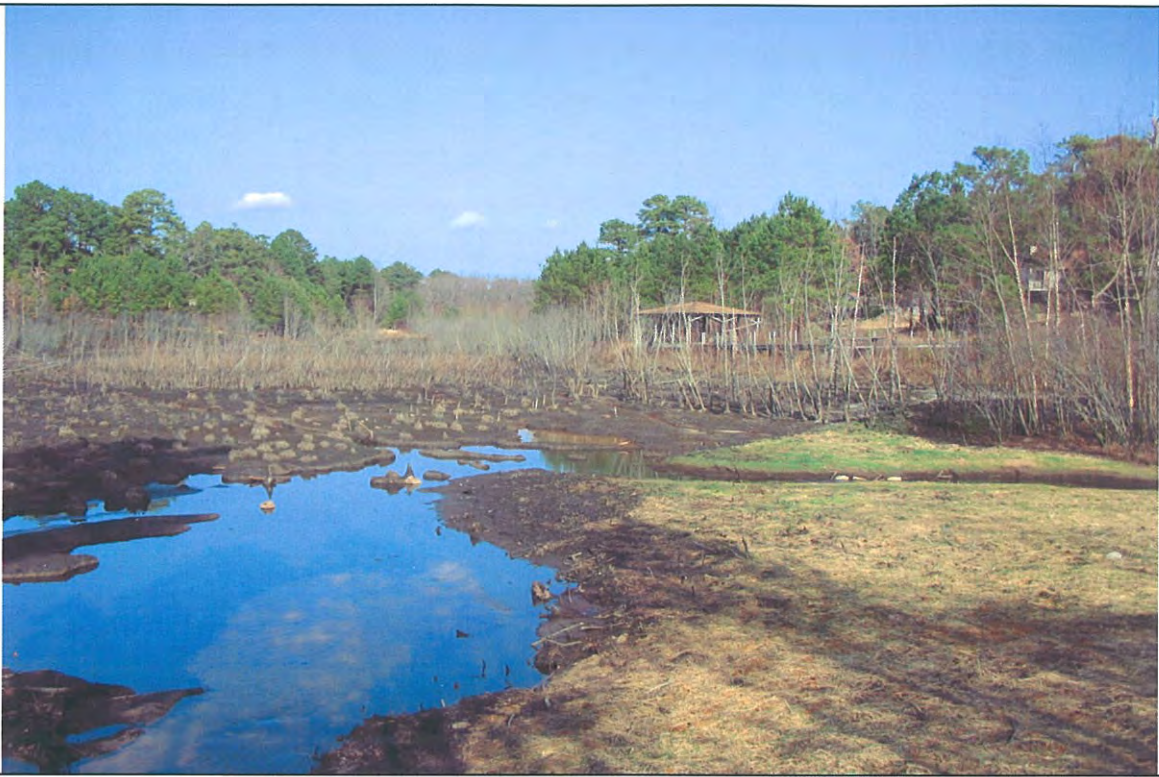
Photograph 11. Gage Location 5: Southeast view from gage location 5. Note grade control and restoration area at downstream end of project area. Photo taken 1/12/2006.

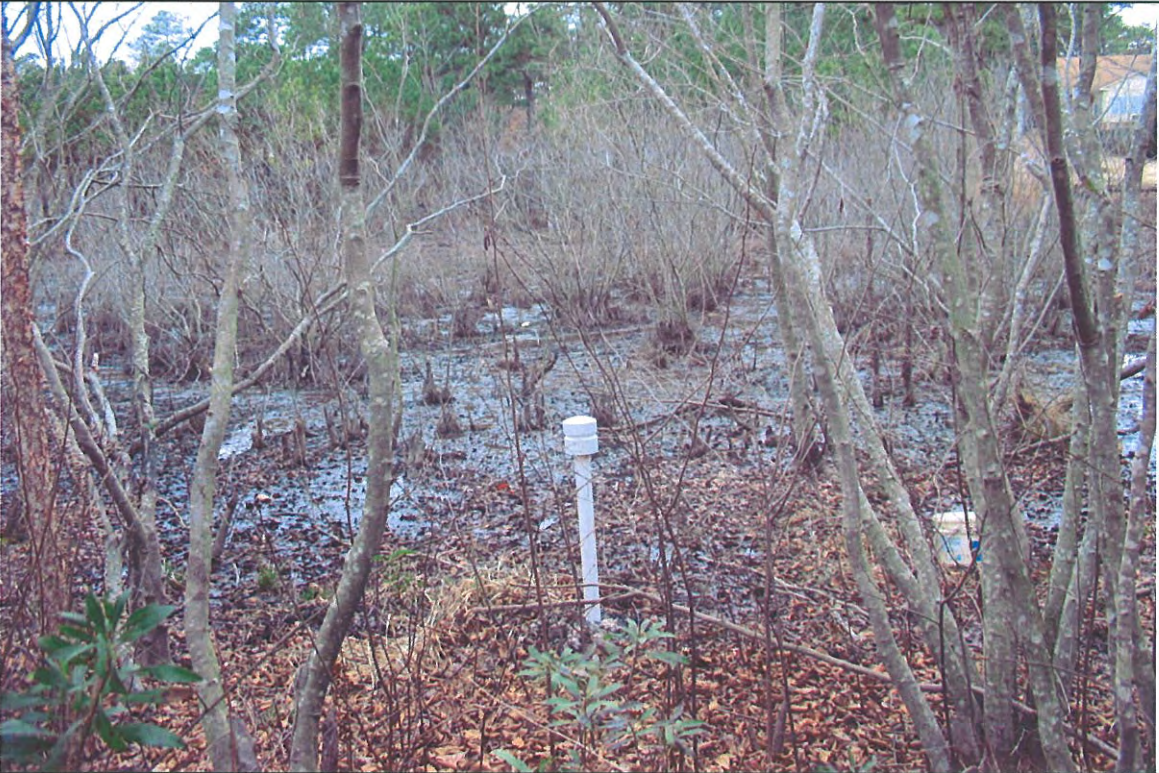
Photograph 12. Gage Location 6: Northwest view of gage location 6, looking towards stream channel. Photo taken 1/17/2006.

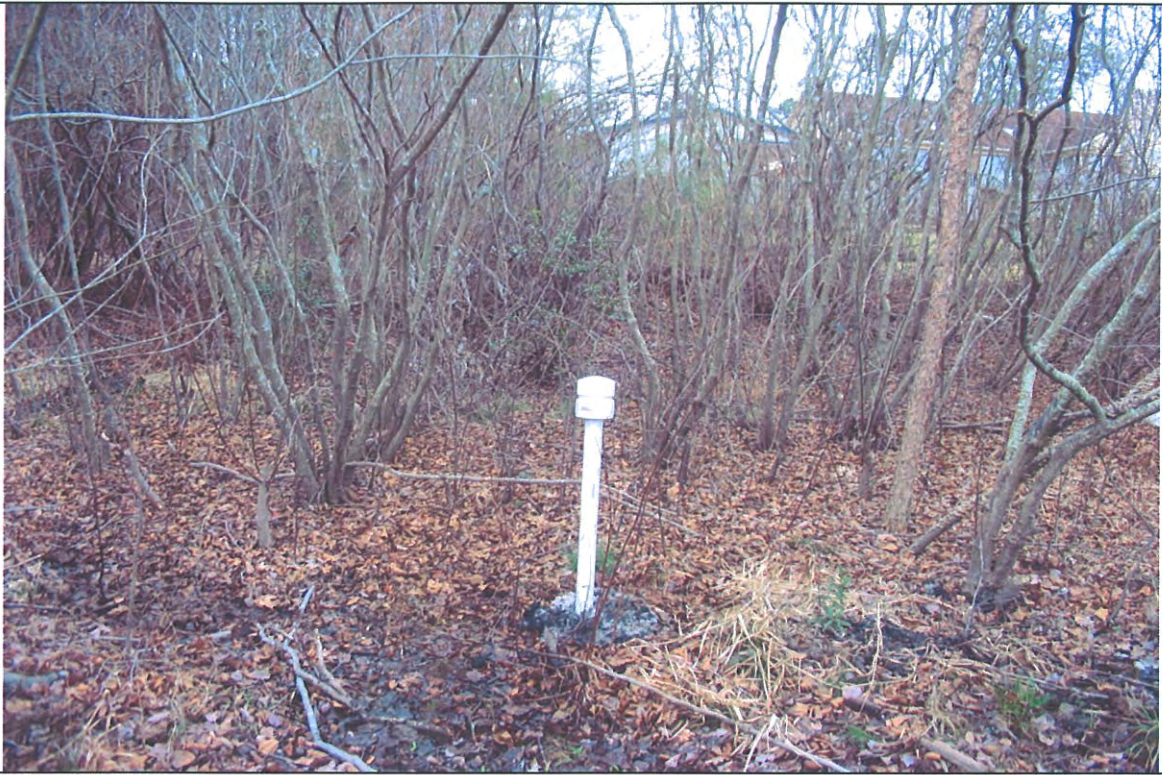
Photograph 13. Gage Location 6: Southeast view of gage location 6, towards easement boundary. Photo taken 1/17/2006.
