# Tarlton Stream and Wetland Restoration Project

Contract #: D05013-1  
County: Cumberland  
Cataloging Unit: Cape Fear 03030004  
Monitoring Firm POC: Mid-Atlantic Mitigation, LLC  
Rich Mogensen (704) 782-4133  
Kimley-Horn Associates, Inc.  
Will Wilhelm (704) 333-5131  
Prepared For: EEP Project Manager, Guy Pearce

## Year 4 (2009) Monitoring Report

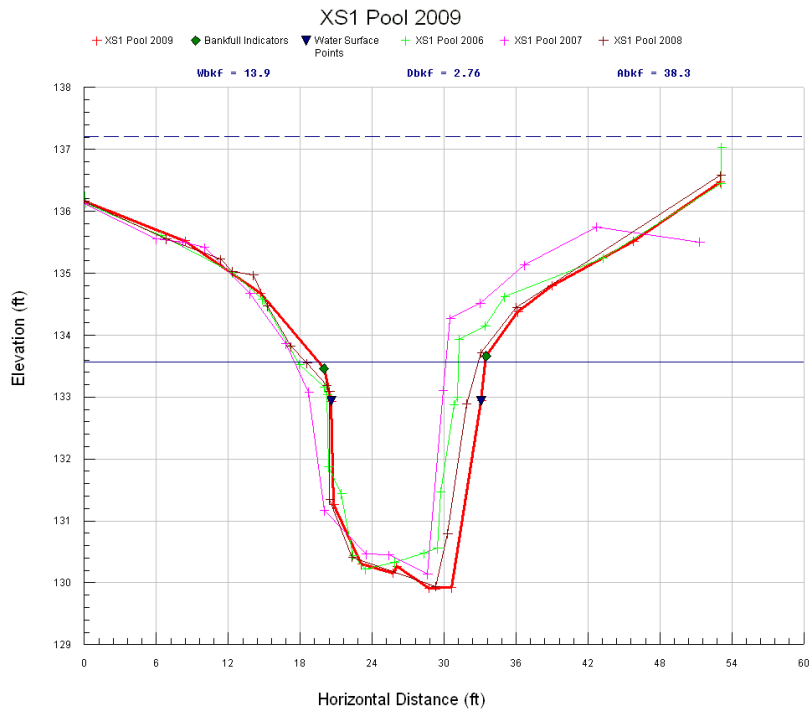
Graph 1: Cross Section 1 Pool

Cross Section 1 Pool – No significant changes, Thalweg right of center.

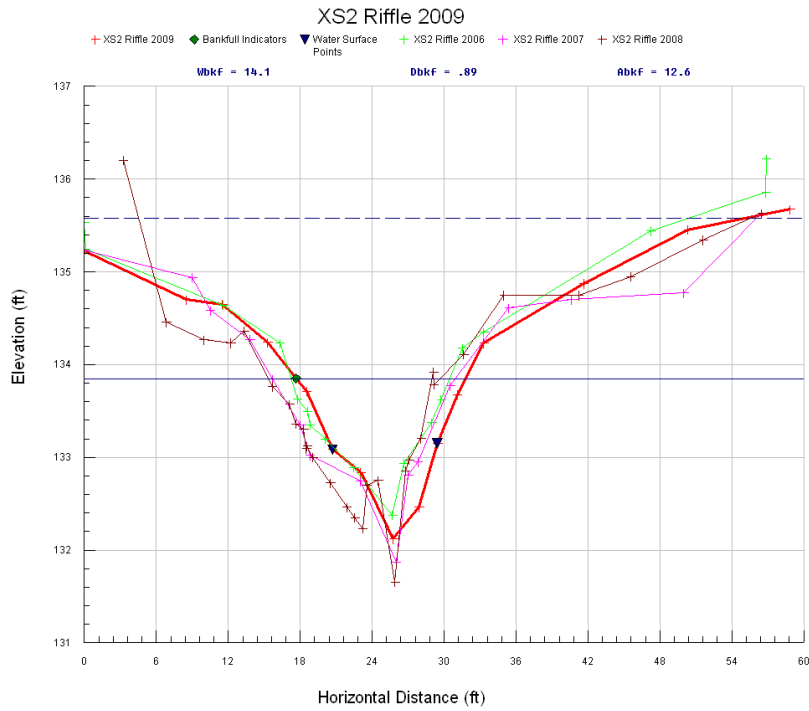
Graph 2: Cross Section 2 Riffle

Cross Section 2 Riffle– Sand deposits from 2008 have washed out returning to the 2006, 2007 trend, thalweg close to centered.

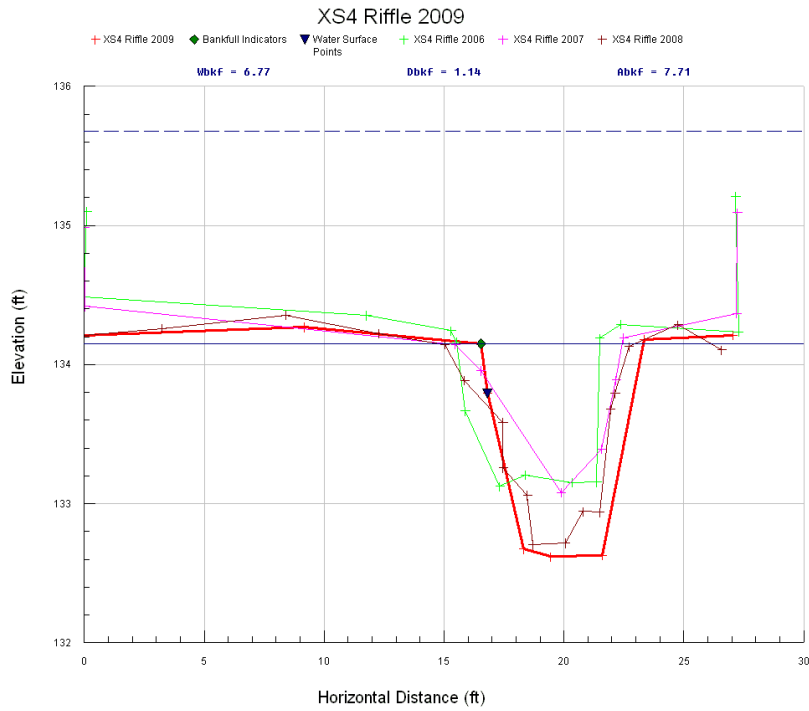
Graph 4: Cross Section 4 Riffle

Cross Section 4 Riffle – Channel continues to deepen slightly, thalweg close to center.

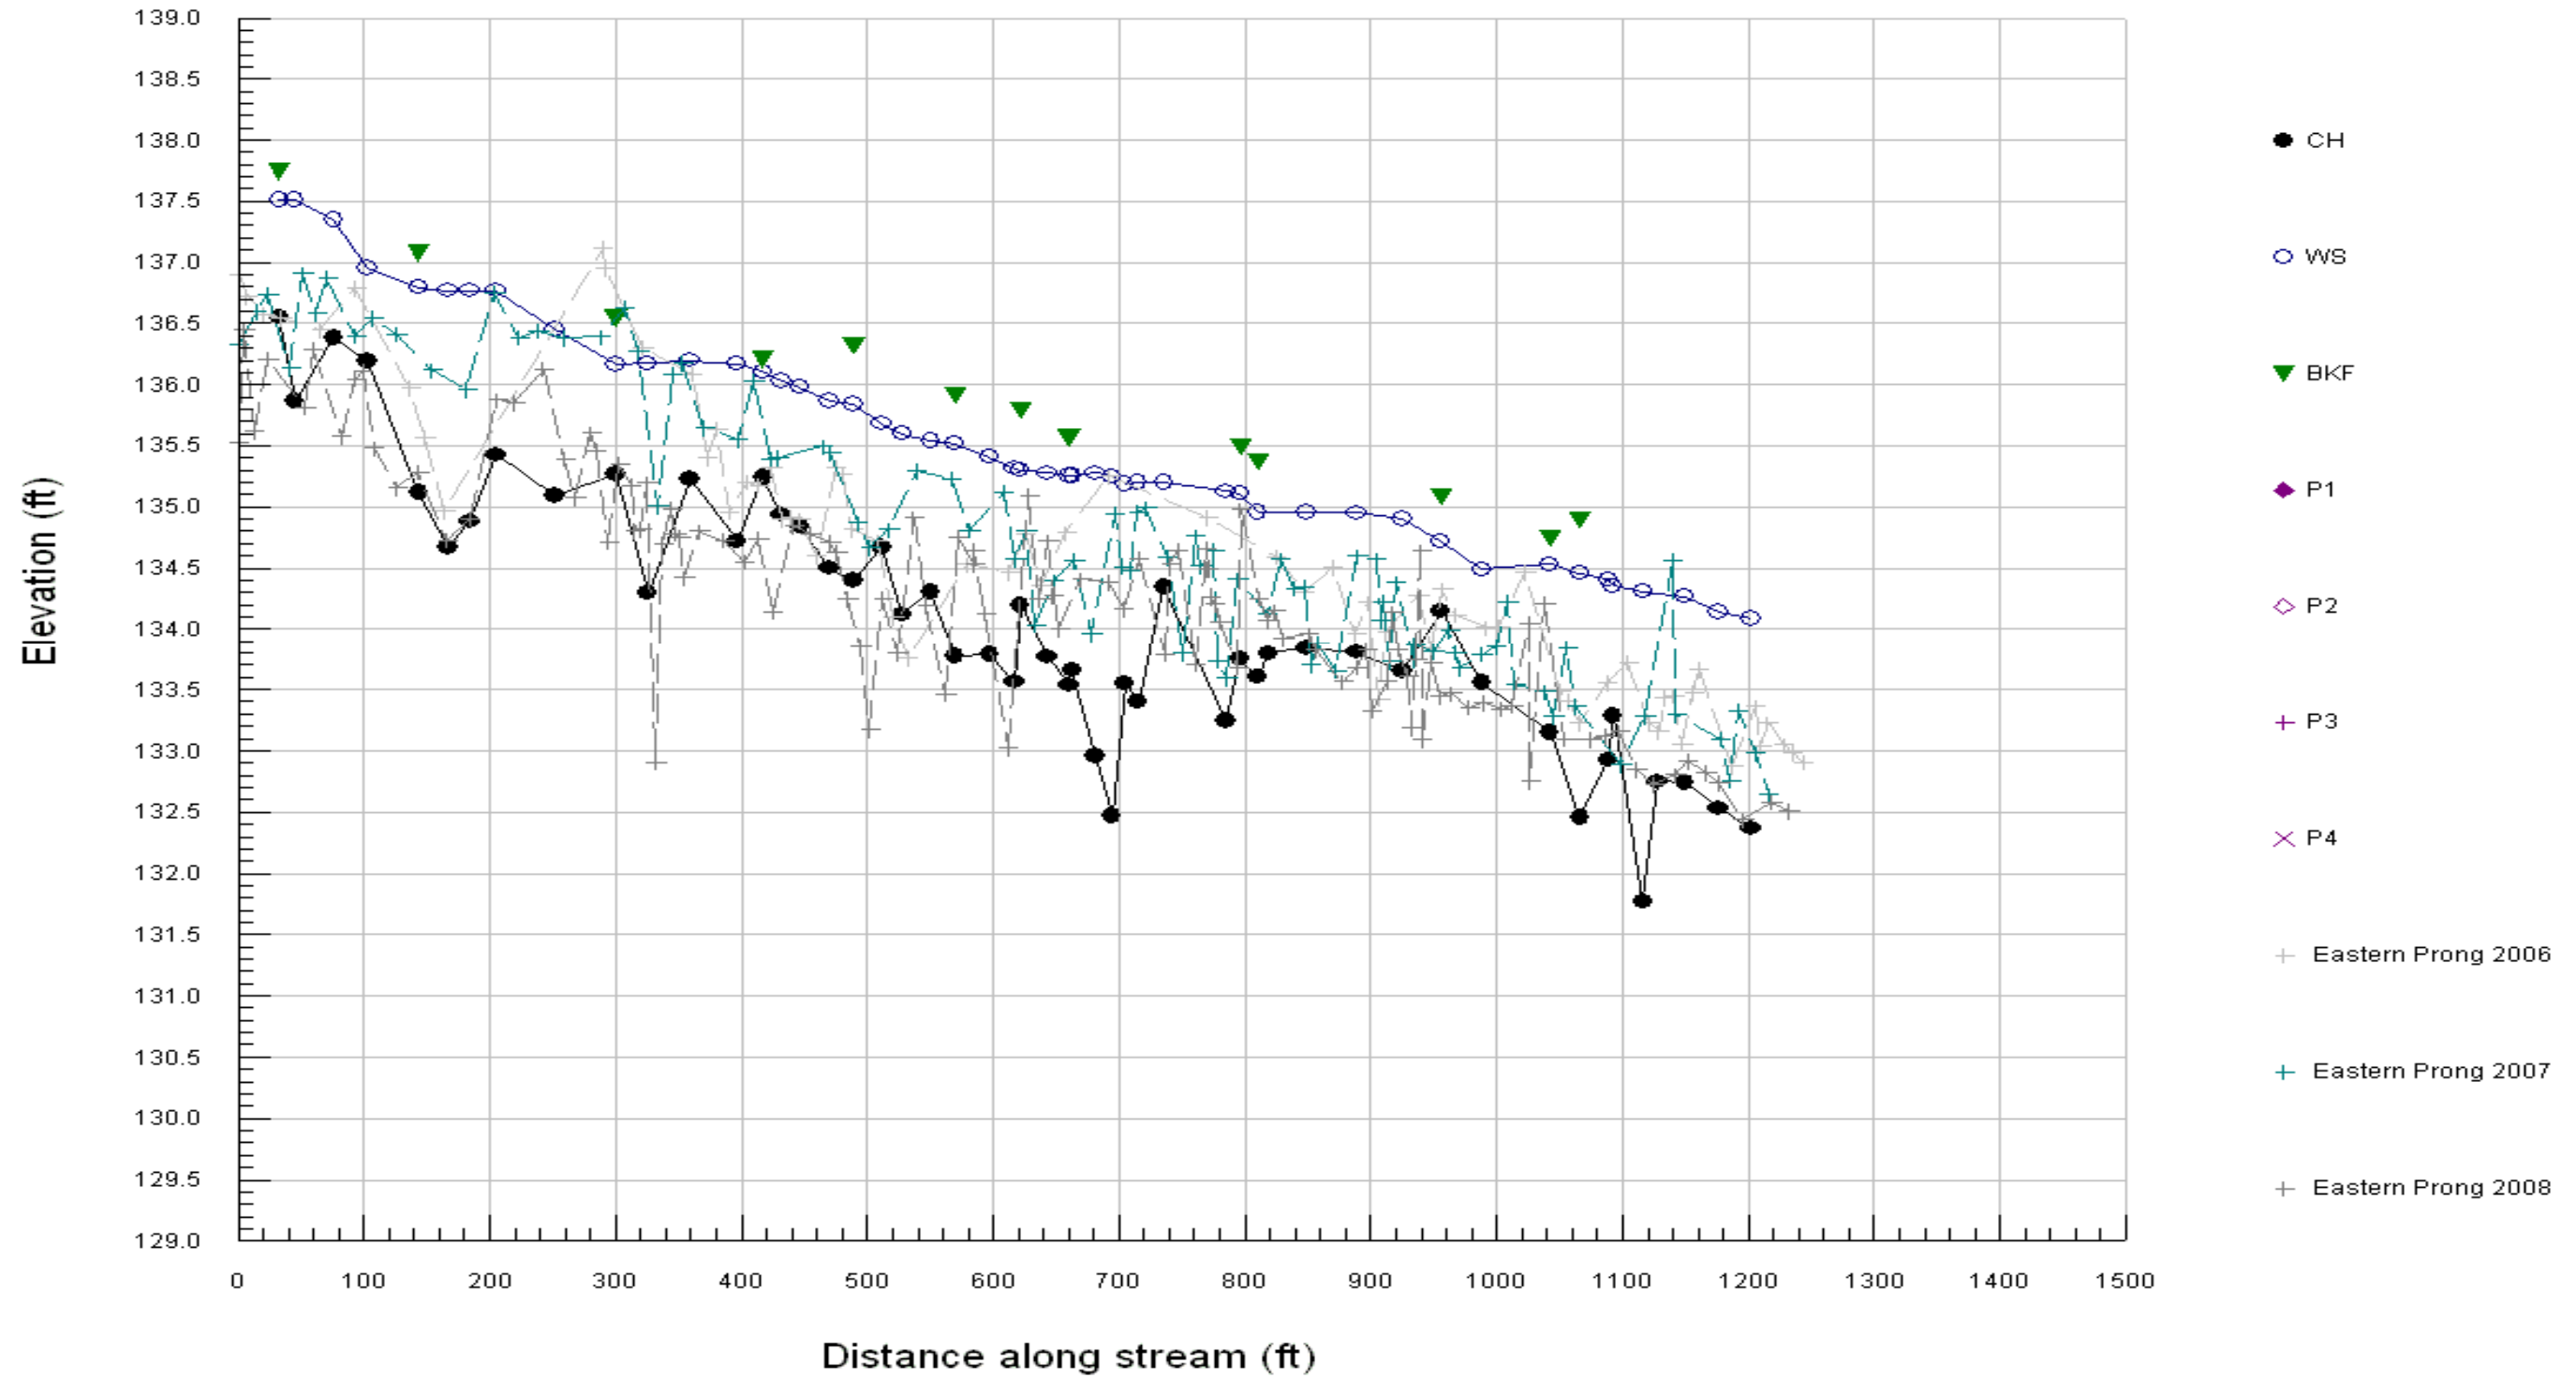
# Eastern Prong 2009

Profiles of the Eastern and Western Prongs show similar trends. While the profiles still appear somewhat inconsistent, several stable pool and riffle features have begun to emerge and an overall trend towards stability from 2006 is developing. Several obvious pools (profile graphs in Appendix C) have formed and appear stable on the upper portion of the Eastern and Western Prongs. Riffle areas appear to be becoming more defined with longer stretches of similar elevation followed by pools or series of pools. The UT appears to have developed a stable pattern as of 2008, but its profile continues to be inconsistent, a stable pool appears to have formed at approximately the 70 foot mark followed by a stable riffle-like stretch for approximately 80 feet. The inconsistent nature of the profile in this reach can be attributed to the presence of large amounts of coarse woody debris and organic material. The current stream morphology is common and typically stable in low-gradient coastal plain systems.

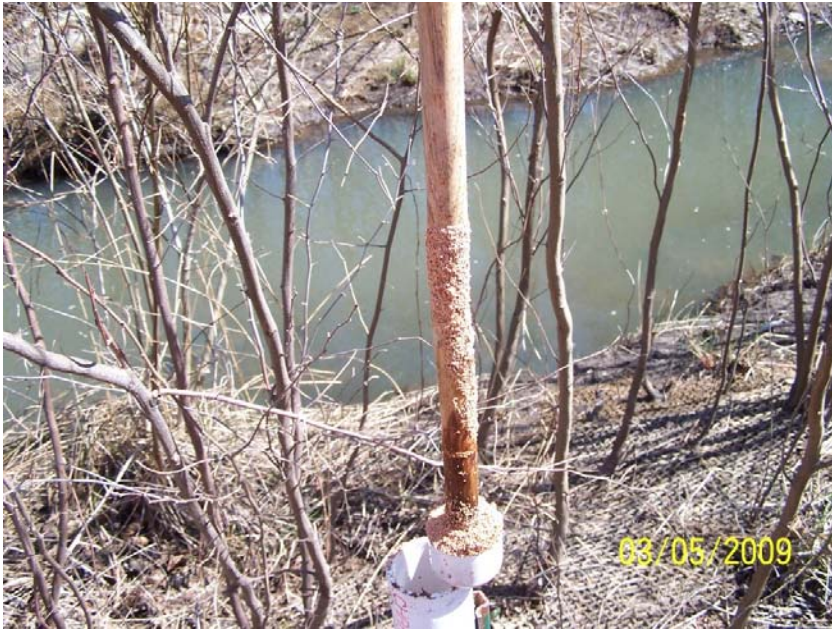
Most likely triggered on February 28<sup>th</sup> and March 1<sup>st</sup>, 2009.

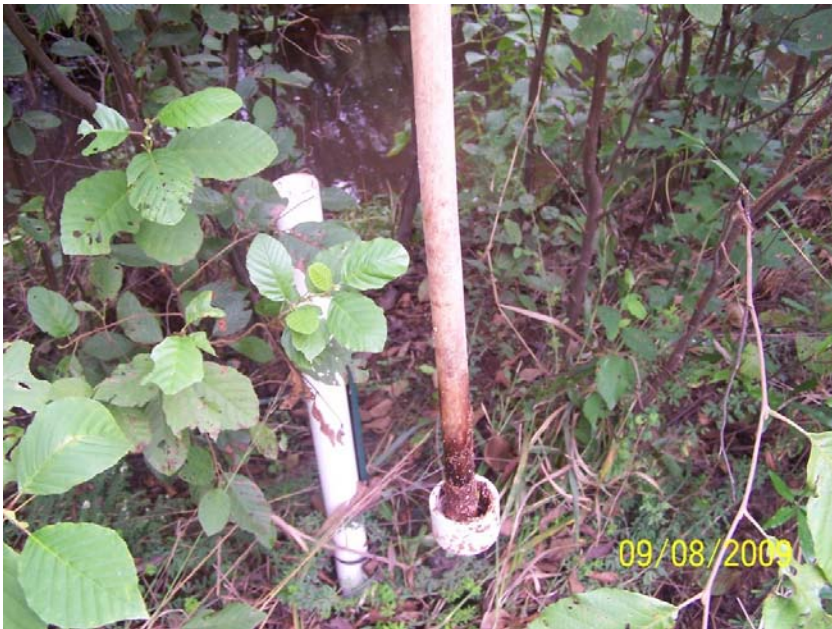
Most likely triggered on August 28<sup>nd</sup> and 23<sup>rd</sup> or 31<sup>st</sup> 2009.
