Tar River Headwaters Wetland Restoration Site

MY-6 (2022) Annual Fall Monitoring Report

NC-DEQ Division of Mitigation Services: DMS Project # 97071
DEQ Contract #6746 DWR # 2016-0233 ACE #SAW-2016-01101
Data Collected: Sep-Nov 2022 Draft Report: December 2022

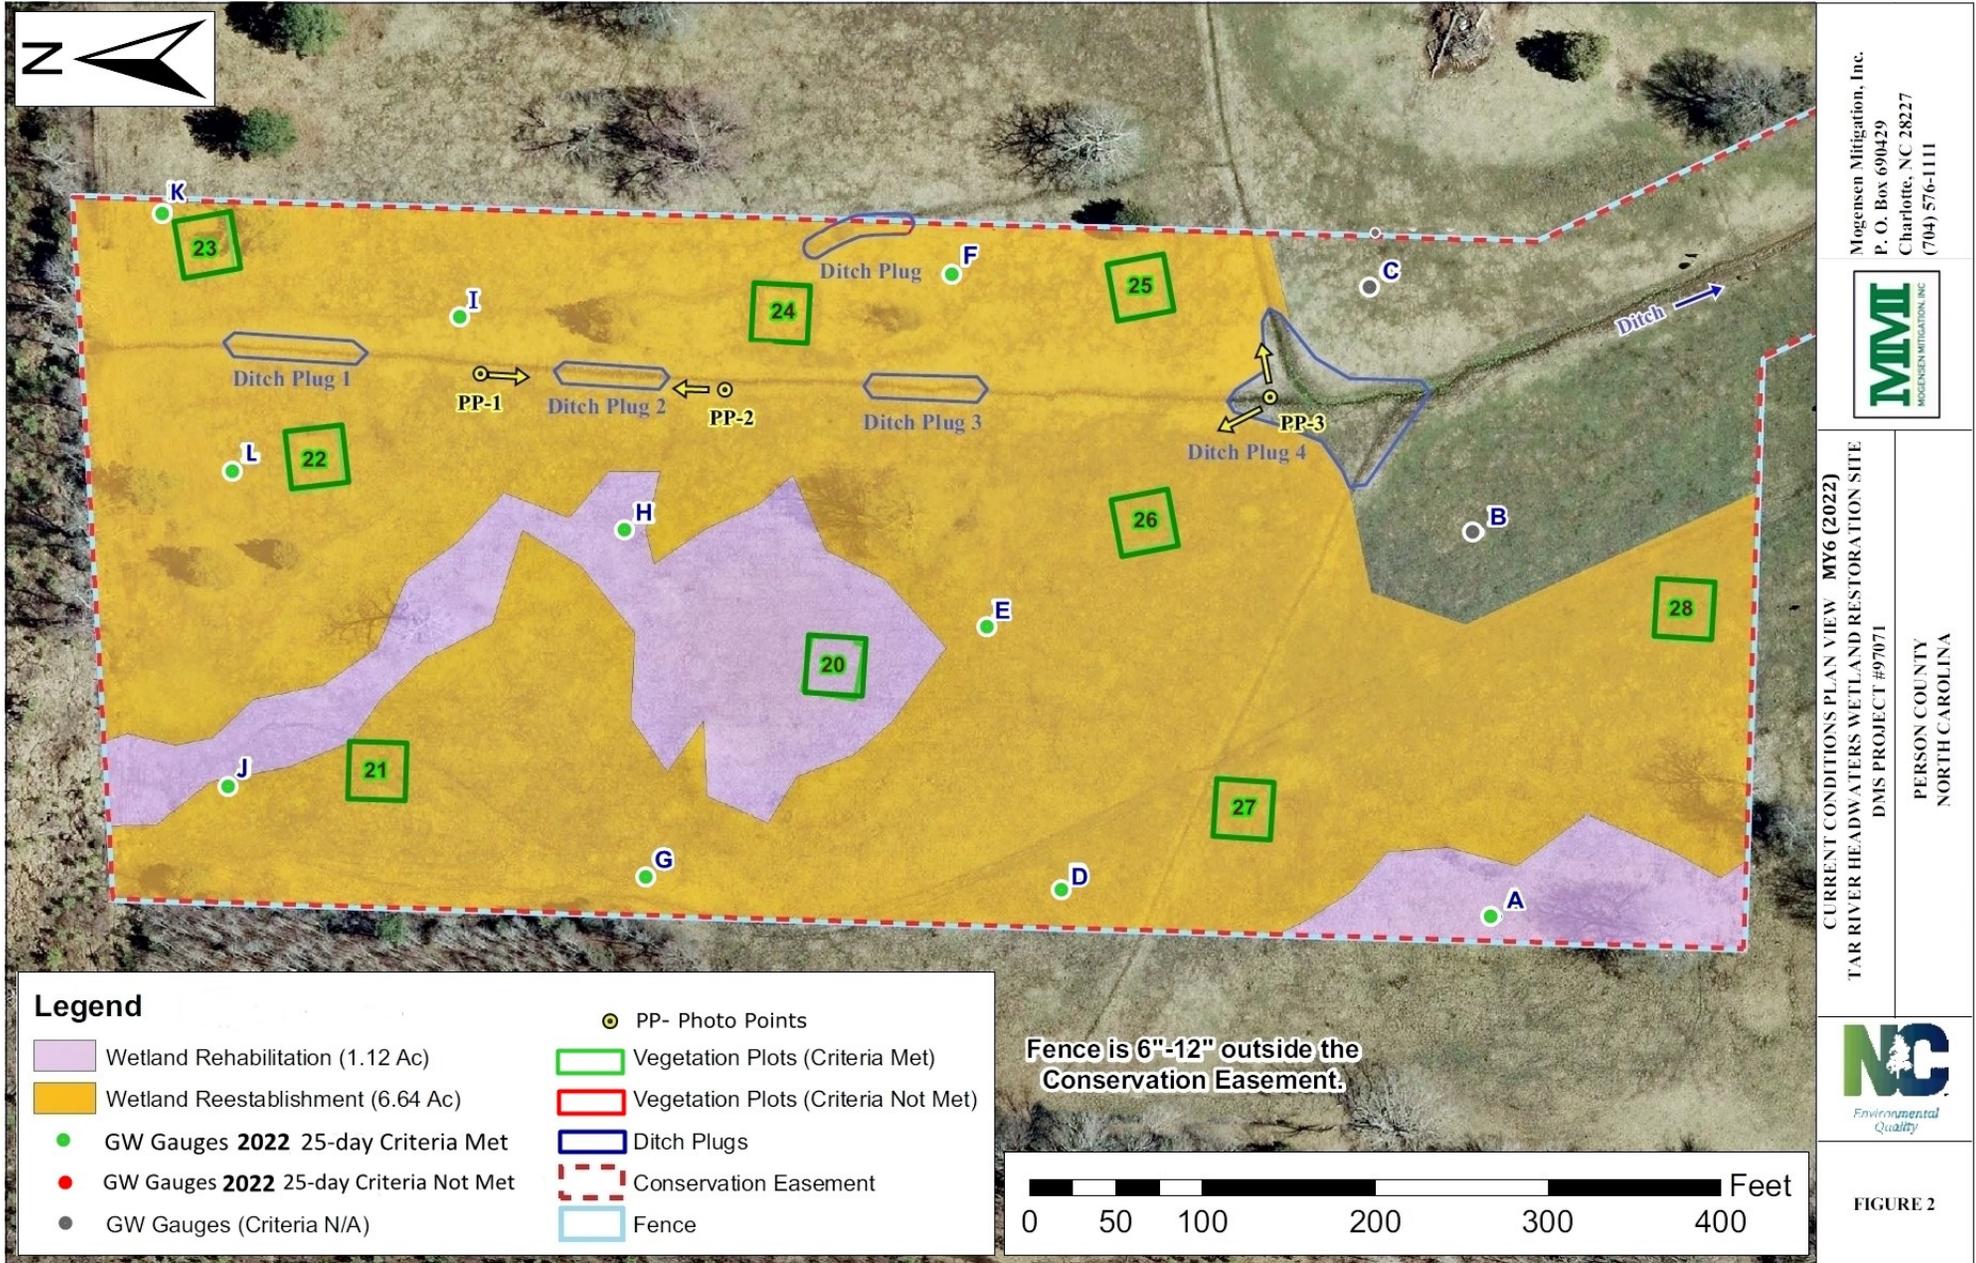
Figure 2A. Current Conditions Plan View, Fall 2022, MY-6.

Two temporary strip plots (100 m² each) were sampled in August 2022 in the areas identified in 2021 that appeared to have low woody stem density. A measuring tape was extended to 108 feet and pinned to stakes at each end, and live stems of planted woody species within 5 feet on each side the tape were counted (Figure 2B). Both strip plots yielded 7 stems of planted tree species (283 stems per acre) and exceed the MY6 stem density criterion for success. Consequently, there is no “low stem density” area mapped for 2022 in Figure 2A.

Ten active groundwater gauges (A through L) on the project site are roughly arranged in four transects perpendicular to the main ditch, as recommended by mitigation plan reviewers during field meetings (Figure 2). Three gauges (A, H and J) are within existing wetland rehabilitation areas, and seven gauges (D, E, F, G, I, L, and K) are within the drained wetland reestablishment areas. Two additional gauges (B and C) are south of the lowermost ditch plug in an area that is not intended to generate wetland credits. These two gauges were monitored from 2016 until 2021 but are no longer monitored as they do not pertain to the project success criteria. Wetland hydrology success for the TRHWR site is based on saturation within 12 inches of the ground surface for 10% of the 248-day growing season (March 1 to November 3). The gauges measure the free water table depth and do not account for capillary fringe saturation which can extend above the free water table in fine-textured soils (<https://vernonjames.ces.ncsu.edu/eleventh-annual-on-site/soil-wetness/>). Manual water table measurements were also collected at each well one or more times during the year, and depth data were adjusted accordingly to fit the actual measurements.

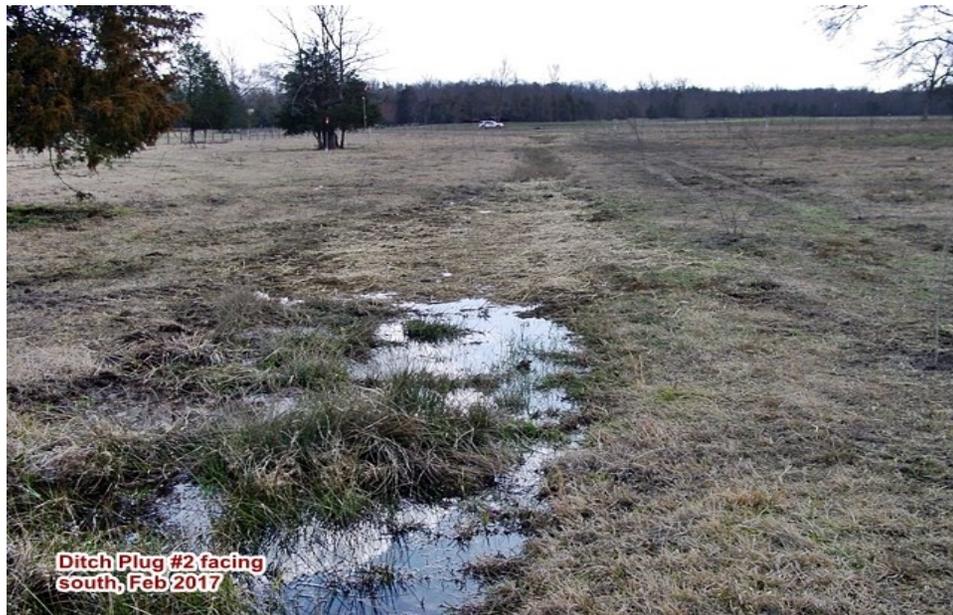
Photo Point 1: MY-0 Spring 2017

Ditch Plug #2 facing south, Feb 2017

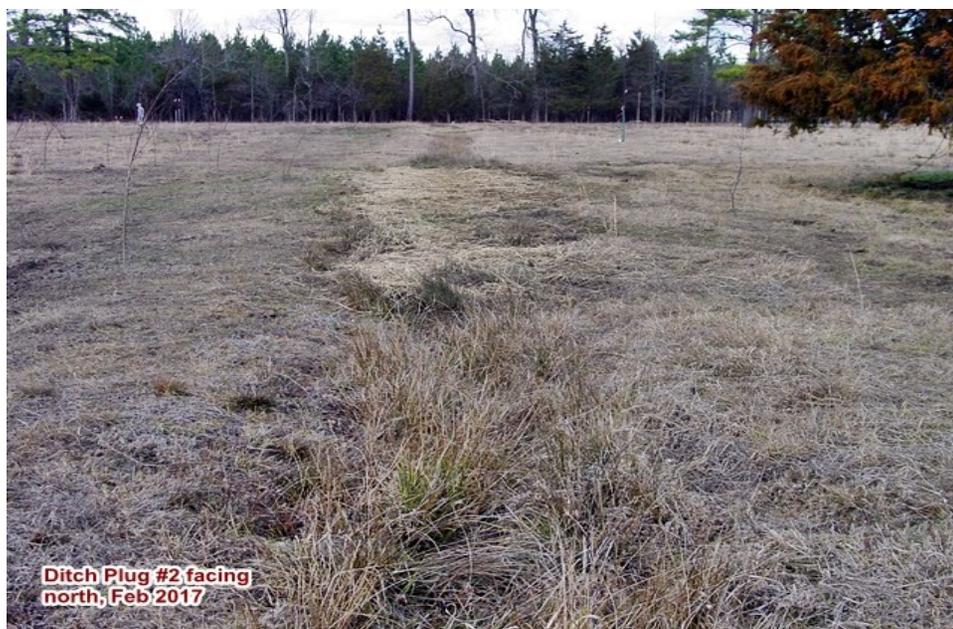
Photo Point 2: MY-0 Spring 2017

Ditch Plug #2 facing north, Feb 2017

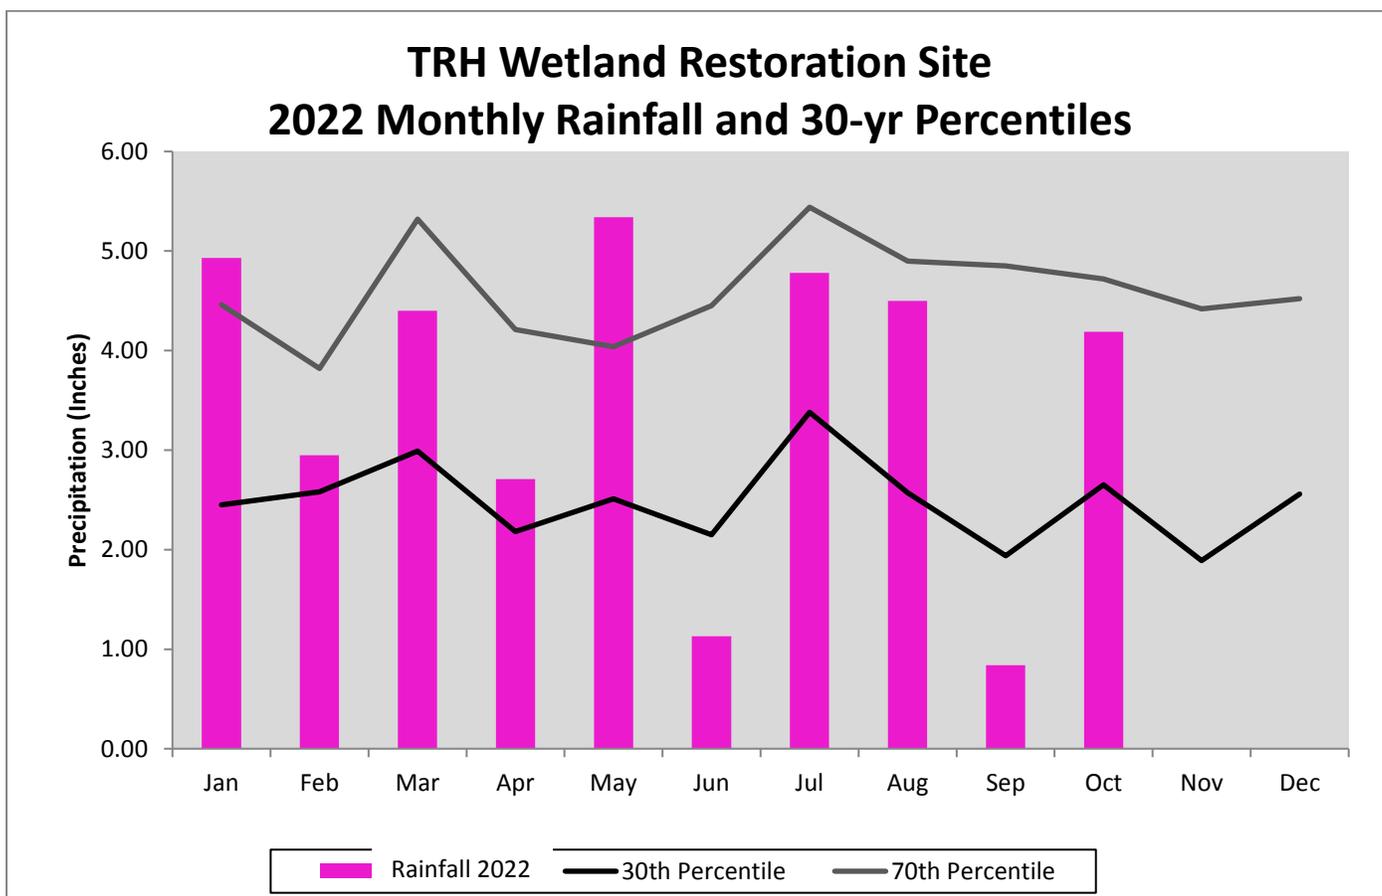
Figure 5. Monthly Rainfall Totals in 2022, with 30th, 50th, and 70th normal percentiles.

Rainfall in 2022, relative to the 30-year normal values (1981 to 2010), was above the 70th percentile during January and May, below the 70th percentile during June and September, and “normal” (between 30th and 70th percentiles during all other months through October. All 11 gauges (ten in the mitigation credit area, and one off-site reference gauge) exceeded the minimum of 25 consecutive days for hydrologic success during the early part of the growing season, with consecutive day saturation periods ranging from 44 to 93 days (Table 8).

30-year historical data (1981-2010) at ROXBORO 7 ESE Gauge # 317516 from NC State Climate Office
30-year Climate Normal precipitation
