Tar River Headwaters Stream and Ditch Buffer

Person County NC -- Tar-Pamlico River HUC# 03020101-0102

MY-0 (2017) As-Built Baseline Monitoring Report

NC-DEQ Division of Mitigation Services: DMS Project # 97071

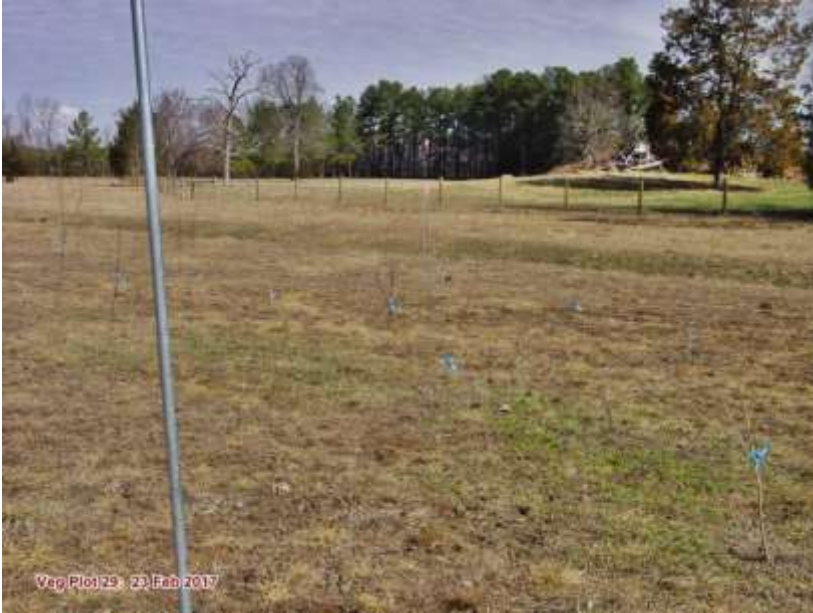
Vegetation Plot 29:
23 Feb 2017

CVS Vegetation Plot Photos: Tar River Headwaters Stream & Ditch Buffer # 97071: MY0 (Feb 2017)
All vegetation plot photos are taken from the SW plot corner, facing NE.
