# Tar River Headwaters Wetland Restoration Site

## MY-0 (2017) As-Built Baseline Monitoring Report

NC-DEQ Division of Mitigation Services: DMS Project # 97071

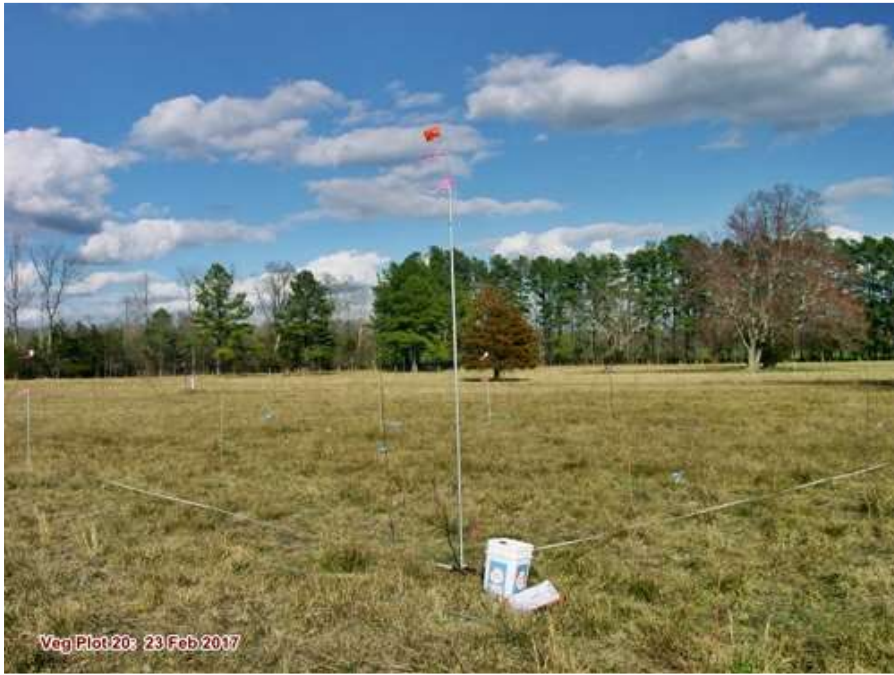
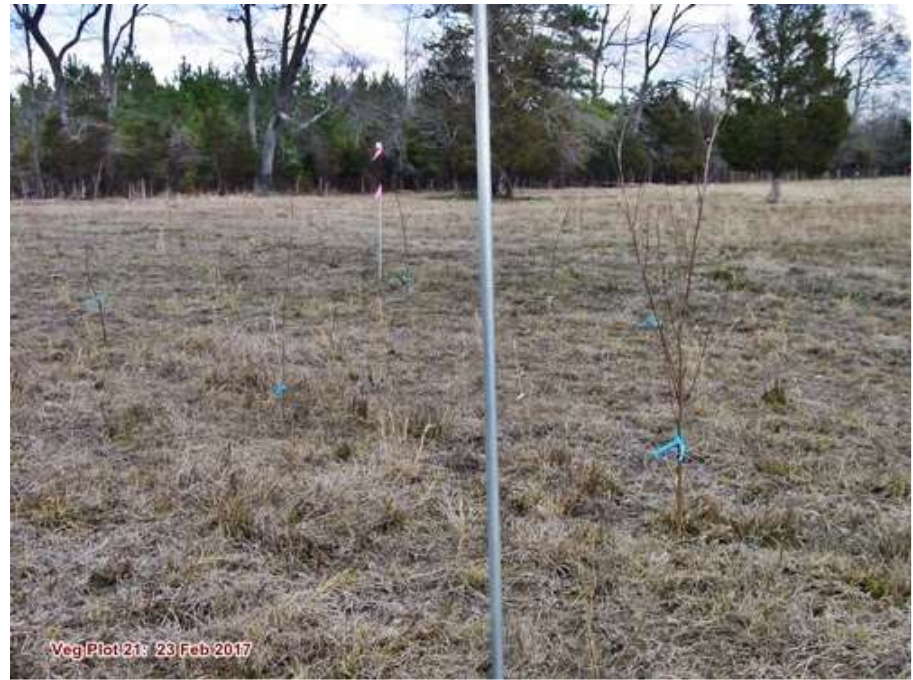
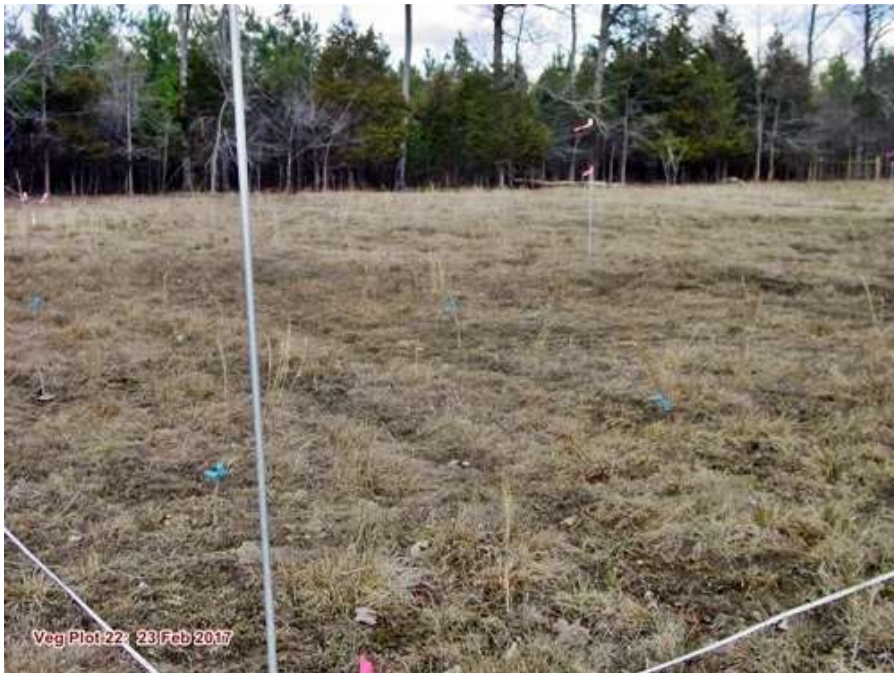
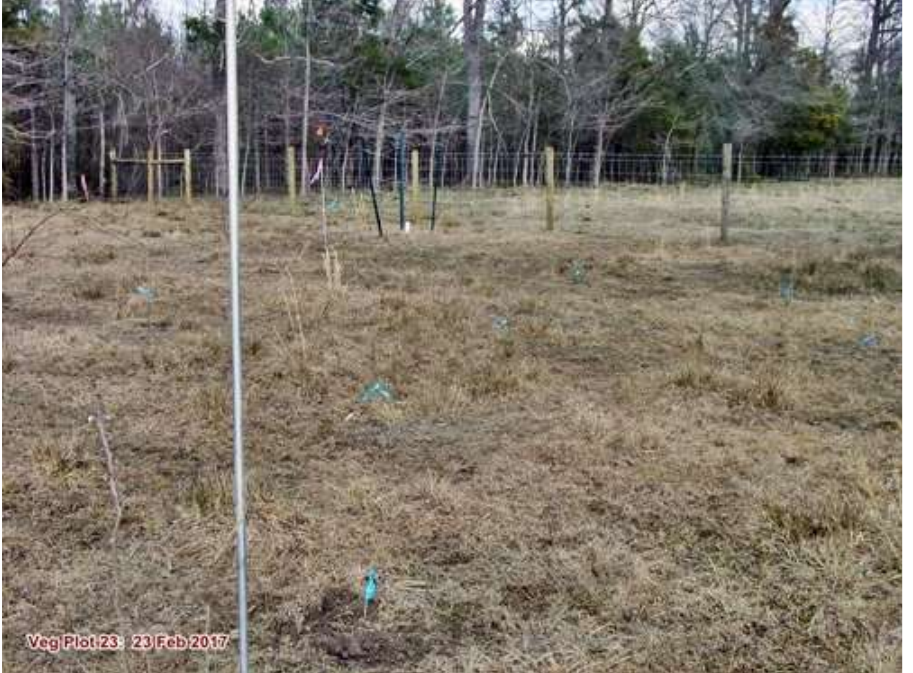
**Appendix B. PHOTOS: CVS Vegetation Plots 20 to 23, MY0 Baseline, February 2017. Tar Headwaters Wetland Restoration #97071**

ALL VEGETATION PLOT PHOTOS ARE TAKEN FROM SOUTHWEST CORNER OF PLOT (0,0 ORIGIN) FACING NORTHEAST

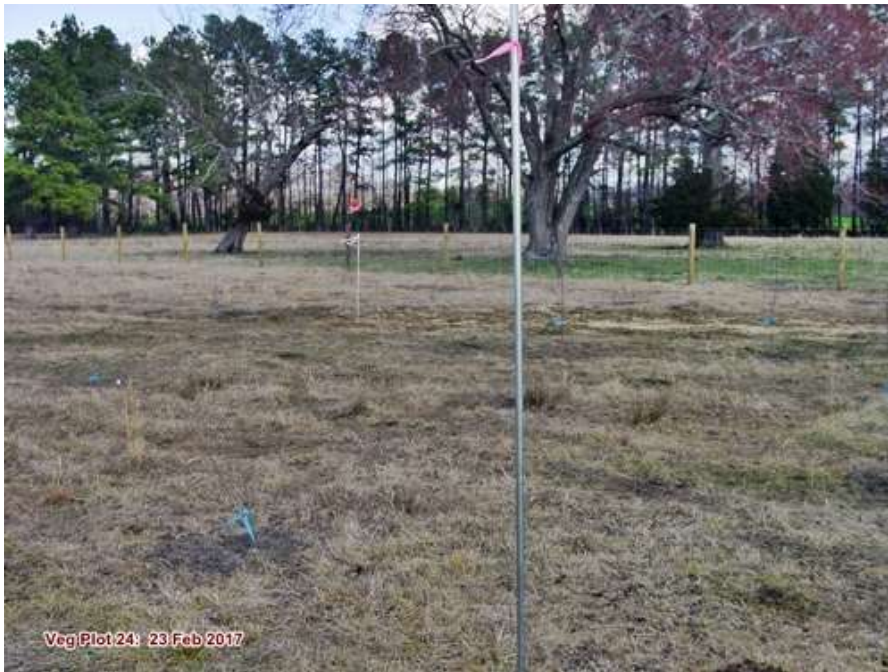
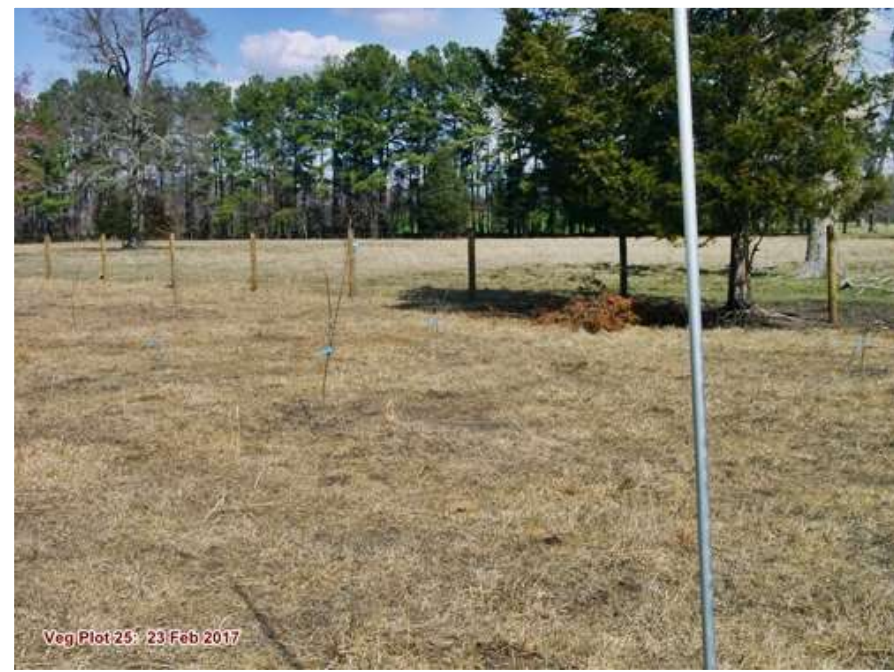
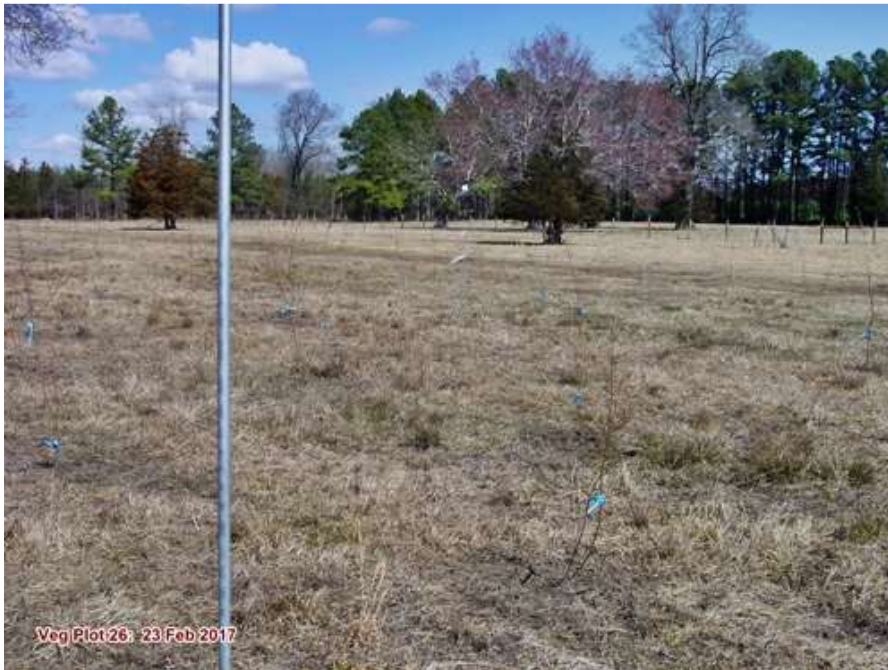
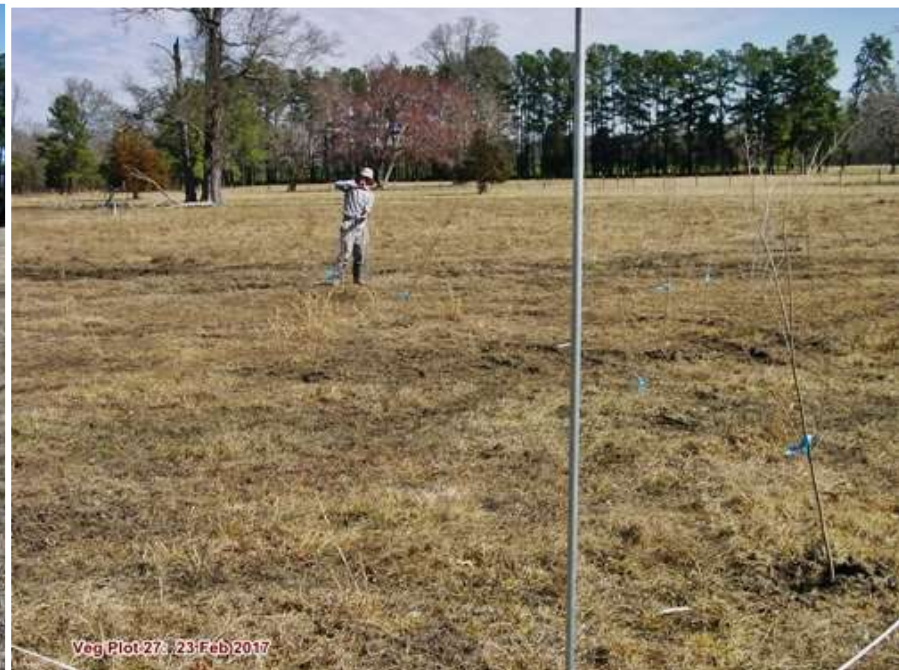
**Appendix B. PHOTOS: CVS Vegetation Plots 24 to 27, MY0 Baseline, February 2017. Tar Headwaters Wetland Restoration #97071.**

ALL VEGETATION PLOT PHOTOS ARE TAKEN FROM SOUTHWEST CORNER OF PLOT (0,0 ORIGIN) FACING NORTHEAST

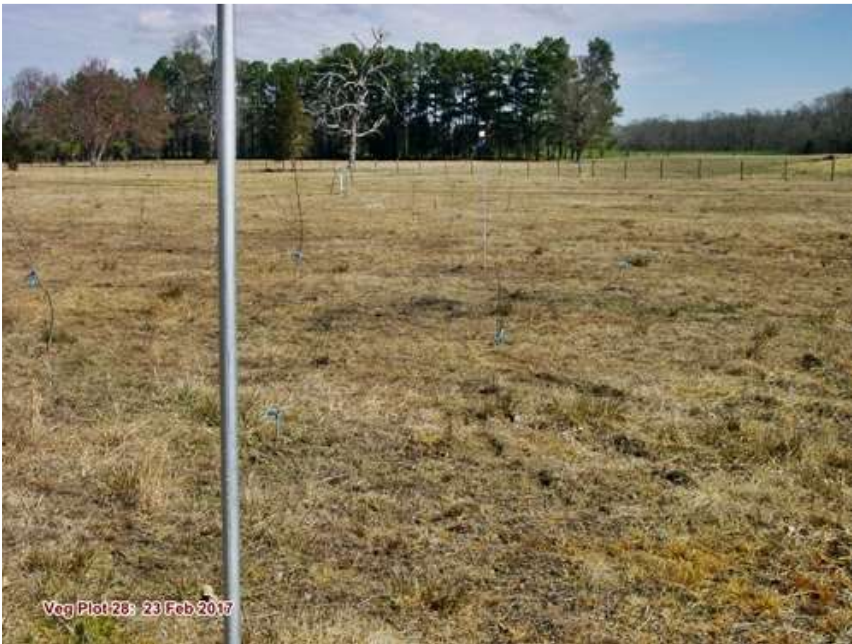
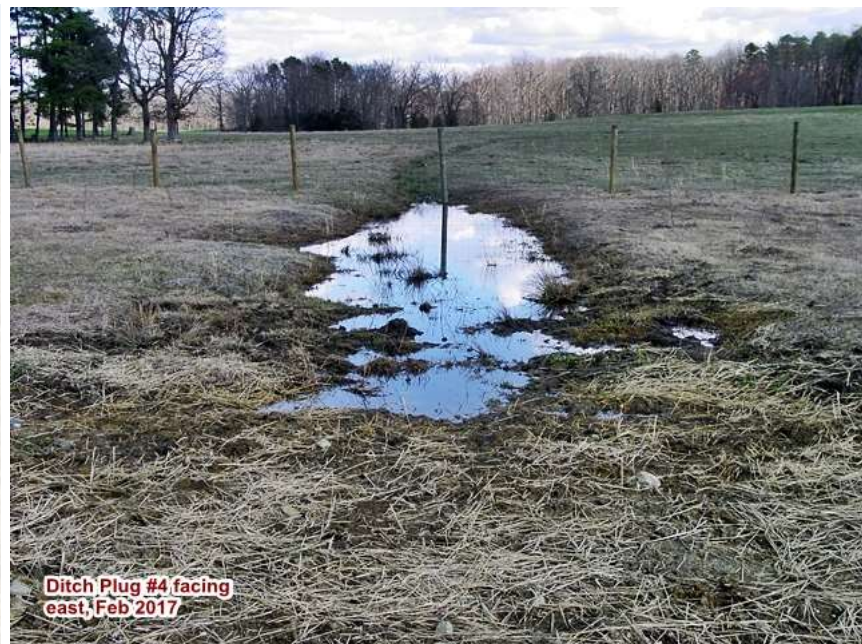
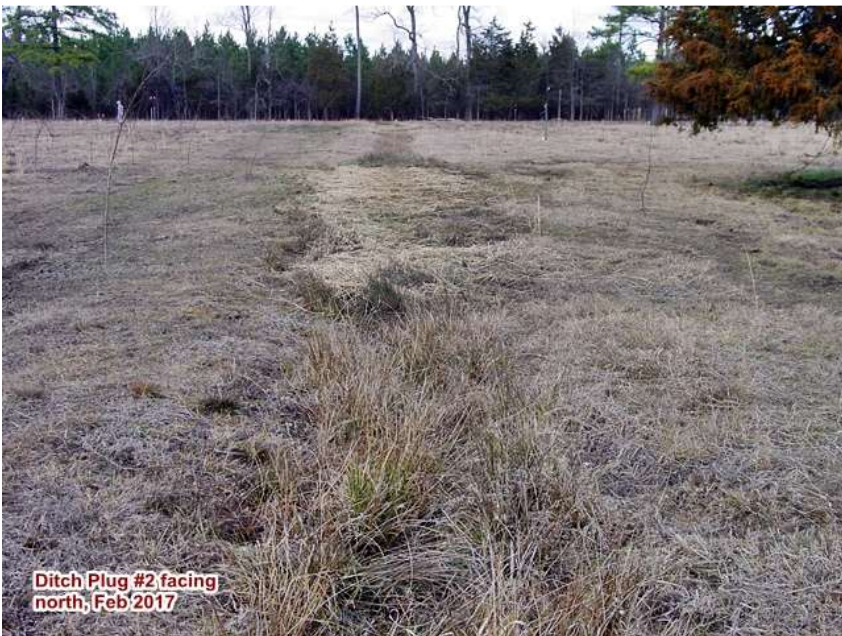
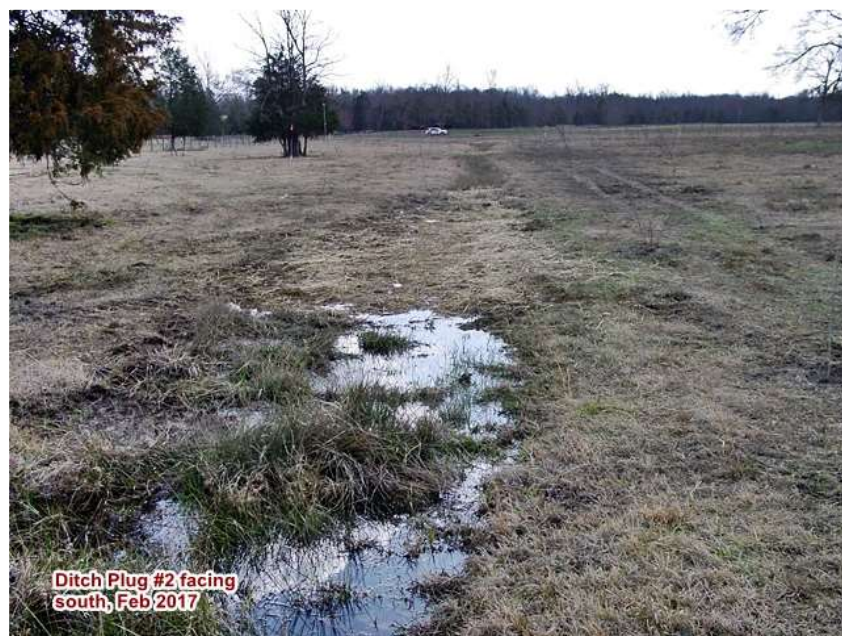
**Appendix B. PHOTOS: CVS Vegetation Plot 28 and Other Photos, MY0 - Feb 2017. Tar Headwaters Wetland Restoration #97071.**

ALL VEGETATION PLOT PHOTOS ARE TAKEN FROM SOUTHWEST CORNER OF PLOT (0,0 ORIGIN) FACING NORTHEAST

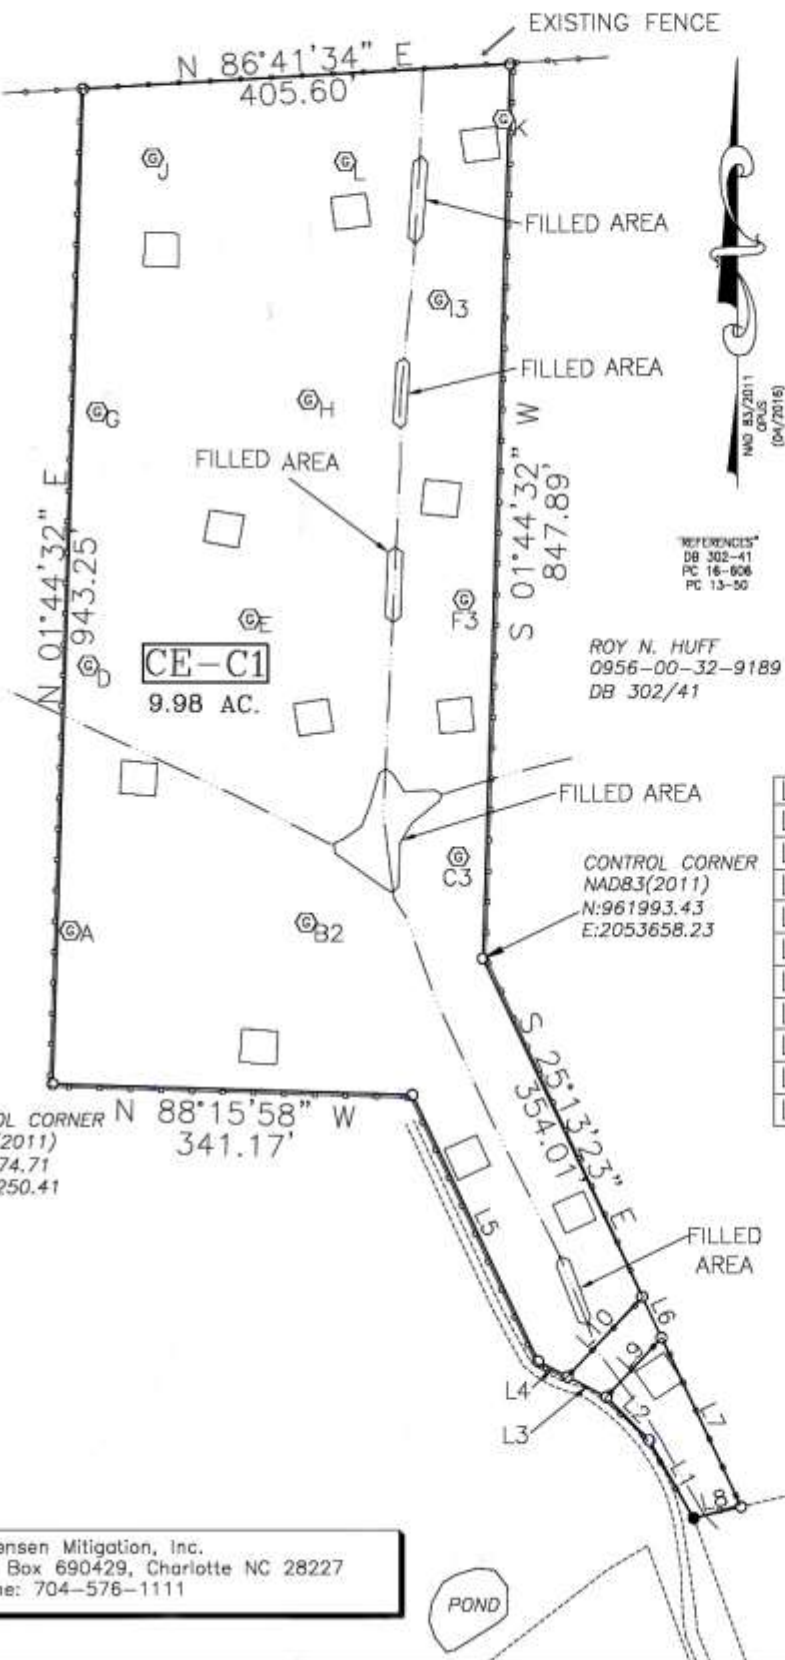
LINE	BEARING	DISTANCE
L1	S 29°41'10" E	84.84'
L2	N 44°47'05" W	57.76'
L3	N 62°19'56" W	41.47'
L4	N 62°19'56" W	31.60'
L5	S 25°14'40" E	279.05'
L6	S 25°13'23" E	43.08'
L7	S 25°13'23" E	176.98'
L8	N 76°34'55" E	46.29'
L9	N 42°58'24" E	76.74'
L10	S 42°58'24" W	103.69'

AS-BUILT SURVEY FOR  
**MOGENSEN MITIGATION, INC.**  
 ALLENVILLE TWP., PERSON CO., NORTH CAROLINA  
 FIELD WORK PERFORMED MARCH 2017  
 PROPERTY AS DESCRIBED IN DB 302-41  
 OWNED BY ROY HUFF

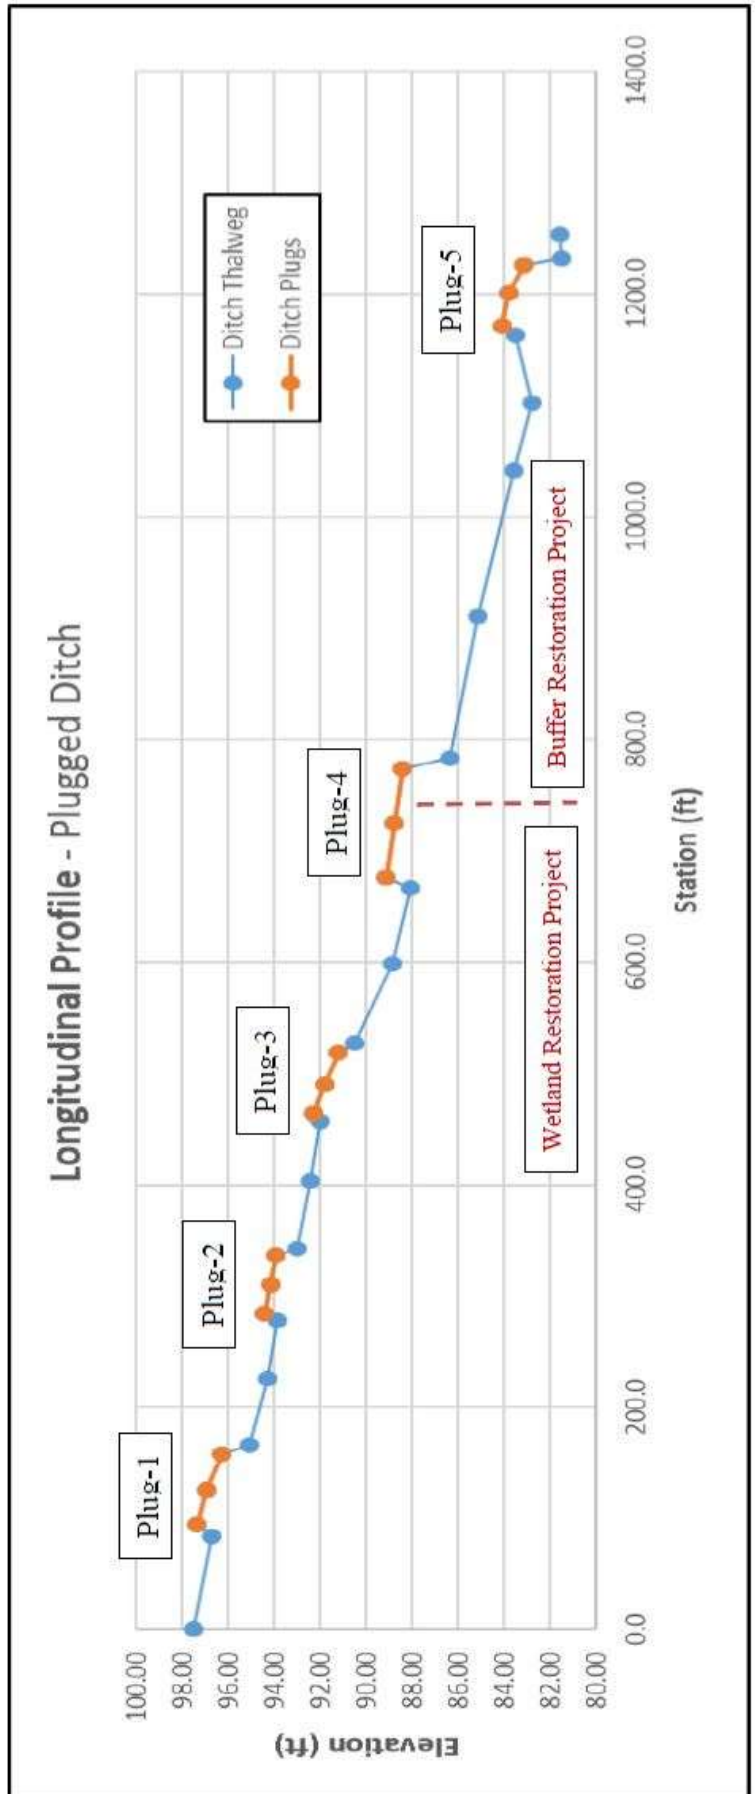
Figure 4. Longitudinal Profile of Plugged Ditch with Relative Elevation Data.  
 Tar River Headwaters Wetland Restoration Site, DMS # 97071

Longit Sta, ft	Elevation feet
ditch upper end @ fence	0.0	97.51
ditch @ upst toe Plug-1	84.3	96.73
Plug-1 top upper	94.0	97.34
Plug-1 top middle	125.2	96.95
Plug-1 top lower	157.6	96.26
ditch @ dnst toe Plug-1	166.4	95.07
ditch midway P1-P2	225.5	94.29
ditch @ upst toe Plug-2	278.0	93.83
Plug-2 top upper	283.8	94.41
Plug-2 top middle	310.2	94.16
Plug-2 top lower	336.8	93.91
ditch @ dnst toe Plug-2	341.8	92.98
ditch midway P2-P3	402.6	92.45
ditch @ upst toe Plug-3	456.3	92.01
Plug-3 top upper	463.6	92.30
Plug-3 top middle	489.4	91.80
Plug-3 top lower	518.3	91.19
ditch @ dnst toe Plug-3	526.7	90.51
ditch midway P3-P4	598.5	88.86
ditch @ upst toe Plug-4	666.1	88.11
Plug-4 top upper	675.4	89.12
Plug-4 top middle	725.2	88.77
Plug-4 top lower	773.6	88.41
ditch @ dnst toe Plug-4	783.3	86.34
ditch 1/3 way P4-P5	910.8	85.17
ditch 2/3 way P4-P5	1041.4	83.58
ditch 3/4 way P4-P5	1102.2	82.78
ditch @ upst toe Plug-5	1163.0	83.49

Plug-5 top upper	1171.8	84.11
Plug-5 top middle	1200.6	83.81
Plug-5 top lower	1225.9	83.14
ditch @ dnst toe Plug-5	1232.2	81.53
ditch @ fence crossing	1253.8	81.55

Station 0.0 = North boundary (easement) fence  
 Station 1253.8 = Fence above road crossing

A series of six ditch plugs were constructed to retain rainfall and disperse runoff on the site. Five plugs along the main north-south ditch include four in the TRHWR area and one downstream in the connector area in the southeastern portion of the easement (Figure 2). The sixth plug is on the eastern side ditch in the TRHWR area. Ditch bed segments to be filled were excavated six inches to remove loose material and plants, to ensure good contact between the fill material and underlying clay. Clay for the plugs was excavated from the pasture area south of the easement fence, and mixed with sand to achieve liquid limit and plasticity characteristics as recommended in the mitigation plan. To further enhance ditch plug stability, the contractor increased the length of plugs on the main ditch, constructing five long plugs (each plug 65 to 118 ft long) rather than the seven short plugs shown in the mitigation plan. The proposed cluster of plugs where three ditches converge were merged into one large plug (plug #4). The centerline of each plug is approximately 2 inches below the adjacent ground surface (old ditch banks), per the mitigation plan. The elevation drop from the toe of each plug downstream to the crest of the next plug in the wetland restoration area is 1 to 2 feet (Figures 3 and 4).
