FINAL
ANNUAL MONITORING REPORT
YEAR 2 (2013)
TATE FARM (RIPSHIN BRANCH)
STREAM/WETLAND RESTORATION SITE
ASHE COUNTY, NORTH CAROLINA
(EEP Project No. 372, Contract No. 004802)
Construction Completed December 2011

January 2014

Prepared by:
Axiom Environmental, Inc.
218 Snow Avenue
Raleigh, North Carolina 27603

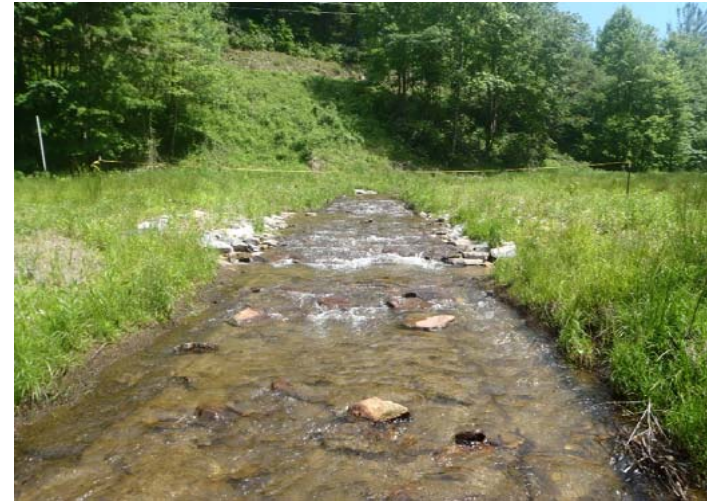
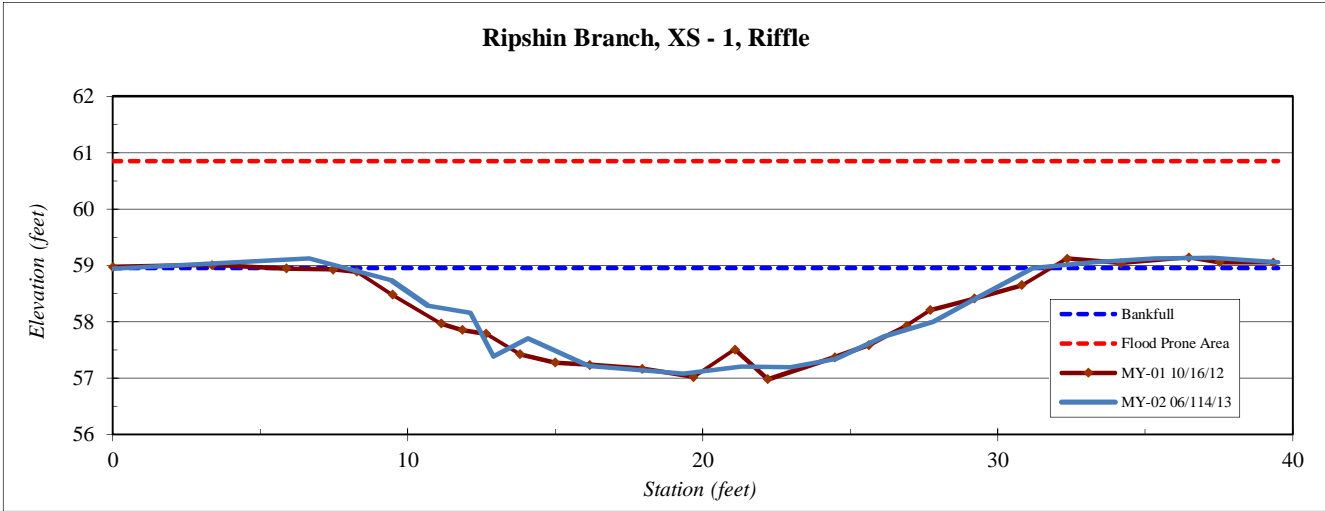
Station	Elevation
0.00	58.95
6.64	59.12
9.44	58.74
10.70	58.28
12.12	58.15
12.91	57.39
14.08	57.71
16.13	57.22
19.34	57.08
21.29	57.20
22.97	57.19
24.52	57.34
26.15	57.74
27.80	58.00
29.21	58.40
31.19	58.95
33.22	59.06
35.34	59.13
37.30	59.13
39.50	59.05

SUMMARY DATA	
Bankfull Elevation:	59.0
Bankfull Cross-Sectional Area:	27.9
Bankfull Width:	23.3
Flood Prone Area Elevation:	60.9
Flood Prone Width:	>80
Max Depth at Bankfull:	1.9
Mean Depth at Bankfull:	1.2
W / D Ratio:	19.5
Entrenchment Ratio:	3.4
Bank Height Ratio:	1.0

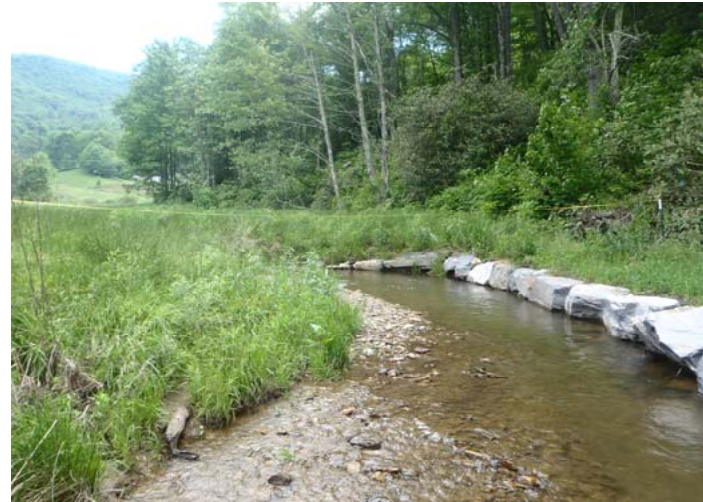
River Basin:	Upper New
Watershed:	Tate Farm
XS ID	XS - 2, Pool
Drainage Area (sq mi):	1.6
Date:	6/14/2013
Field Crew:	Perkinson, Jernigan

Station	Elevation
0.00	64.21
3.70	64.37
6.33	64.20
8.17	63.74
9.09	60.97
11.00	60.91
12.30	61.49
14.05	61.98
16.58	62.74
18.71	62.94
21.17	63.25
21.89	63.36
23.31	63.31
26.31	63.70
30.21	64.03
33.1	64.47
35.1	64.64

SUMMARY DATA	
Bankfull Elevation:	64.2
Bankfull Cross-Sectional Area:	32.2
Bankfull Width:	25.0
Flood Prone Area Elevation:	-
Flood Prone Width:	-
Max Depth at Bankfull:	3.3
Mean Depth at Bankfull:	1.3
W / D Ratio:	-
Entrenchment Ratio:	-
Bank Height Ratio:	-

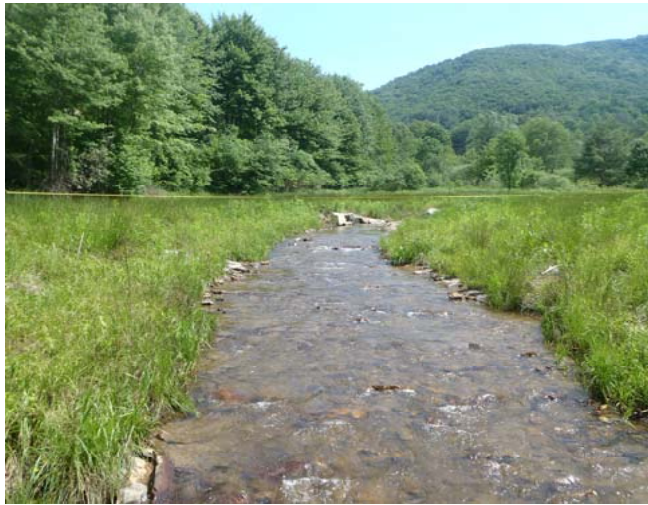
River Basin:	Upper New
Watershed:	Tate Farm
XS ID	XS - 3, Riffle
Drainage Area (sq mi):	1.6
Date:	6/14/2013
Field Crew:	Perkinson, Jernigan

Station	Elevation
0.54	66.18
5.67	65.80
8.03	65.94
9.89	65.23
12.64	64.95
13.93	64.56
16.01	64.06
18.51	64.06
19.79	63.89
22.28	64.15
24.43	64.19
25.36	64.37
26.72	64.65
28.73	64.95
30.8	65.85
32.6	66.17
35.5	66.23
38.7	66.14

SUMMARY DATA	
Bankfull Elevation:	65.9
Bankfull Cross-Sectional Area:	30.7
Bankfull Width:	23.3
Flood Prone Area Elevation:	67.9
Flood Prone Width:	>80
Max Depth at Bankfull:	2.0
Mean Depth at Bankfull:	1.3
W / D Ratio:	17.7
Entrenchment Ratio:	3.4
Bank Height Ratio:	1.0

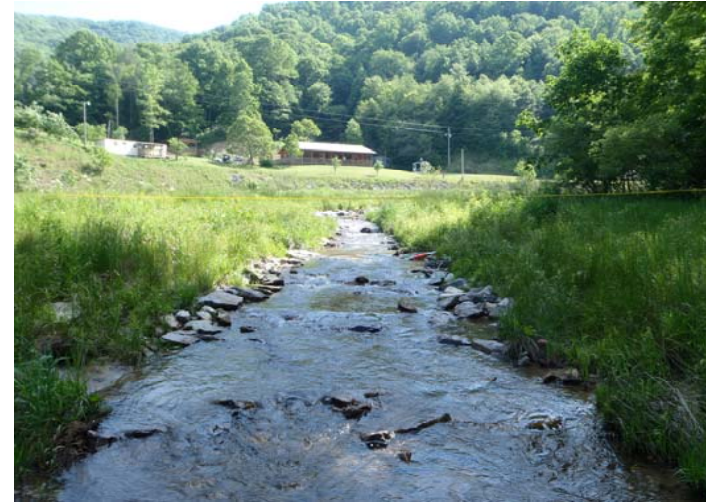
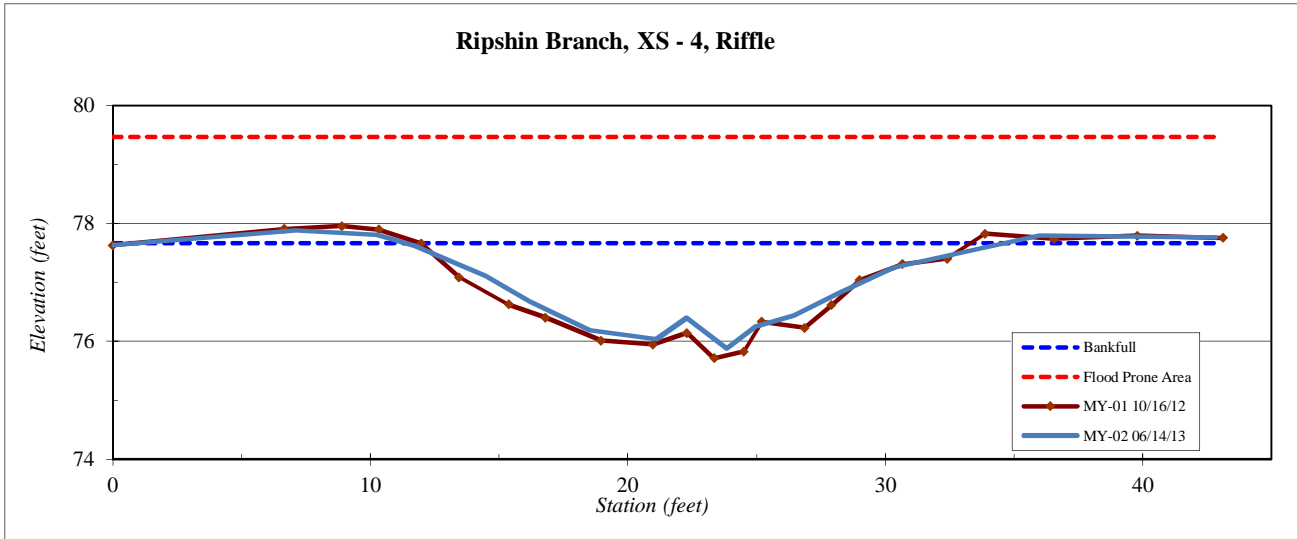
River Basin:	Upper New
Watershed:	Tate Farm
XS ID	XS - 4, Riffle
Drainage Area (sq mi):	1.6
Date:	6/14/2013
Field Crew:	Perkinson, Jernigan

Station	Elevation
0.00	77.63
7.12	77.88
10.28	77.81
11.71	77.63
14.48	77.11
16.19	76.68
18.52	76.19
21.10	76.04
22.28	76.39
23.85	75.88
24.99	76.25
26.46	76.44
28.13	76.80
30.34	77.26
32.2	77.44
36.0	77.80
40.4	77.77
42.8	77.76

SUMMARY DATA	
Bankfull Elevation:	77.7
Bankfull Cross-Sectional Area:	21.0
Bankfull Width:	23.3
Flood Prone Area Elevation:	79.5
Flood Prone Width:	>80
Max Depth at Bankfull:	1.8
Mean Depth at Bankfull:	0.9
W / D Ratio:	25.9
Entrenchment Ratio:	3.4
Bank Height Ratio:	1.0

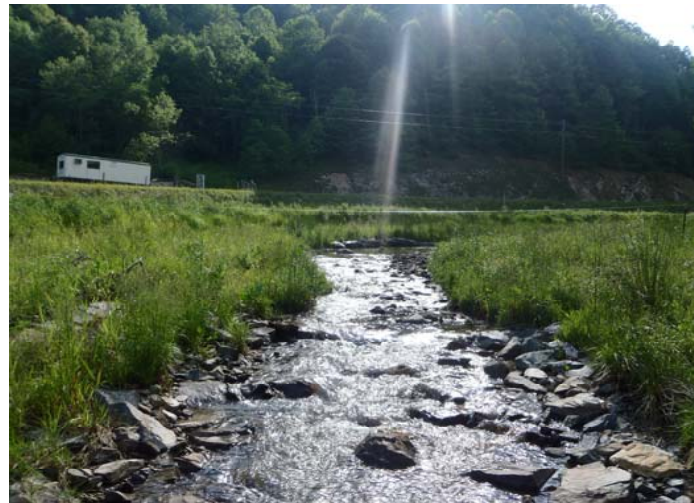
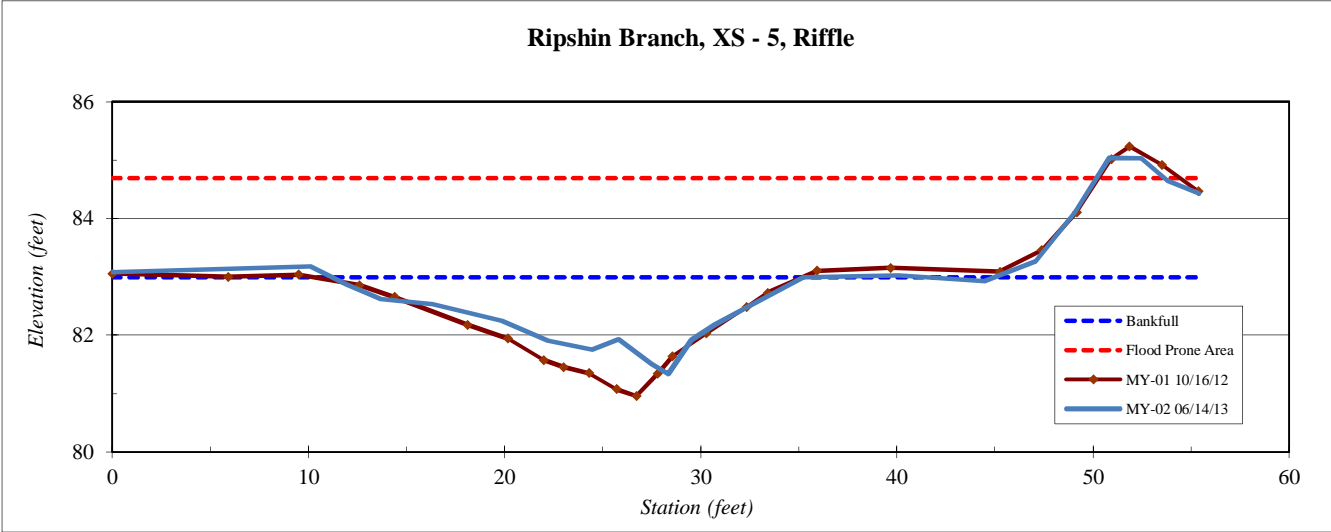
River Basin:	Upper New
Watershed:	Tate Farm
XS ID	XS - 5, Riffle
Drainage Area (sq mi):	1.6
Date:	6/14/2013
Field Crew:	Perkinson, Jernigan

SUMMARY DATA	
Bankfull Elevation:	83.0
Bankfull Cross-Sectional Area:	18.0
Bankfull Width:	24.0
Flood Prone Area Elevation:	84.7
Flood Prone Width:	>80
Max Depth at Bankfull:	1.7
Mean Depth at Bankfull:	0.8
W / D Ratio:	32.0
Entrenchment Ratio:	3.3
Bank Height Ratio:	1.0

Station	Elevation
0.0	83.1
10.1	83.2
11.9	82.9
13.7	82.6
16.3	82.5
19.8	82.2
22.2	81.9
24.5	81.8
25.8	81.9
27.5	81.5
28.3	81.3
29.5	81.9
30.7	82.2
32.2	82.44
35.2	82.99
40.1	83.03
44.5	82.93
47.1	83.27
49.1	84.10
50.8	85.03
52.5	85.03
53.8	84.64
55.4	84.43

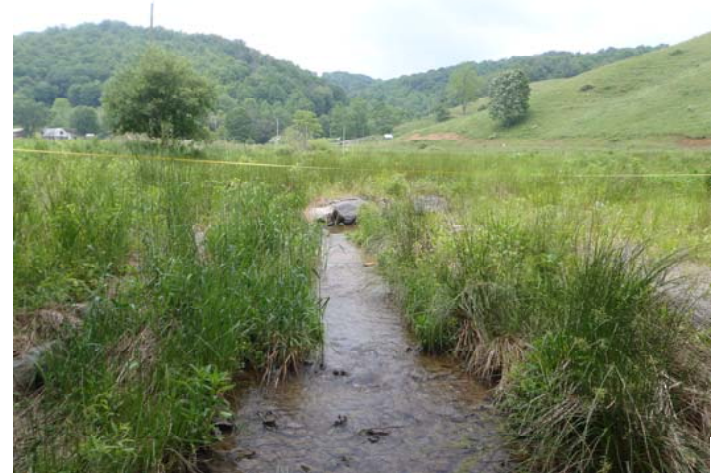
River Basin:	Upper New
Watershed:	Tate Farm
XS ID	XS - 6, Riffle
Drainage Area (sq mi):	0.6
Date:	6/14/2013
Field Crew:	Perkinson, Jernigan

Station	Elevation
0.0	80.3
4.9	80.3
6.8	80.2
9.2	80.0
10.4	79.3
12.1	79.3
13.0	79.2
14.0	79.1
14.9	79.1
15.6	78.6
16.5	78.4
17.5	78.4
18.4	78.4
19.3	78.60
20.2	78.77
21.6	78.98
22.9	79.30
24.0	79.63
25.1	79.83
26.4	80.16
29.4	80.35
32.9	80.66

SUMMARY DATA	
Bankfull Elevation:	80.0
Bankfull Cross-Sectional Area:	15.8
Bankfull Width:	16.8
Flood Prone Area Elevation:	81.7
Flood Prone Width:	>80
Max Depth at Bankfull:	1.7
Mean Depth at Bankfull:	0.9
W / D Ratio:	17.9
Entrenchment Ratio:	4.8
Bank Height Ratio:	1.0

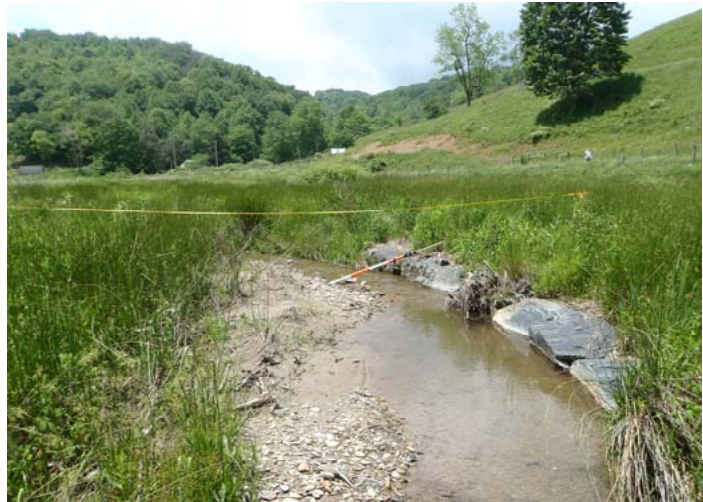
River Basin:	Upper New
Watershed:	Tate Farm
XS ID	XS - 7, Pool
Drainage Area (sq mi):	0.6
Date:	6/14/2013
Field Crew:	Perkinson, Jernigan

Station	Elevation
0.0	87.7
2.3	87.7
3.7	87.7
4.6	87.4
5.2	87.0
5.8	86.3
6.7	85.8
7.8	86.1
8.9	86.4
10.2	86.8
11.8	86.9
13.4	87.1
14.4	87.1
16.2	86.96
17.7	87.00
20.4	87.38
22.0	87.45
23.8	87.61

SUMMARY DATA	
Bankfull Elevation:	87.4
Bankfull Cross-Sectional Area:	8.9
Bankfull Width:	15.8
Flood Prone Area Elevation:	-
Flood Prone Width:	-
Max Depth at Bankfull:	1.6
Mean Depth at Bankfull:	0.6
W / D Ratio:	-
Entrenchment Ratio:	-
Bank Height Ratio:	-

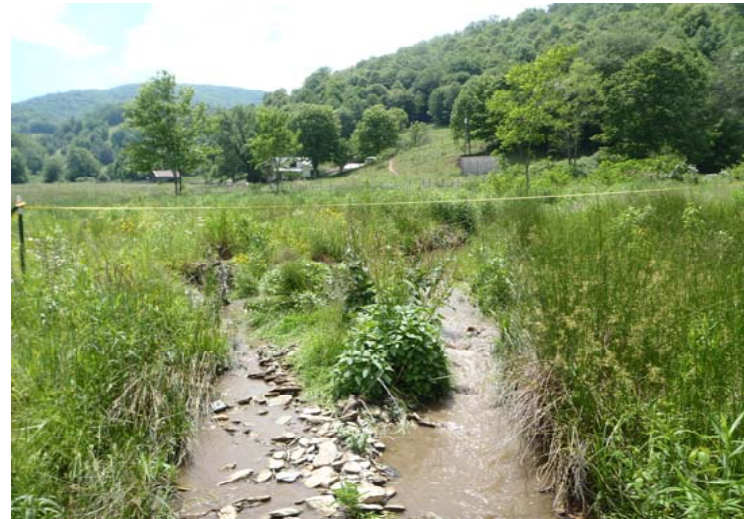
River Basin:	Upper New
Watershed:	Tate Farm
XS ID	XS - 8, Riffle
Drainage Area (sq mi):	0.6
Date:	6/14/2013
Field Crew:	Perkinson, Jernigan

Station	Elevation
0.0	94.7
3.2	94.3
5.5	94.2
7.1	93.9
9.0	93.9
10.5	94.0
11.5	94.0
12.5	94.3
13.6	94.2
15.7	93.9
16.6	93.8
17.5	93.9
18.0	94.2
18.9	94.39
20.1	94.52
23.1	94.62

SUMMARY DATA	
Bankfull Elevation:	94.5
Bankfull Cross-Sectional Area:	7.6
Bankfull Width:	18.7
Flood Prone Area Elevation:	95.2
Flood Prone Width:	>80
Max Depth at Bankfull:	0.7
Mean Depth at Bankfull:	0.4
W / D Ratio:	46.0
Entrenchment Ratio:	4.3
Bank Height Ratio:	1.0
