DETAILED BUFFER RESTORATION PLAN
TERRIBLE CREEK BUFFER RESTORATION
WAKE COUNTY, NORTH CAROLINA

(SCO Project Number 050667901)
NEUSE RIVER BASIN
CATALOGIC UNIT 03020201

September 12, 2006

Axiom Environmental, Inc.
2126 **Rowland** Pond Drive
Willow Springs, North Carolina 27592
(919) 215-1693 (phone)
(919) 341-3839 (fax)
Project Manager: Corri Faquin

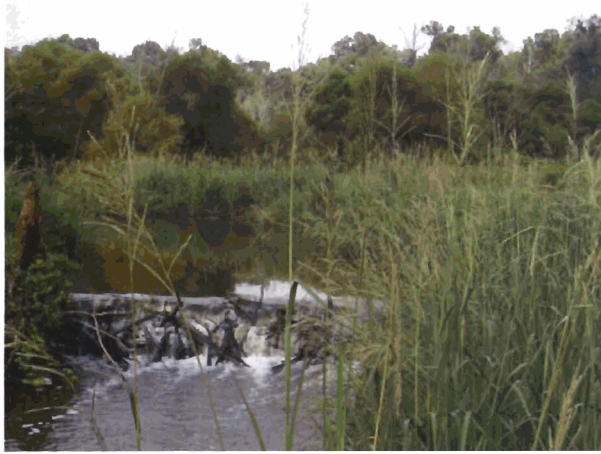
Outer Bend #1 - Looking Upstream
at beaver dam.
(Low Erosion)

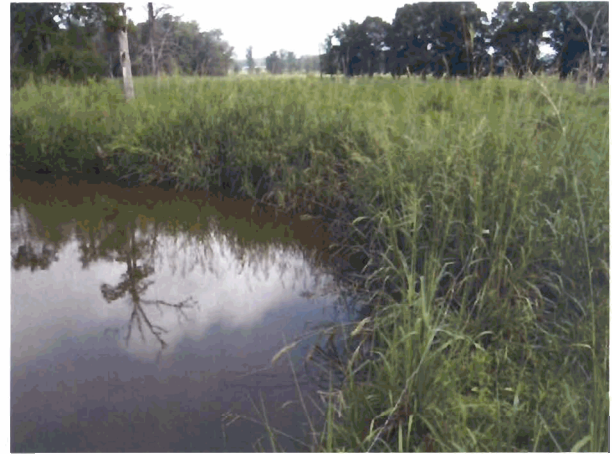
Outer Bend #2 - looking upstream
approximately 150 feet upstream from beaver dam.
(Low Erosion)

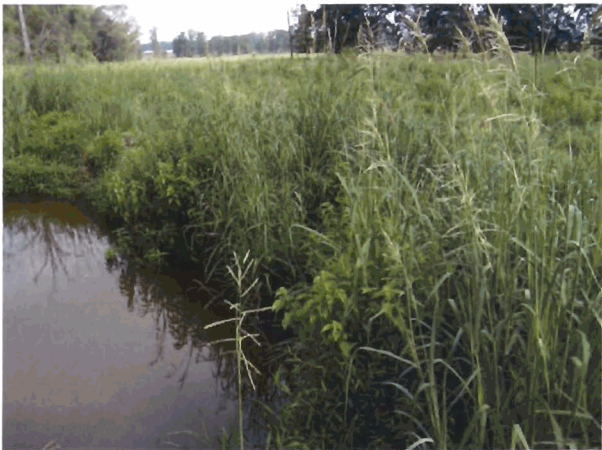
Outer Bend #3 - Looking Upstream
approximately 400 ft upstream from beaver dam,
still in impounded reach.
(Low Erosion)

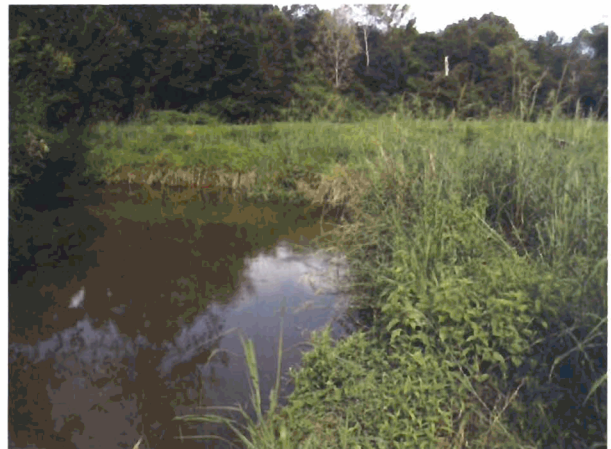
Outer Bend #4 - Looking Upstream
approximately 500 ft upstream from beaver dam,
still in impounded reach.
(Moderate Erosion)

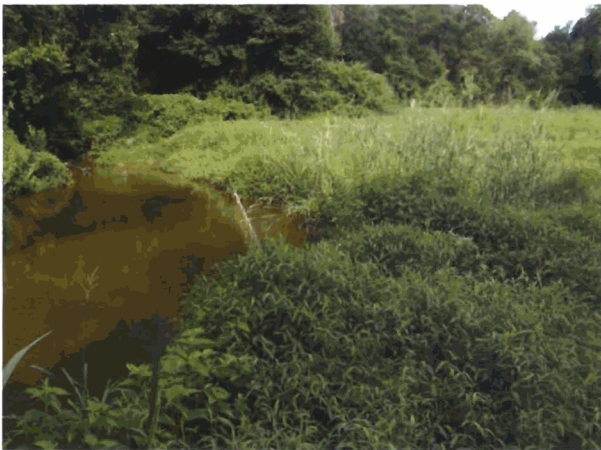
Outer Bend #5 - Looking Upstream
a bend with a larger radius.
(Low Erosion)

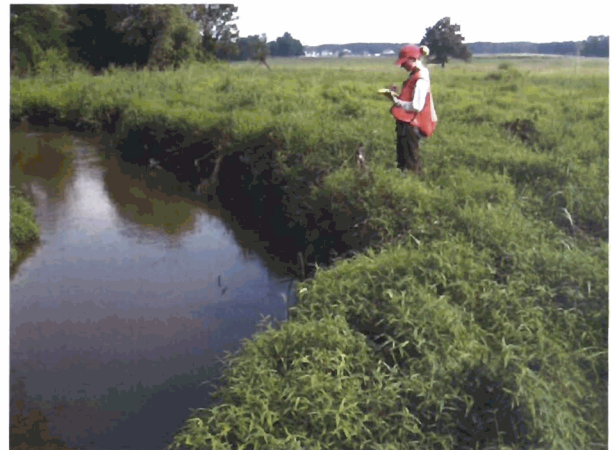
Outer Bend #6 - Looking Upstream
in a double outer bend.
(Moderate Erosion)

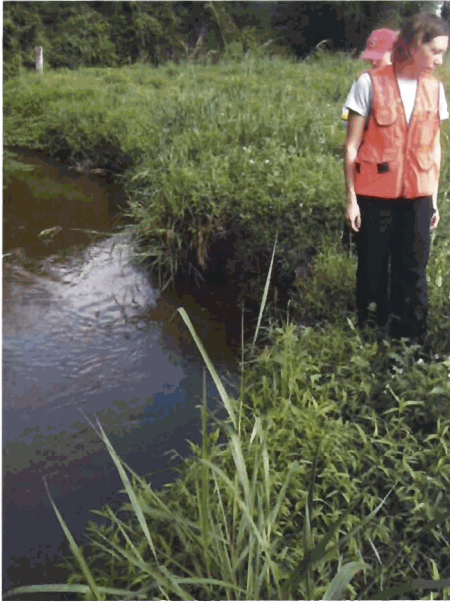
Outer Bend #7 - Looking Upstream
Privet on opposite bank may causing
erosion on Site bank.
(Moderate Erosion)

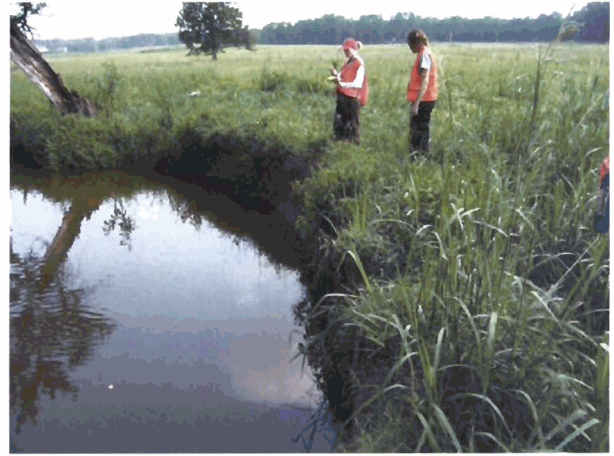
Outer Bend #8 - Looking Upstream
(Severe Erosion)

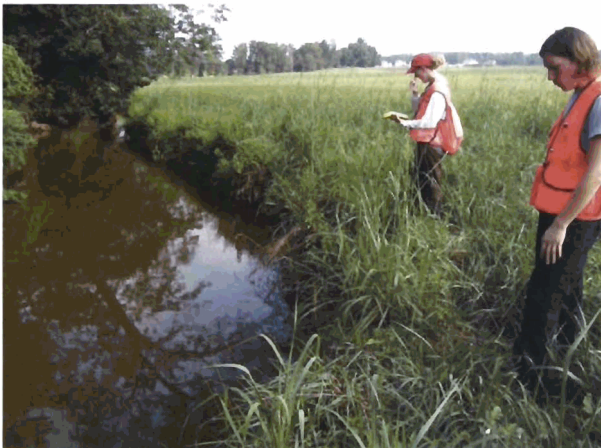
Outer Bend #9 - Looking Upstream
at outer bend in a straight, immediately
upstream from a tight radius.
(Moderate Erosion)

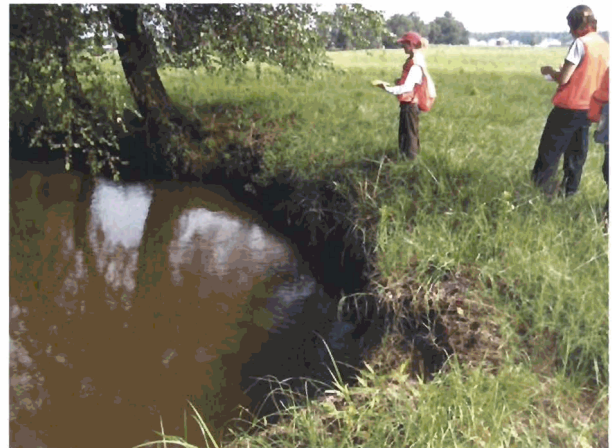
Outer Bend #10 - Looking Upstream
at tight radius below a large river birch.
(Moderate Erosion)

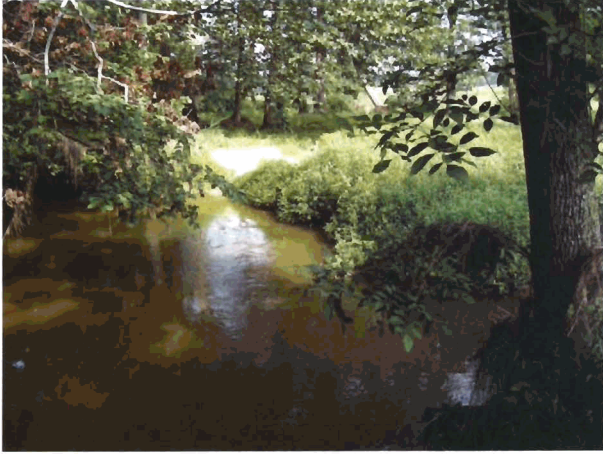
Outer Bend #11 - Looking Upstream at tight radius. A fallen tree has cause a hole in the bank.
(Severe Erosion)

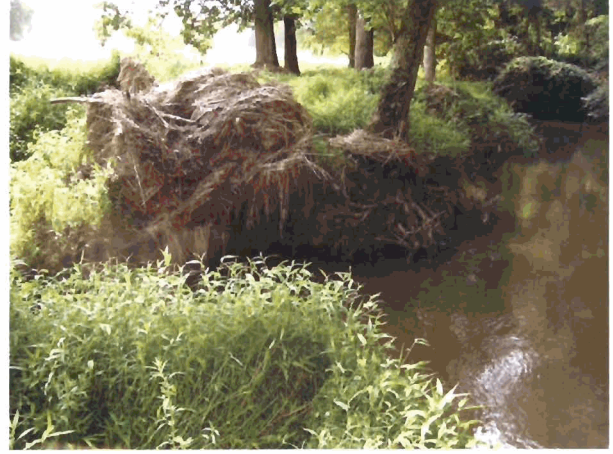
Outer Bend #11 - Looking Downstream at fallen tree causing a hole in the bank.
(Severe Erosion)

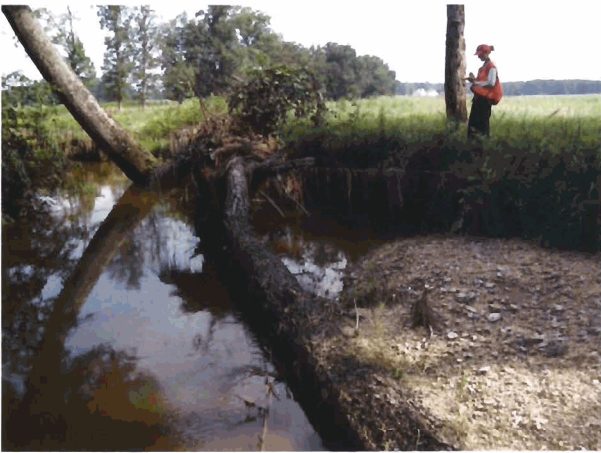
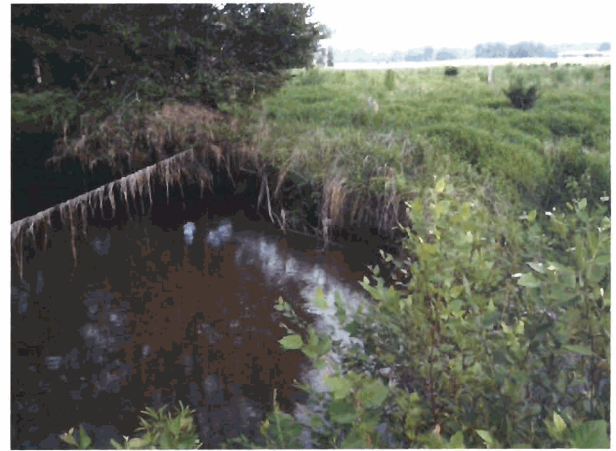
Outer Bend #12 - Looking Upstream
(Severe Erosion)

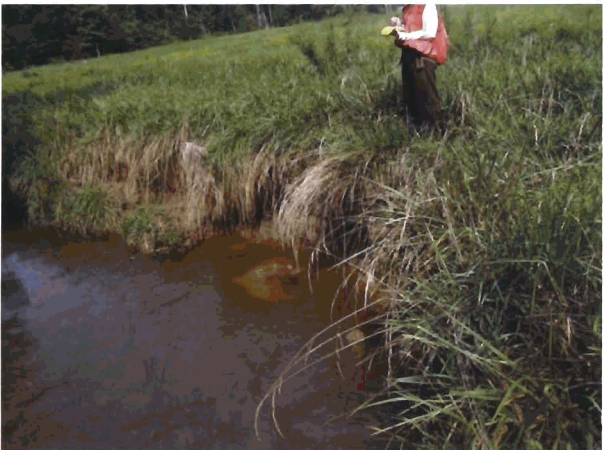
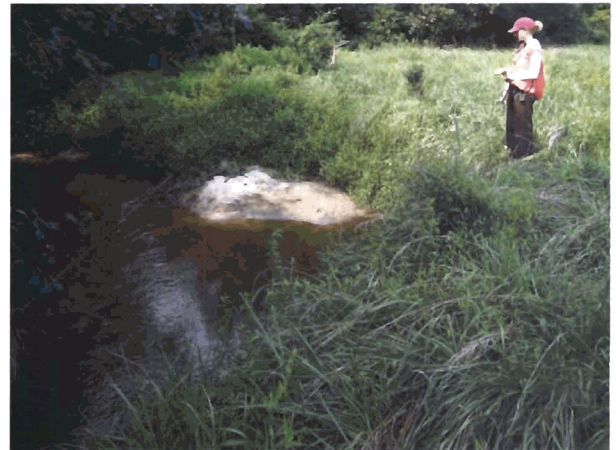
Outer Bend #13 - Looking Upstream
A fallen tree may be causing erosion on Site stream banks.
(Severe Erosion)

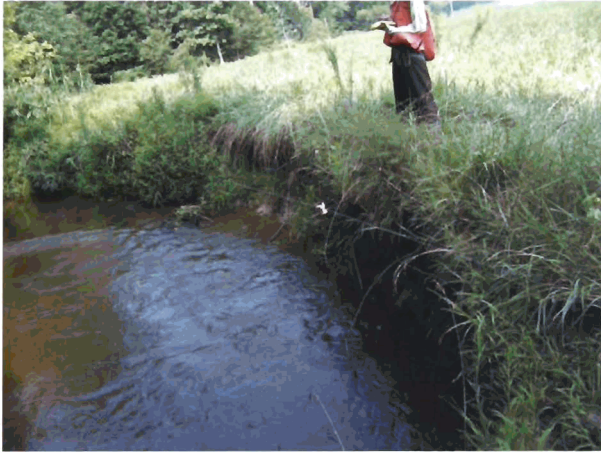
Outer Bend #14 - Looking Upstream at tight radius caused by point bar and transverse bar.
(Severe Erosion)

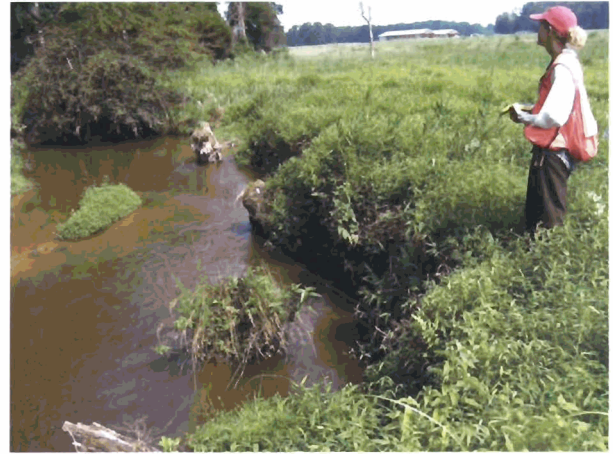
Outer Bend #15 - Looking Upstream at a long bend with two stumps extending into the stream.
(Moderate Erosion)

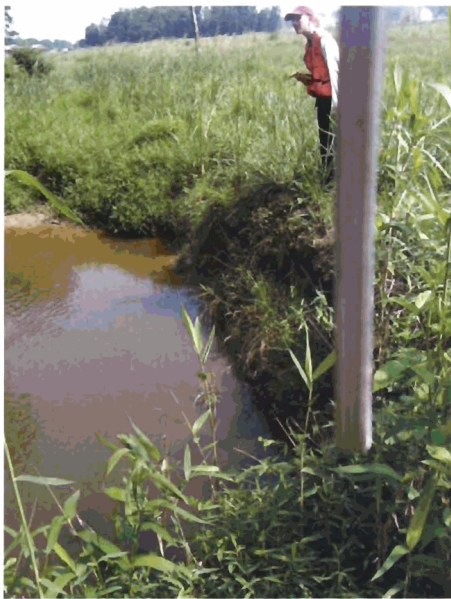
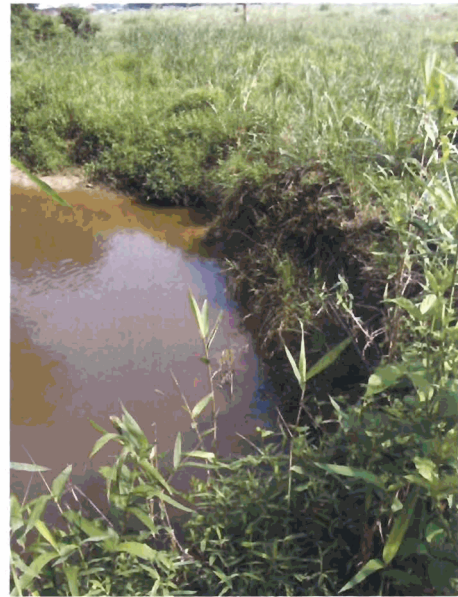
Outer Bend #16 - Looking Upstream at tight bends. This is not a good reach for bank stabilization comparisons.
(Moderate Erosion)

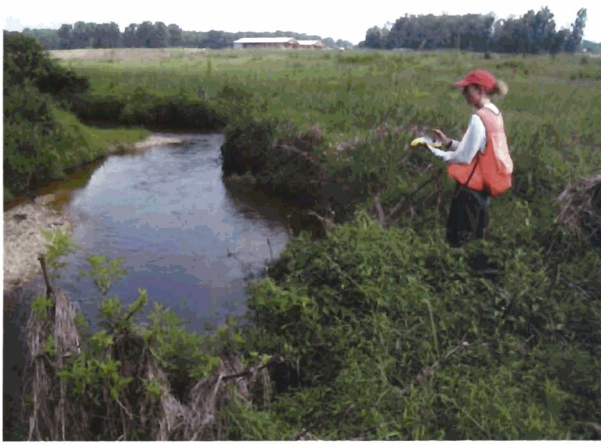
Outer Bend #17 - Looking Upstream
(Severe Erosion)

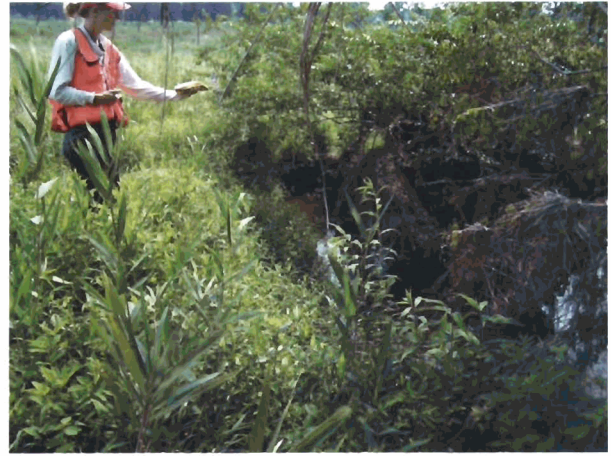
Outer Bend #17 - Looking Downstream
(Severe Erosion)

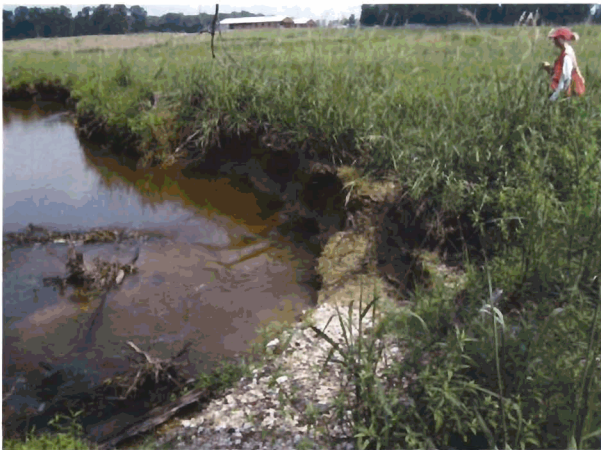
Outer Bend #18 - Looking Upstream
(Extreme Erosion)

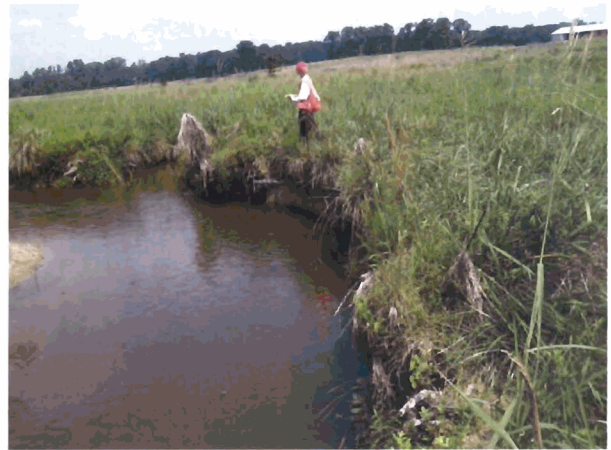
Outer Bend #19 - Looking Upstream
(Severe Erosion)

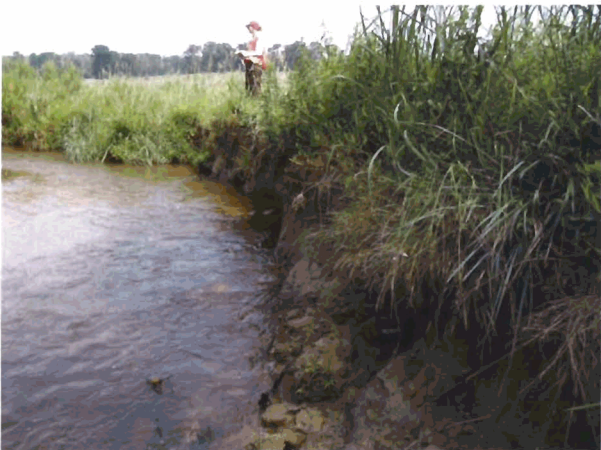
Outer Bend #20 - Looking Upstream
at a long bend with a tight radius in the
middle of the bend.
(Extreme Erosion)

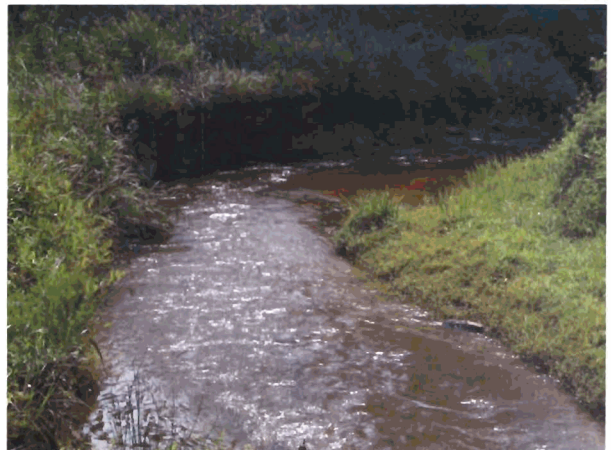
Outer Bend #20 - Looking Downstream
at a long bend with a tight radius in the
middle of the bend.
(Extreme Erosion)

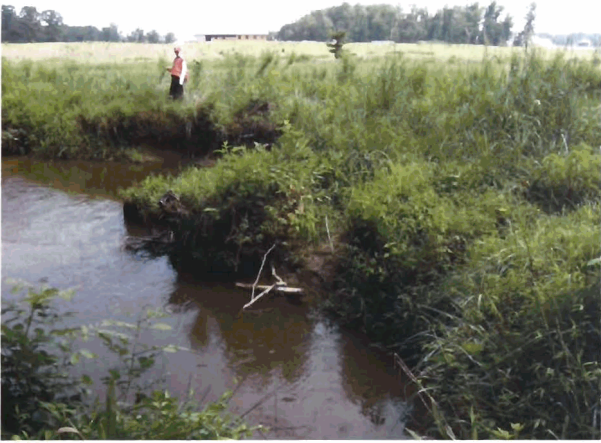
Outer Bend #21 - Looking Upstream
at bank sloughing
(Extreme Erosion)

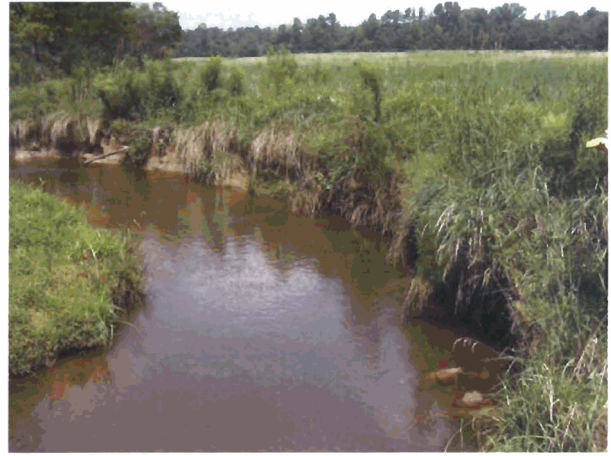
Outer Bend #22 - Looking Upstream
at lateral migration of outer bend with
point bar extension into the stream bed.
(Severe Erosion)

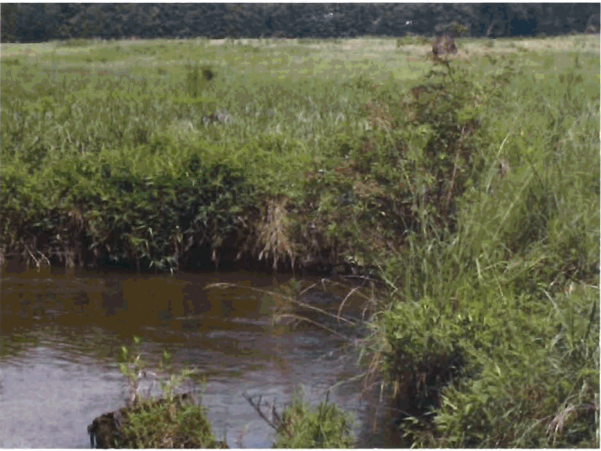
Outer Bend #23 - Looking Upstream
at root balls in channel and bank sloughing
(Severe Erosion)

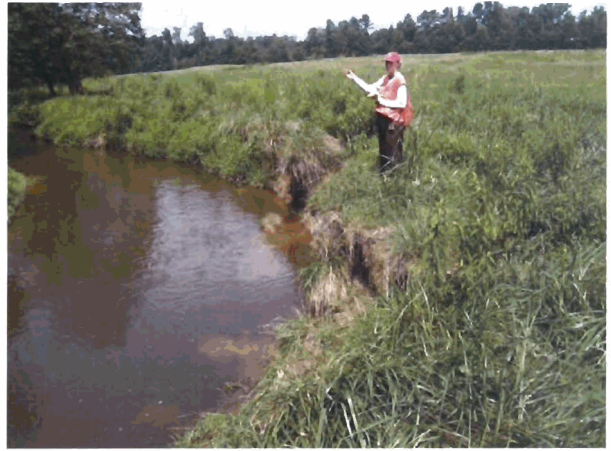
Outer Bend #24 - Looking Upstream
at a short reach of erosion.
(Severe Erosion)

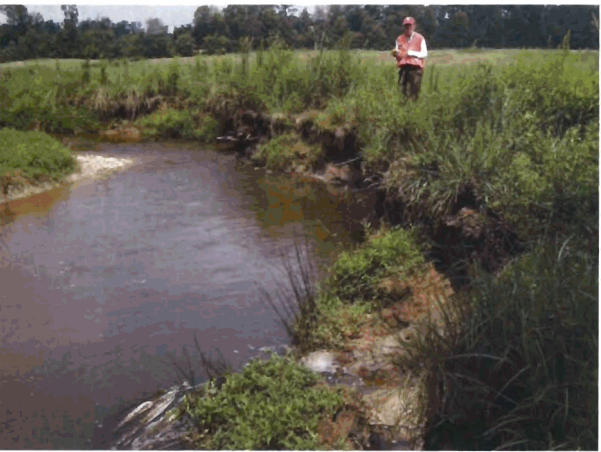
Outer Bend #25 - Looking Upstream
at transverse bar and tight radius at upper
reach of the bend.
(Extreme Erosion)

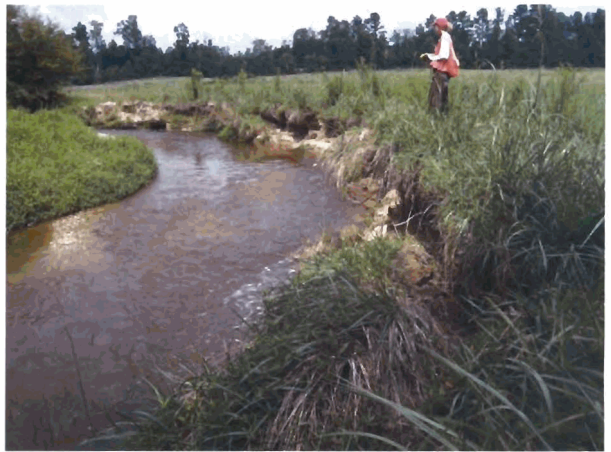
Outer Bend #26 - Looking Upstream
at migrating outer bend and extension of
point bar/transverse bar at lower
reach of bend.
(Extreme Erosion)

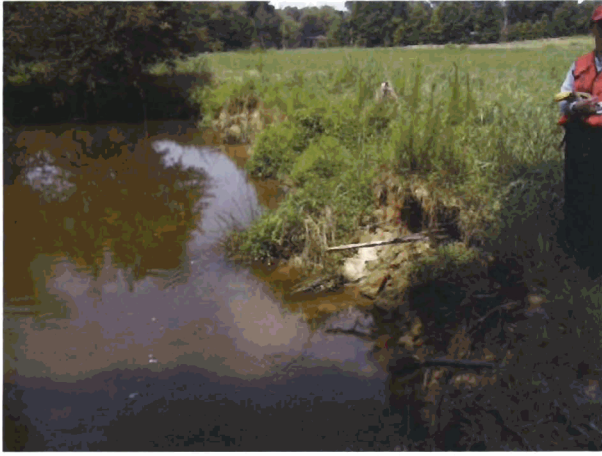
Outer Bend #27 - Looking Upstream at erosion on low slope reach. (Severe Erosion)

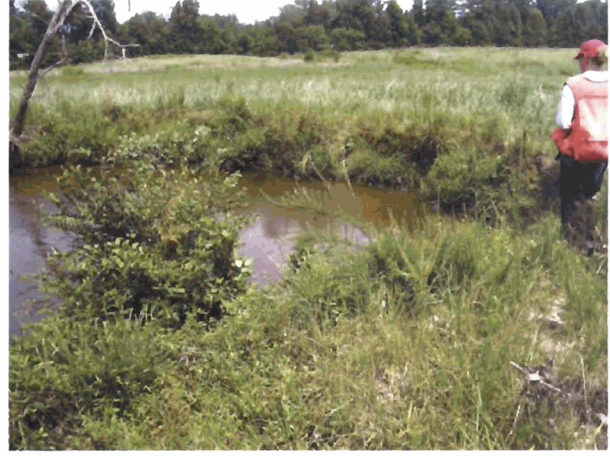
Outer Bend #28 - Looking Upstream at potential shoot cutoff development. (Severe Erosion)

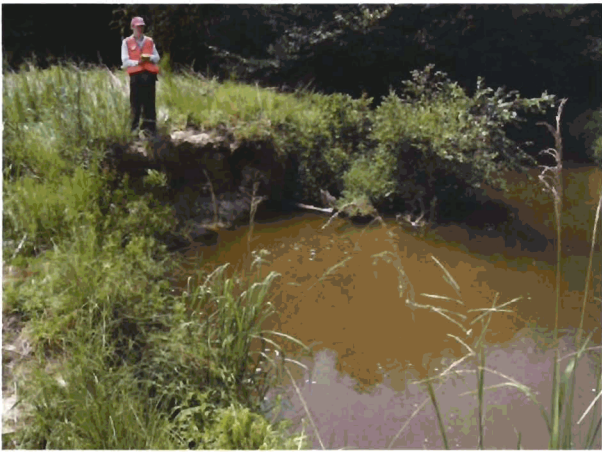
Outer Bend #28 - Looking Downstream at potential shoot cutoff development. (Severe Erosion)

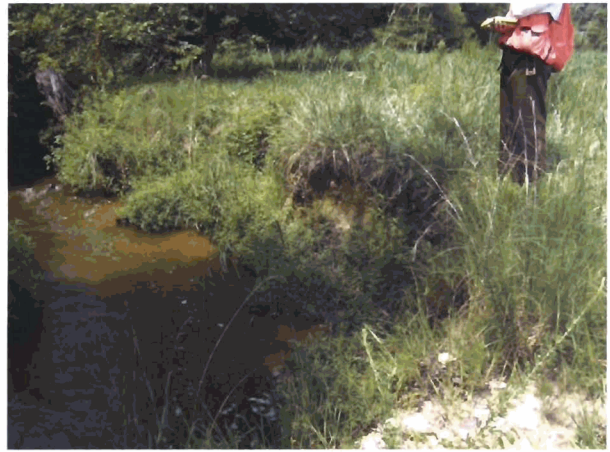
Outer Bend #29 - Looking Upstream at shoot cutoff. Not a good bank erosion treatment comparison area. (Severe Erosion)

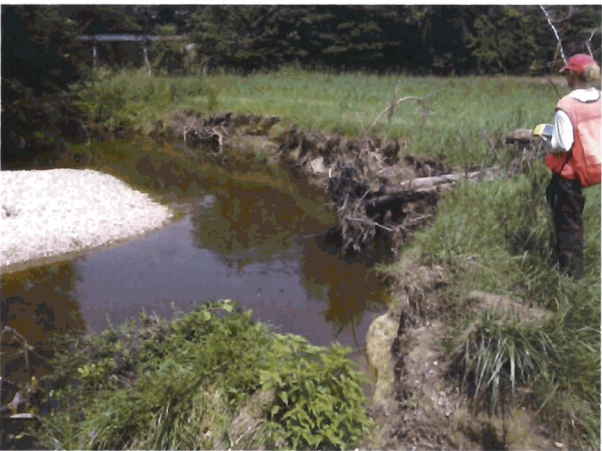
Outer Bend #30 - Looking Upstream at lateral migration of out bend with extension of point bar into the stream bed. (Extreme Erosion)
