# **FINAL ANNUAL MONITORING REPORT TERRIBLE CREEK**

**BUFFER RESTORATION  
WAKE COUNTY, NORTH CAROLINA  
(EEP Project Number 134)  
NEUSE RIVER BASIN  
CATALOGING UNIT 03020201  
Monitoring Year 3 of 5 (2010)**

**January 2011**

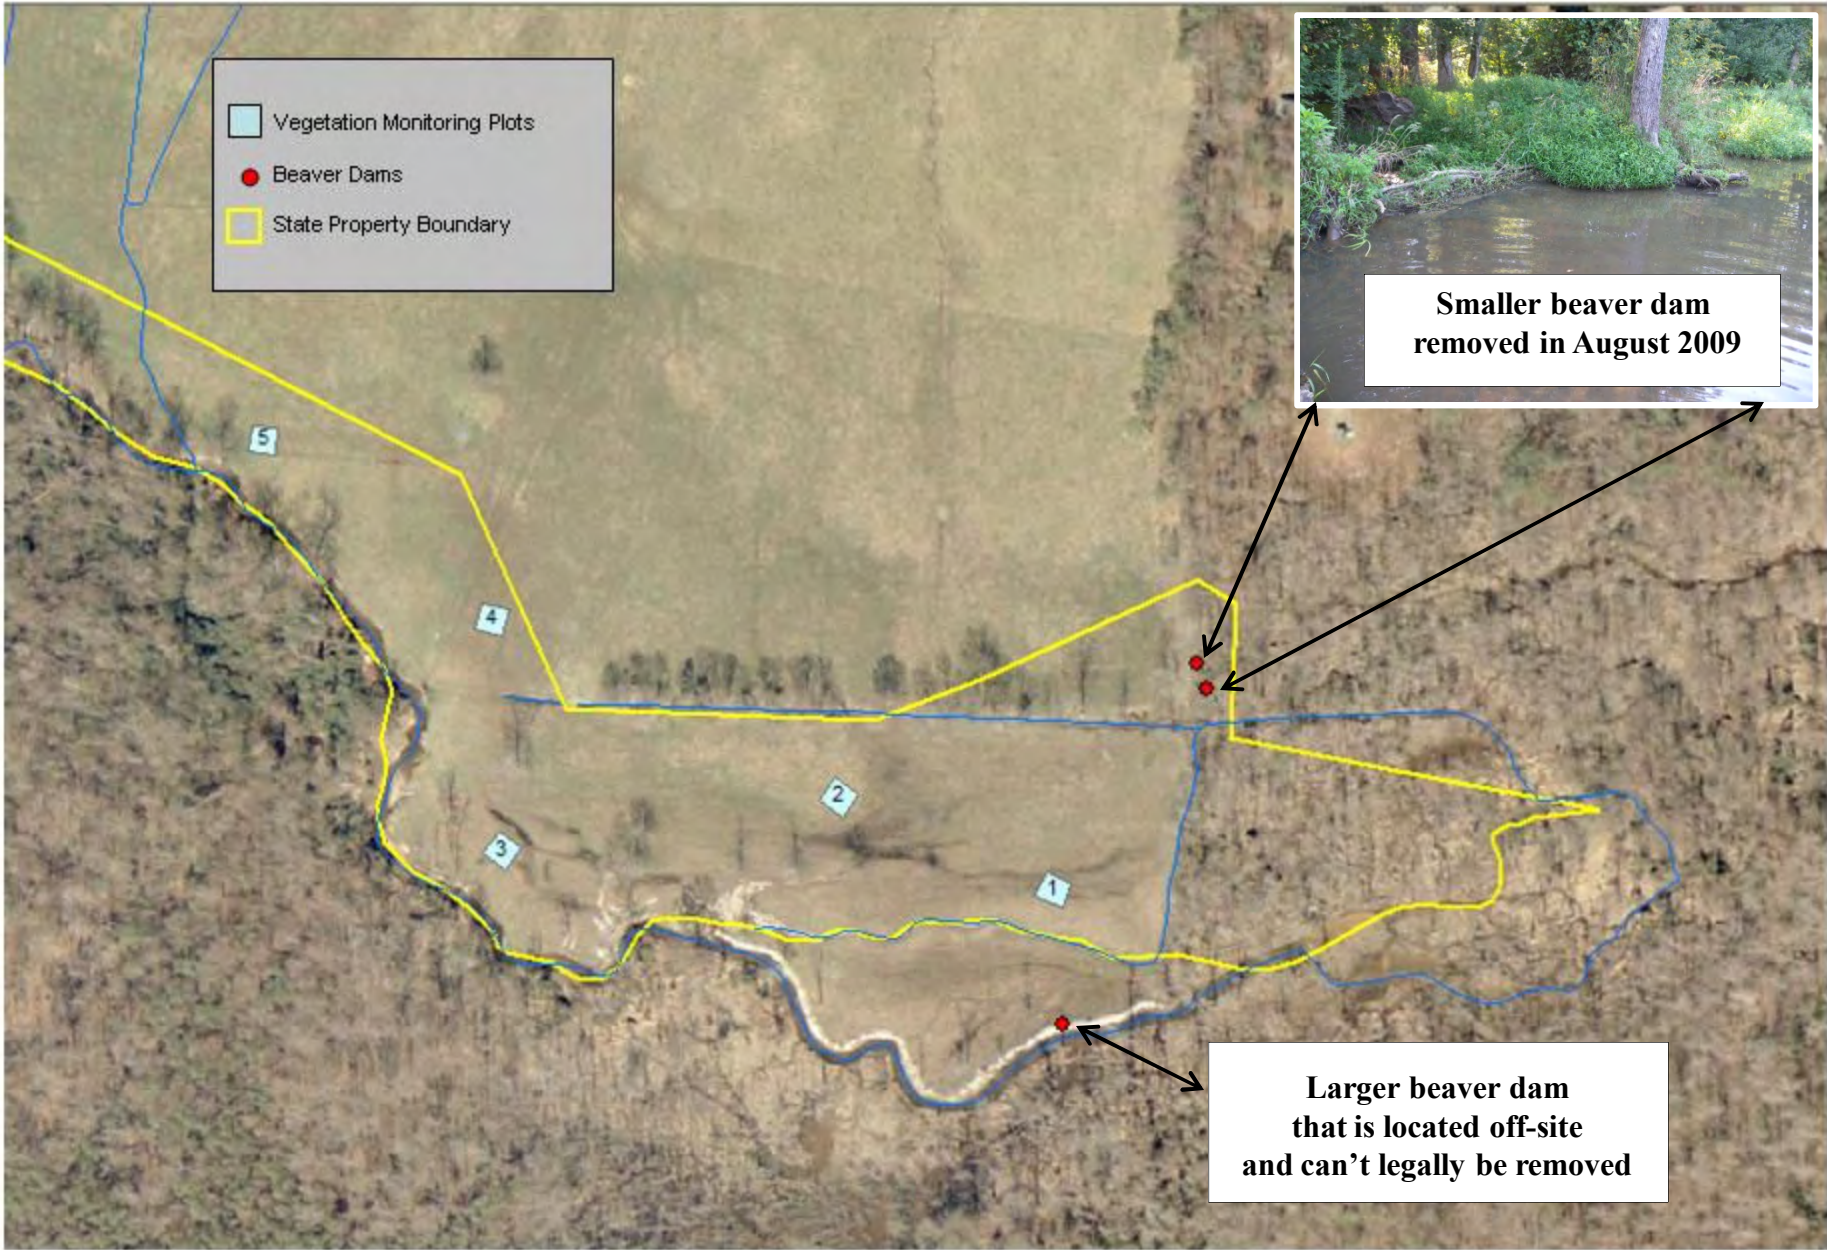
APPENDIX D  
BEAVER MANAGEMENT INFORMATION  
Map of Located and/or Removed Beaver Dams

In summary, the Site achieved success criteria for vegetation in the Third Monitoring Year (2010). Approximately 430 linear feet of outerbend within the Site shows some sign of bank sloughing or reduced integrity. However, when compared to preconstruction conditions the issue areas have not worsened and in general, the stream channel as a whole is trending toward more stable conditions. Beaver dams located near the eastern portion of the Site were mapped in August 2009 (Appendix D). The smaller beaver dams located in the northern portion of the Site were removed; the larger dam located just off-site was not removed because it is not located on the State's easement.
