Thompsons Fork and Unnamed Tributary Mitigation Plan (Lowdermilk Properties)

Nebo Township, McDowell County
North Carolina
NC EEP Project Number: D06030-A

Submitted: September 3, 2008

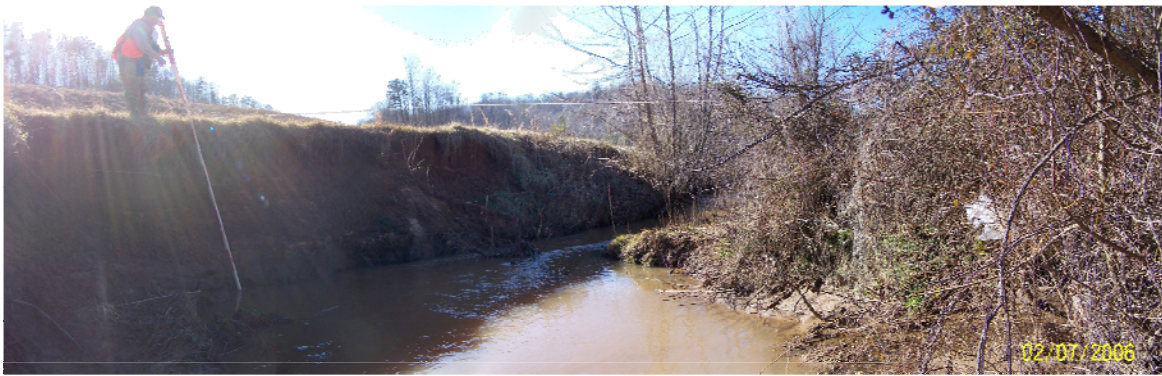
*Thompsons Fork Mainstem Pool Cross-Section – Pre-Restoration
Photograph taken near confluence with the UT, looking upstream.*

Prior to restoration, a combination of historical and recent anthropogenic factors and practices impacted the channel along the impaired mainstem reach, resulting in its unstable Rosgen G4 stream type. The deeply incised and entrenched condition of the channel, prior to restoration, is attributed to aggressive vegetative management of the riparian corridor for hay production, cattle intrusion resulting in streambank hoof shear and vegetative denuding from grazing and browsing, combined with the erosive nature of the clear water discharge of “sediment hungry” water from the 30-inch reinforced concrete pipe

The Thompsons Fork mainstem unstable bank height ratio ($BHR = \text{low bank height} / \text{bankfull maximum depth} = LBH/D_{\text{max}} = 2.36$), entrenchment ratio (flood prone width/bankfull width = 1.33), channel slope (0.0039 ft/ft) greater than valley slope (0.0031 ft/ft) and poorly defined bedform features shows the instability of the deeply incised, unstable, degrading stream channel disconnected from its floodplain prior to restoration. Mid-channel, lateral, and transverse sand and gravel bars were present at locations throughout the mainstem reach, demonstrating the stream lacked stable pattern, profile, dimension, capacity and competency to entrain the extremely high sediment load coming out of its unstable streambanks. The locations of these depositional features in the near-bank region deflected flows from the center of the channel toward the incised vertical to undercut, steep, denuded streambanks, resulting in accelerated erosion rates. Near-bank stress at a critical riffle cross-section was approximately 2.24 lbs/square foot, based on design calculations. The near vertical, denuded streambanks at this location were typical of the existing impaired stream reach conditions throughout the mainstem project corridor up to the former farm stream crossing. Utilizing the near-bank stress method algorithm included in RiverMorph® v.4.0.1a, it was estimated 2,076 cubic yards per year (or 2,700 tons per year) of sediment was being eroded from the streambanks along the mainstem.

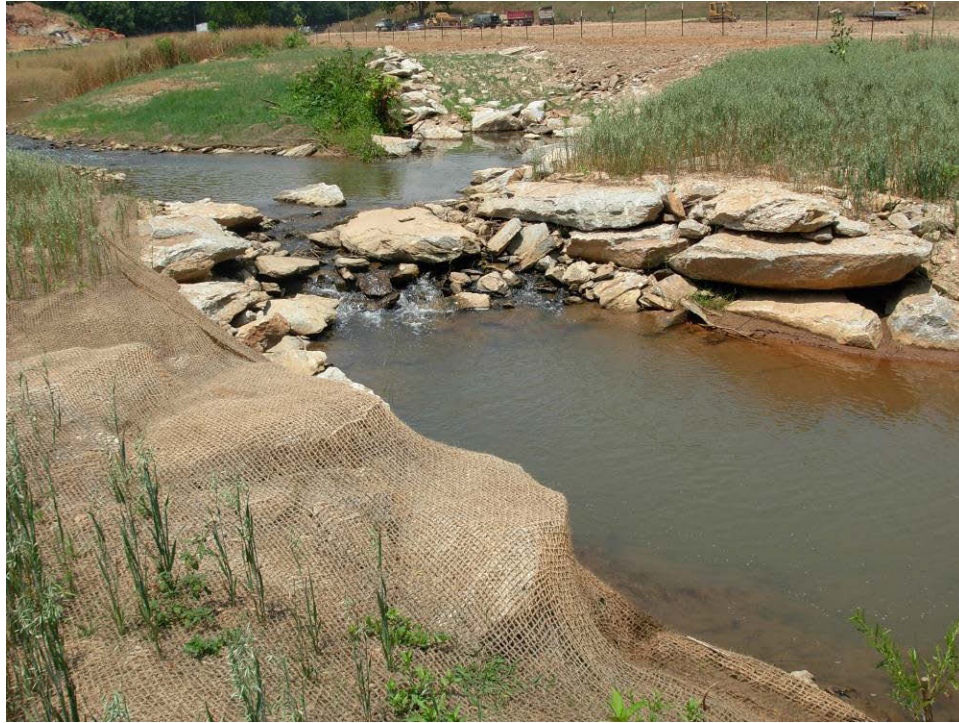
*Thompsons Fork Mainstem– Post-Restoration
Photograph taken at Station 26+45, near confluence with the UT, looking upstream.*

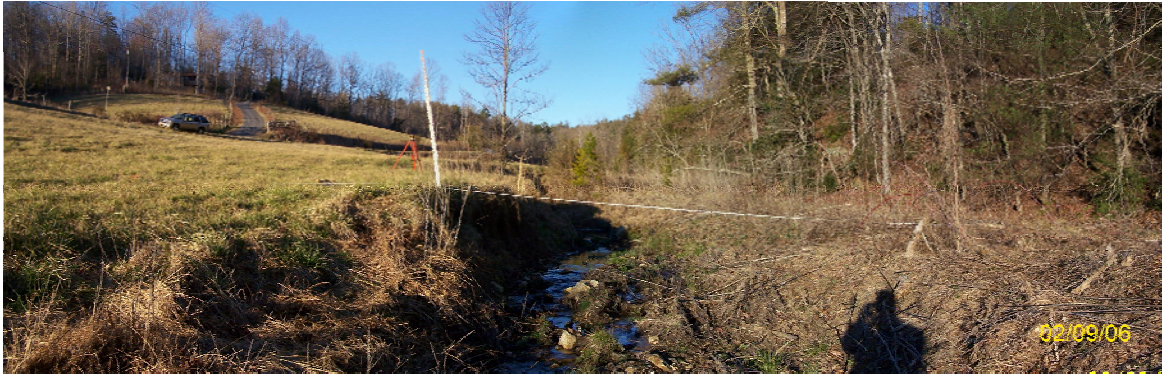
*Thompsons Fork UT Riffle Cross-Section – Pre-Restoration
Photograph taken from left to right, looking upstream.*

The UT channel is a classic Rosgen Type I valley confined, A1-A2 stream type transitioning to a Type II colluvial valley, B3 stream type at the point where the stream emerges from its mixed deciduous hardwood and evergreen forested corridor into an open meadow at the top of the impaired reach. The forested reach segment has some bedrock control, in-stream boulders with negligible instream woody debris accumulation. The indigenous, well established, healthy riparian vegetative communities in the channel and in the overbank regions provide extremely stable channel conditions for this reach, are preserved within the conservation easement recorded for the project.

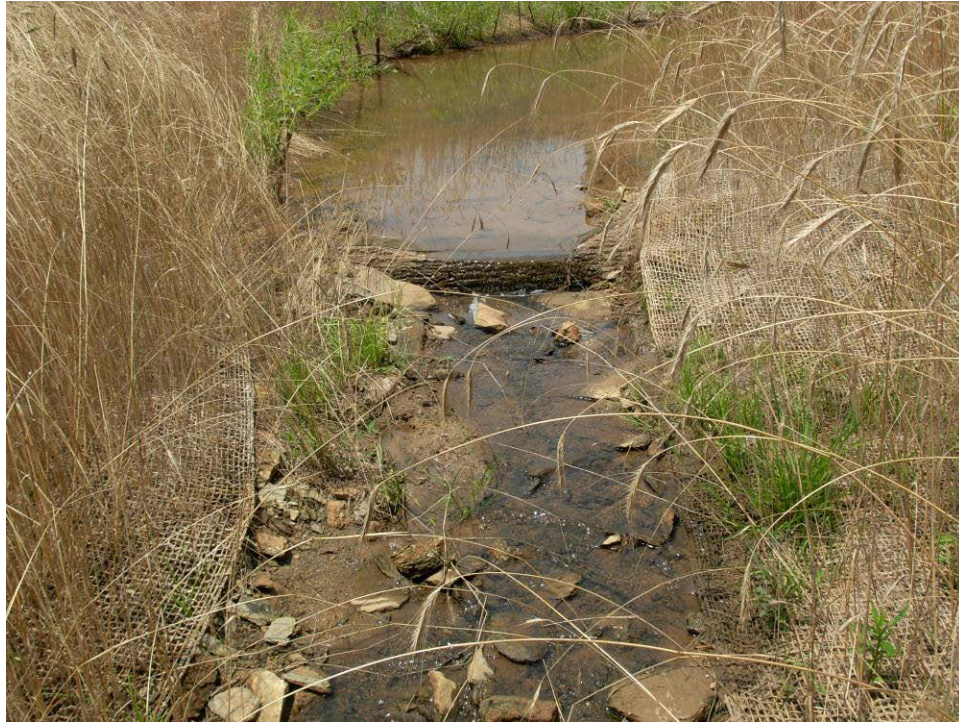
*Thompsons Fork UT Riffle Cross-Section – Post-Restoration
Photograph taken at Station 18+30, looking upstream.*

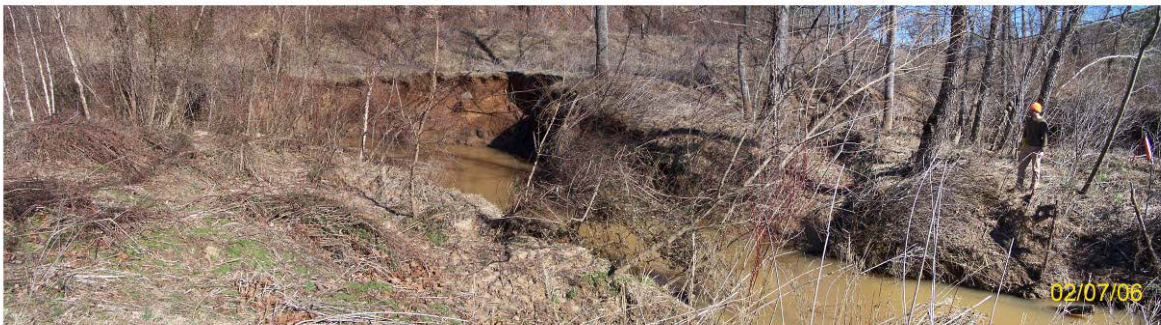
*Thompsons Fork Mainstem – Pre-Restoration
Photograph taken near downstream limits of project.
15-ft Vertical to Undercut Stream Bank*

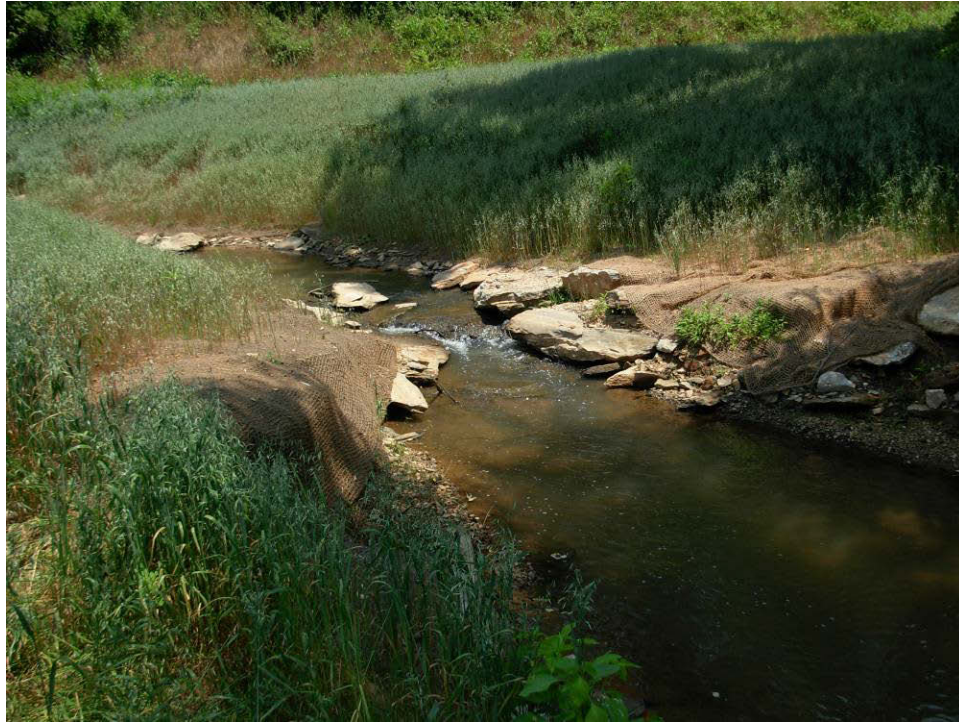
*Thompsons Fork UT – Post-Restoration
Photograph taken at Station 27+57, near downstream limit of project, looking upstream.*

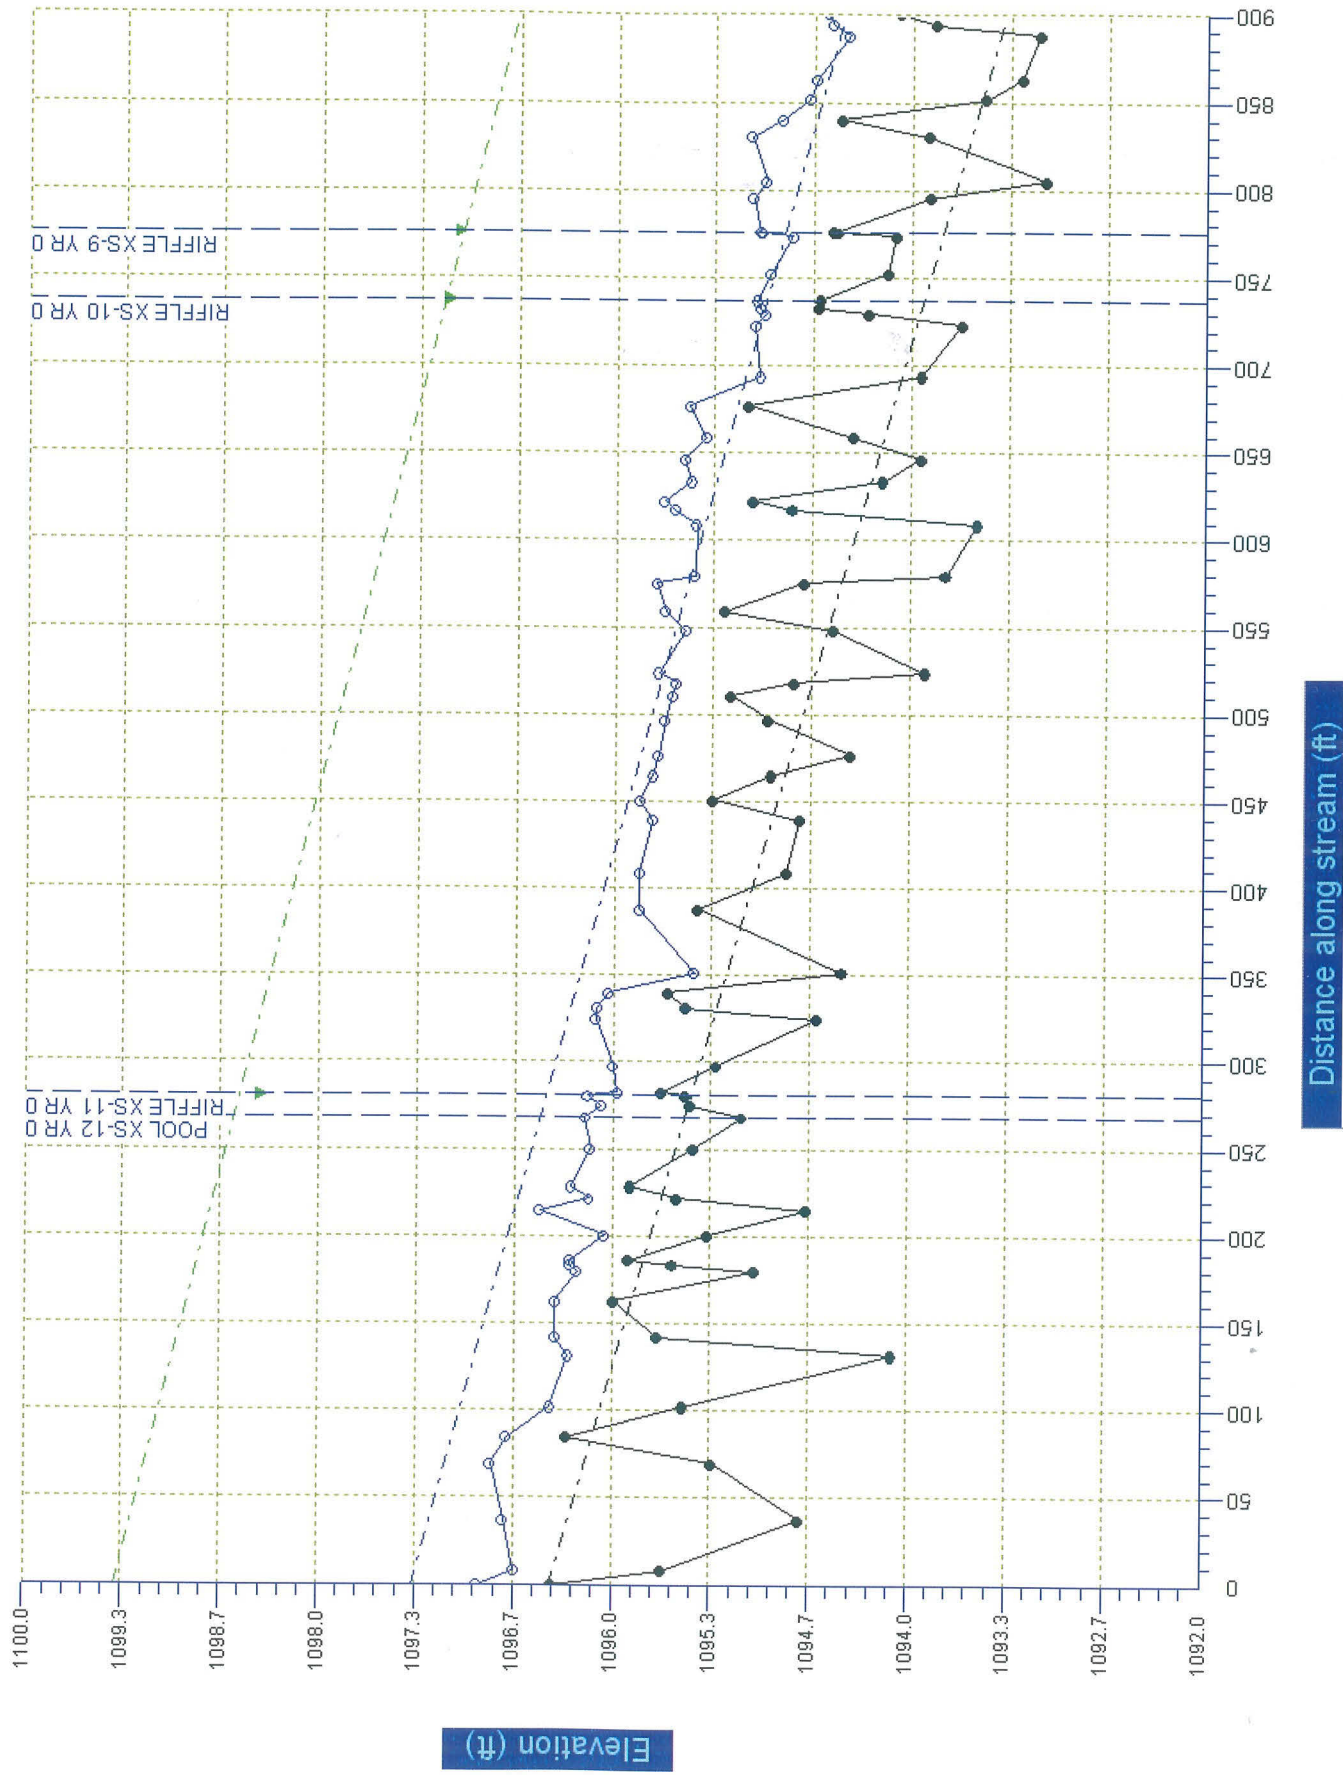
Thompsons Fork 'As-Built' Longitudinal Profile - Station 0+00 - 9+00 - Yr 0

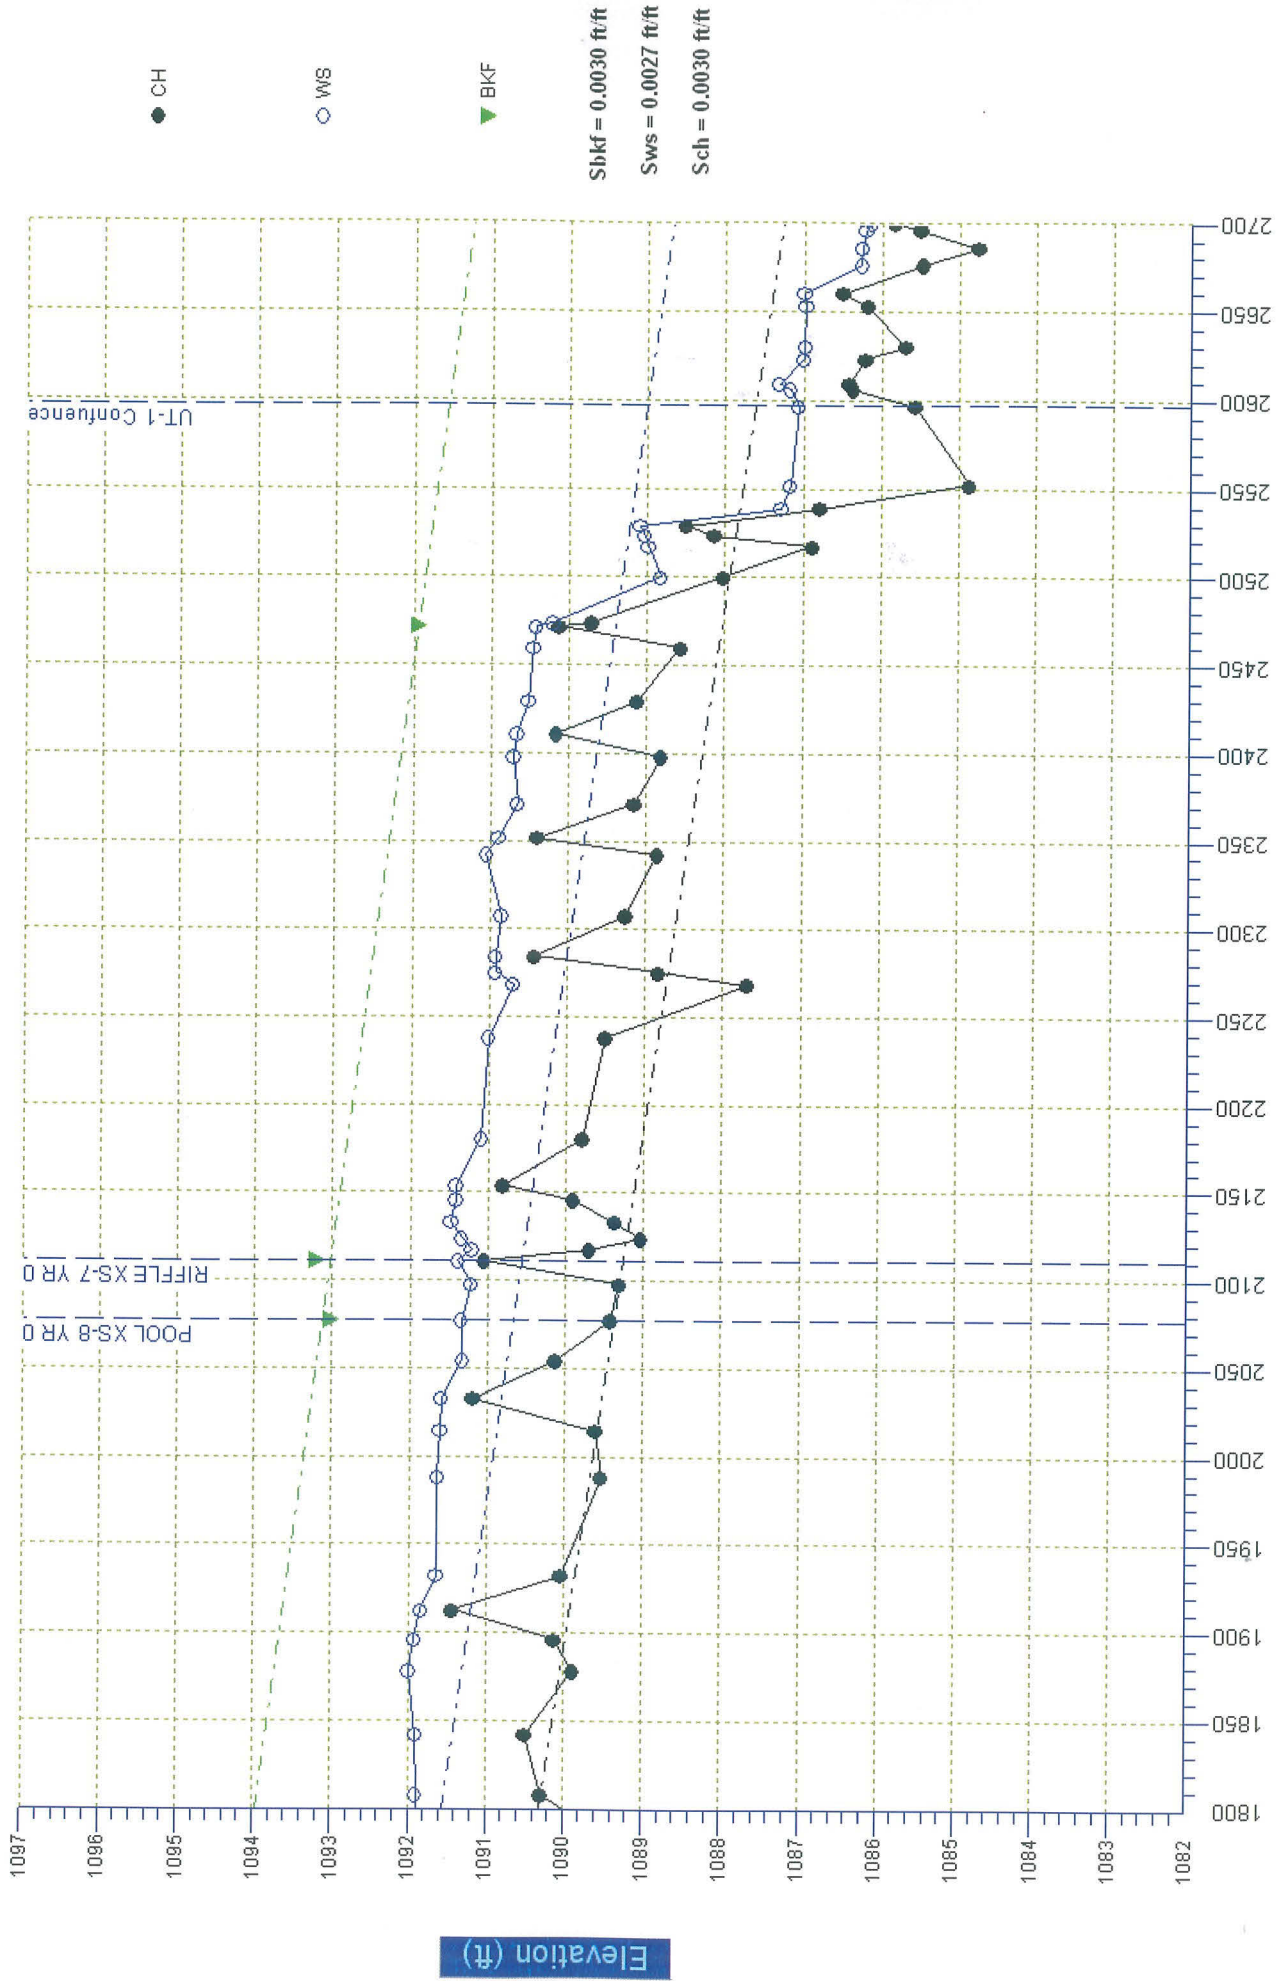
Thompsons Fork 'As-Built' Longitudinal Profile - Station 18+00 - 27+00

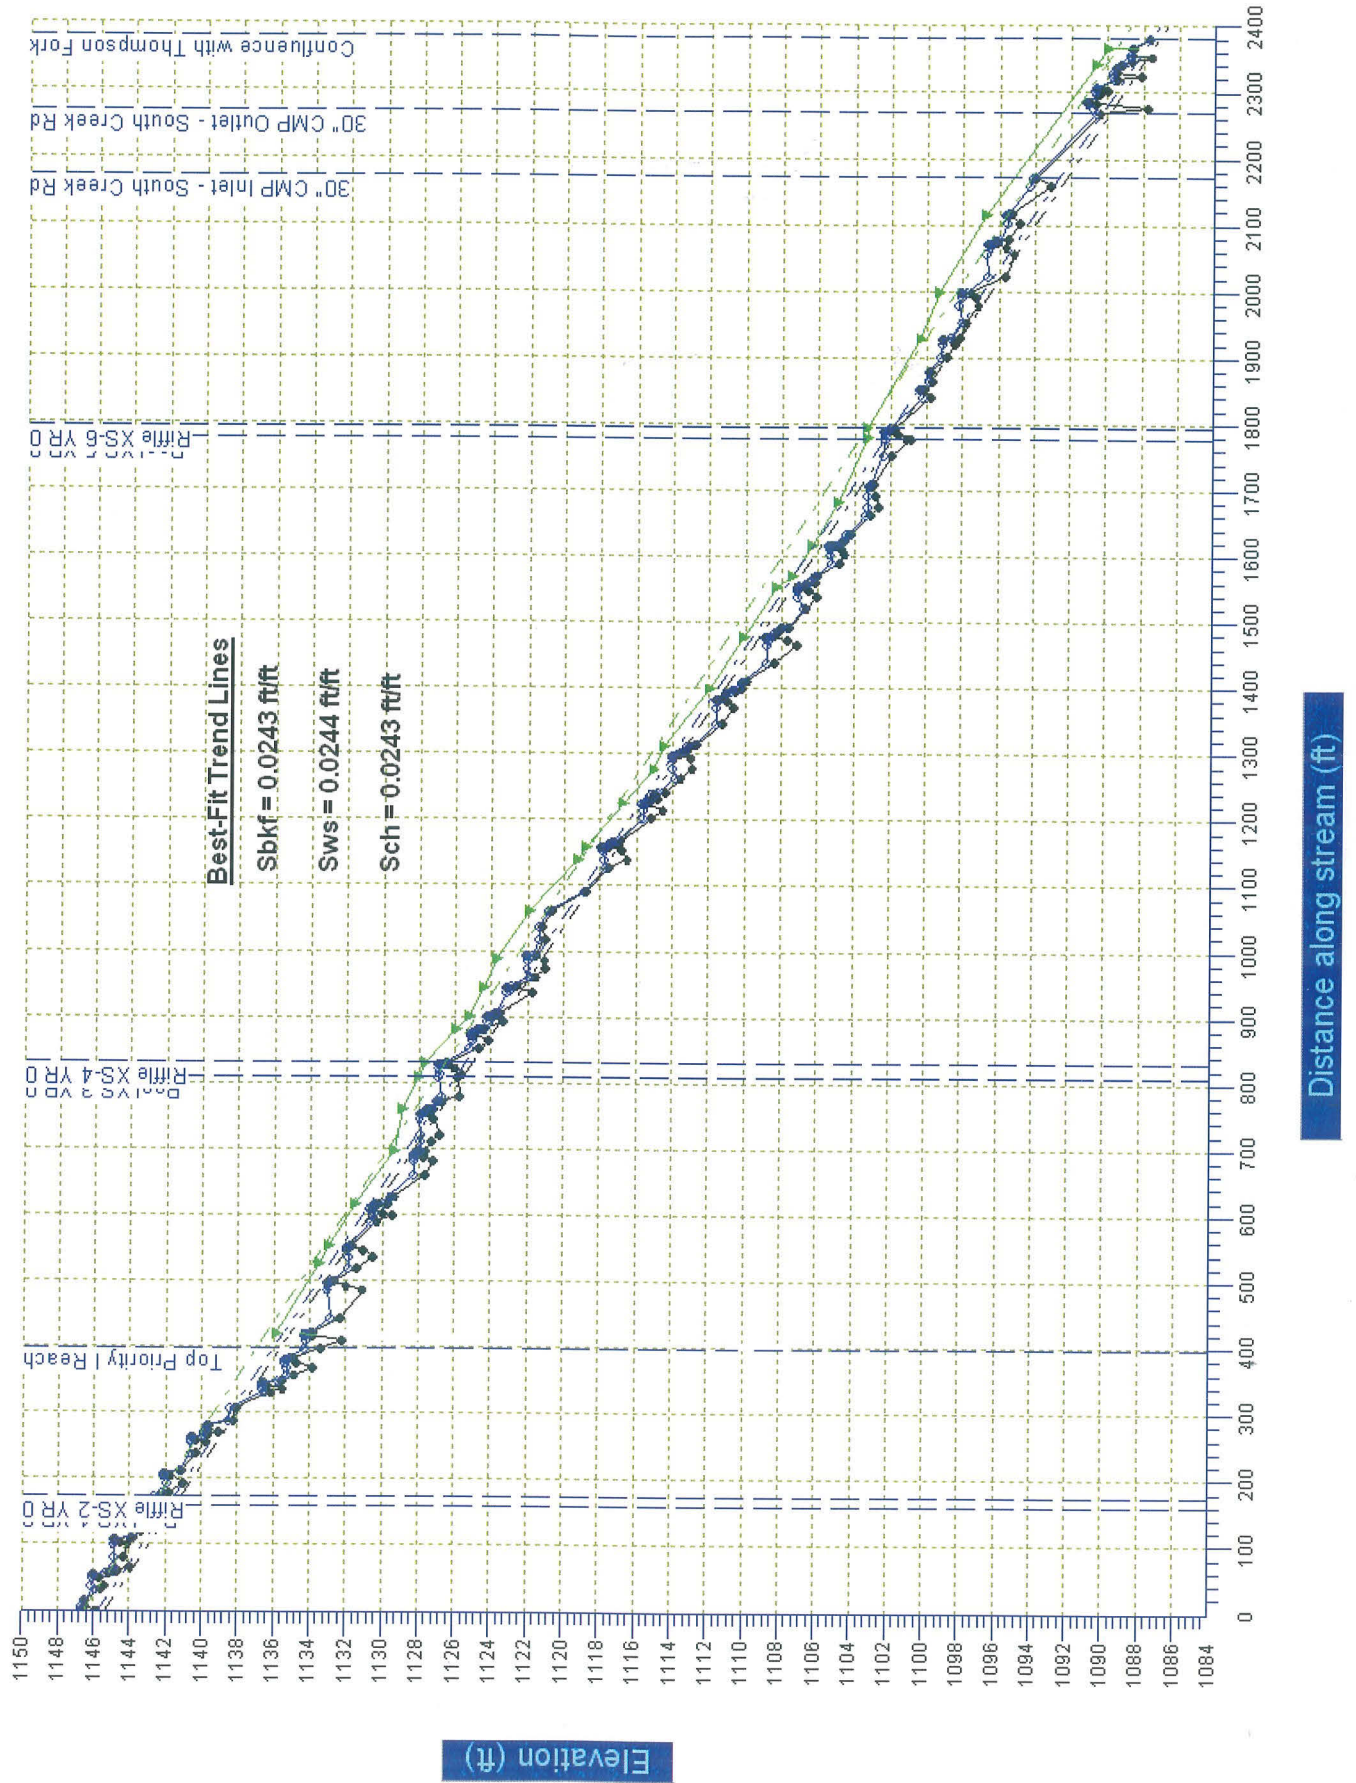
Thompsons Fork UT-1 "As-Built" Longitudinal Profile - 3/26/2008

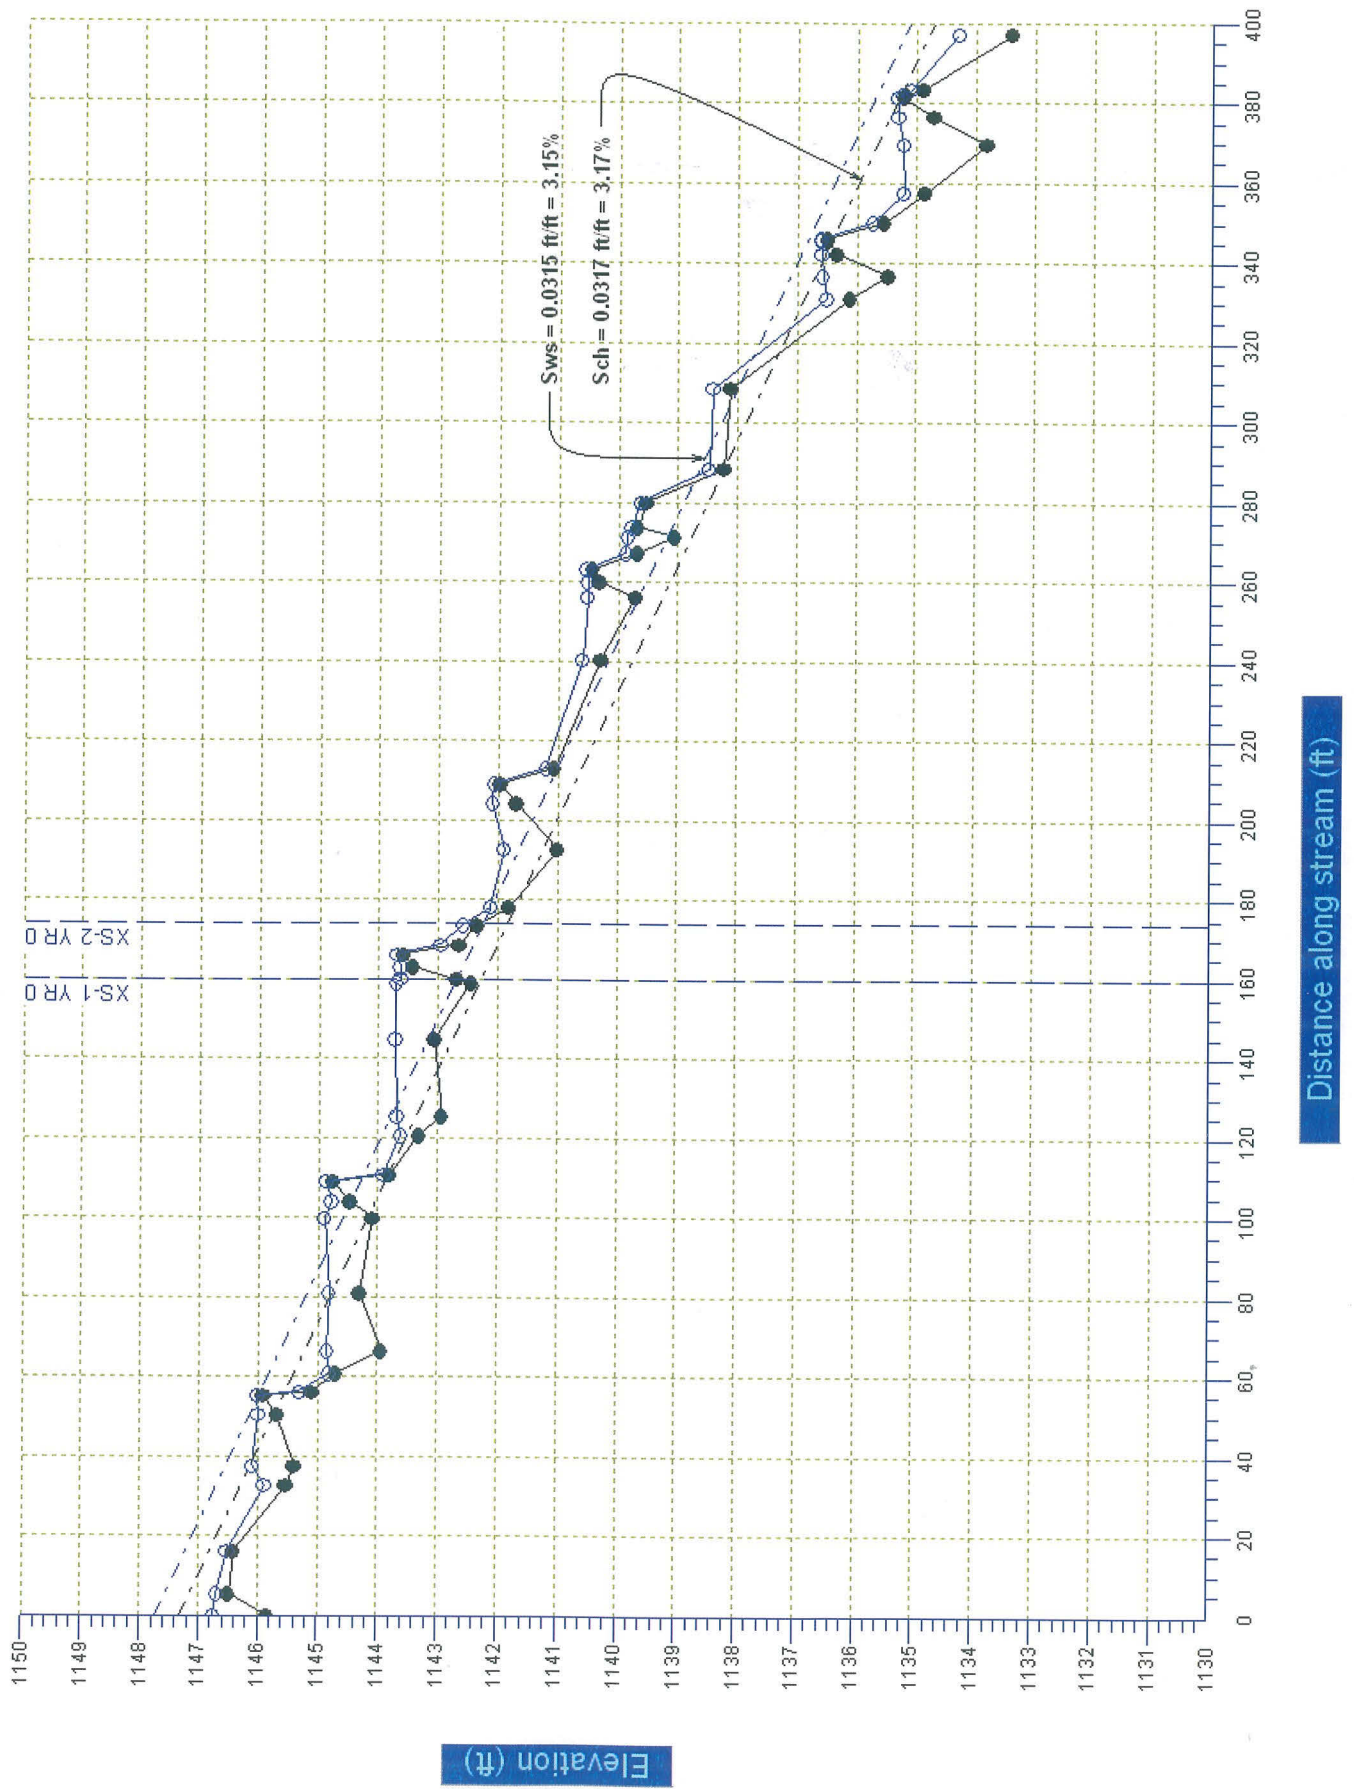
UT-1 - E2 Reach - Longitudinal Profile Sta. 0+00 to 3+97.22 - YR 0 - 03/26/08

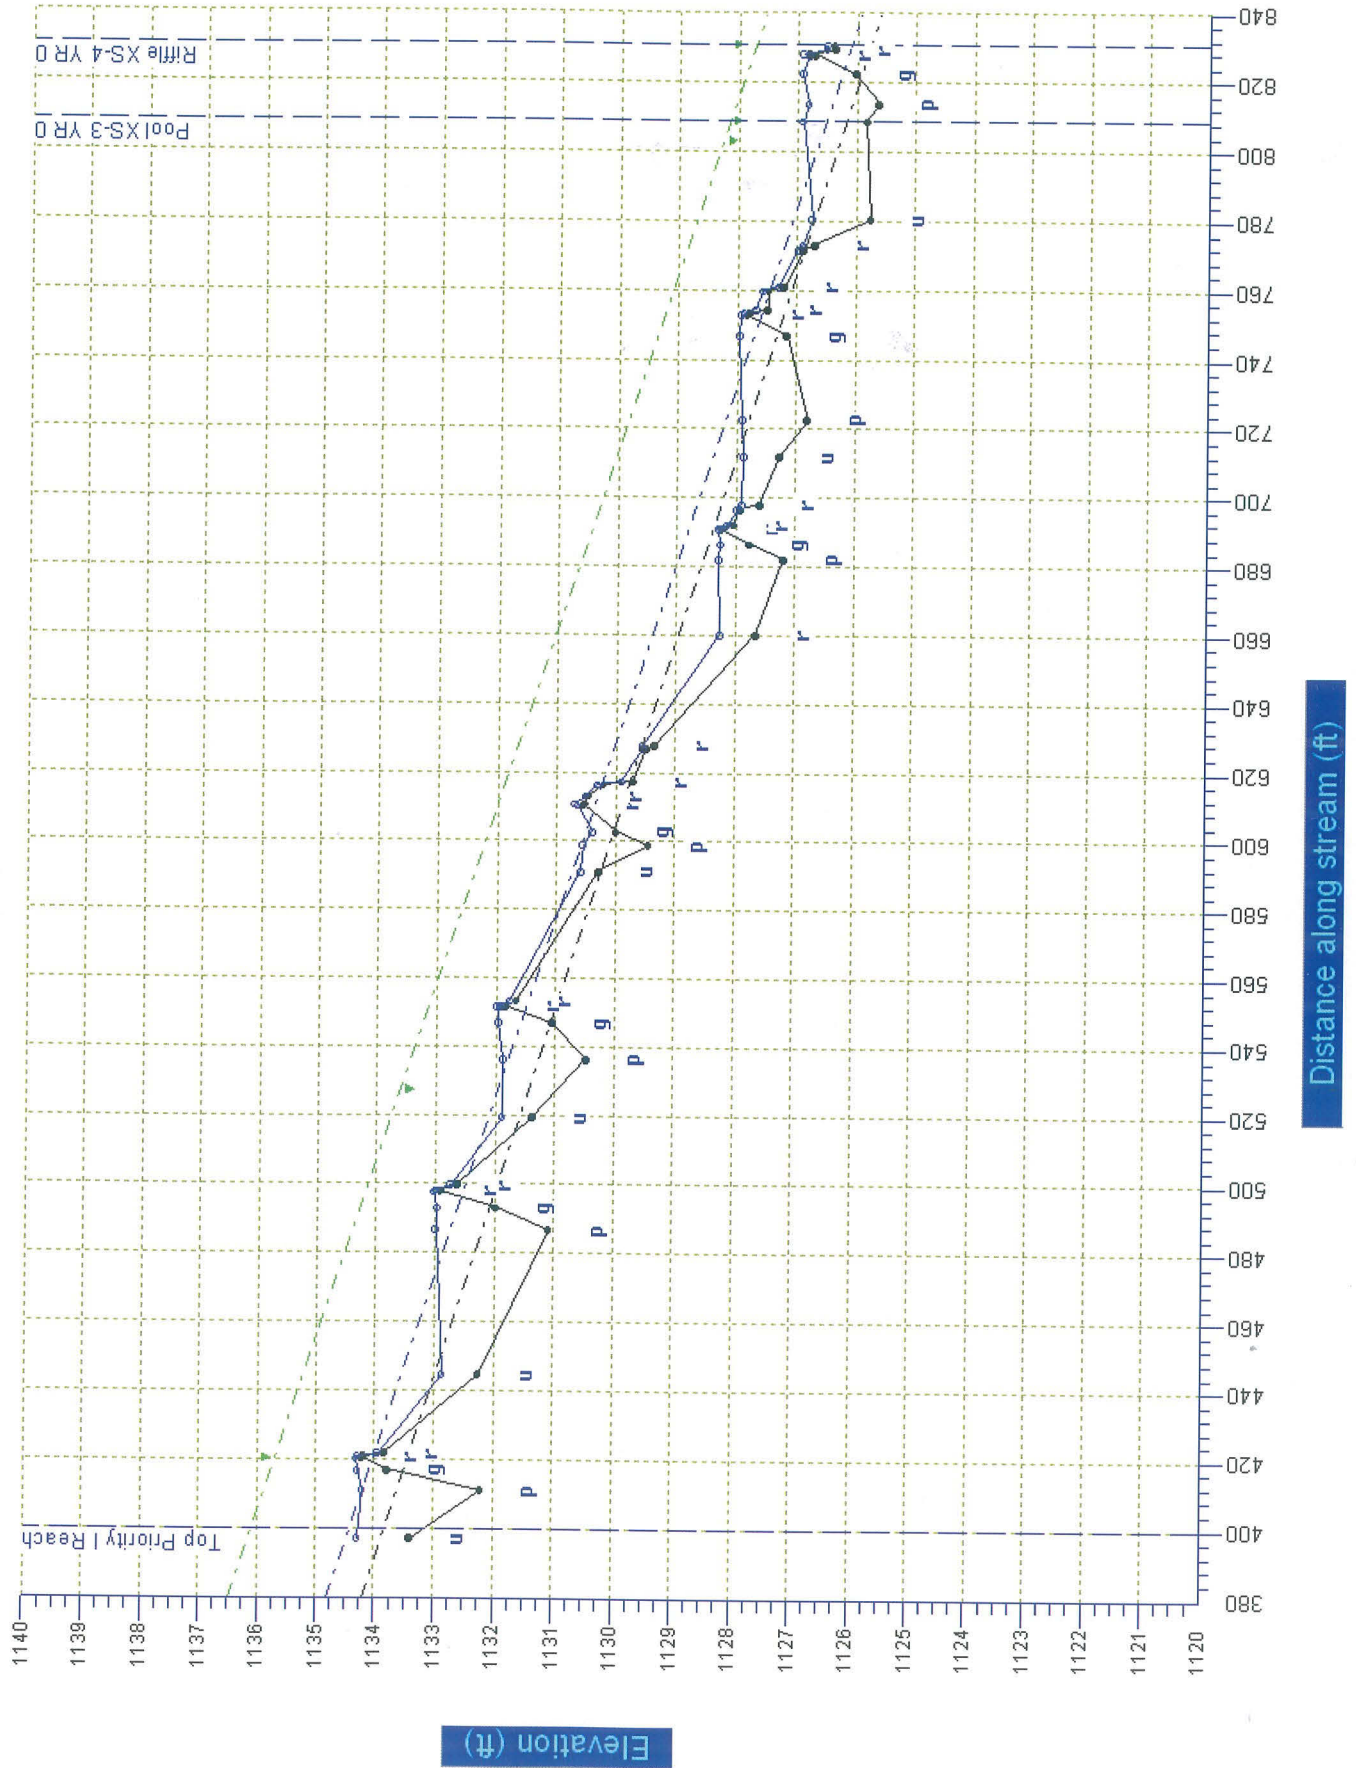
UT Restoration Reach 3+97.22 - 8+30.96 - Yr 0 - 03/26/2008

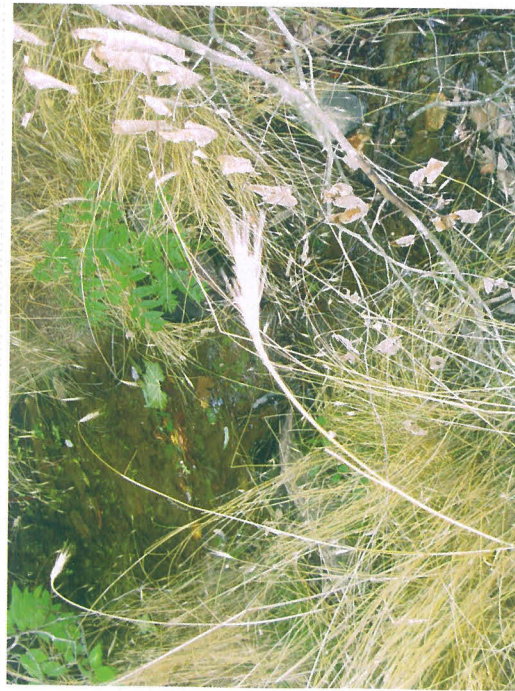
CROSS SECTION: 1

FEATURE: Pool

Cross-section photo – looking upstream

UT-1 - E2 REACH - POOL XS-1 - YR 0 - 03/26/2008

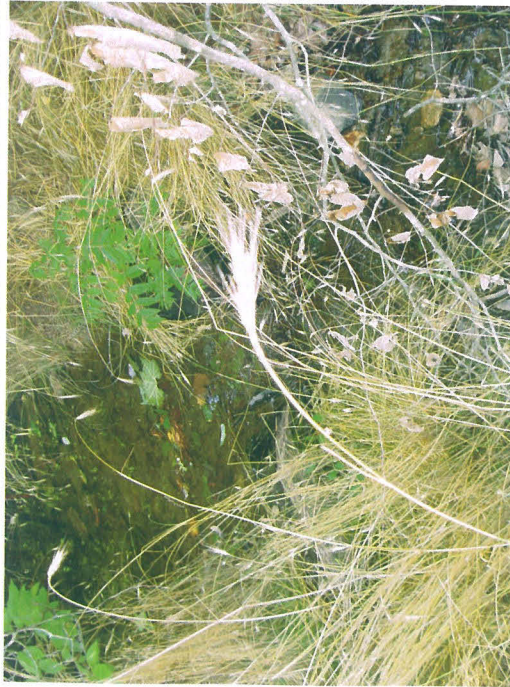
CROSS SECTION: 2

FEATURE: Riffle

Cross-section photo – looking upstream

UT-1 - E2 REACH - RIFFLE XS-2 - YR 0 - 03/26/2008
