**RESTORATION PLAN**  
**THREEMILE CREEK RESTORATION SITE**  
**AVERY COUNTY, NORTH CAROLINA**  
**(Contract #16-D06125-A)**

**FULL DELIVERY PROJECT**  
**TO PROVIDE STREAM AND WETLAND MITIGATION**  
**IN THE FRENCH BROAD RIVER BASIN**  
**CATALOGING UNIT 06010108**

September 2007

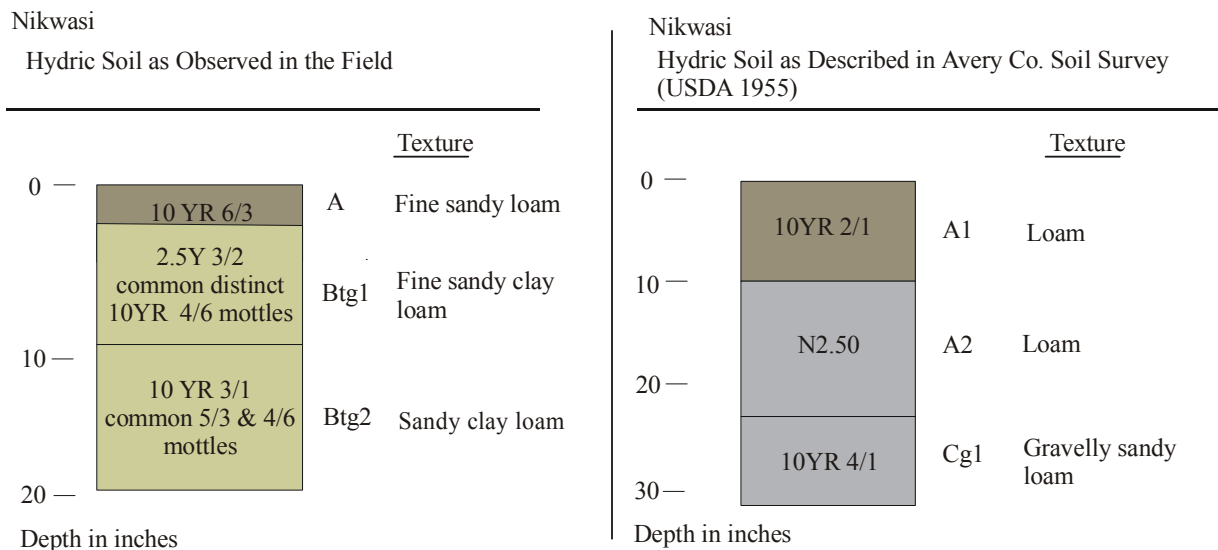
#### Soil Profiles (Boring Log)

Restorable portions of the Site are underlain by hydric Nikwasi soils. Soils have been impacted by plowing, land clearing, ditching, agricultural production, in addition to landscape alterations associated with dredging and straightening of stream channels. A typical profile is as follows.

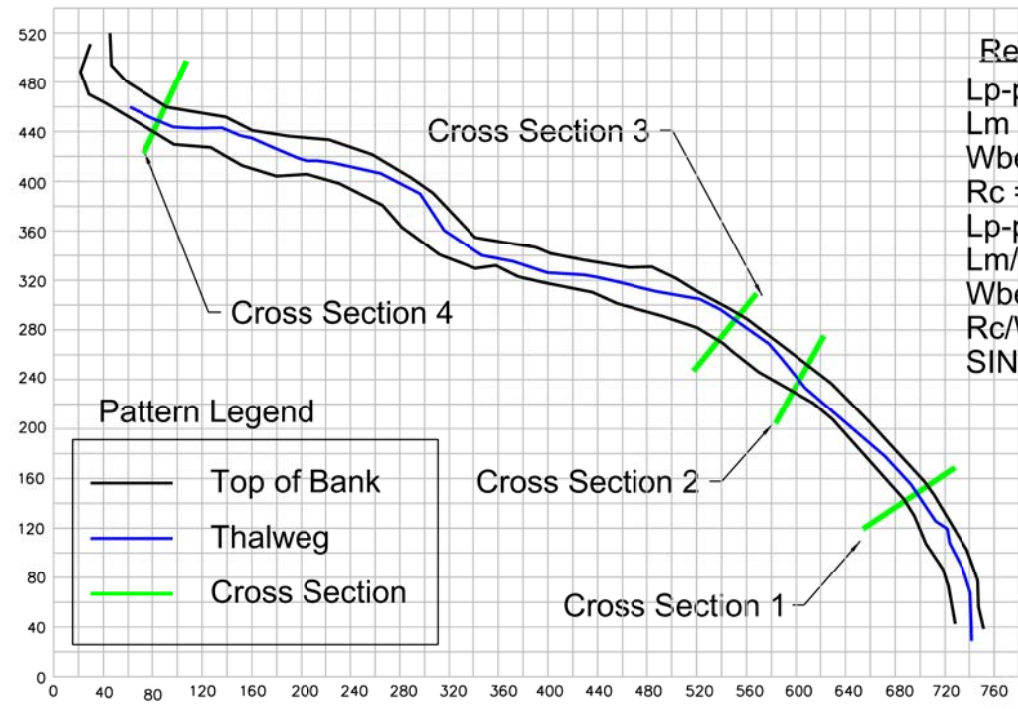
**Reference Pattern**  
 Lp-p = 104 (65 - 167) ft  
 Lm = 199 (102 - 273) ft  
 Wbelt = 46.8 (40 - 55) ft  
 Rc = 94 (62 - 312) ft  
 Lp-p/Wbkf = 3.5 (2.2 - 5.5)  
 Lm/Wbkf = 6.6 (3.4 - 9.1)  
 Wbelt/Wbkf = 1.6 (1.3 - 1.8)  
 Rc/Wbkf = 3.1 (2.1 - 10.4)  
 SIN = 1.2

Distinct bankfull indicators were present within the reference stream channels. In addition, dimension, pattern, and profile variables have not been altered or degraded, allowing for assistance with the proposed restoration reaches (Figure 5A-B, Appendix A).

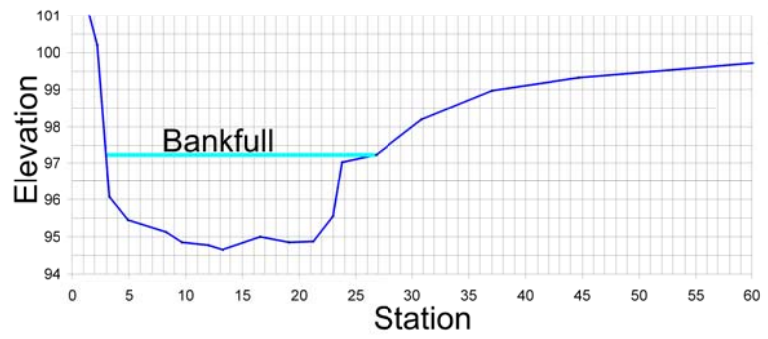
**Cross Section 1 - Pool**  
 Abkf = 44.8 ft  
 Wbkf = 23.8 ft  
 Dmax = 2.6 ft

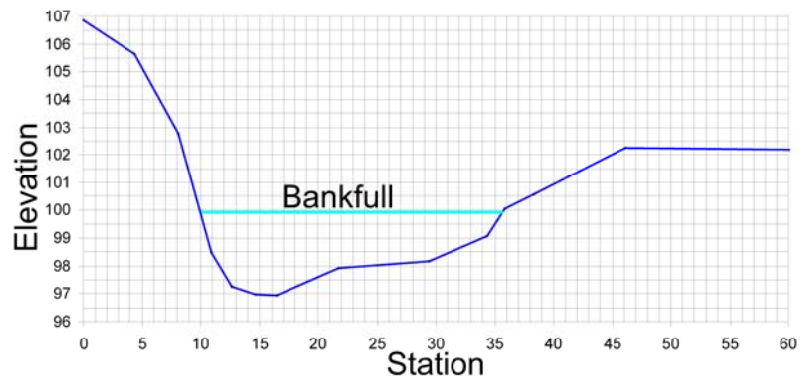
**Cross Section 3 - Pool**  
 Abkf = 41.8 ft  
 Wbkf = 25.0 ft  
 Dmax = 2.7 ft

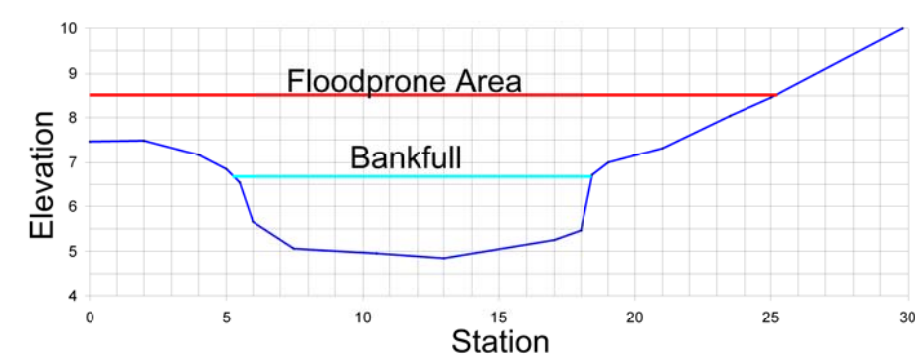
**Cross Section 1 - Riffle**  
 Abkf = 20.4 ft  
 Dave = 1.5 ft  
 Wbkf = 13.2 ft  
 Dmax = 1.9 ft  
 Bank Height = 1.9 ft  
 W/D = 8.5  
 FPA = 75  
 ENT = 5.7  
 Stream Type = E

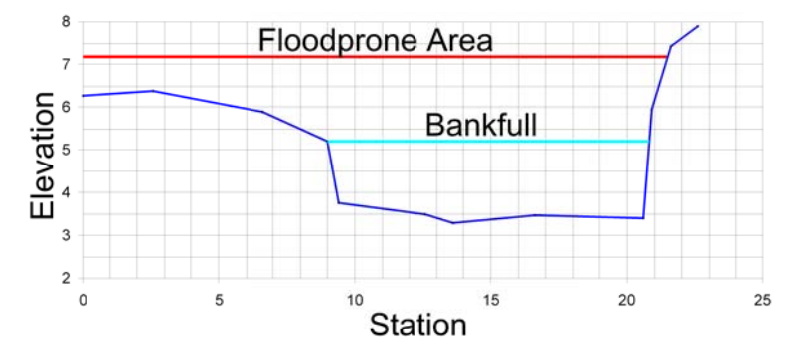
**Cross Section 2 - Riffle**  
 Abkf = 19.9 ft  
 Dave = 1.7 ft  
 Wbkf = 11.8 ft  
 Dmax = 1.9 ft  
 Bank Height = 1.9 ft  
 W/D = 7.0  
 FPA = 75  
 ENT = 6.3  
 Stream Type = E

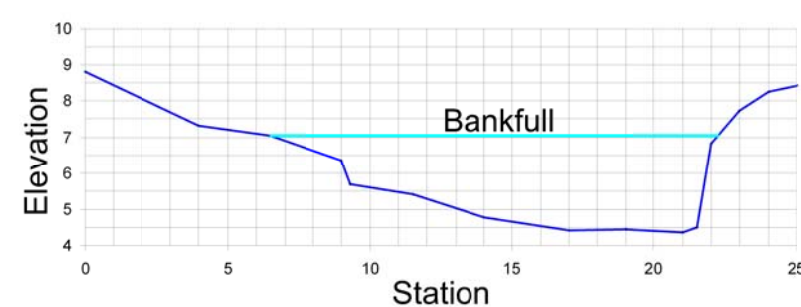
**Cross Section 3 - Pool**  
 Abkf = 29.2 ft  
 Wbkf = 15.7 ft  
 Dmax = 2.7 ft

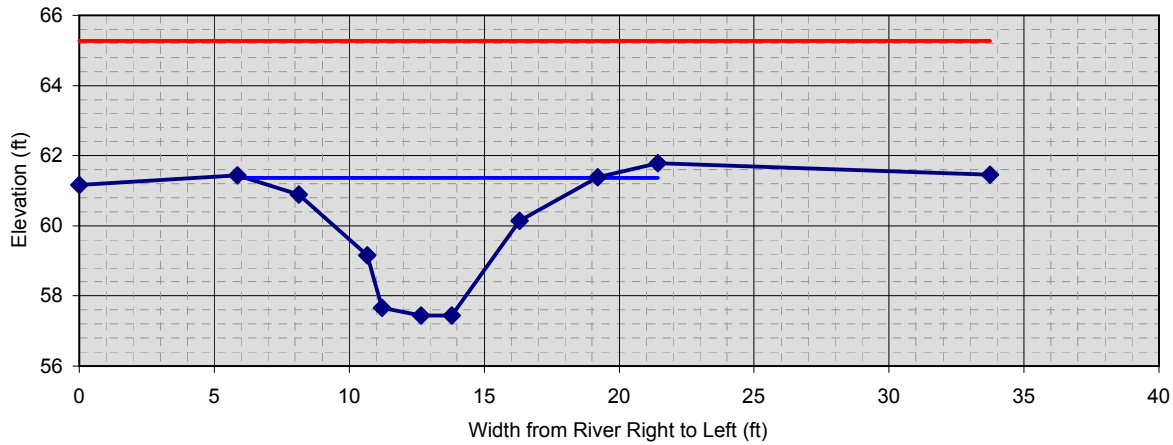
Three Mile Site (Fork Creek)- Cross Section 52 Riffle ---

description: Three Mile Site (Fork Creek)- Cross Section 52  
height of instrument (ft): 90.00
