# THUNDER MITIGATION SITE

**As-built & Baseline Monitoring Report  
Wayne County, North Carolina  
Neuse River Basin - 03020201**

DMS Project ID No. 100185  
Full Delivery Contract No. 0402-02  
DWR Project No. 2021 0018 v3  
USACE Action ID No. SAW-2021-01102  
RFP No. 16-20200402

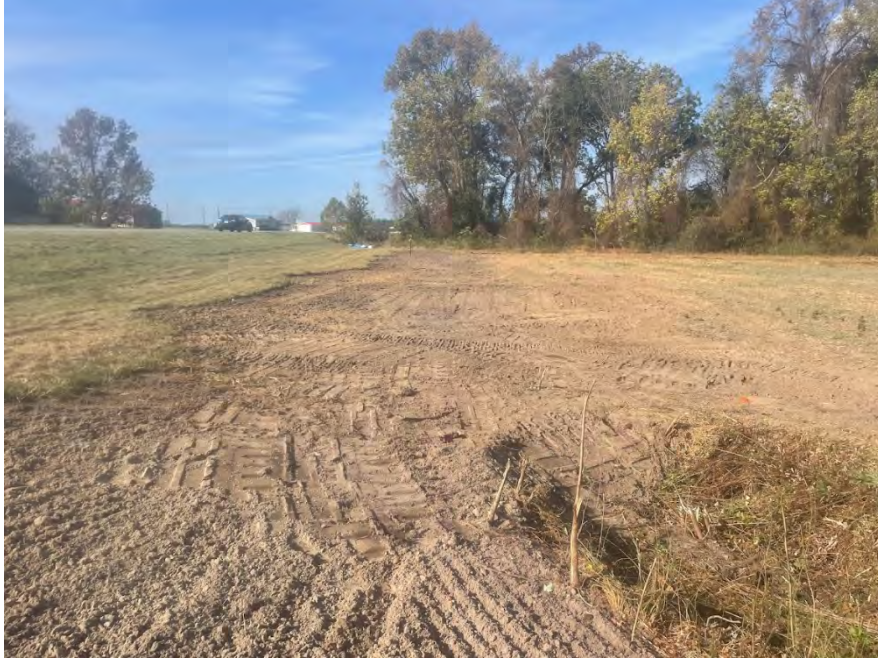
**Photo 1: Upper portion of Feature 1C (ditch) filled in, facing west. November 9, 2022**

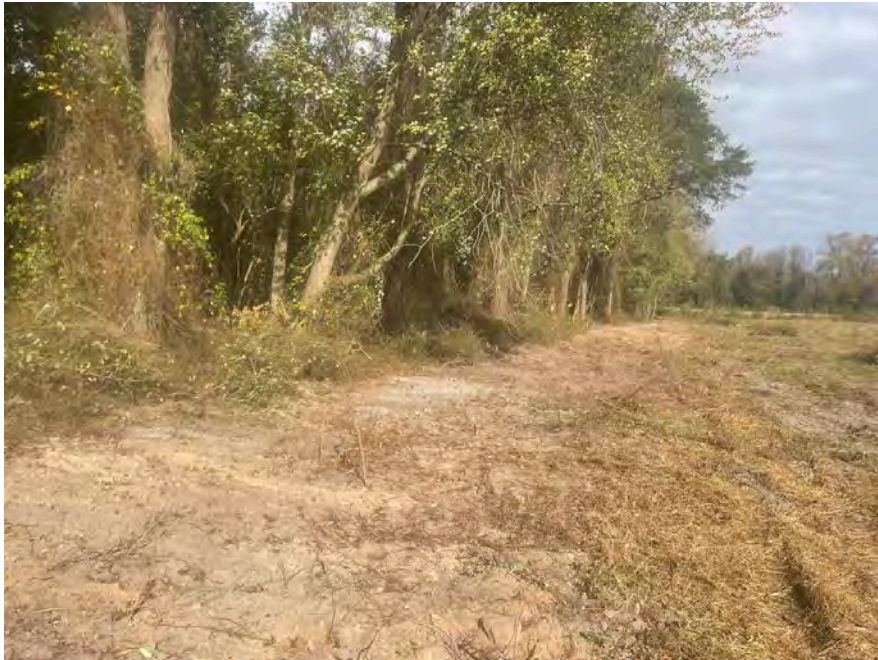
**Photo 2: Ditch adjacent to Feature 2 filled in, facing north. November 9, 2022**

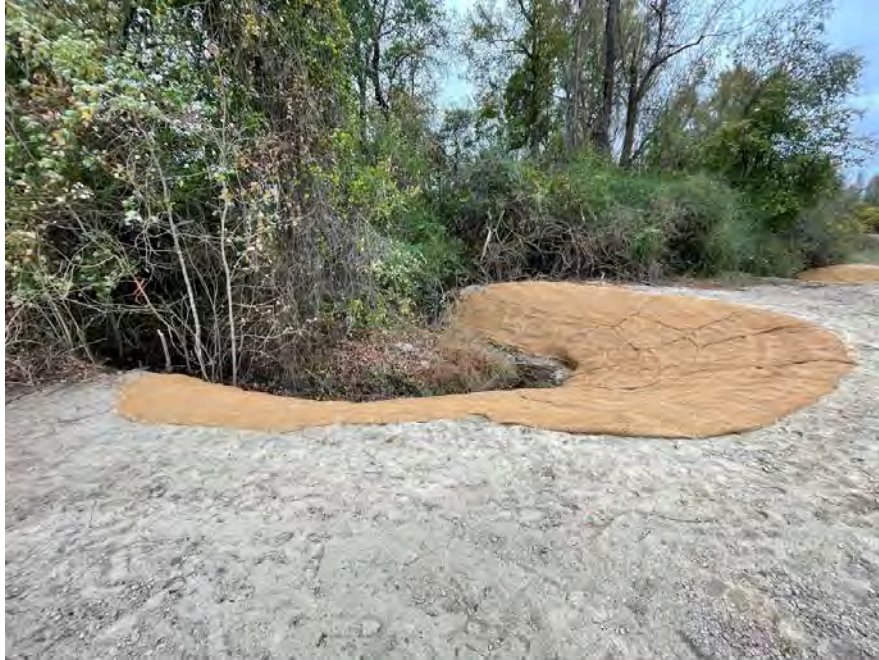
**Photo 3: Bank Stabilization on Feature 4, facing north. November 9, 2022**

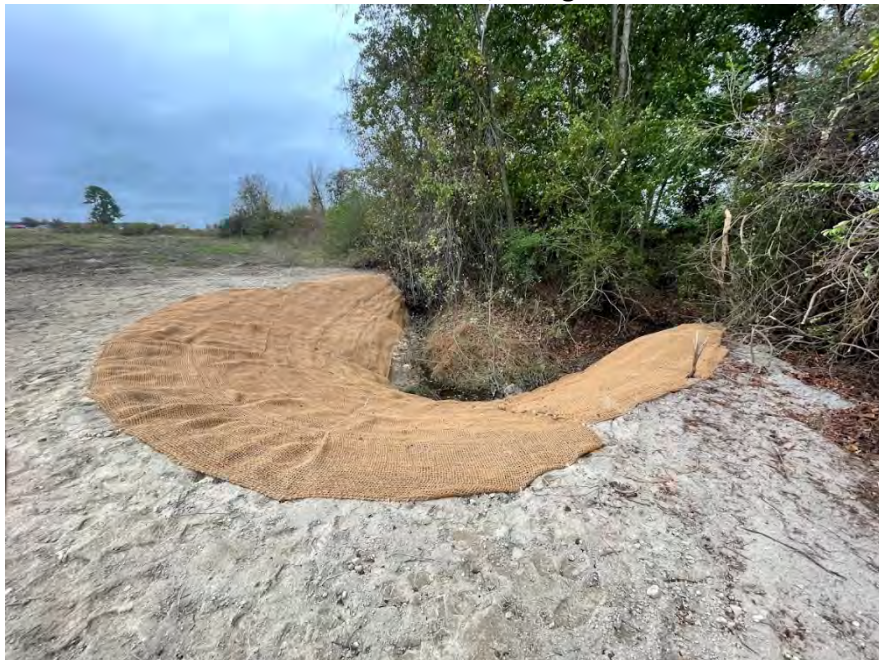
**Photo 4: Bank Stabilization on Feature 4, facing south. November 9, 2022**

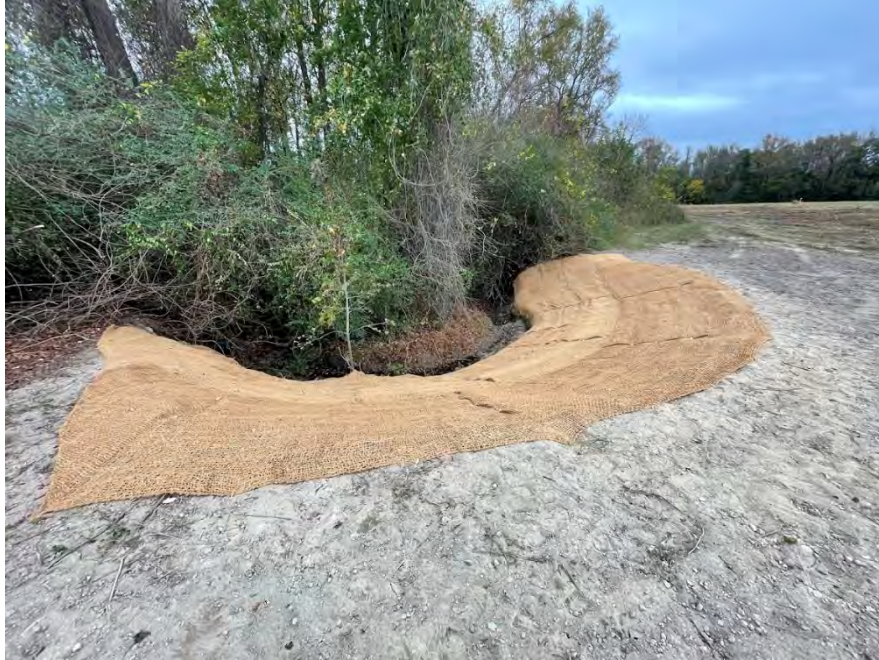
**Photo 5: Bank Stabilization on Feature 4, facing north. November 9, 2022**

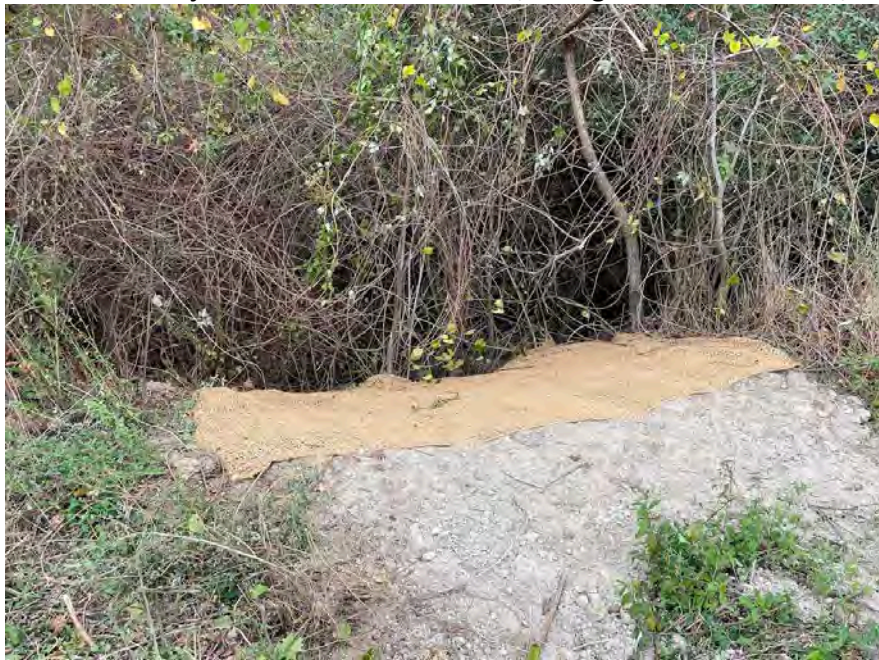
**Photo 6: Ditch adjacent to Feature 2 filled in, facing west. November 9, 2022**

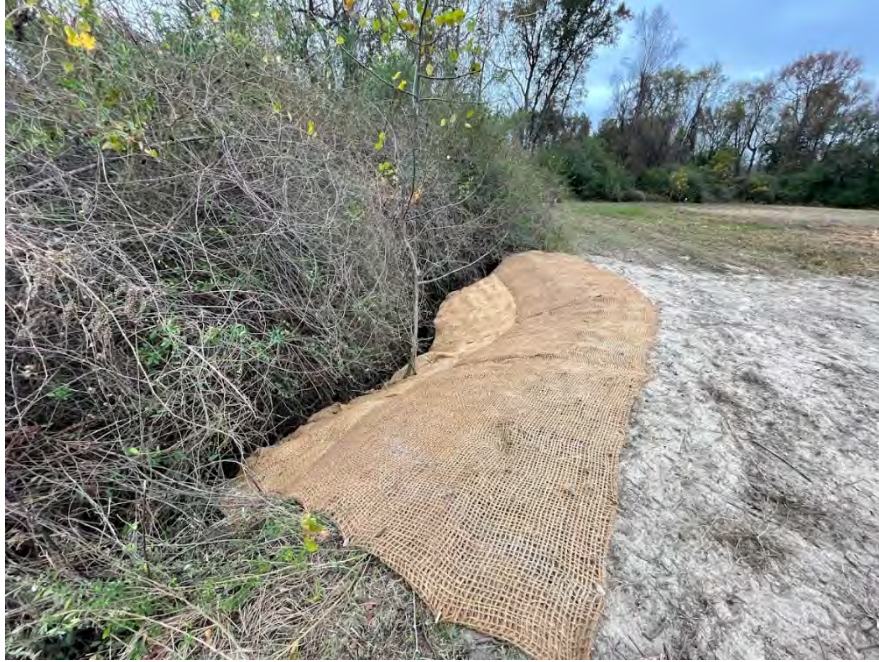
**Photo 7: Ditch adjacent to Feature 2 filled in, facing north. November 9, 2022**

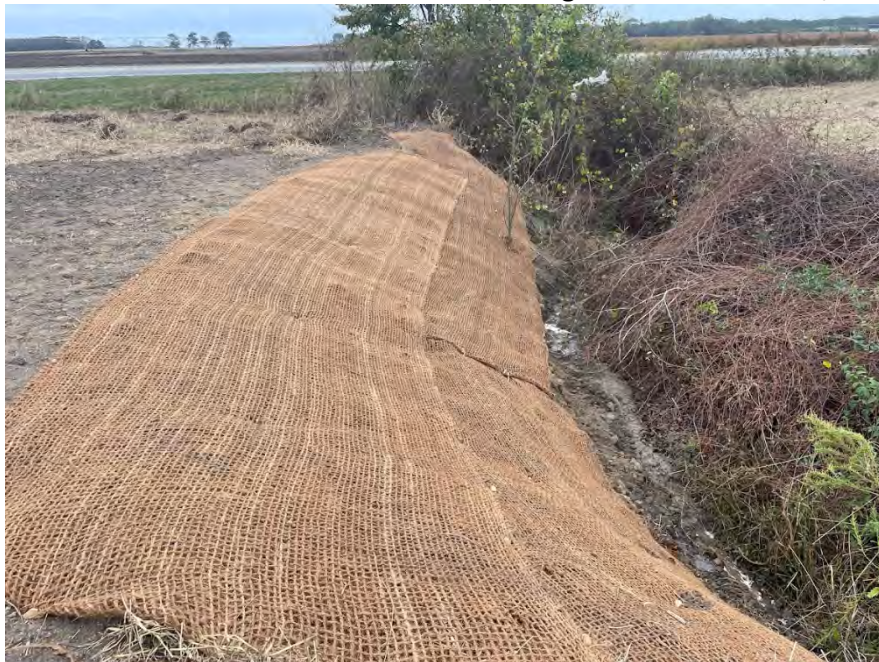
**Photo 8: Bank Stabilization on Feature 5, facing south. November 9, 2022**

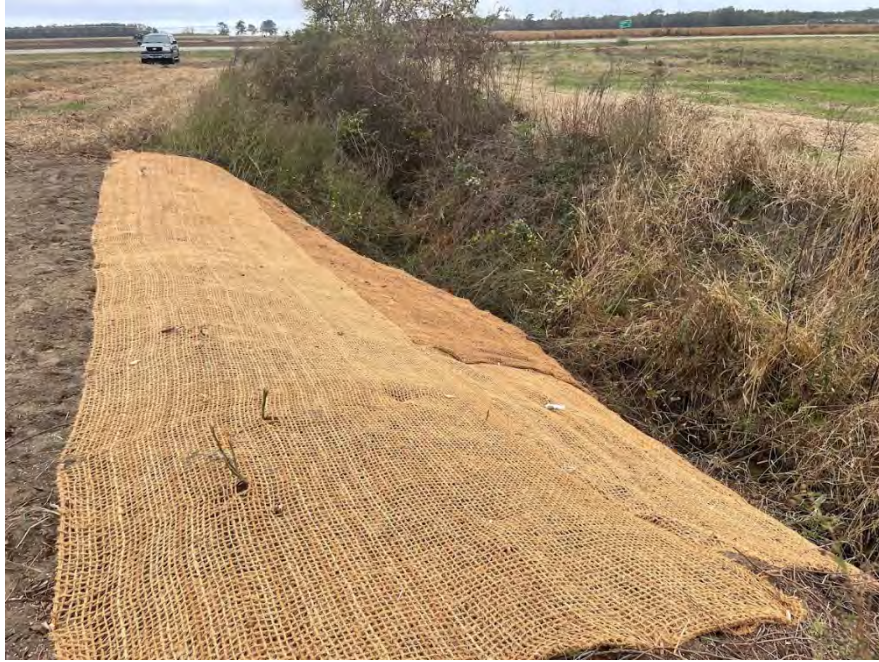
**Photo 9: Bank Stabilization on Feature 5, facing south. November 9, 2022**

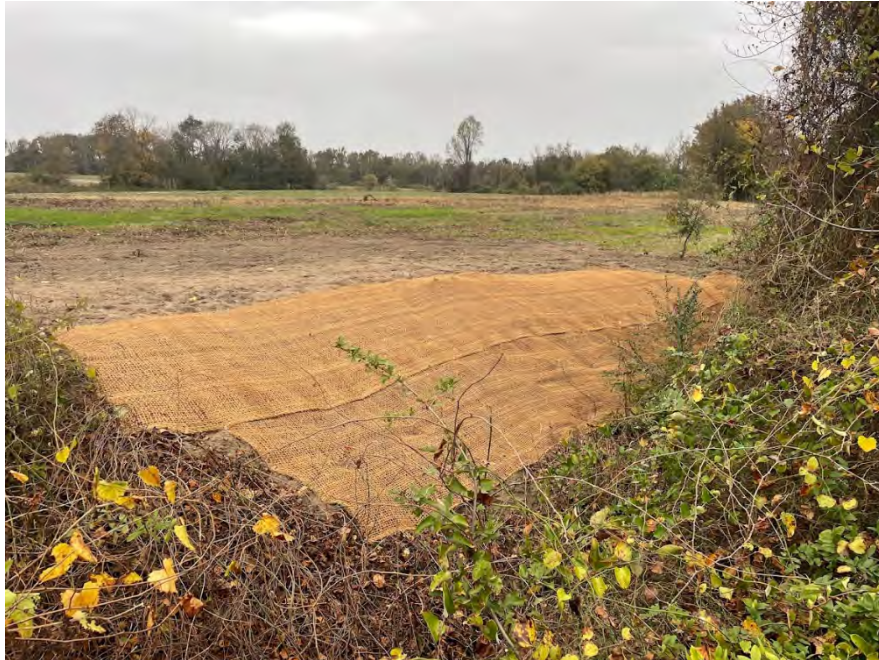
**Photo 10: Bank Stabilization on Feature 5, facing northwest. November 9, 2022**

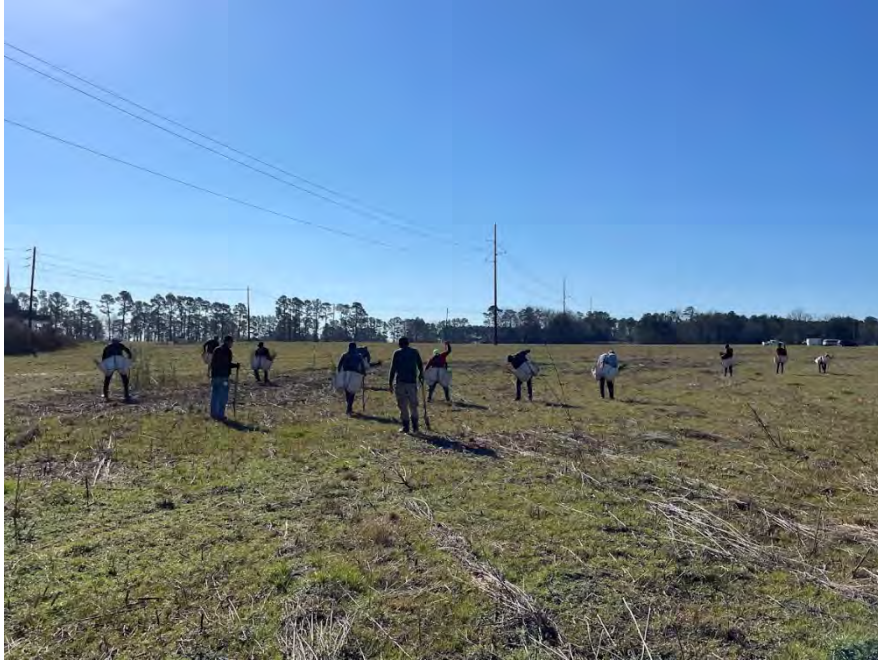
**Photo 11: Planting Bareroots. February 6, 2023**

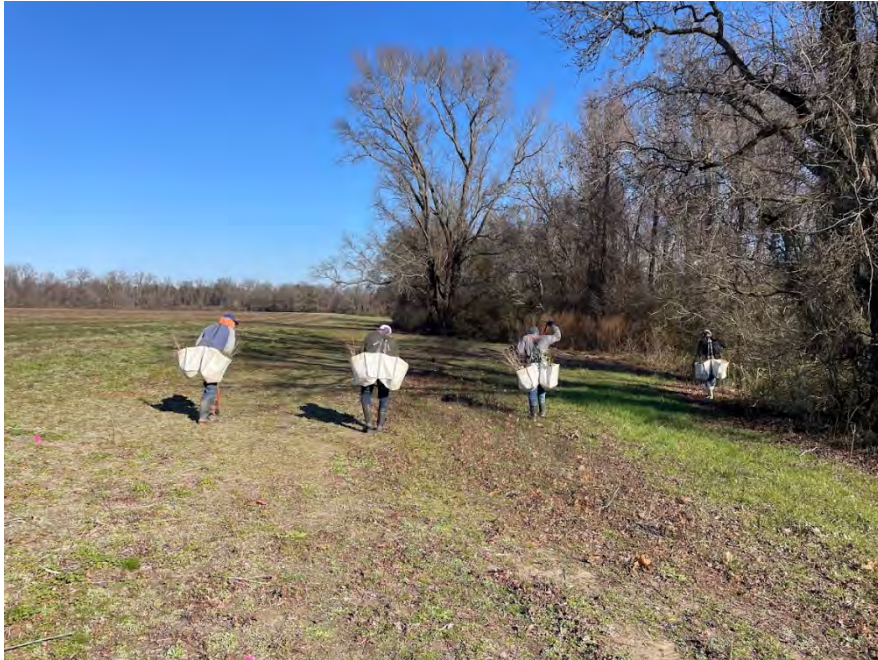
**Photo 12: Planting Bareroots. February 6, 2023**

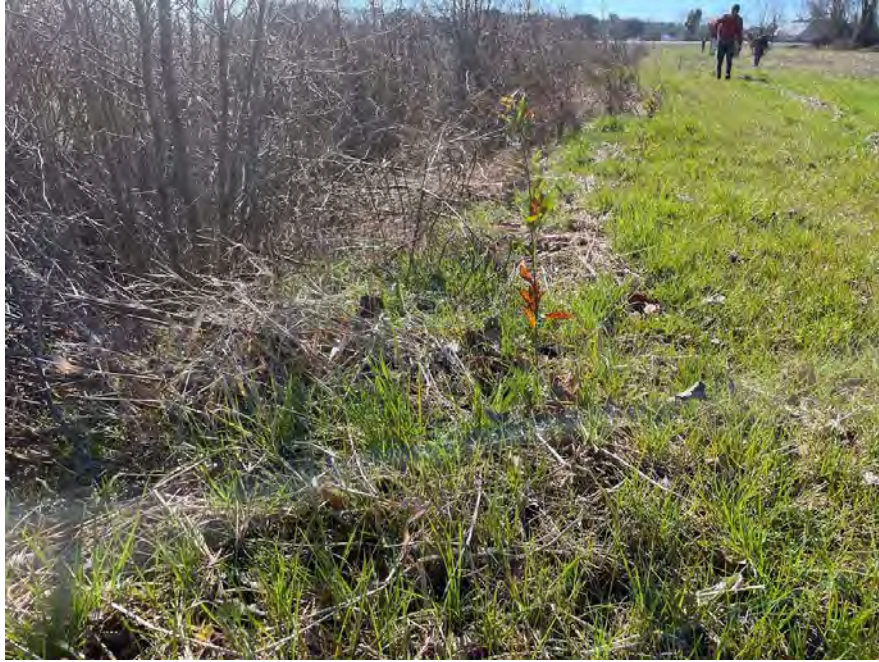
**Photo 13: Planting Bareroots. February 6, 2023**

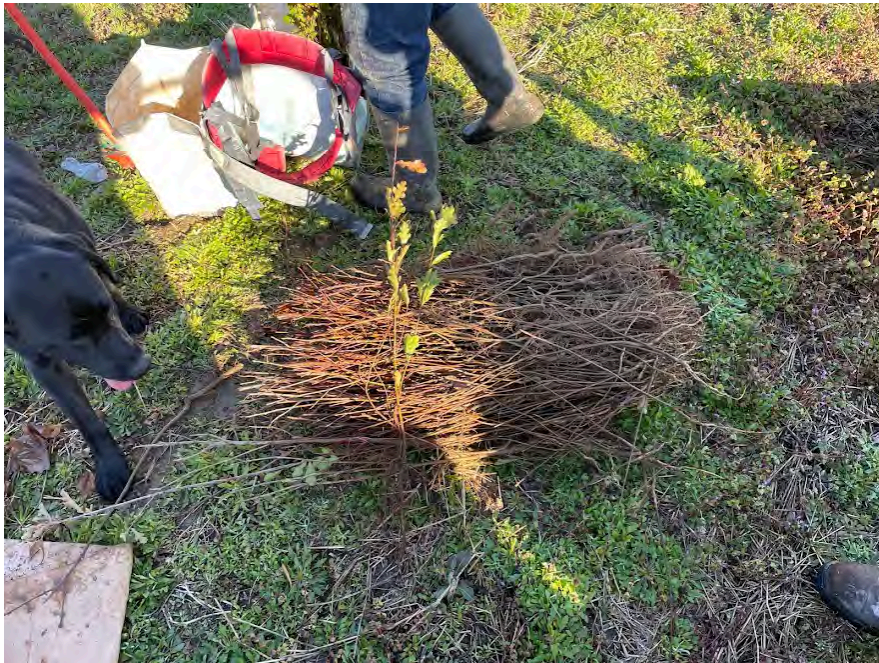
**Photo 14: Planting Bareroots. February 6, 2023**

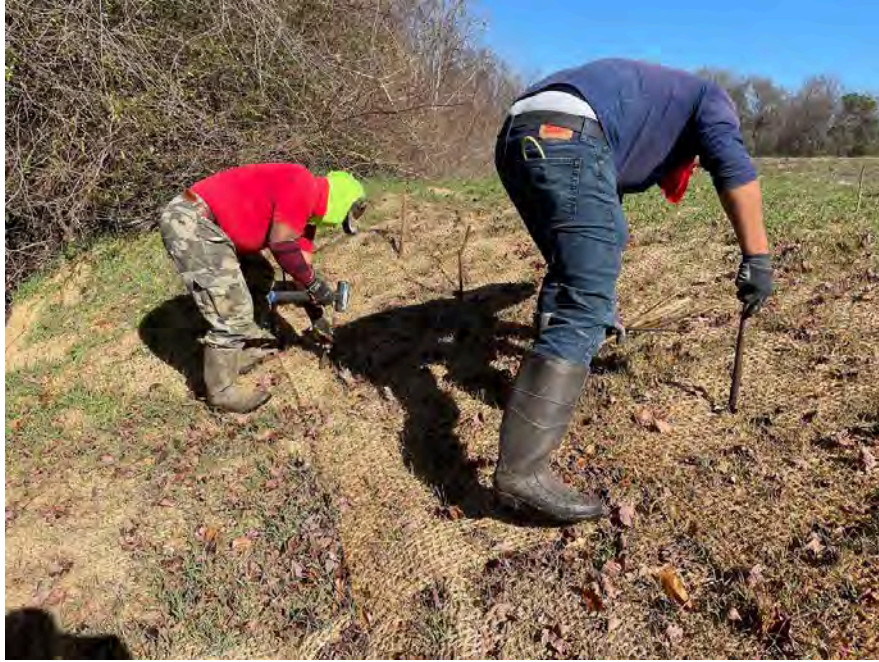
**Photo 15: Planting Livestakes. February 6, 2023**

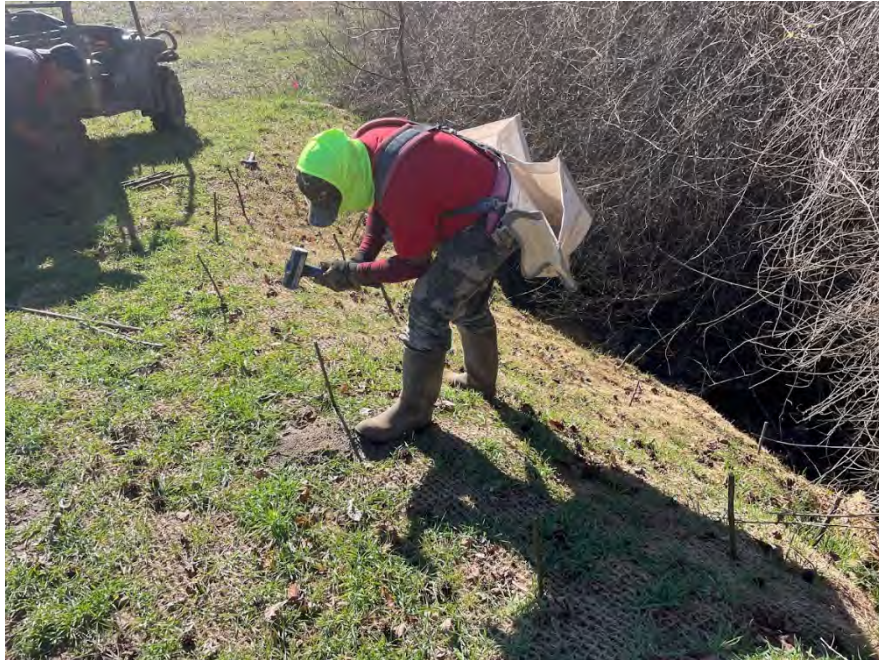
**Photo 16: Planting Livestakes. February 6, 2023**
