# THUNDER MITIGATION SITE

**Year 1 (2023) Monitoring Report**  
**Wayne County, North Carolina**  
**Neuse River Basin - 03020201**

DMS Project ID No. 100185  
Full Delivery Contract No. 0402-02  
DWR Project No. 2021 0018 v3  
RFP No. 16-20200402

**FINAL  
MY1 (2023) MONITORING REPORT**

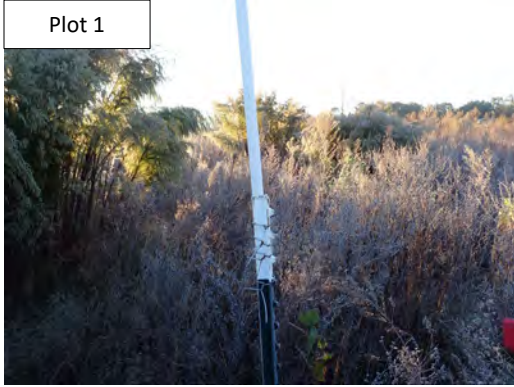
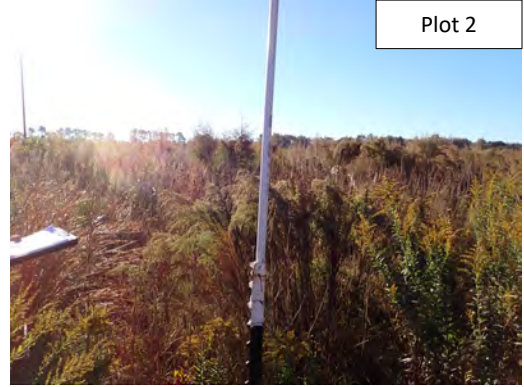
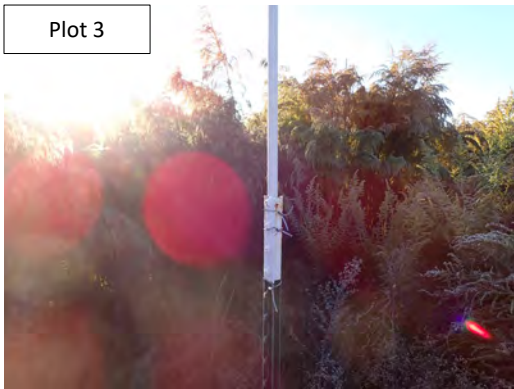
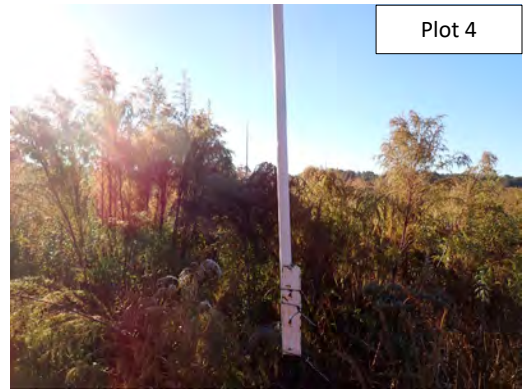
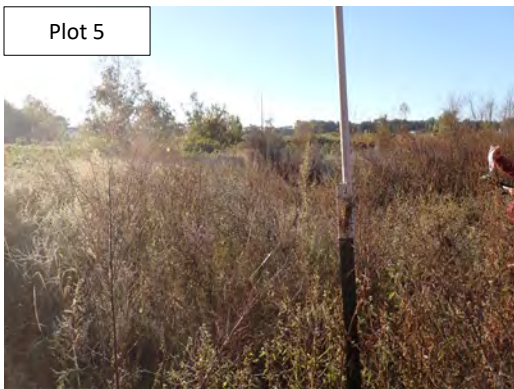
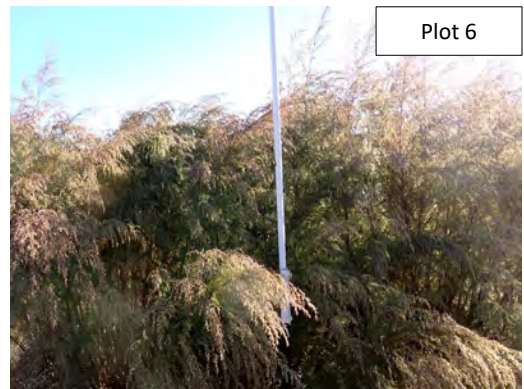
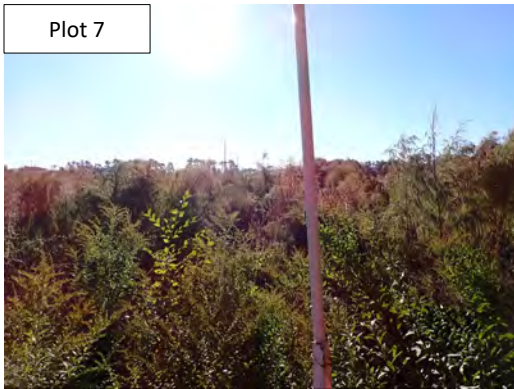
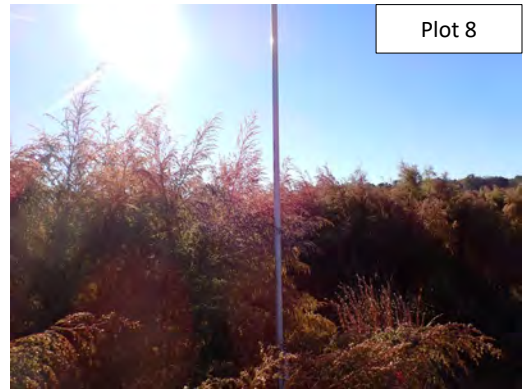
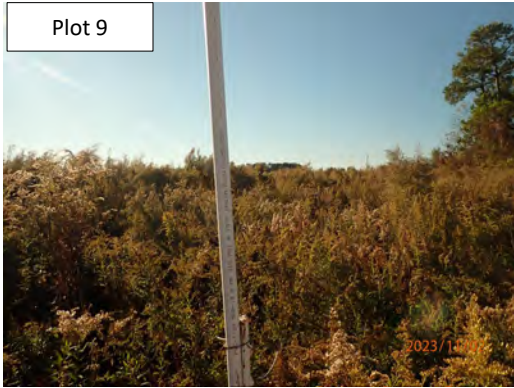
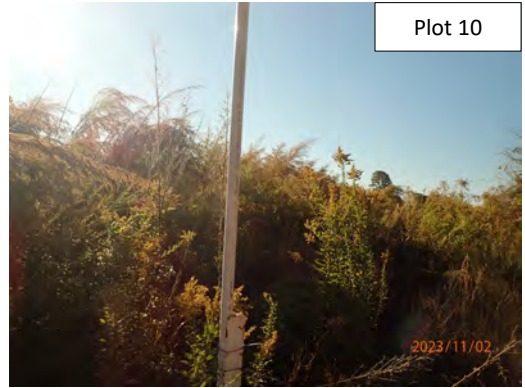
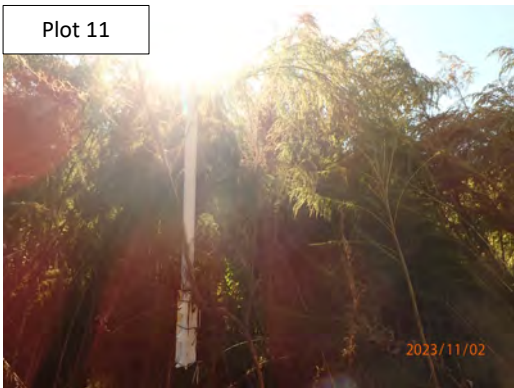
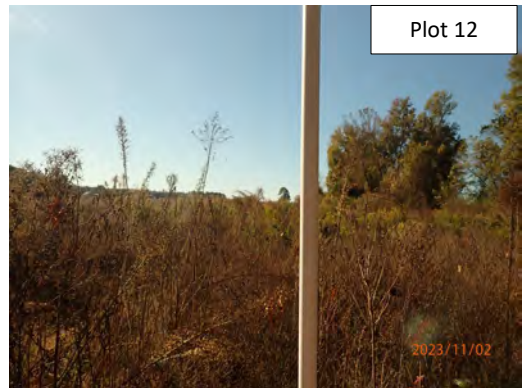
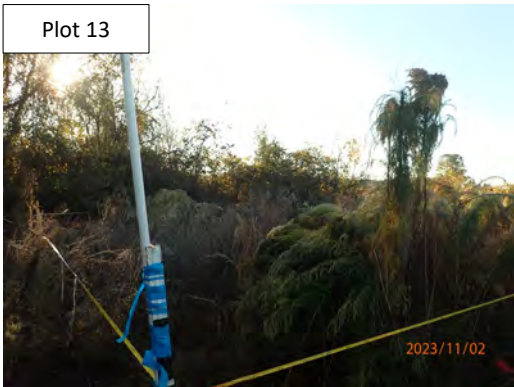
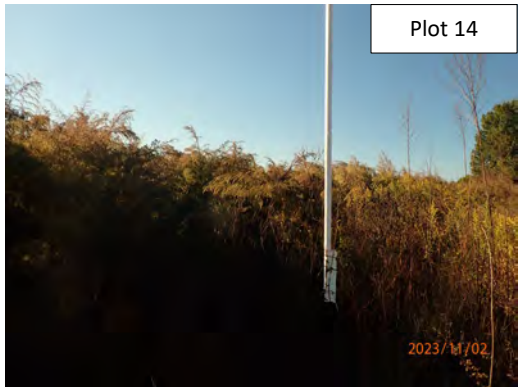
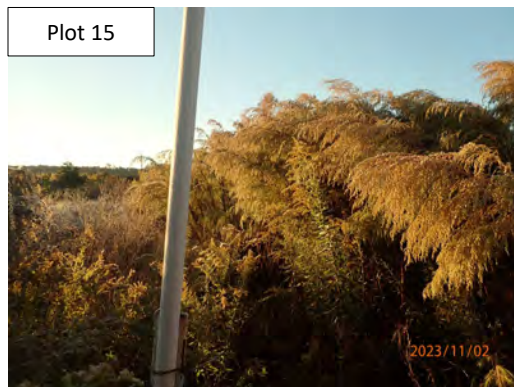
Thunder Swamp  
MY1 (2023) Vegetation Monitoring Photographs (taken November 2023)

- Measurements of the 15 vegetation plots resulted in an average of 413 planted stems/acre. Fourteen of the fifteen individual plots met success criteria. Plot 5 was just 2 stems shy of meeting success criteria.

Year 1 (2023) data was collected on November 1-2, 2023, by Axiom Environmental and derived an average planted stem density of 413 stems per acre. Additionally, all but one of the individual plots met success criteria. Plot 5 was just 2 stems shy of meeting success criteria. Appendix B includes Year 1 (2023) vegetation plot photographs along with planted and total stem counts.

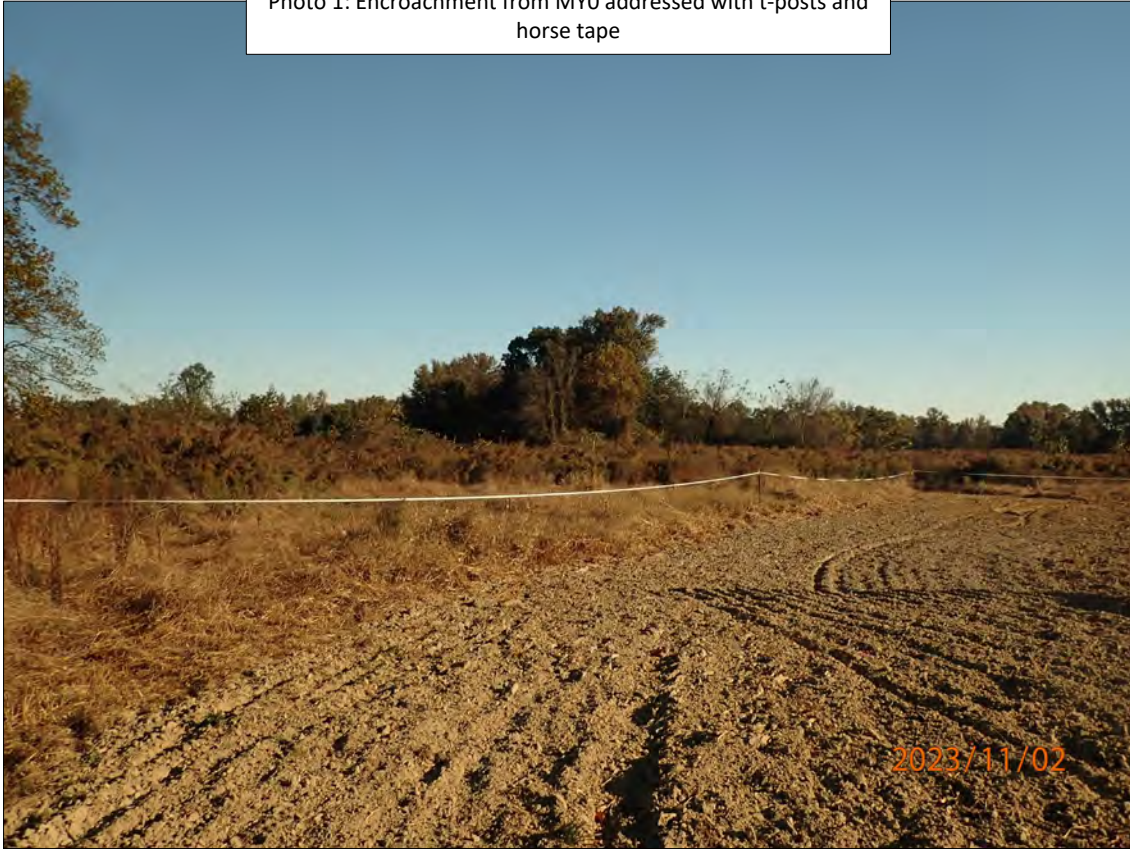
Photo 1: Encroachment from MY0 addressed with t-posts and horse tape

- Encroachment by the tenant farmer occurred in multiple locations around the Site totaling 0.7 acres. Restoration Systems (RS) met with the tenant farmer to remediate the encroached areas. RS added extra t-post and horse tape along encroached boundaries. RS replanted these areas in Q1 2024 with mitigation plan-approved species while planting the Thunder Phase B Site. Upgraded, high-visibility markings were installed around both Thunder and Thunder Phase B sites to prevent encroachment from occurring in Q1 2024 as well.
- No evidence of nuisance animal activity (i.e., heavy deer browsing, beaver activated, etc.) was observed.

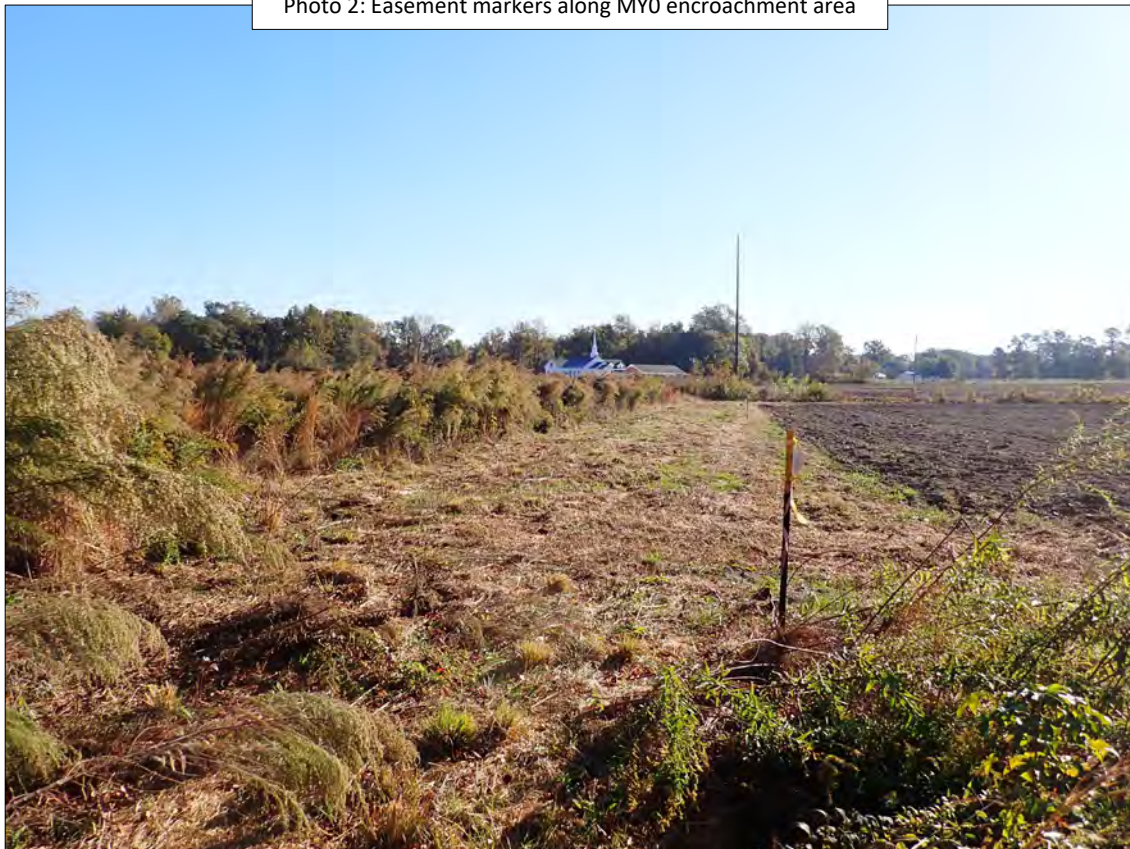
Photo 2: Easement markers along MY0 encroachment area

*phellos*). Photo documentation of the planting will be added to the MY2 (2024) report. Photos of the additional easement marking are provided in Appendix A. Locations of the encroachment are depicted in Figure 2 (Appendix A).

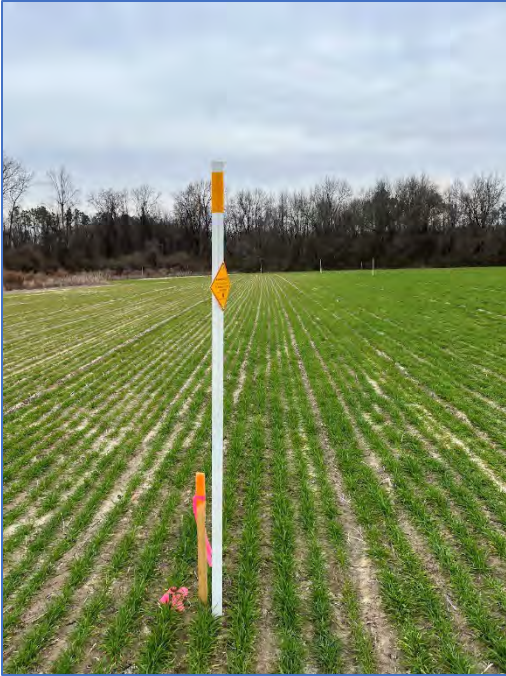
1. High Visibility Witness post, typical

- Install a witness post with sign at each corner monument where signs are missing or not positioned immediately adjacent to the monument.  
*Response: Additional witness posts were added as requested.*
- Upgrade sign fasteners to a material that is likely to meet the longevity specifications in the marking requirements. Partially driven 16d aluminum nails are frequently used to allow room for the tree to grow without compromising the easement signs.  
*Response: Fasteners were upgraded as requested. See photos at end for typical.*

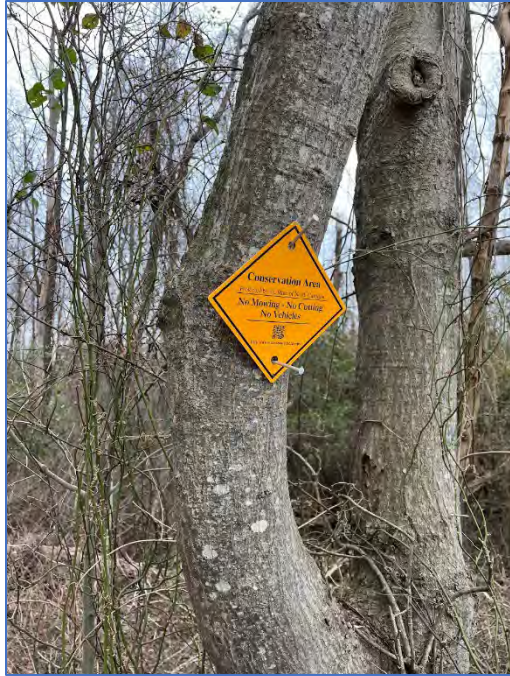
2. Additional in-line marking, typical

- Install missing in-line markings and consider decreasing the spacing to promote visibility in densely vegetated areas.  
*Response: Additional in-line markings were added as requested. In some dense areas visibility is still limited, however these are considered at low-risk for encroachment due to lack of access.*

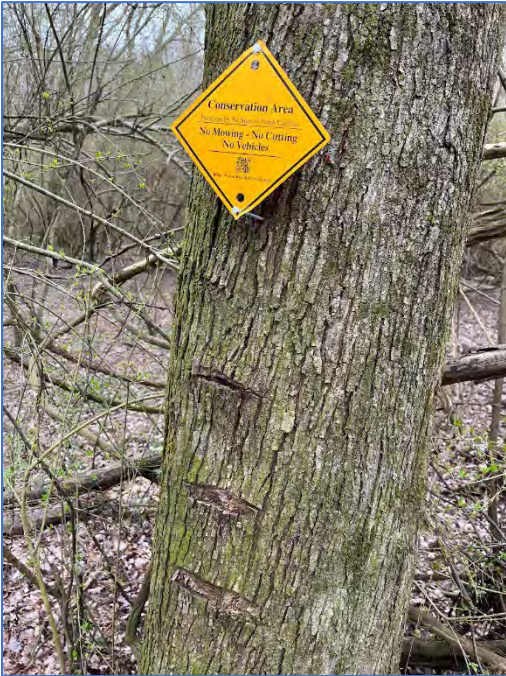
3. Upgraded fasteners, typical

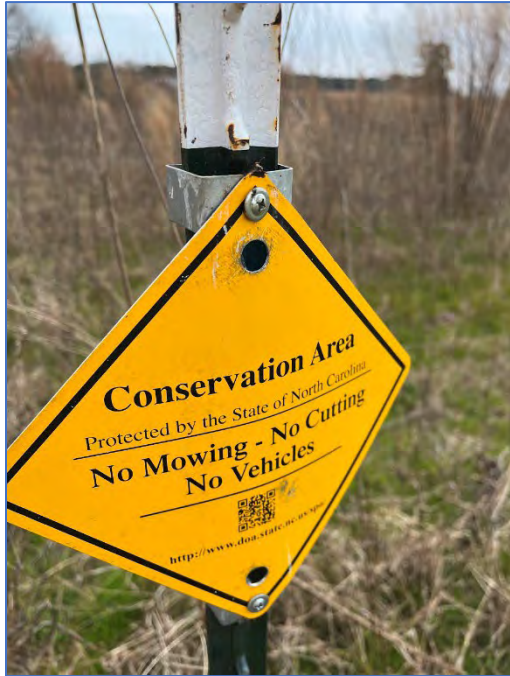
4. Upgraded sign clip, typical

- A high failure rate was observed onsite where plastic insulators were used to attach the easement signs to the T-posts. These fasteners should also be upgraded.  
*Response: Plastic insulators were replaced with metal clips. See photos at end for typical.*

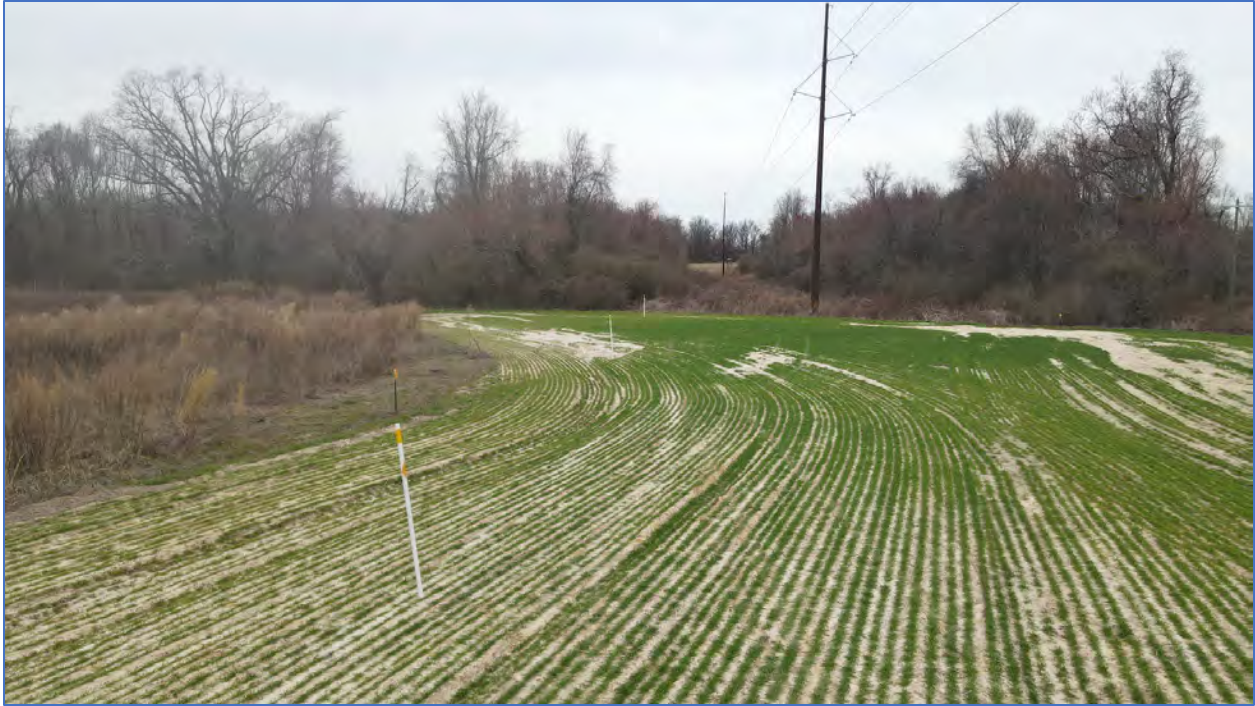
5. Additional markings bordering utility corridor.

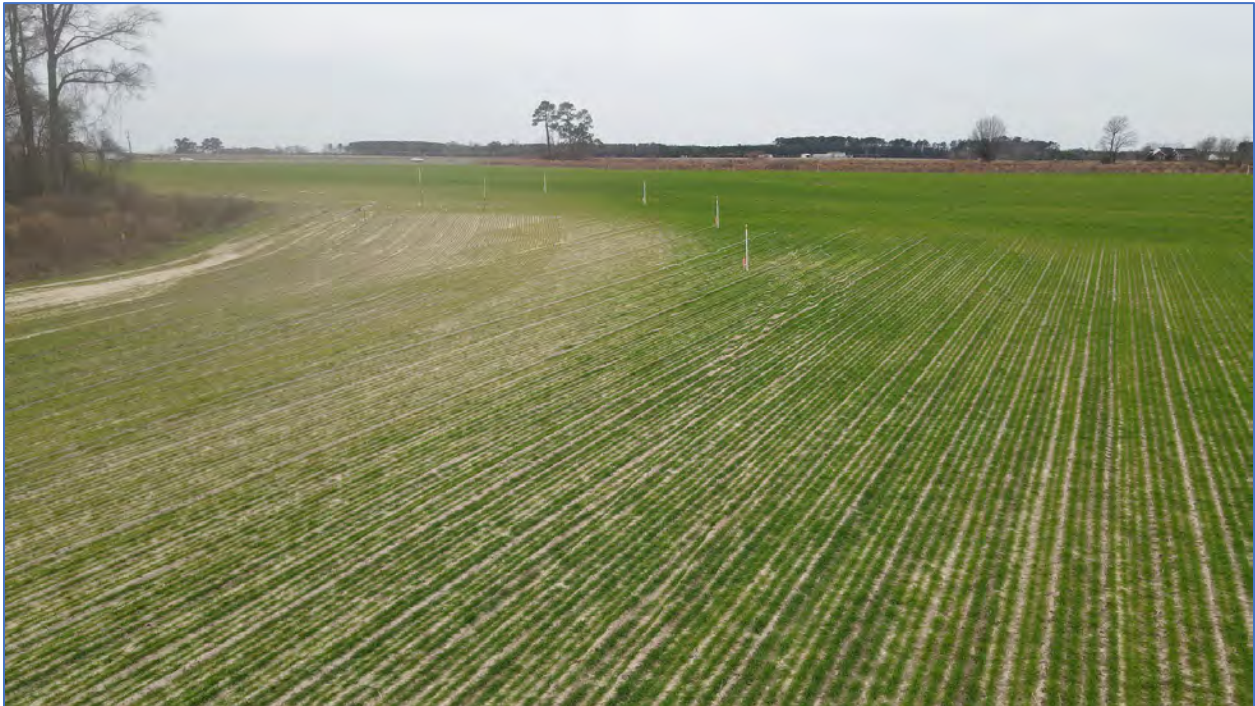
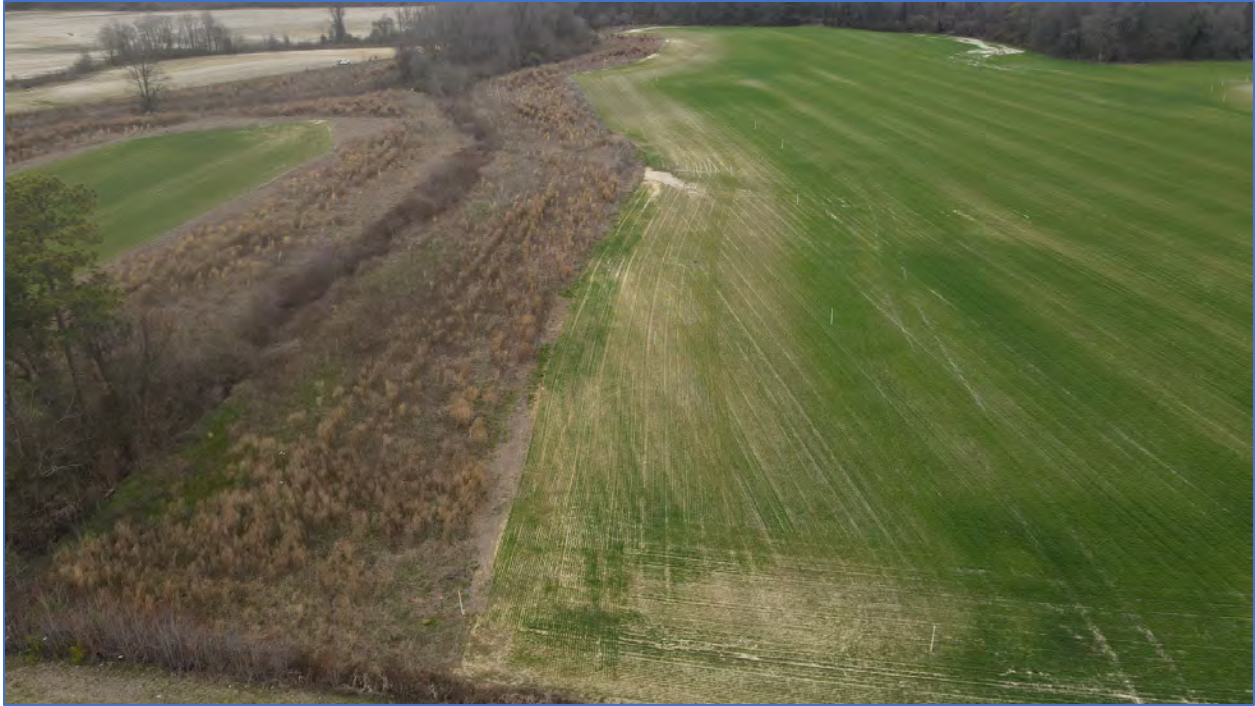
6. High visibility posts along ag field along Phase B easement outside of original easement.

7. High visibility posts along ag field along Phase B easement outside of original easement.

- Supplemental boundary markings should be installed as necessary to prevent encroachment.  
*Response: Noted. Higher visibility poles were used to mark the Thunder Phase B easement which borders this easement, as well as sections of this easement which border farm fields.*

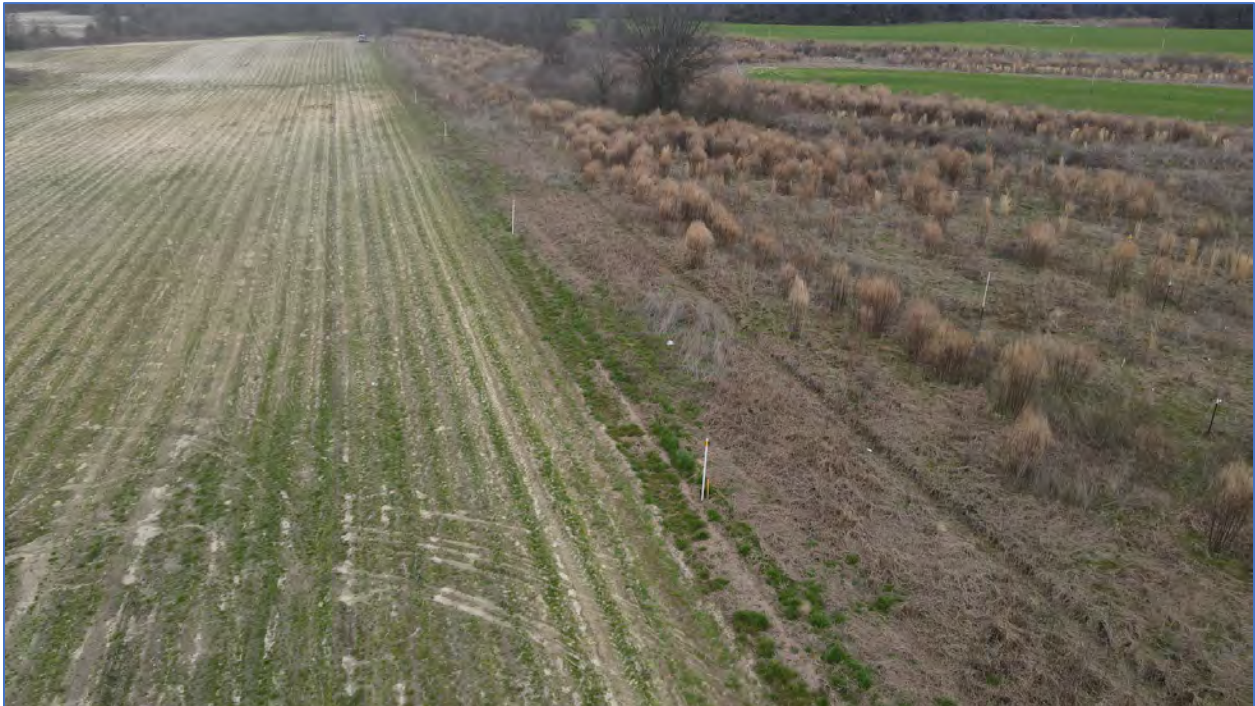
8. High visibility posts along ag field at boundary where re-planting occurred.

Shortly after planting, the farmer encroached along the edges of the easement in nine separate areas (totaling 0.7 acres) while preparing the fields adjacent to the easement for row-crop planting. RS discussed the encroachment with the farmer by phone on May 18, 2023, and scheduled a site visit with the farmer to review the encroachment areas. On June 12, 2023, RS met with the farmer to ensure that row crop planting was performed outside the easement. Also, the easement boundary was walked with the farmer and no further evidence of easement encroachment was observed. On June 15, 2023, and October 17, 2023, RS installed additional T-posts, easement placards, and horse tape along areas of extreme encroachment to ensure diffuse flow into the buffer. Additionally, RS will replant 450 bare roots during the 2024 dormant season within the 0.7 acres of encroachment. Species from the approved Mitigation Plan will be used, including a minimum of five of the following species: black gum (*Nyssa sylvatica*), redbud (*Cercis canadensis*), persimmon (*Diospyros virginiana*), sycamore (*Platanus occidentalis*), tulip poplar (*Liriodendron tulipifera*), water oak (*Quercus nigra*), red oak (*Quercus rubra*), and willow oak (*Quercus*
