# THUNDER PHASE B NUTRIENT OFFSET SITE

**As-built & Baseline Monitoring Report  
Wayne County, North Carolina  
Neuse River Basin - 03020201**

DMS Project ID No. 100651  
Full Delivery Contract No. 519674731-03  
DWR Project No. 2021-0018 v2  
RFP No. 16-519674731

Baseline Data Collected: February 2024  
Date Submitted: March 2024

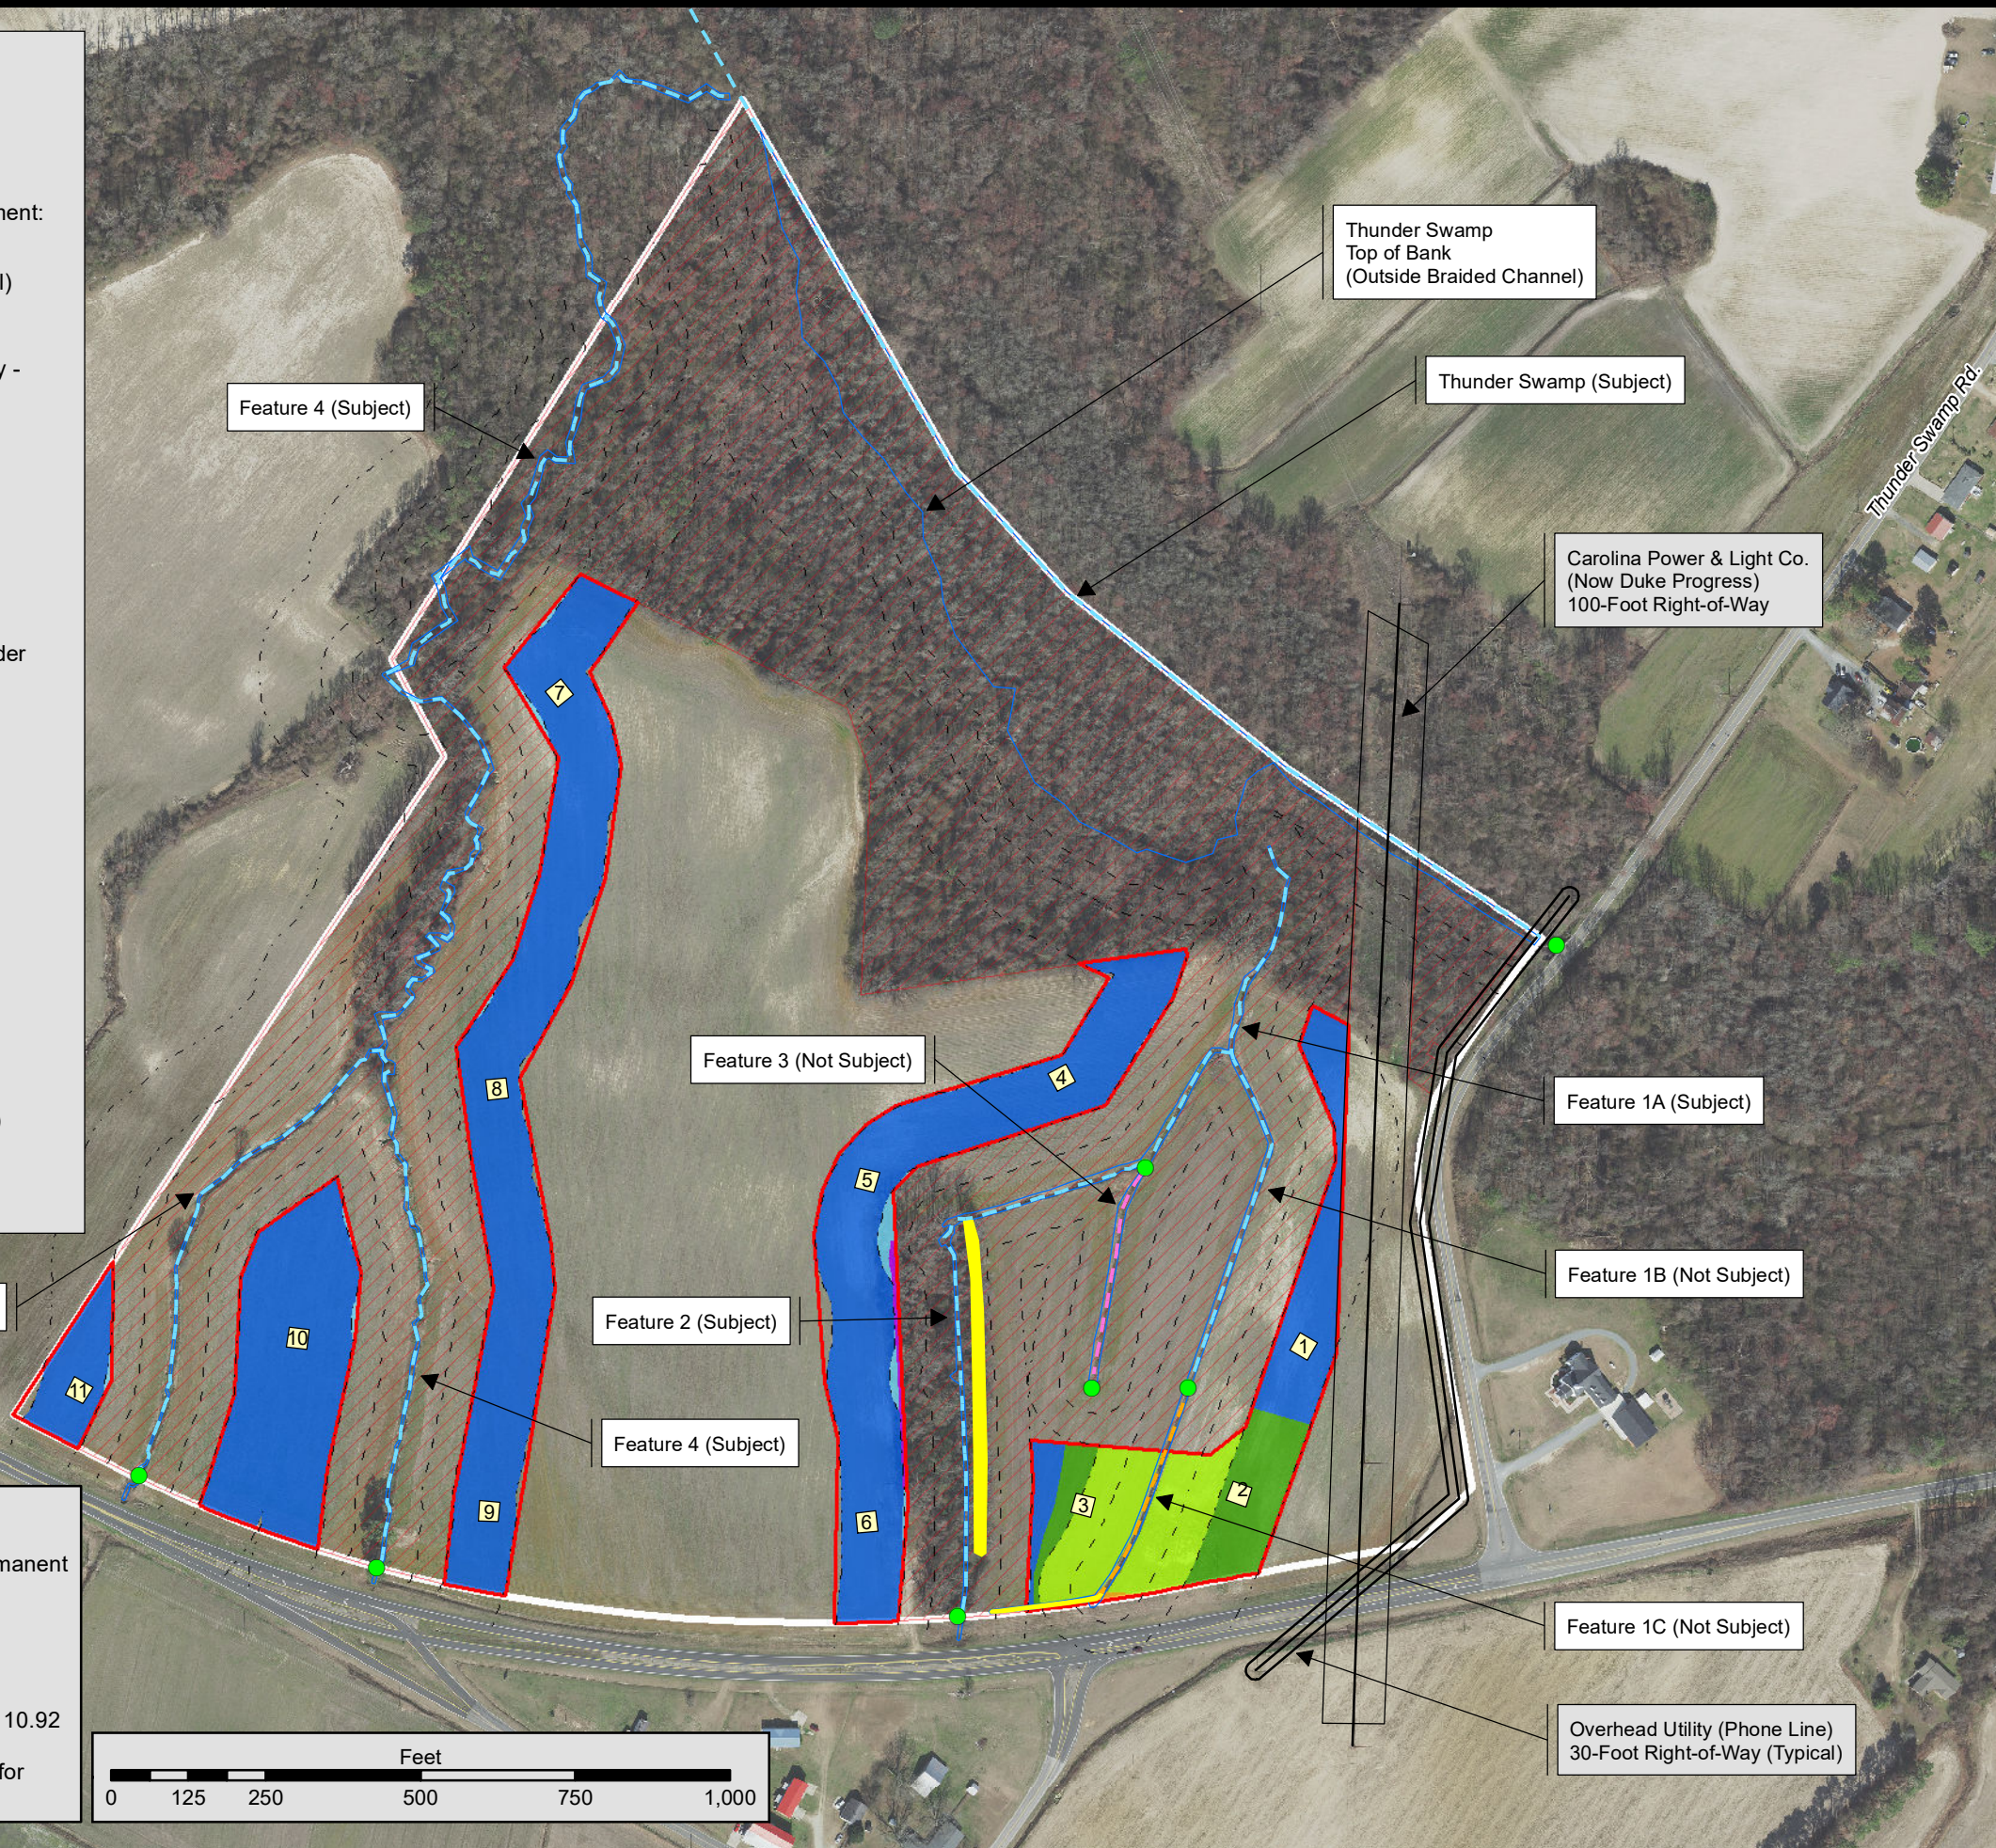
**FIGURE  
 2**

Title:  
**CURRENT  
 CONDITIONS  
 PLAN VIEW**

Quantitative sampling will include eleven (11) permanent 10 x10-meter vegetation plots, 2.02% of the Total Restoration Area (TRA).
